# North Gwendraeth Fawr Biosecurity Method Statement

| DOCUMENT INFORMATION | | | |
|---|---|---|---|
| Project | North Gwendraeth Fawr - Rail Bridge Abutments | | |
| Title | North Gwendraeth Fawr - Rail Bridge Abutments - Maintenance - Band 2 Works | | |
| Document Ref | BioSec-MS/2 | Issue / Revision | 2.0 |

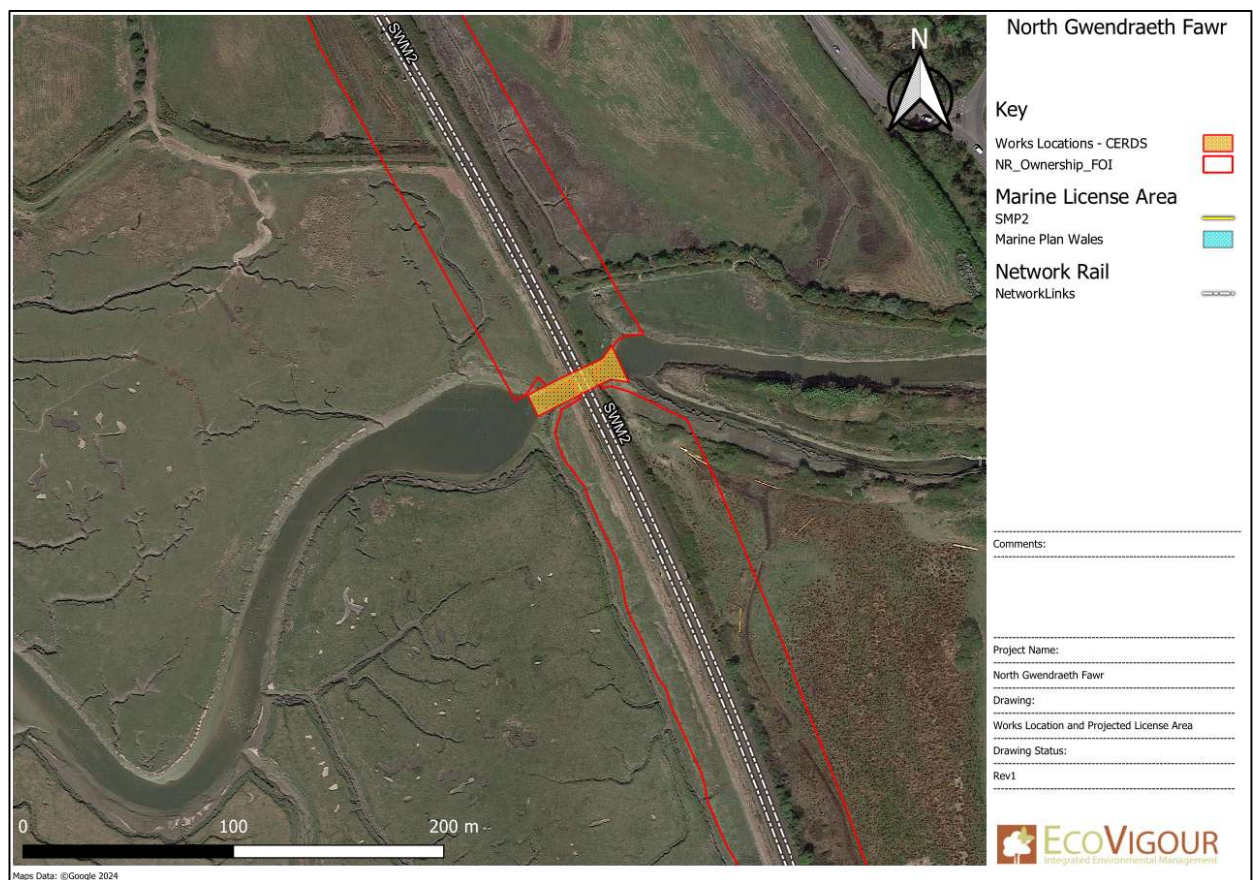
**Figure 1: Proposed Marine License Footprint.**

- 1.2.1 The work site focuses on the areas of wall masonry and scour protection measures at and below MHWS on the seaward facing side of the Sea Defence Abutments. Working access to the north and south abutment sections is only possible during low tide.
- 1.2.2 These will be accessed on foot during those periods, no machines will be utilised within the estuarine environment. A vehicle utilising an existing agricultural track may be used to provide material and supporting functions to teams during works. The vehicle will not be permitted off the track or improved grassland, as to ensure the adjacent saltmarsh areas are not impacted upon.
- 1.2.3 Any access within Saltmarsh habitats will be on foot only (see figure 9) for an indicative location of broad saltmarsh habitat. Material may be stored within the rail boundary, outside of the MHWS areas, where space allows.
