## Compliance Assessment Report CAR\_NRW0045108

**Permit being assessed:** BP3330LS.

**For:** Ty Mawr Farm Landfill, **held by:** Mr Griffith Wyn Griffiths and Mr Edward Lloyd Griffiths

**Type of assessment:** Site Inspection,

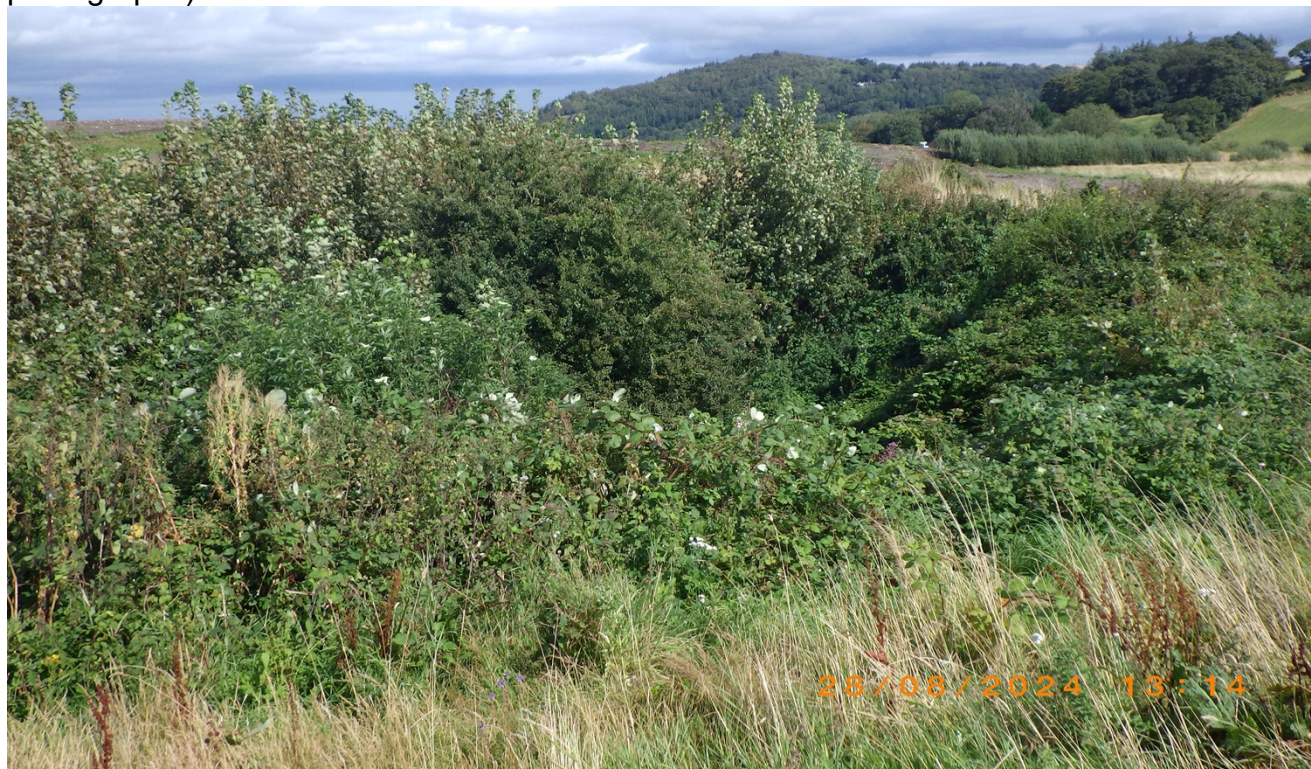
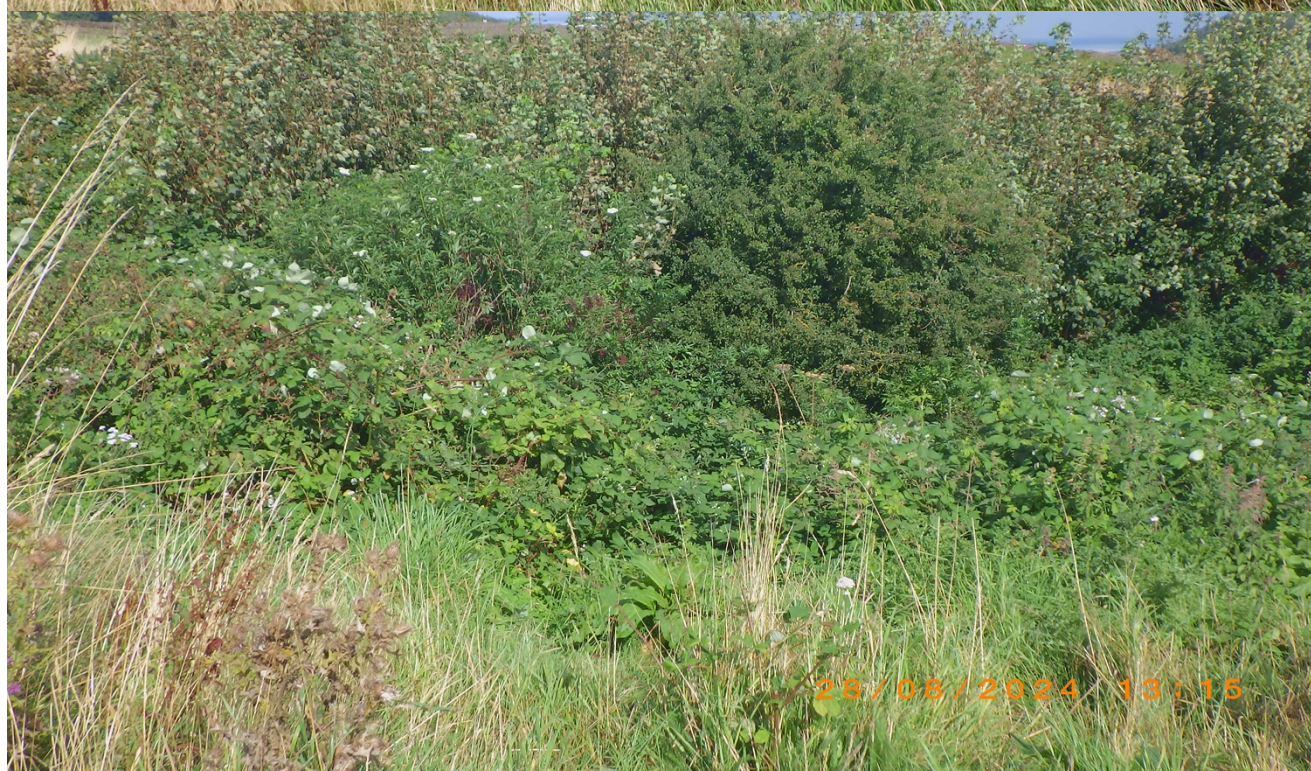
**Photographs showing location of monitoring point GW1**

The site of GW1 was very overgrown and there was no visible well/monitoring point due to the amount of vegetation. Officers tried to access the monitoring point, but no route could be found to GW1. According to monitoring results submitted by the operator, GW1 was last sampled in August 2024. However, this location looks like it has not been accessed for a significant amount of time. It is evident that the monitoring point is not being maintained

and access is very limited due to lack of maintenance. Officers continued to try and find the monitoring points as noted on drawing ESID4. Griffith led officers to two points he believed were boreholes for landfill gas monitoring. The photos below show the two locations.

**ACTION:** Review the condition of and re-instate all serviceable monitoring points as specified in schedule 4 of site permit. Ensure monitoring points are constructed in accordance with permit drawing ESID4 and guidance notes LFTGN02 and LFTGN03 (see links below).

Replace any un-serviceable infrastructure by 27th March 2025.

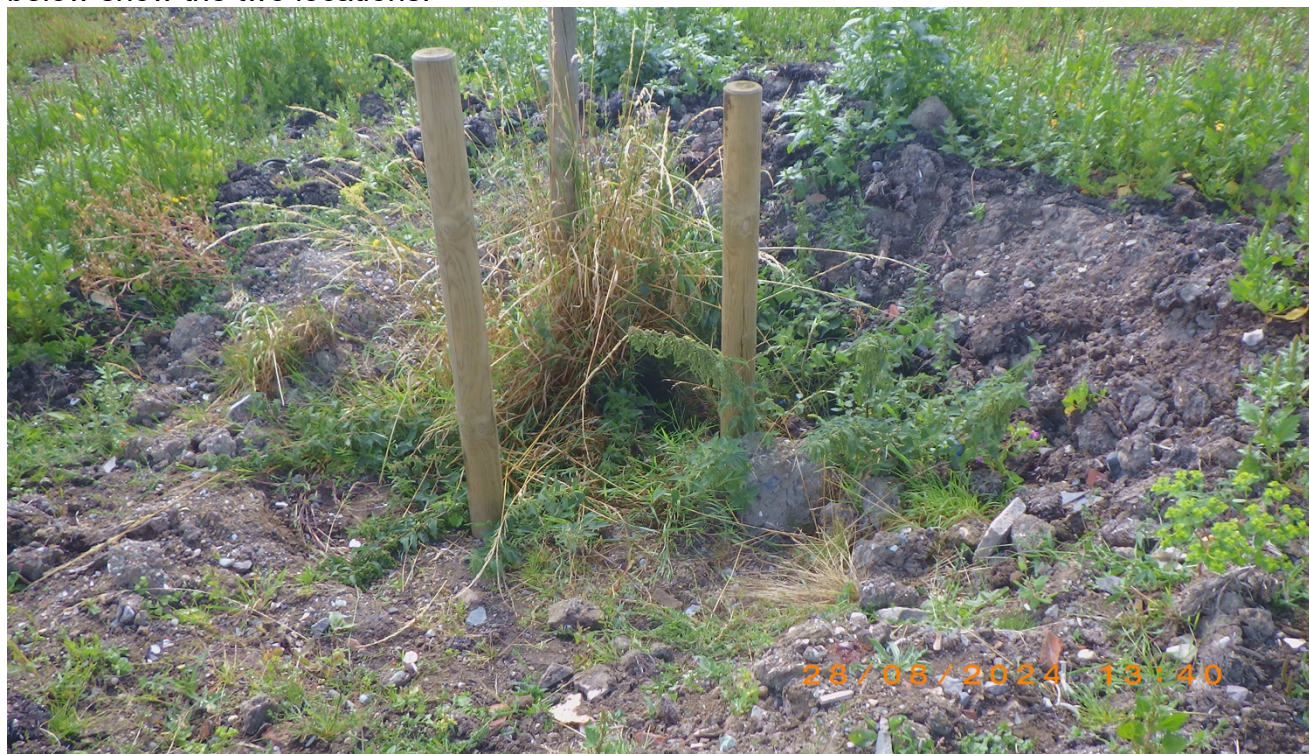
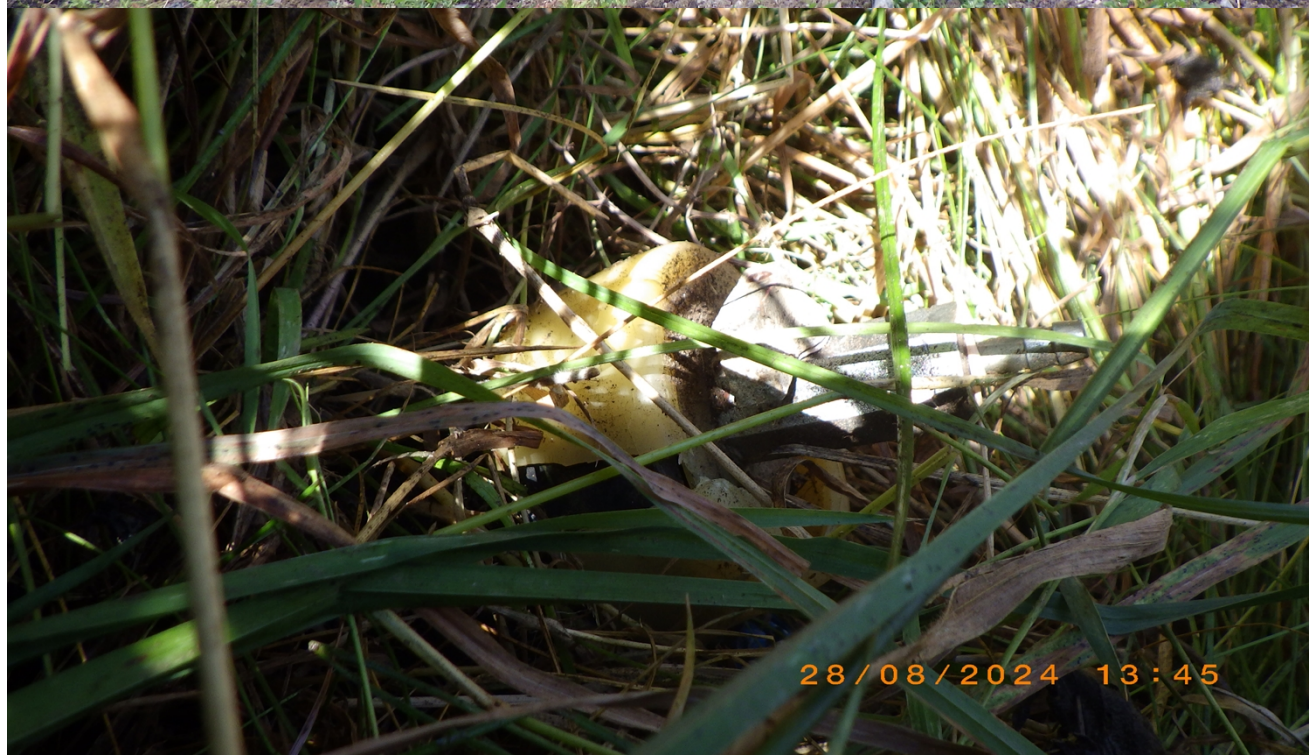
#### Photographs showing 2 monitoring points - references unknown

The first two photographs show one of the monitoring points, but Griffith was unsure which borehole/sample point this was. After moving some of the vegetation, a damaged gas tap was found. It was lying horizontal and the plastic surround was also broken. It has clearly been damaged by operations on site.

At this point, officers queried how monitoring data was being sampled and reported to NRW, when the monitoring infrastructure on site was clearly either inaccessible, damaged or location unknown. NRW believe that the submitted monitoring data is likely to be inaccurate and documents may have also been falsified.

**Because sampling is not being undertaken in accordance with permit condition 3.6.1, a CCS C2 score has been applied for this non-compliance. This permit breach has the potential to have a significant environmental impact.**

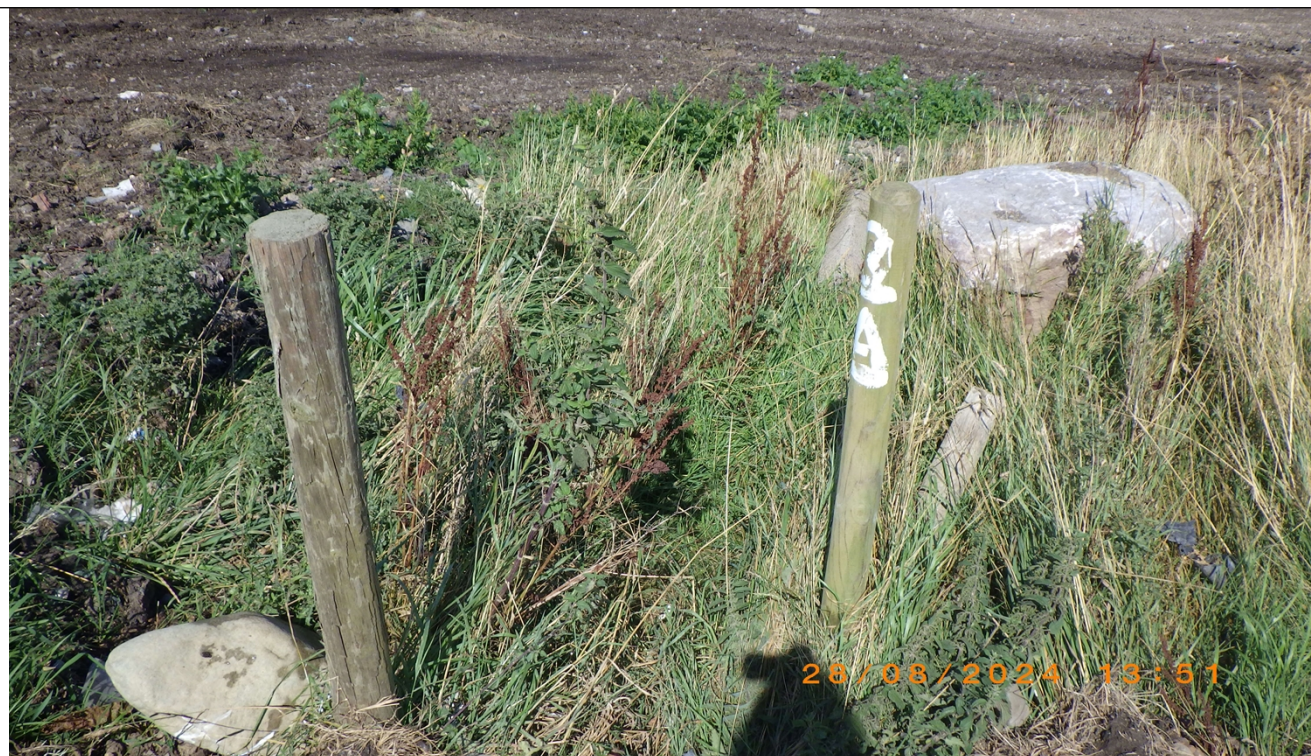
The third photograph shows a further monitoring location, however Griffith was unsure which borehole it was and he could not find the headworks of the borehole.

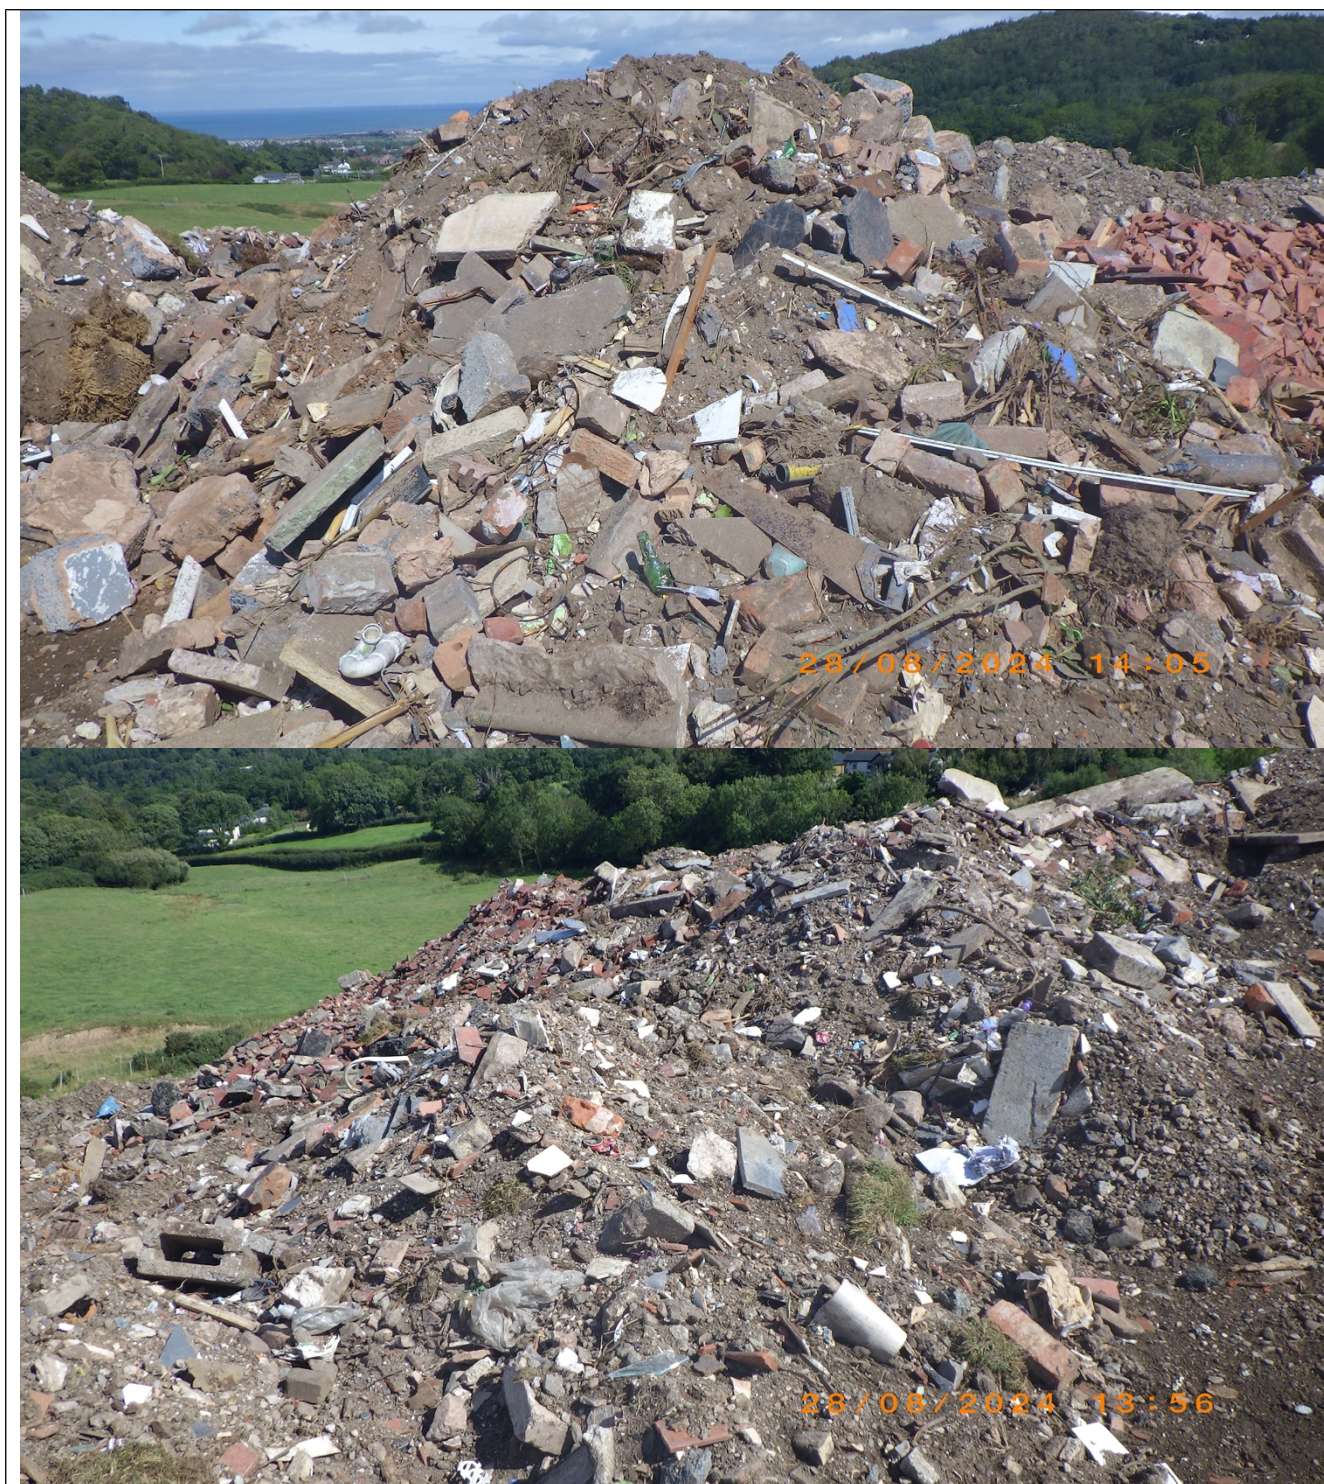
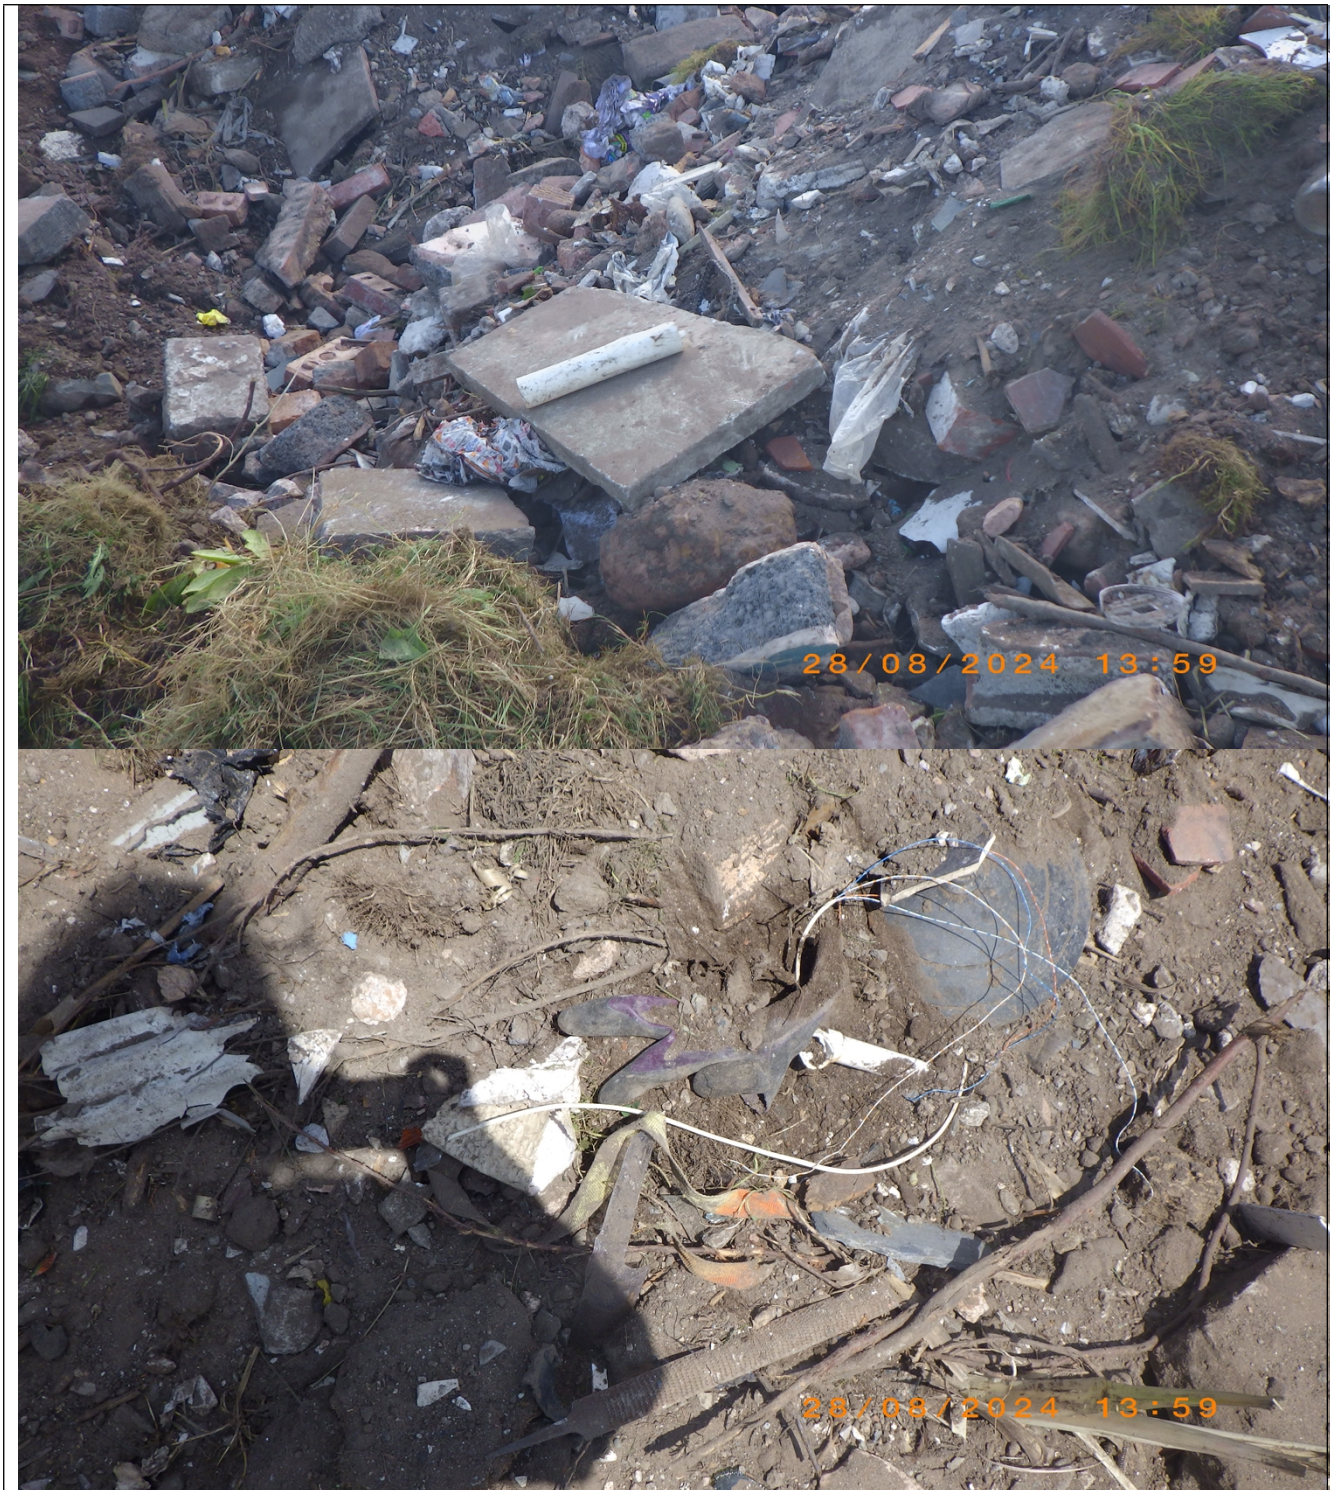
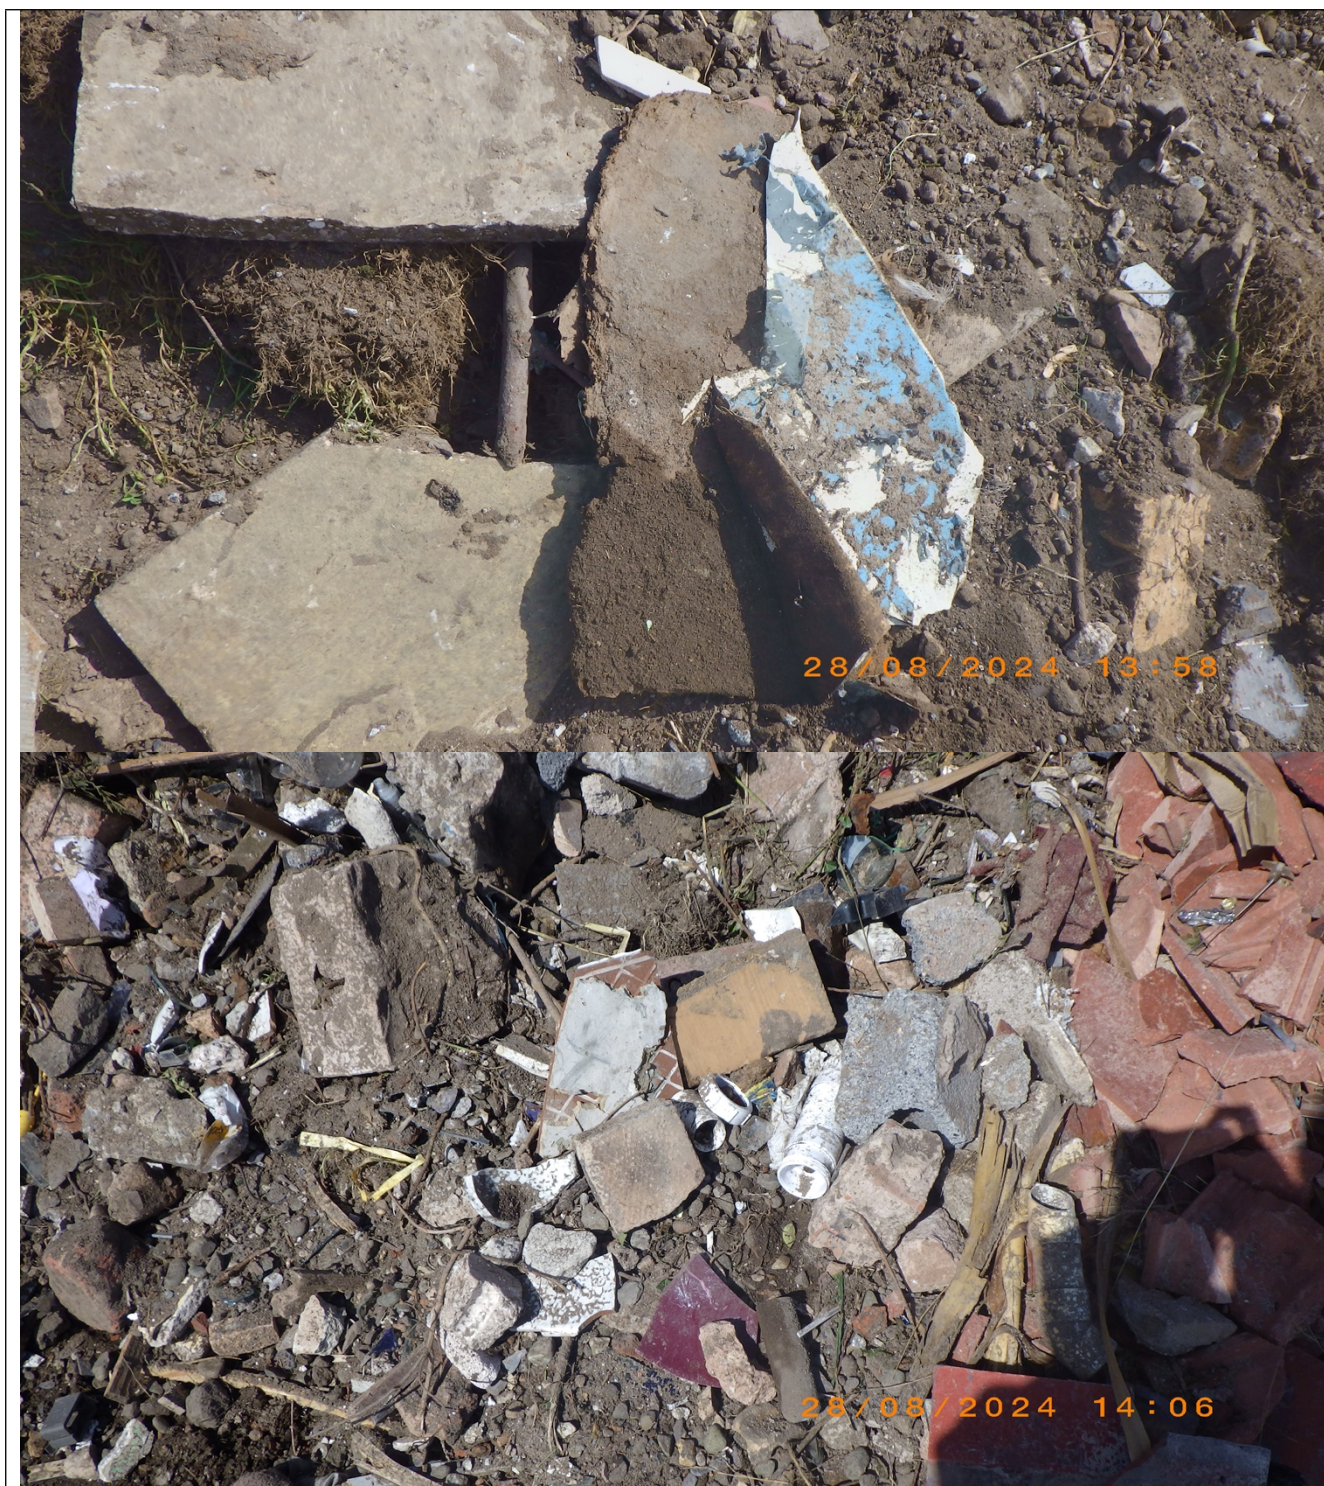
**Photographs showing waste deposited on site**

The above photographs show waste that was deposited on site that morning (28/08/2024). Waste Transfer Notes were requested for this waste movement, which show 15.6 tonnes of waste going into site across two loads, described as 'soil and stone' and coded 17-05-04. It is evident from the photographs that this waste has been inaccurately coded and described. It appeared to be a variety of mixed construction and demolition waste. There was also a significant amount of contamination. This waste had been deposited by another known permitted waste operator.

Within the deposited waste, officers identified parts of plastic piping, rubber gloves, metals including a saw, electrical wiring, plant material, plastic bags, plastic bottles, plasterboard and other various contaminants.

The producer of this waste has failed to correctly classify their waste. Given the visual nature of this waste, Ty Mawr Farm Landfill should not have accepted this waste to site. The landfill is only permitted to accept specific inert waste. The waste shown above is not entirely inert and is not 'soil and stone'.

**The permit has been scored a CCS C3 for this permit breach. The site has accepted waste that has clearly been mis-described. Within the waste deposit was biodegradable waste, plastics, metals etc, that are not inert and have the potential to degrade, either causing production of landfill gas or impact to surface/groundwater.**

**ACTION: Ensure all non-complaint waste is removed from site and taken to a suitably authorised facility. Amend EMS procedures, to ensure site has thorough waste acceptance procedures in place.**
