Compliance Assessment Report CAR_NRW0045513

Permit being assessed: CB3797CA.

For: Units 9 & 10, **held by:** New Horizon Biofuel and Animal Bedding Co Ltd

Type of assessment: Site Inspection,

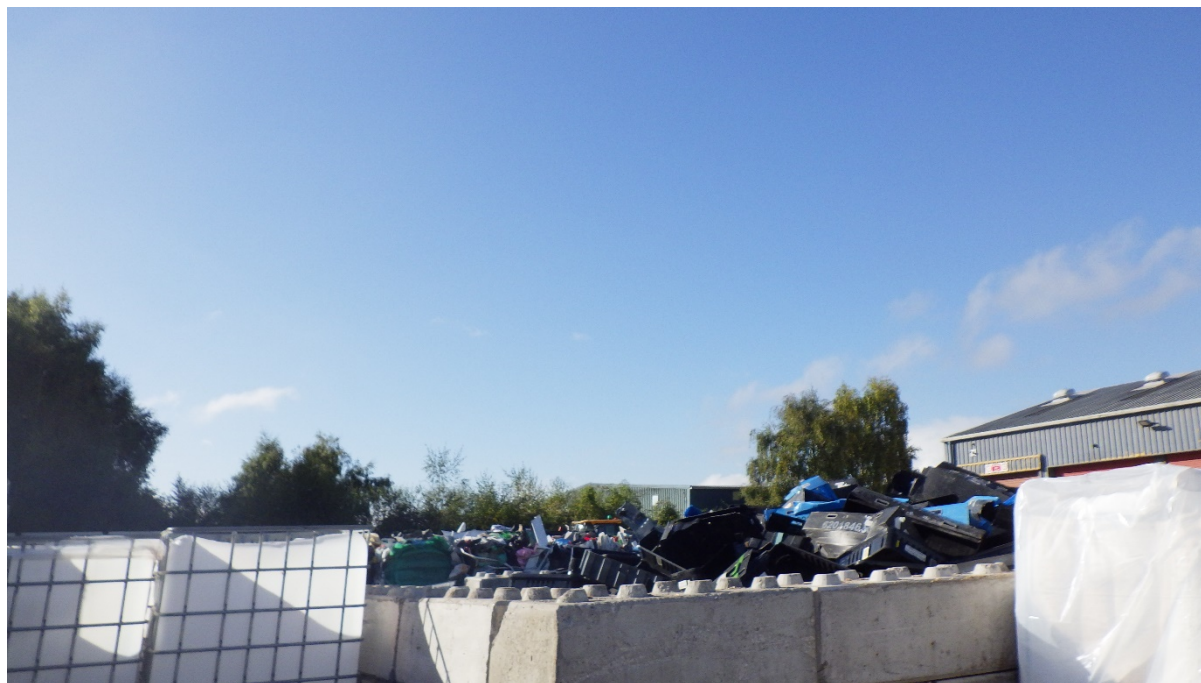
The fire walls were not of the required height, the waste stored was overspilling onto the next storage bays in places, the distance between the storage bays and the proposed tyre recycling unit was approximately 4 metres, and not 19m as stated on site plan.

These changes create an increased risk for fire to travel between waste piles and of pollution in the event of a fire.

Waste stored at Unit 11

Action: Please remove all waste from the storage areas at Unit 11 and store in approved storage areas available on site. Please comply by the **8th of November 2024**.

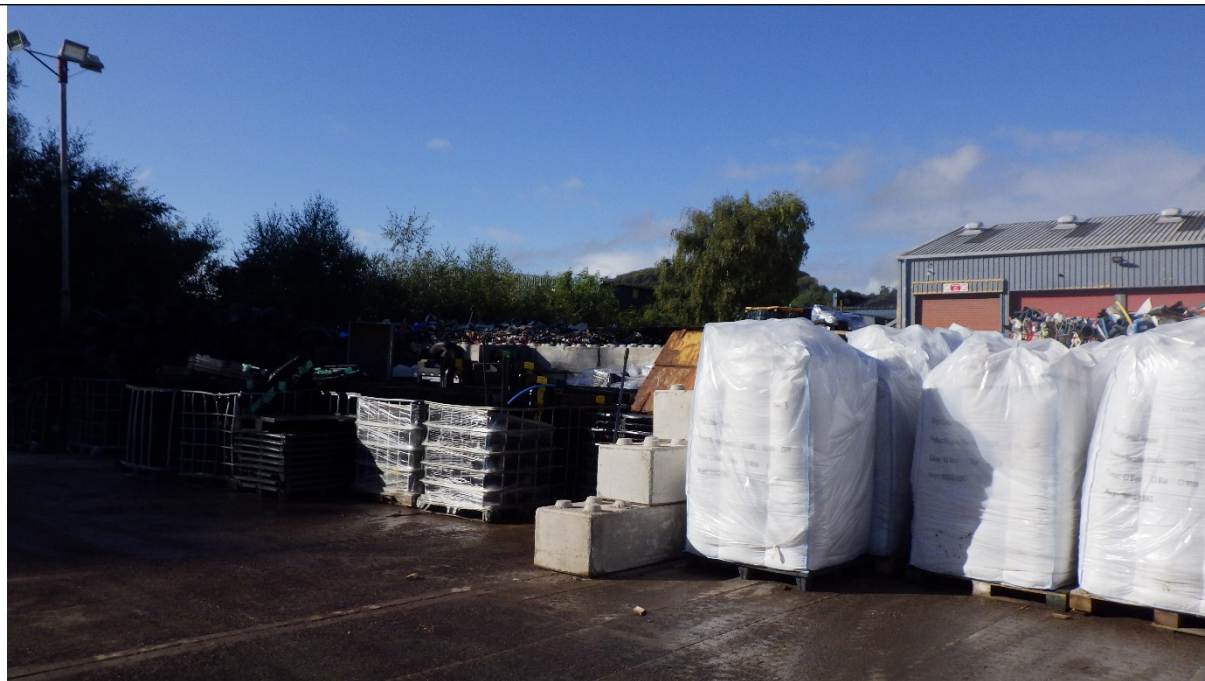
Waste at Unit 11

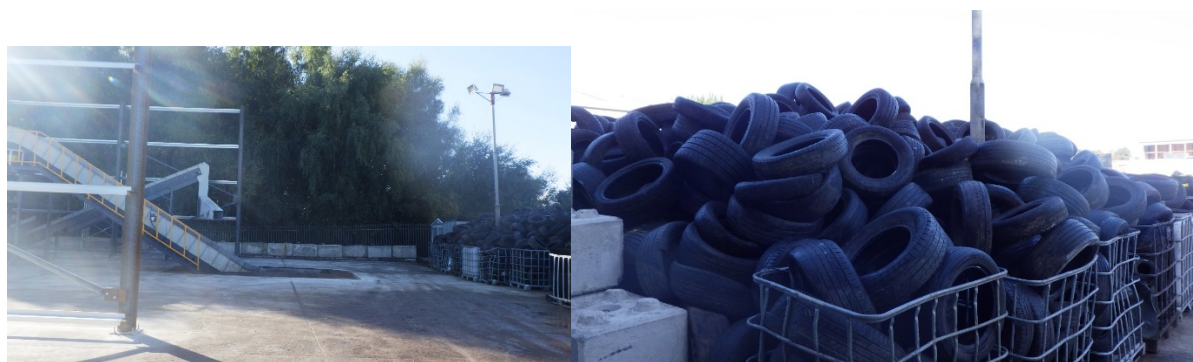
Waste tyres stored at Unit 11

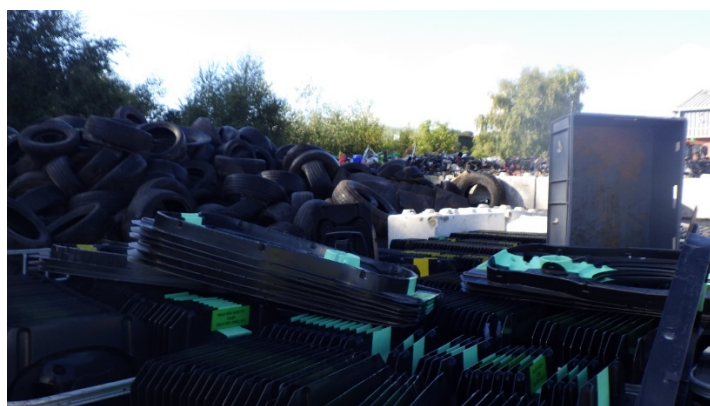
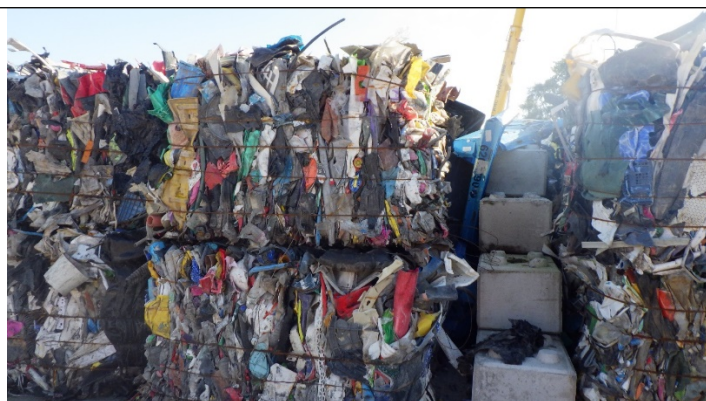
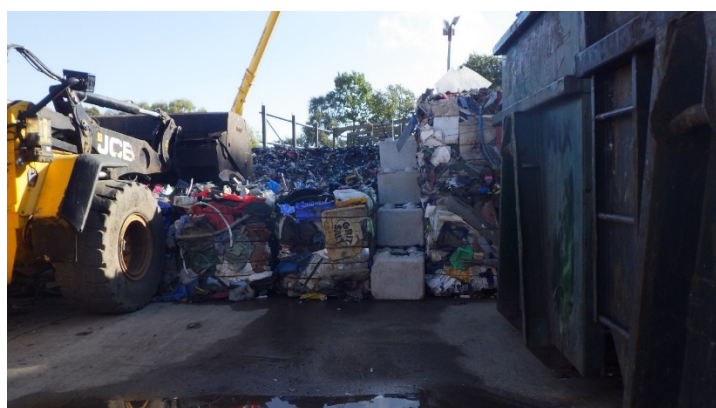
Waste stored higher than concrete fire walls

This is a breach of the permit condition and has been given a **C3** score as activities have started in this area of the site prior to the relevant infrastructure being demonstrated as fit for purpose to NRW.

Please ensure the storage bays are as detailed in the approved site plan or, alternatively, should you wish to change the storage arrangements, revise and submit a revised site plan detailing the changes for assessment.

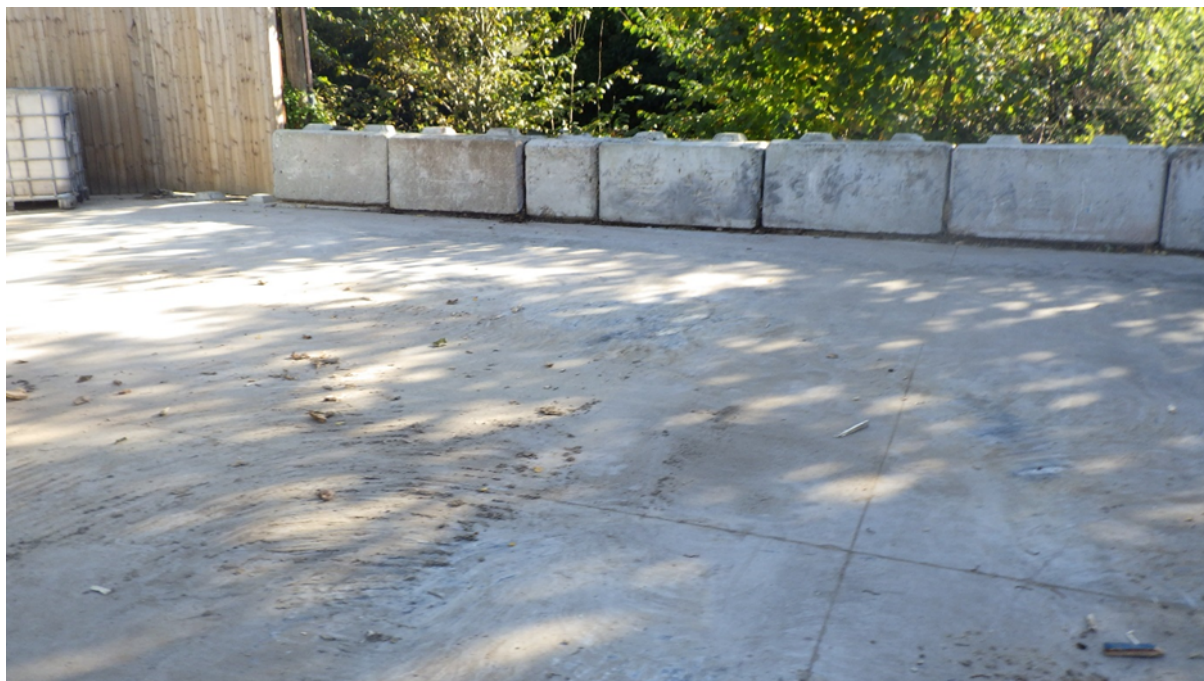
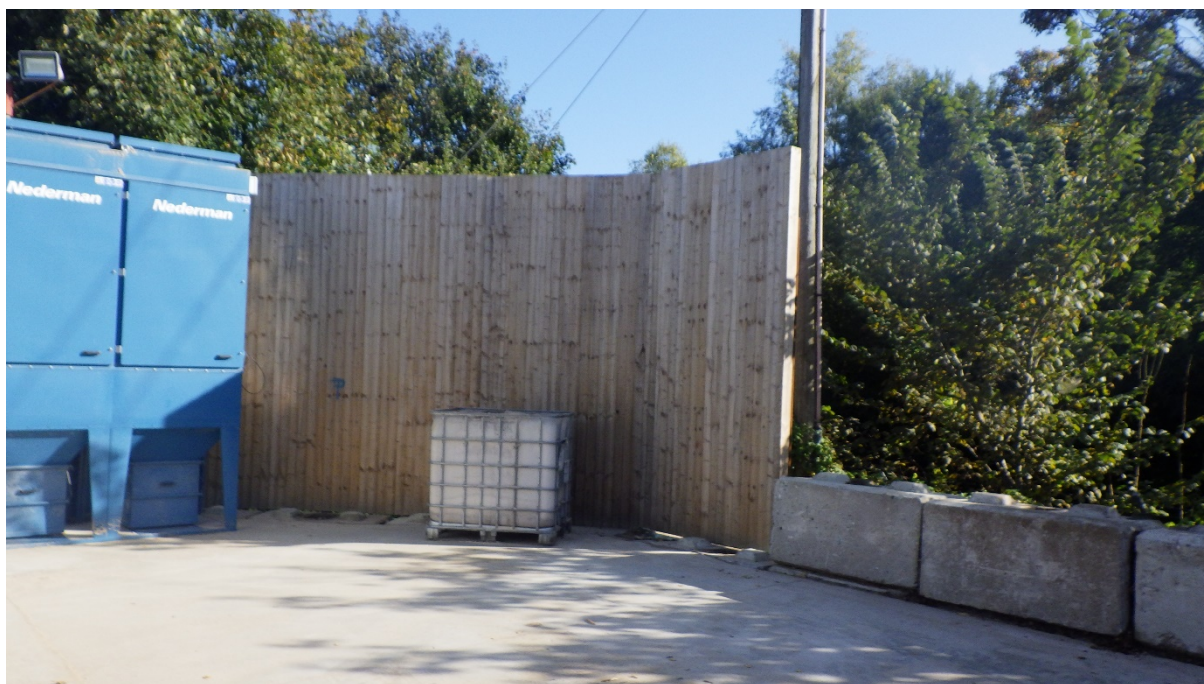
It was noted that the wall construction was not as detailed in the site plan submitted with the permit variation. The 3m high acoustic Lego block wall was replaced by a wooden panel wall next to the dust extraction filters. The remaining part of the wall which, according to the site plan, follows the site boundary, past the tyre recycling building and up to where the storage area 17 is located, was not in place.

This change may affect the noise emissions from site. Mr Thomas stated that Sol acoustics were contracted to conduct tests on site. Depending on the results a decision will be made if the wall is still needed.

Wooden panel wall

Action: Please ensure that the wall is constructed as detailed in the Environment Noise Impact assessment and the site plan.

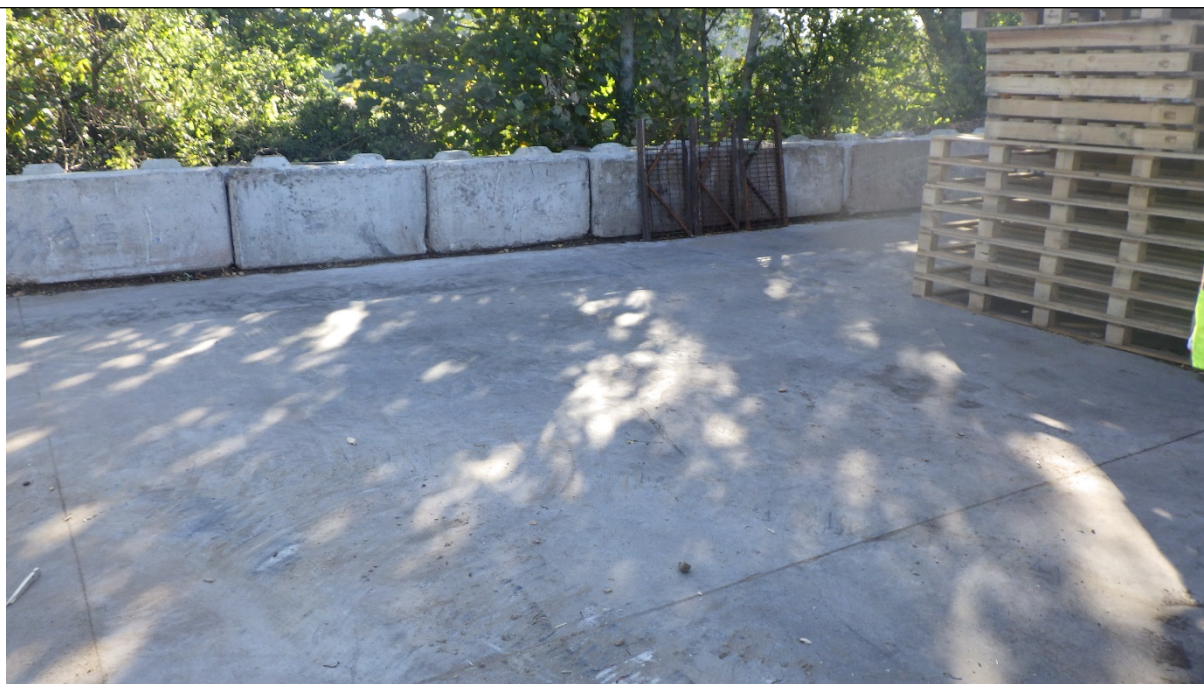
Section of the wall detailed on the site plan as 3m high concrete Lego blocks, not constructed

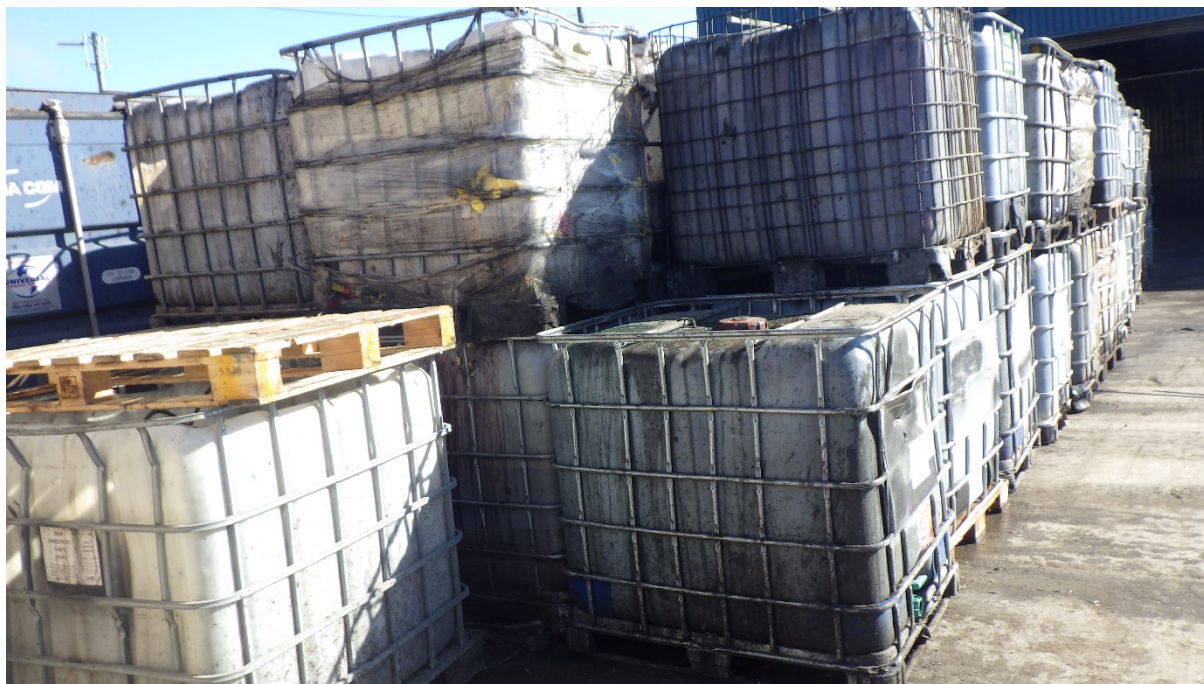
IBC with waste water stored outside the building

The waste water should not be stored in the yard for any longer that is absolutely necessary, for the purpose of collection, as it creates a pollution risk.

Action: Please ensure that the storage of waste water is compliant with the site EMS. For immediate compliance.

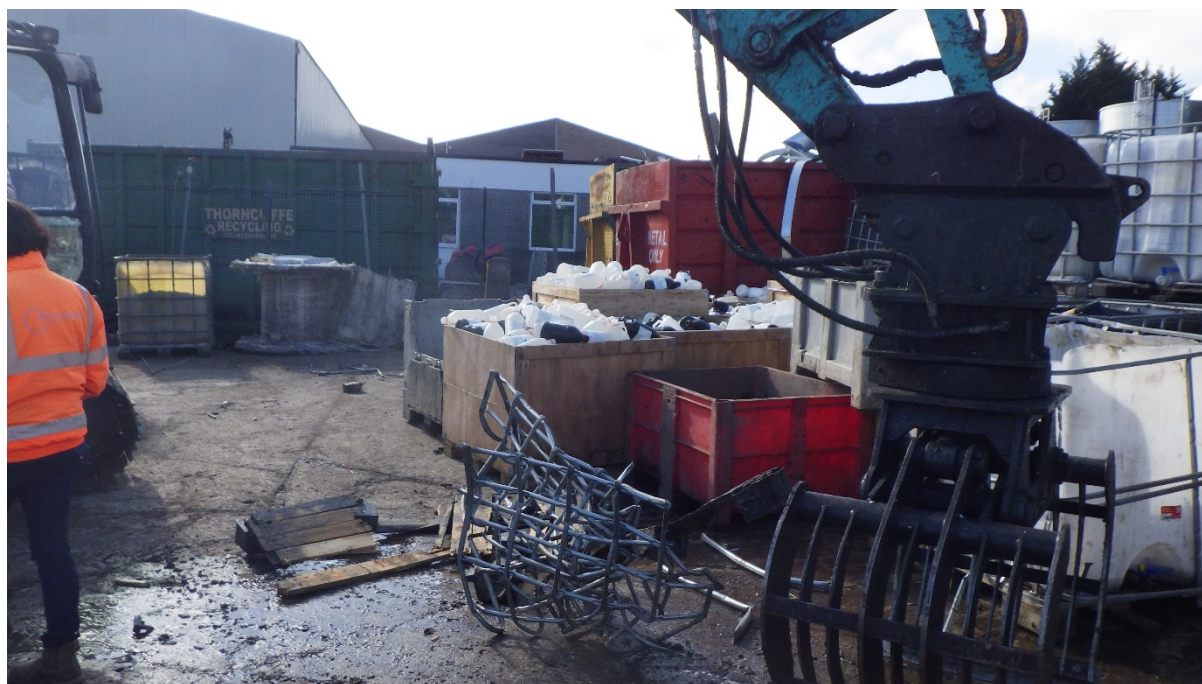
It was pointed out that the works were affecting the storage arrangements and that the waste storage was not compliant with the site EMS and FPMP. The changes create a risk of pollution.

Quarantine area used as temporary storage

Action: Please ensure waste storage is compliant with the EMS and FPMP. Please comply by the 8th November.

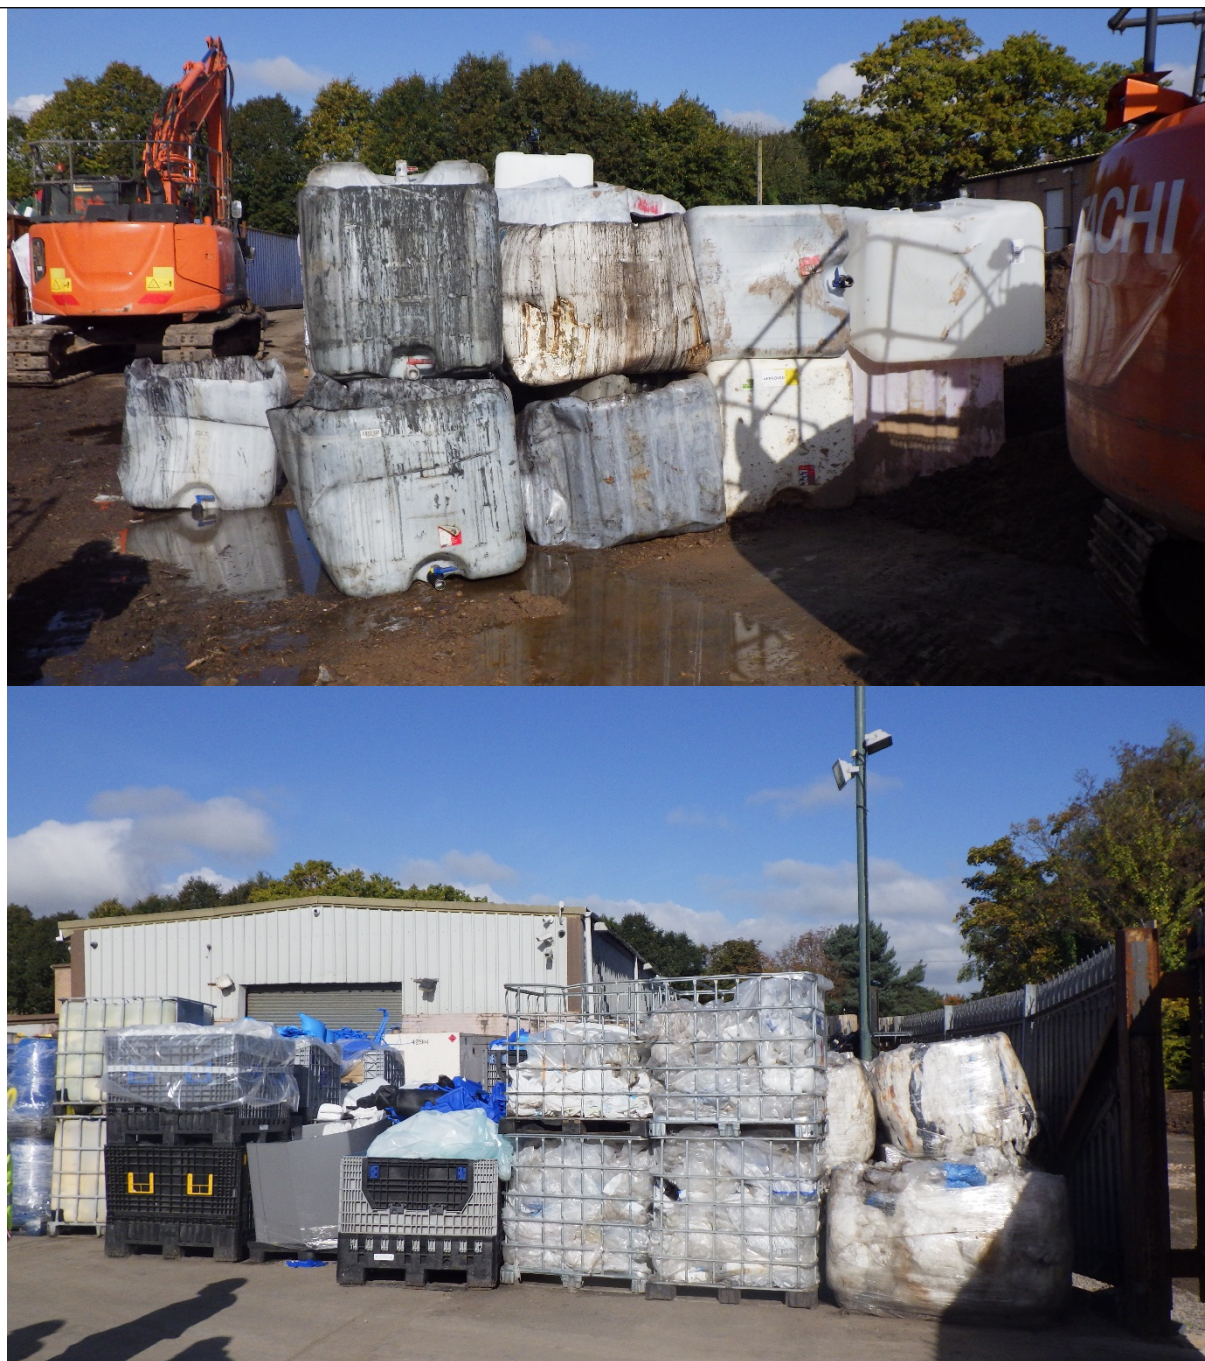
Storage of waste by the waste unloading area
