Compliance Assessment Report CAR_NRW0045544

Permit being assessed: CG0123301

For: GORSE HILL CARAVAN PARK TREFRIW ROA, held by GORSE HILL CARAVANS LTD

Type of assessment carried out: Site Inspection, Reason: Incident Response (Incident number: 2413279).

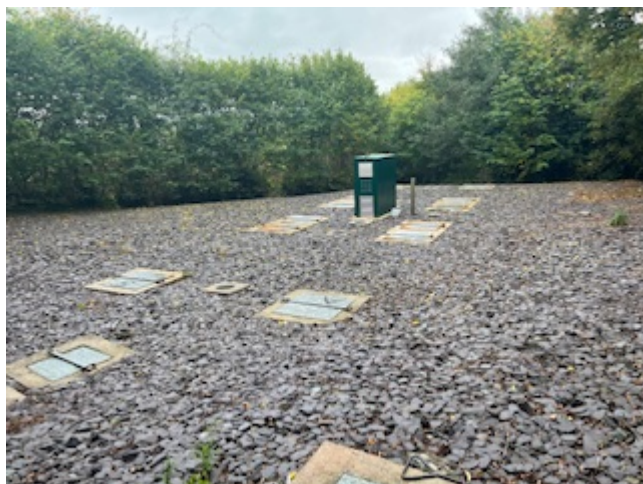
Image 1, below ground treatment system with a Left and Right bank. Banks A and B.

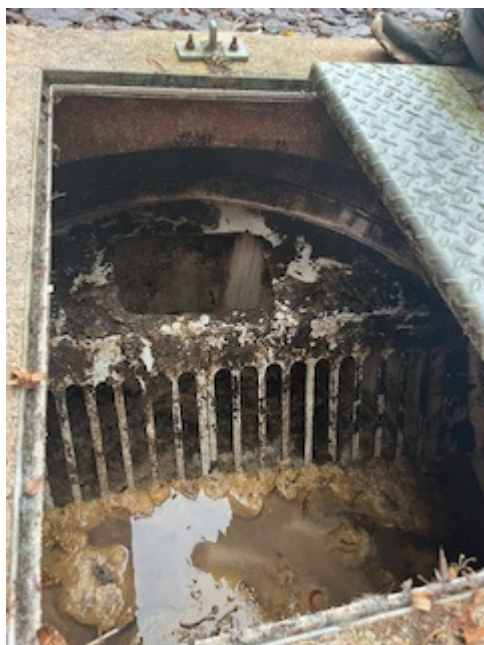
Image 2 Inlet screen

The inlet screen was intact, however there was significant build-up of rags/debris in this chamber suggesting it had not been emptied in quite some time. Flow was passing forward from here relatively un hindered.

- Ensure the package treatment plant is serviced and emptied on a regular basis
- Repair the faulty diffuser in the secondary aeration and media chamber.

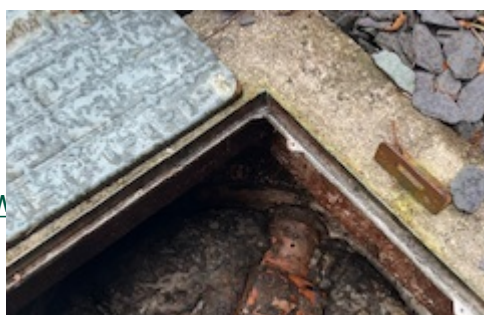
Image 3, Primary settlement chamber with distribution channels

The primary/distribution chamber had significant build-up of materials again suggesting the plant had not been emptied in some time. Flow from here at the point of inspection was only going to the right hand treatment bank (bank A) of the treatment plant.

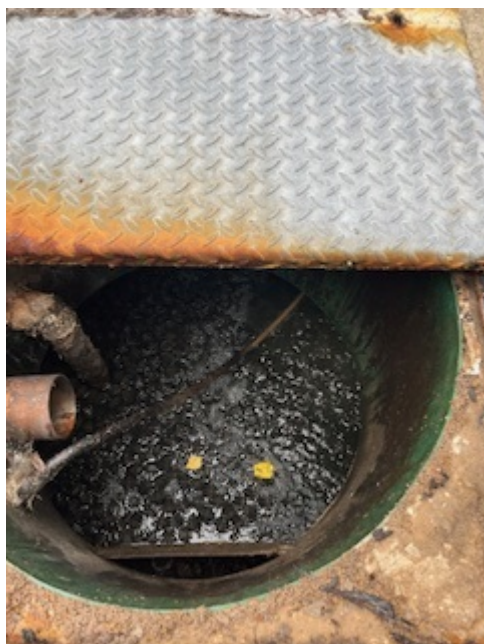
Image 4, Aeration and Media chamber.

The first of 2 of the media and aeration chambers was working nominally with treatment taking place.

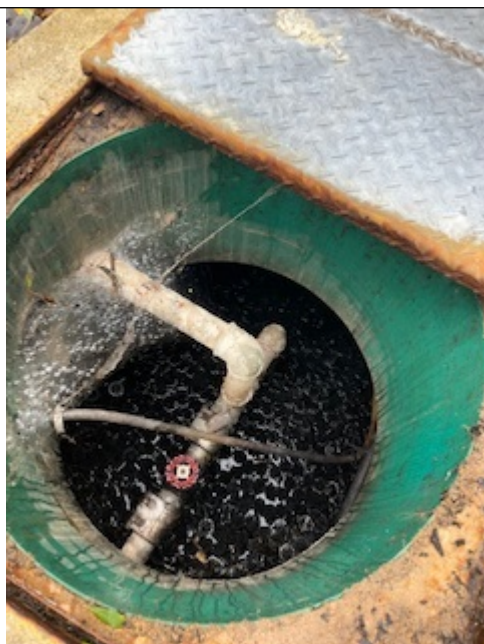
Image 5, Secondary Aeration and media chamber.

Secondary aeration media chamber, this chamber was not operating nominally diffuser was clearly in a state of disrepair and requires urgent attention.

NRW officers decided on site that due to the partial failing of the secondary aeration chamber and the amount of matter within the tanks it would be beneficial to carry out a sample of the end product to determine if treatment was being achieved and Permit Condition 4 was being met.

Please can the actions for emptying the plant and repairing the diffuser be carried out no later than 31st December 2024. There is an ongoing requirements for emptying and maintaining the plant throughout its operational life span.

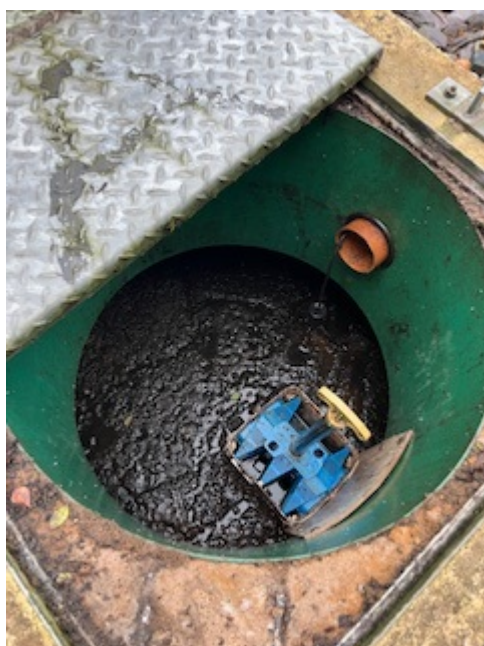
Image 6, final settlement chamber

The final settlement chamber had a significant amount of matter in suggesting treatment further back had been compromised.

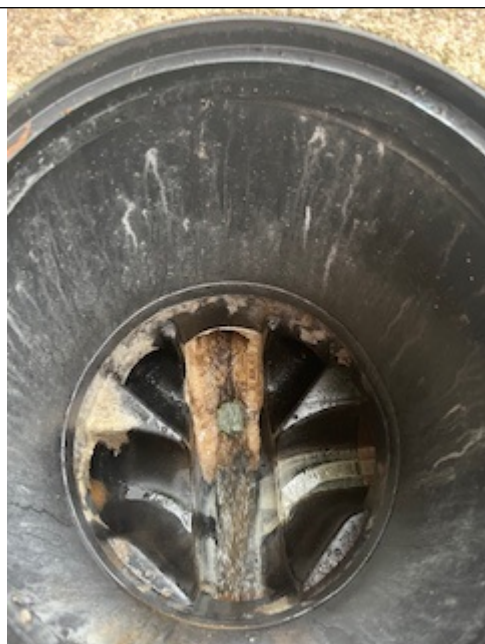
Image 7. Outlet chamber

The outlet chamber was free from any growth of sewage fungus.
