# Traeth Crugan

Beach renourishment and monitoring strategy

June 2024

| Document History and Authorisation | | |
|---|---|---|
| Document ref | R.4542 | |

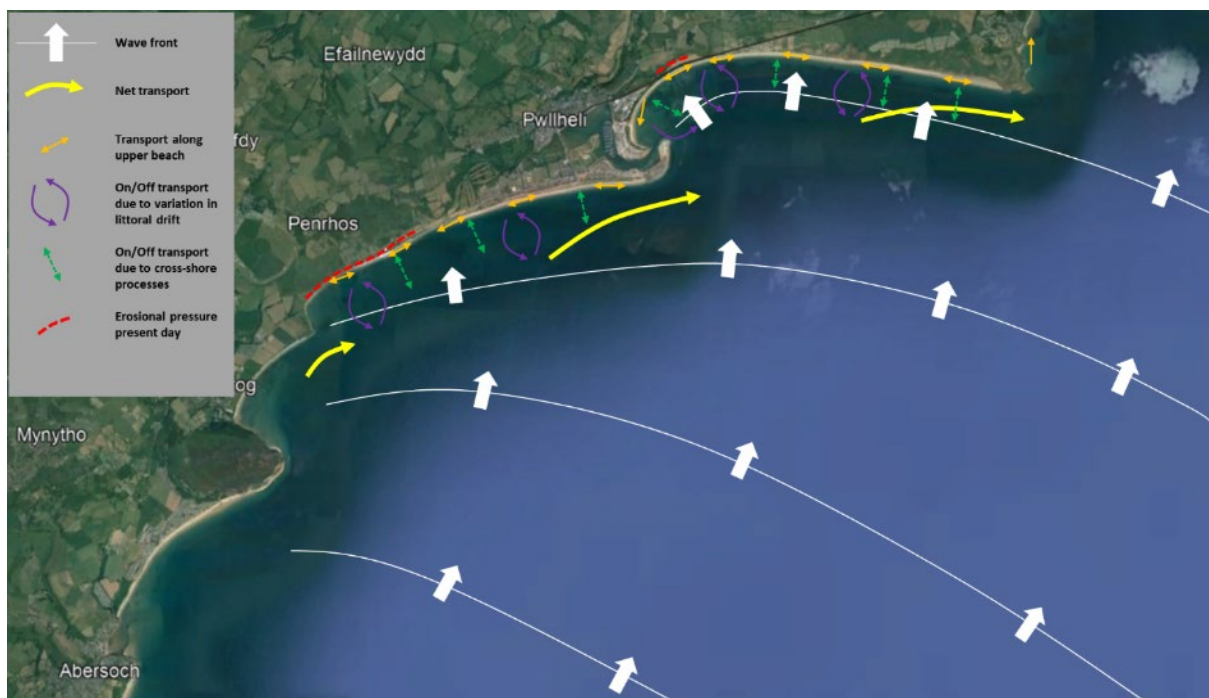
Figure 7. Conceptual understanding of sediment transport

As described above, the sediment transport processes along this section of frontage are complex. The Coastal Process Conceptual Understanding (ABPmer, 2022) contains detailed understanding of the Traeth Crugan frontage, their conceptual understanding visualised in Figure 7 (reproduced from ABPmer, 2022).

- The previous assessments differ in their view of drift convergence and drift divergence along the Traeth Crugan frontage. The concept of drift convergence and divergence along the frontages should be treated with caution, whilst it is noted that under certain wave conditions these will occur, the shoreline is generally fixed by headlands, the bed features along the shoreline, and the prevailing wave conditions.

- Along the section with no revetment towards the western end of the Traeth Crugan frontage, where the shoreline protrudes seawards of the general bay shape, the sediment budget figure in Halcrow (2011), identifies erosion, but in the conceptual understanding plot within the same report reports accretion. Here, the shoreline protrudes seaward due to the offshore shoals, however either side of this there has been erosional pressures. From more recent imagery the central, without revetment, section also appears to have been afforded some erosion. The shoreline alignment in this location may be variable, subject to changes in offshore bathymetry.

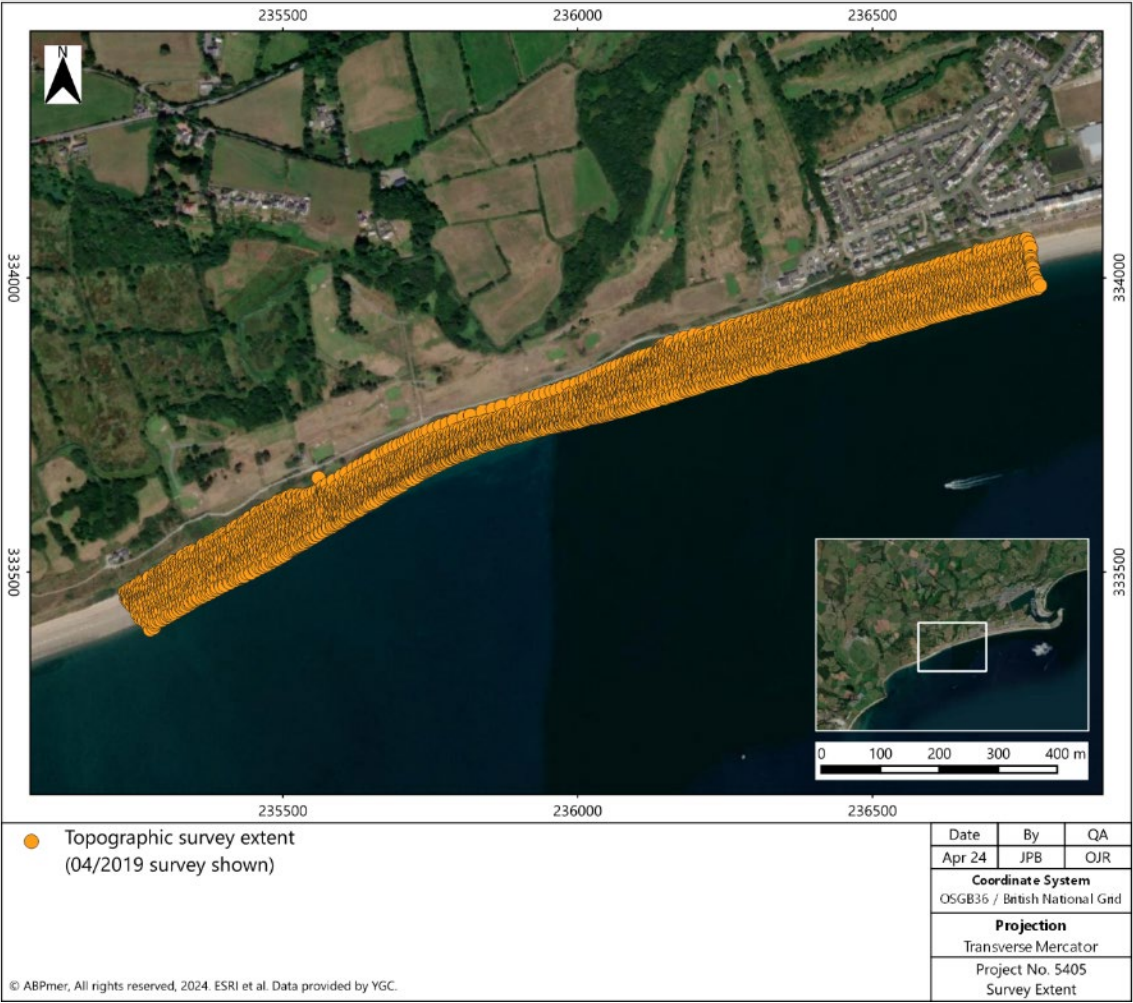
Figure 9. Topographic survey typical extent of data provided by YGC

- From 2002 to 2019, point topographic data covering a section of the dry beach at low water. The horizontal resolution of the data improved over the years from about 8 to 15 m in 2002 to about 5 m in 2019. The typical coverage of these surveys is shown in Figure 9.

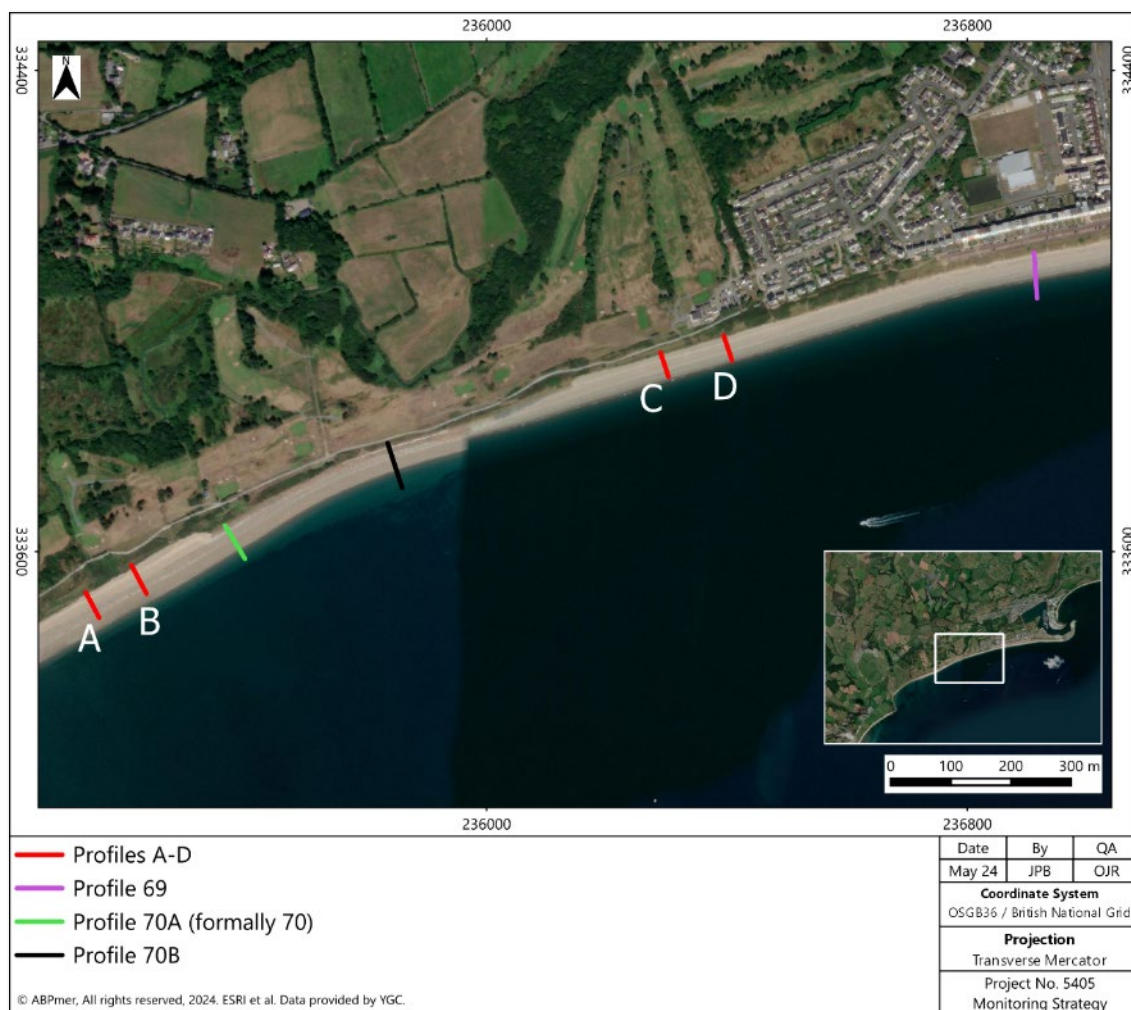
Figure 21. Monitoring recommendations in terms of beach profiles

- **Beach and renourished area tracking:** Biannual monitoring of the beach and the nourished backshore. The frequency and locations of beach surveying in recent years has been very variable. It would be advisable to return to biannual monitoring of the beach (and its backshore) as this would help manage the renourishment and the revetment. Ideally, topographic surveys of the beach and its backshore would be recommended, either with LiDAR or point data

covering the crest, base of the renourishment, hinterland and beach. If topographic surveys were not available, at a minimum, survey two profiles either side of the renourishment. These two profiles would be in similar positions to the derived transects in Figure 17, plus Profile 70 and a new profile in the Eastern end of the revetment, Profile 70B, as well as Profile 69. These recommended seven profiles are shown in Figure 21. These should be surveyed with at least 1 m horizontal resolution. Their seaward limit should aim to be MLWS and the landward end should reach beyond the expected point of storm wave influence, so should reach the vegetated area behind the renourishment.

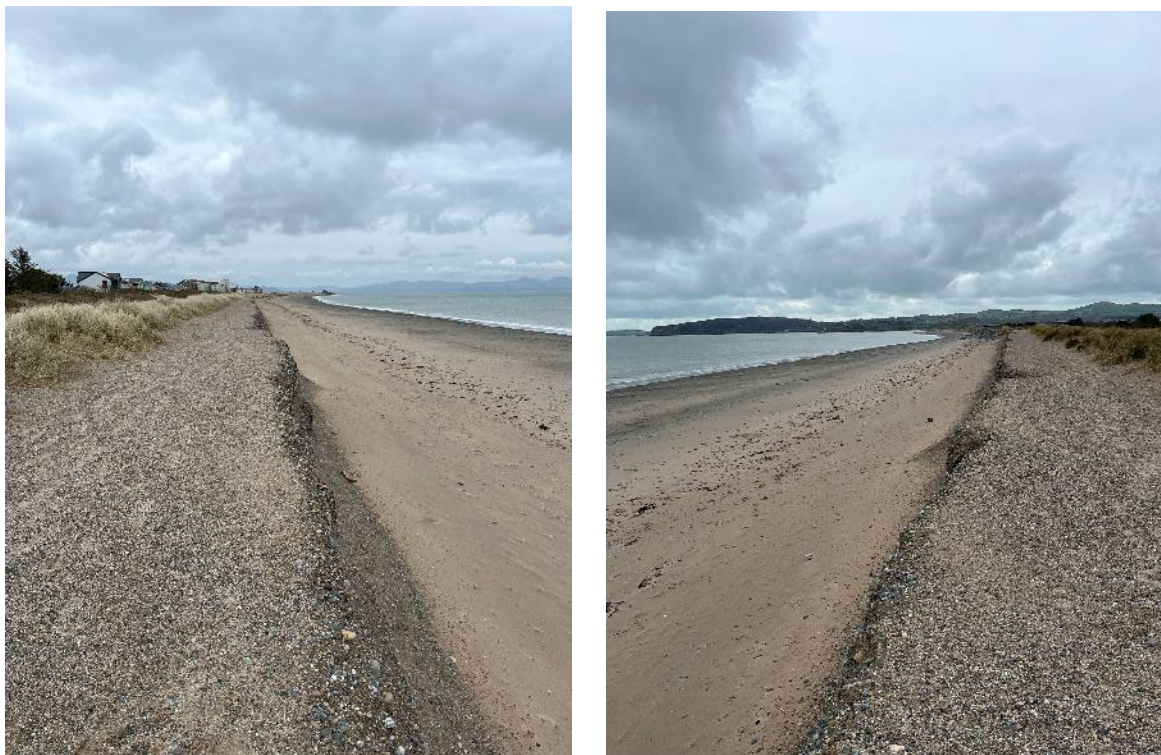
The area renourished was always denuded of vegetation, see for example Figure F1, where the steep berm of the renourishment is apparent. The renourishment material is clearly identified as the area without vegetation.

Figure F1. Left: Looking East towards the start of the renourishment at the East. Right: same location looking West

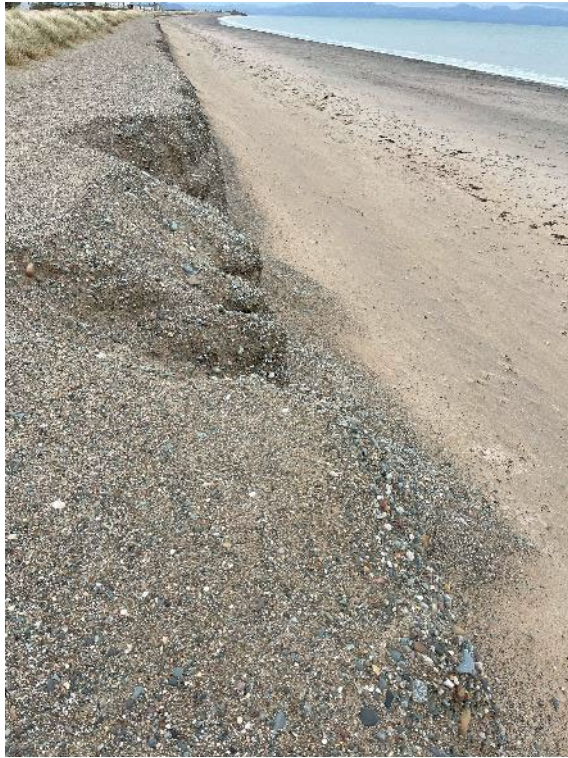
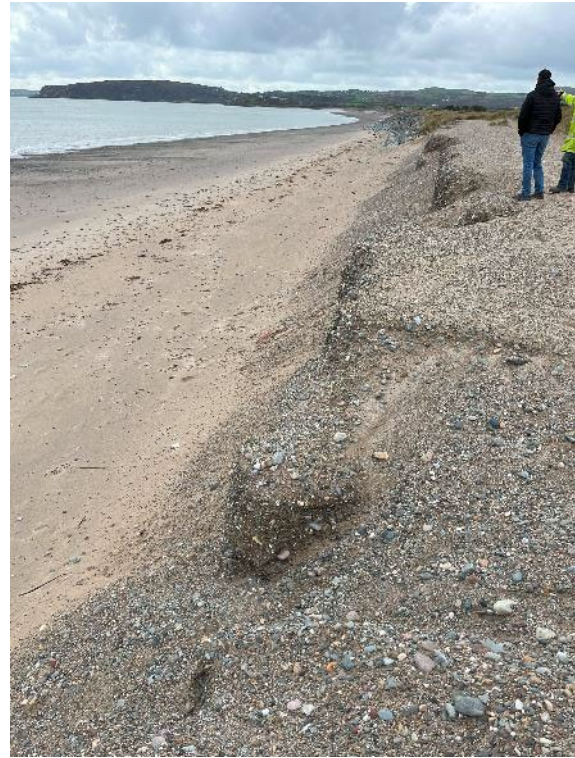
**Figure F2.** Left: Looking East towards the start of the renourishment at the East. Right: same location looking West

The Eastern part of the renourishment is lower than the Western part, as it will be seen in the photos. The photos below show slumping of the renourishing material and the nearly vertical face of the renourishment.

The renourishment material was a mix of gravel and sand. The surficial beach material, at the base of the nourishment, was mostly sand on this part of the beach. Towards the water line, there seemed to be patches of fine gravel material on top of the sand. The front face of the renourishment area to the East of the Eastern end of the revetment was not as vertical, see Figure F3, and the height of the top of the renourishment was higher than in the Eastern end (Figure F1). In Figure F3, it is appreciated how as soon as the revetments starts the vegetation is very abundant.

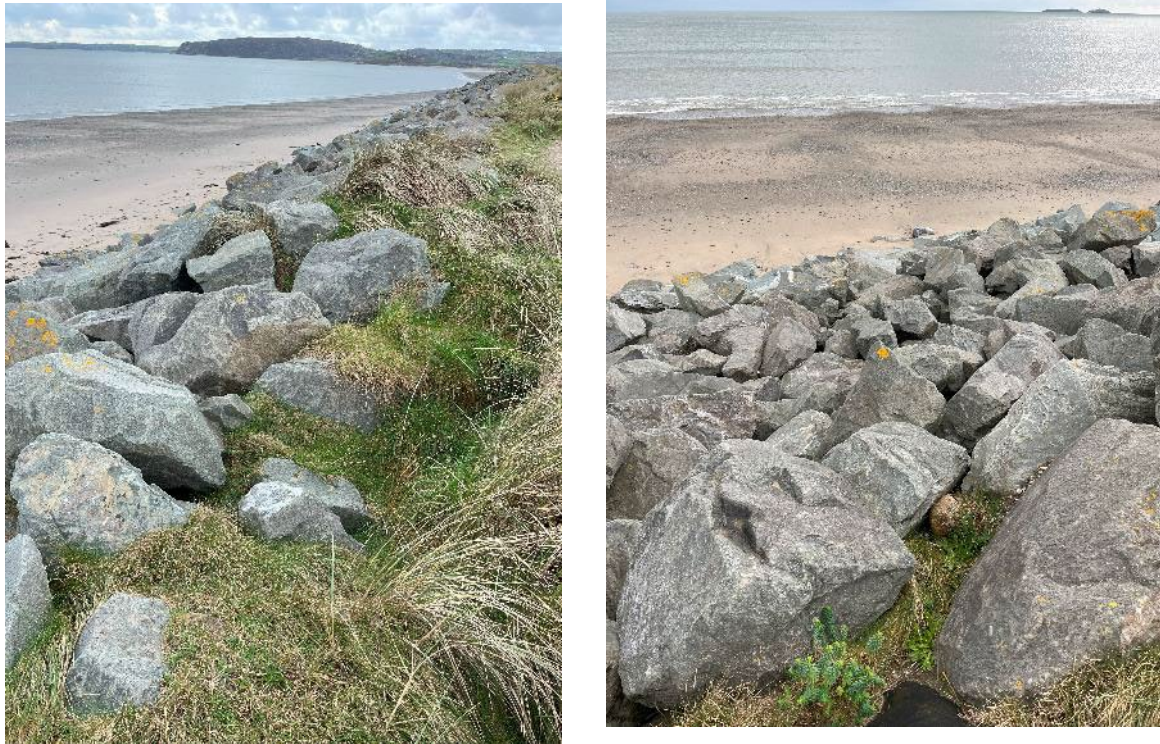
The rocks at the Eastern end of the revetment have fallen, see Figure F4.

Figure F4. Left: Looking towards the East; Right: looking down onto the beach

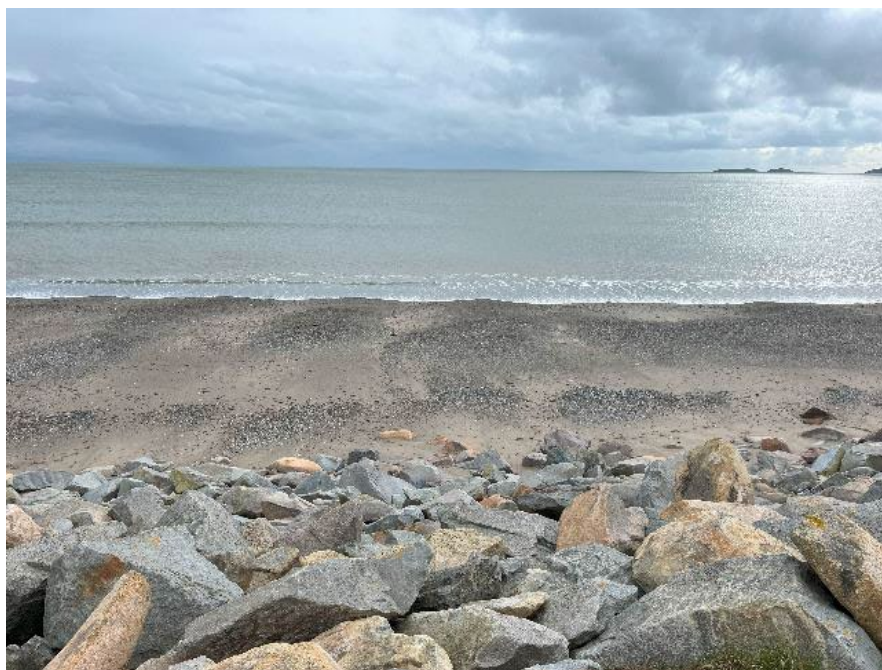
Figure F5 shows how the toe of the revetment has lost rocks. It also shows a cyclical pattern of the shingle on the sand on the beach associated with beach cusps on the edge of the beach.

Figure F5. Looking down onto the beach

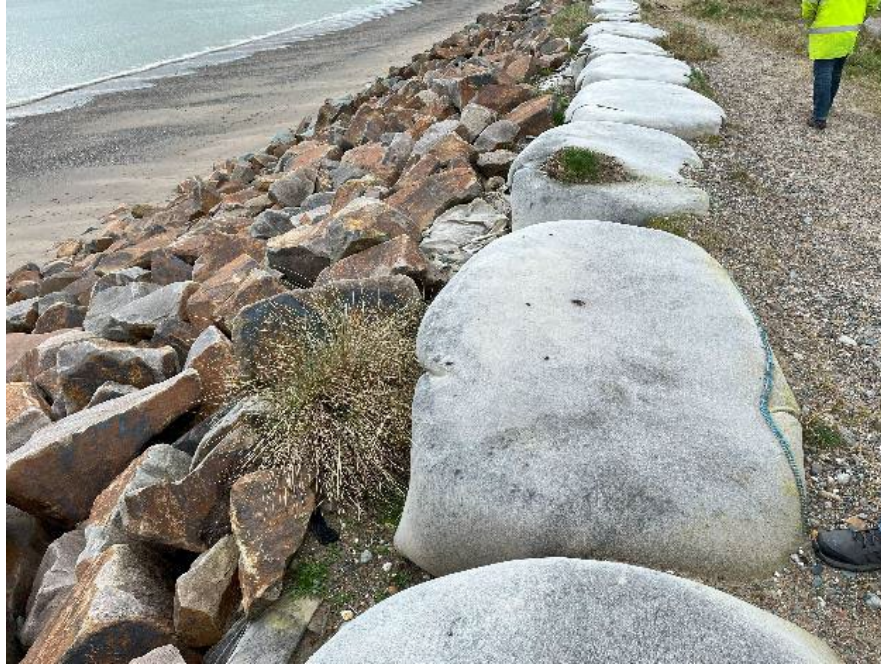
YGC/CGC representatives pointed to the repair work carried out in 2017 where about 200 bags of material from the harbour were placed on the top of the revetment (see Figure F6) and covered with sediment. The sediment is now long gone and although some bags have holes in them, most of them have remained intact. Anecdotally, the overtopping in this part of the revetment has been known to be higher than an average person's height on top of the revetment.

**Figure F6.** Repair work with bags full of dredged sediment

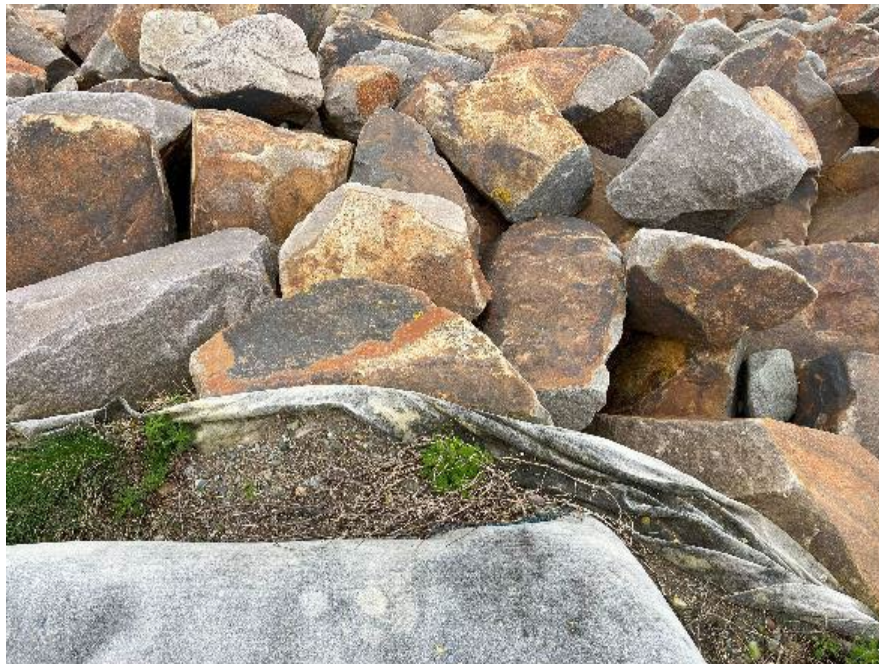
There were also signs of the geotechnical lining coming through at points, see Figure F7.

**Figure F7.** Geotechnical material coming through the rocks

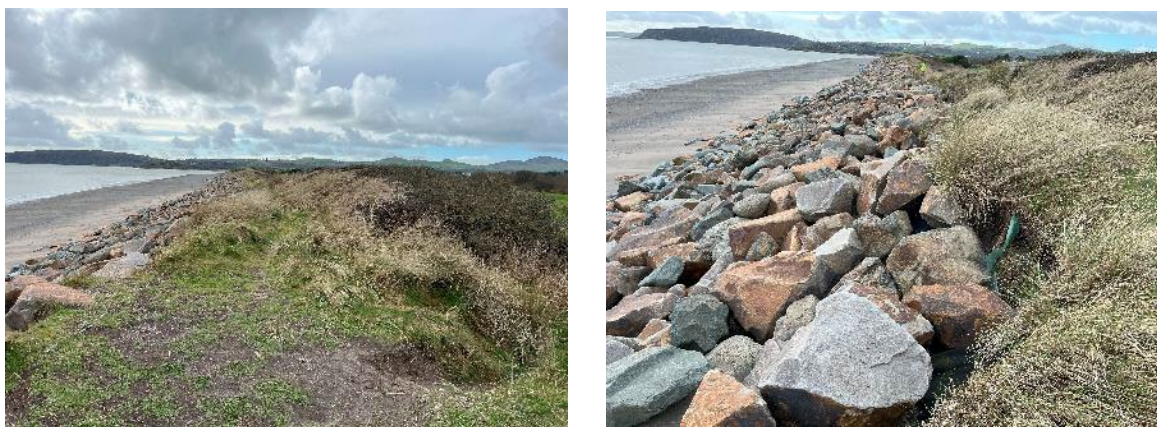
**Figure F10.** Area with high vegetation. Left: Looking towards the West. Right: Looking towards the West.

Figure F9 shows in plan view the area where the bags were placed. It also shows the area adjacent to it, where there is very high vegetation and no access. This area is not known to suffer from overtopping (referred as OT in the figure).

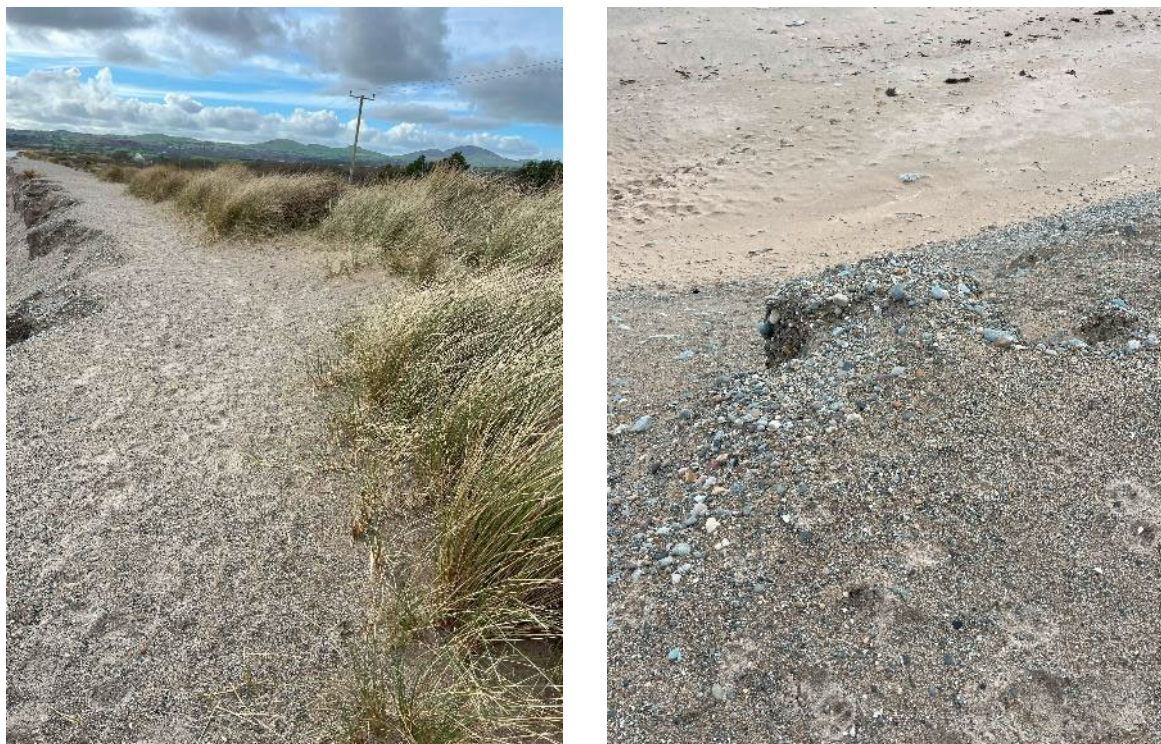
Figure F12 show the start of the Western area of the renourishment. It shows the vertical face of the shoreface, the lack of vegetation on the renourished material and the beach at the toe of the renourishment.

Figure F12. Start of the renourishment at the West.

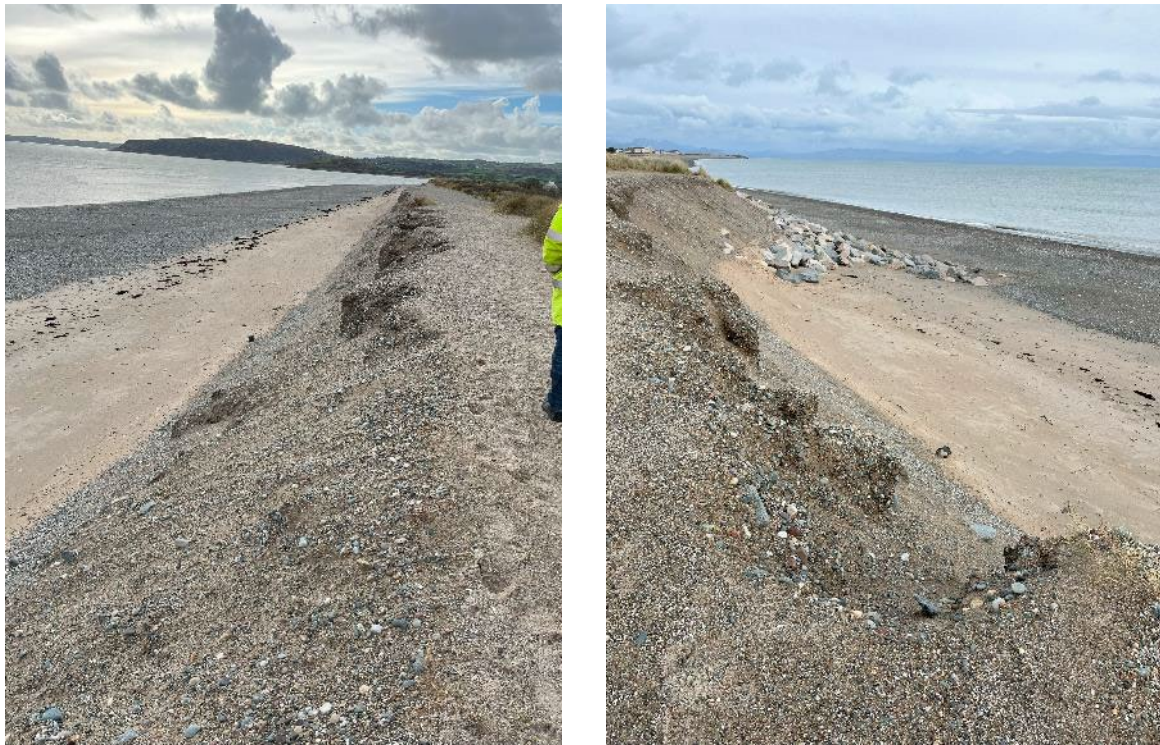
Going towards the West, similar features are also encountered, see Figure F13.

Figure F13. Renourishment in the Westen area (to the West of the revetment) Left: Looking towards the West. Right: Looking towards the East.

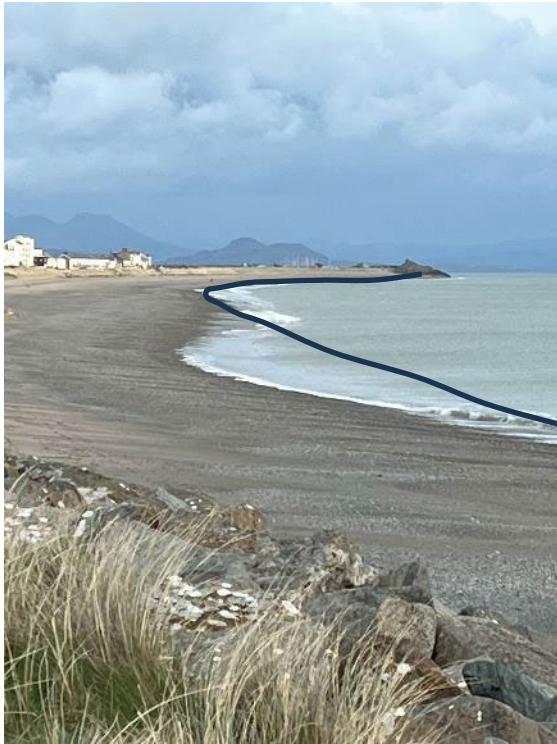
Halfway along the revetment, when looking towards the West, a change in the orientation of the shoreline is observed, as seen in Figure F14. It is not clear whether this is a bulge in the shoreline midway along the frontage, or a cut back in the shoreline within the foreground. In the only available nearshore survey of the beach, from Faber Maunsell Aecom 2008, reproduced here in Figure F15, one can see a shallow area by Pwllheli Golf Course, in between the clubhouse and the Eastern end of the revetment. Shoals, such as this in the nearshore will introduce localised changes in wave refraction and introduce more complex flow patterns, which may result in material being eroded from some areas with accretion in other areas. This then leads to local changes in the orientation of the coast. In this instance this could be reducing the beach level in front of the Eastern of the revetment which is subjected to the greatest overtopping revetment (see Figure F9). Such beach lowering will subject the revetment to greater wave energy and thus overtopping. Hence, it is important to understand the location and changes to the shoals in the nearshore region.

Figure F14. Looking towards the East half way from the revetment

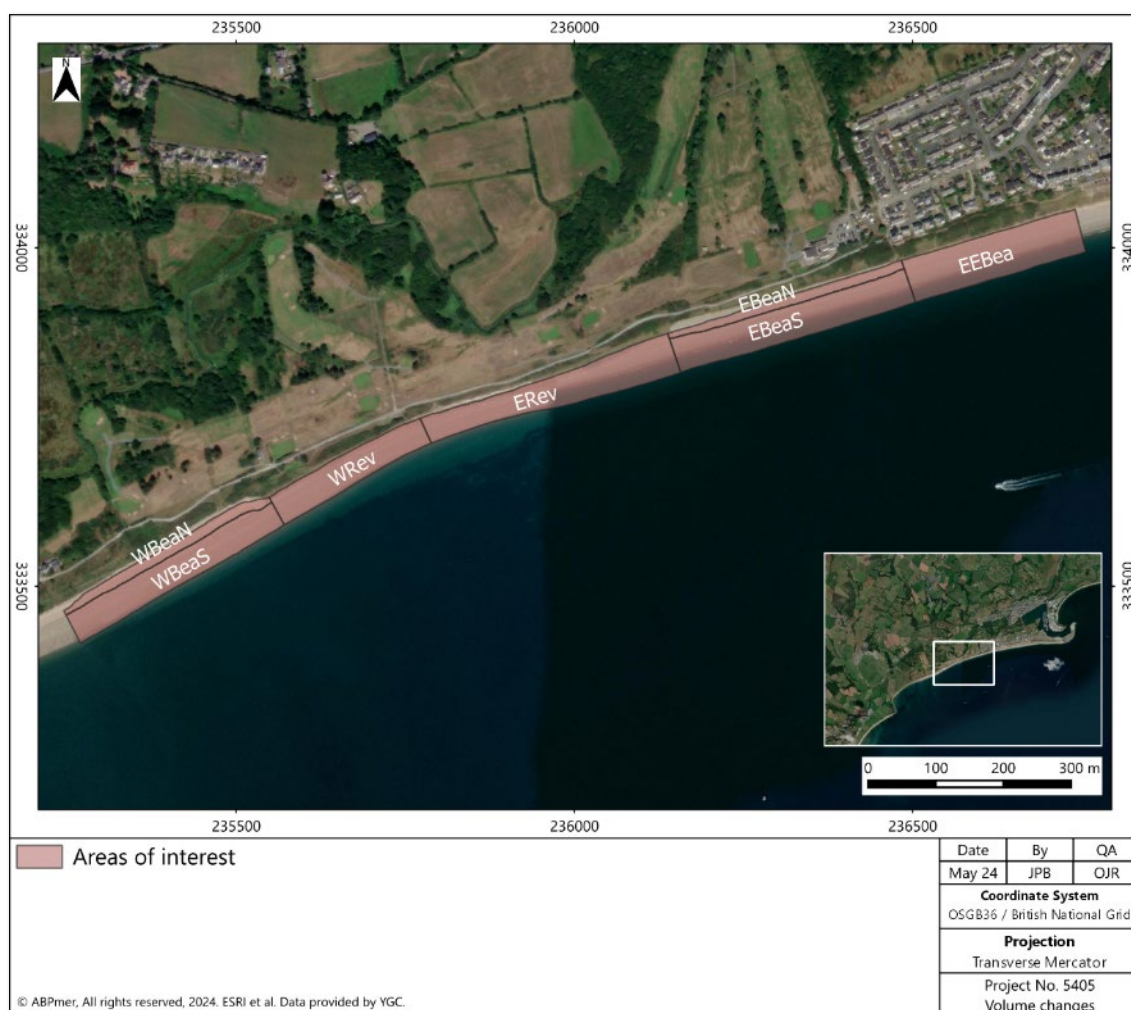
Figure I6. Location of areas outlines to calculate beach volumes

The evolution of the volumes of sediment at each of the areas outlined in Figure I6 is shown in the figures below, Figure I7 to Figure I12.

Within this assessment, to maximise the spatial coverage of the assessment, several of the temporal datasets were excluded from the analysis. This is because the spatial coverage of these individual surveys was more limited.
