EVENT DURATION MONITORING

**EDM TEN Initial Investigation Report – BC0003001**  
**Gowerton WwTW**

**Asset ID No. 50628**

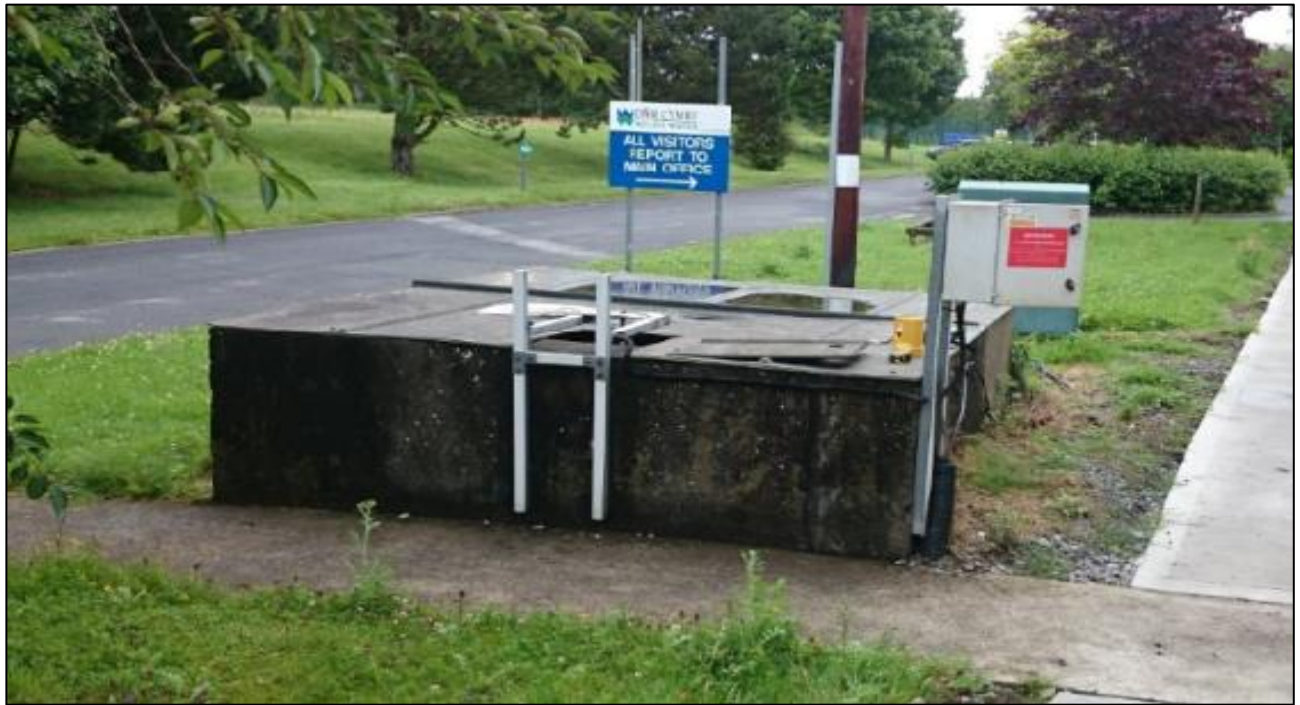
*Figure 3: Image of the Storm Overflow Chamber*

When flows exceed 912l/s, the level in the inlet pump sump rises and the storm pumps operate, pumping flow into the storm storage tanks. Once the tanks are full, excess flow spills over the weirs, through the storm monitoring chamber and to the outfall pipes. After storm cessation, the storm tanks empty, and their contents returned to full treatment.

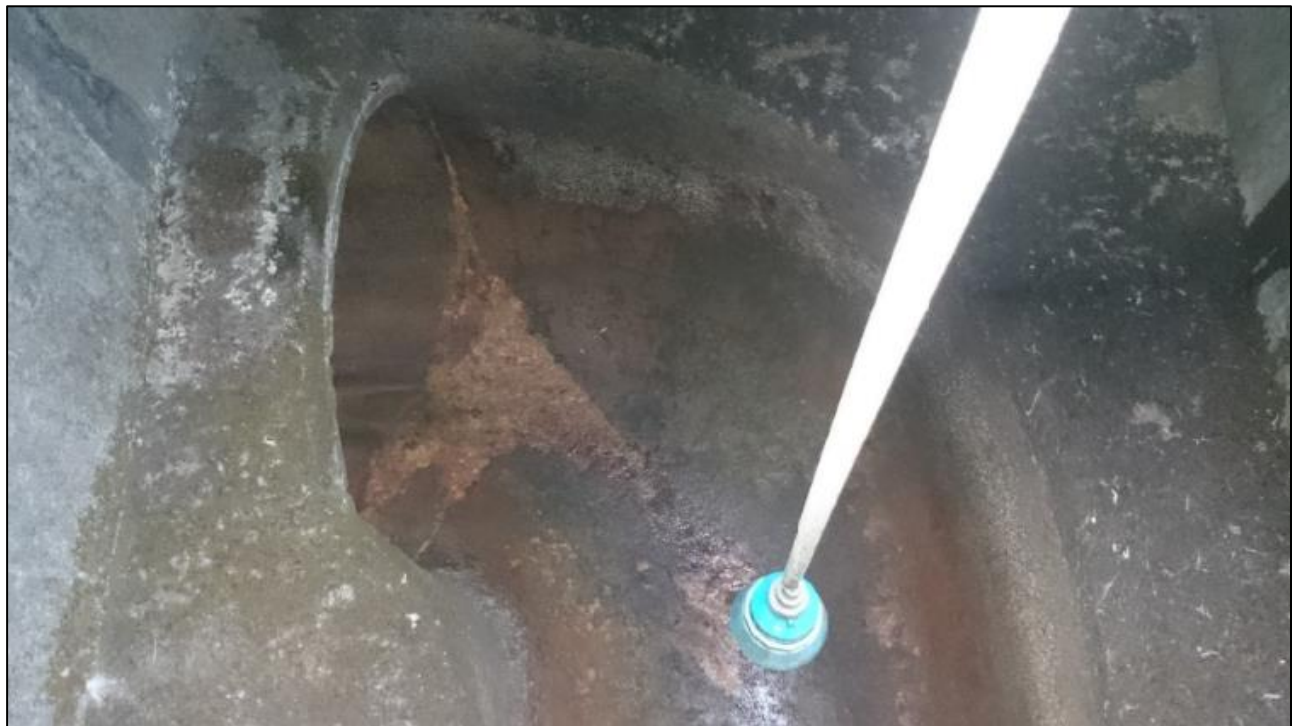
*Figure 4: Image of the Level monitor in the Storm Overflow Chamber*

Monitoring of the spills from the storm tanks is undertaken using an ultrasonic level in the storm monitoring chamber.
