Our reference: 315487 L01 (00)

**Application Reference: PAN-027307**

**Operator: Wates Construction Limited**

**Facility: Channel View (Phase 1), Channel View Road, Cardiff, CF11 7HU**

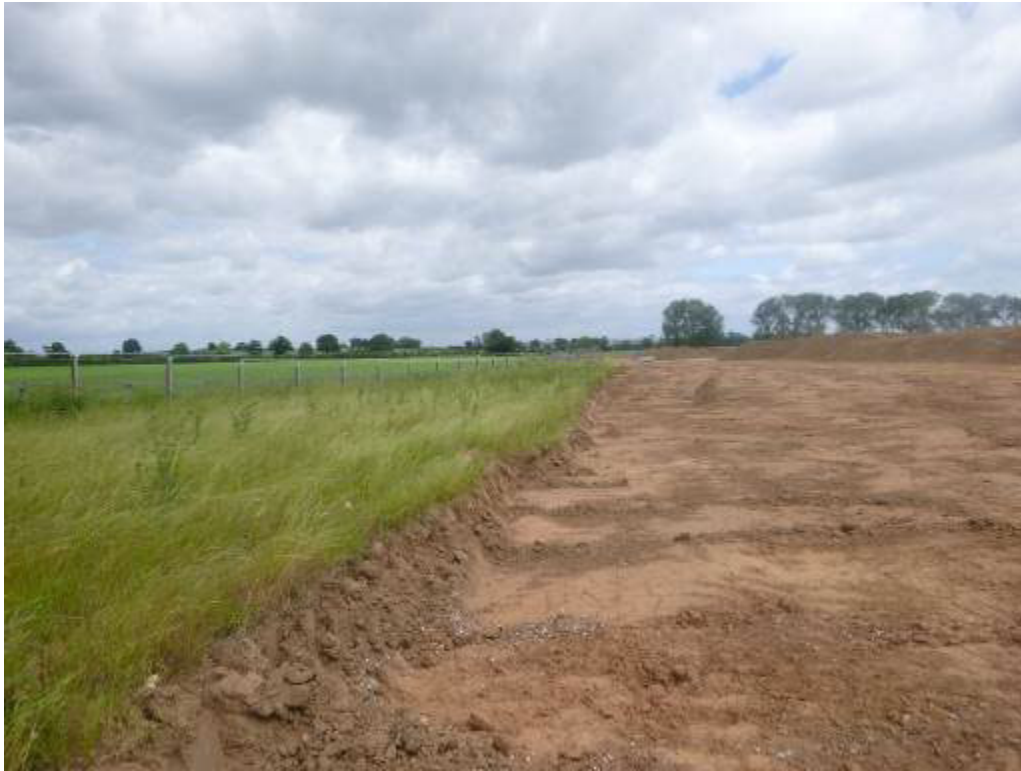
Retention of a wide vegetated buffer adjacent to a surface watercourse

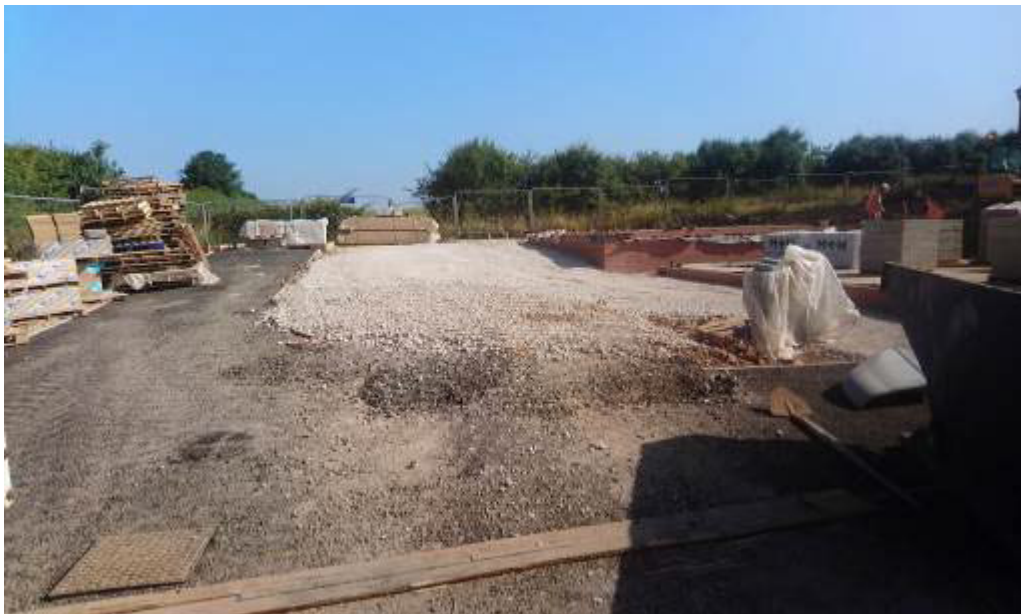
Placement of stone to the front of plots to create clean forklift access

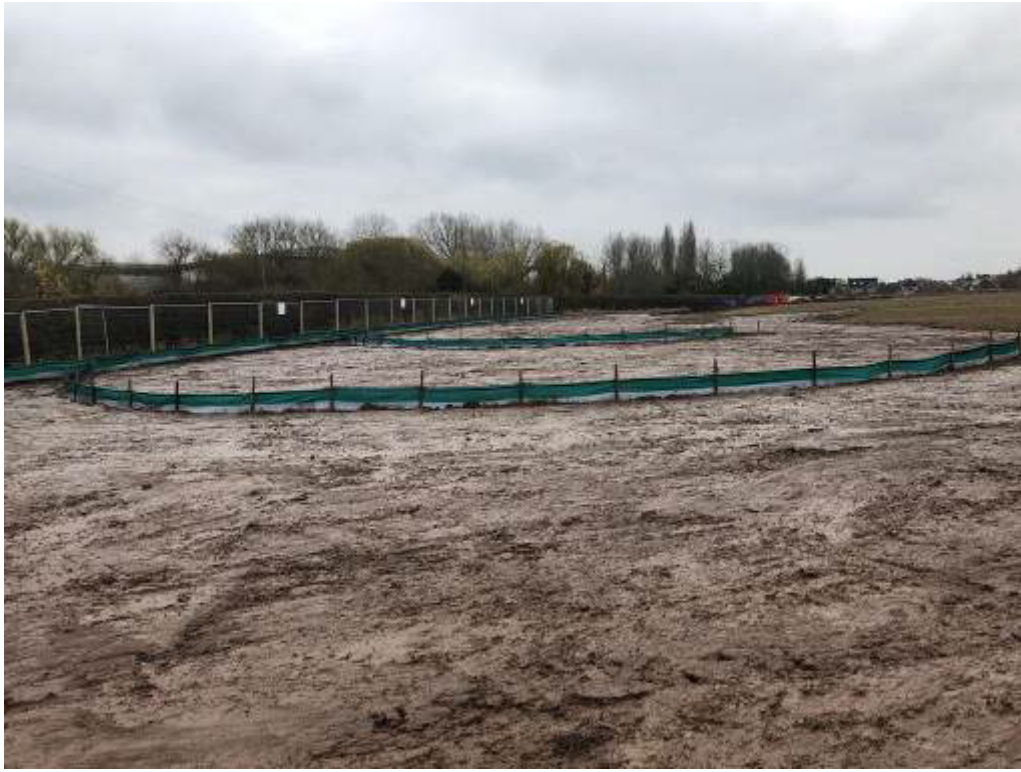
Installation of silt fencing to control run-off from an unsurfaced area

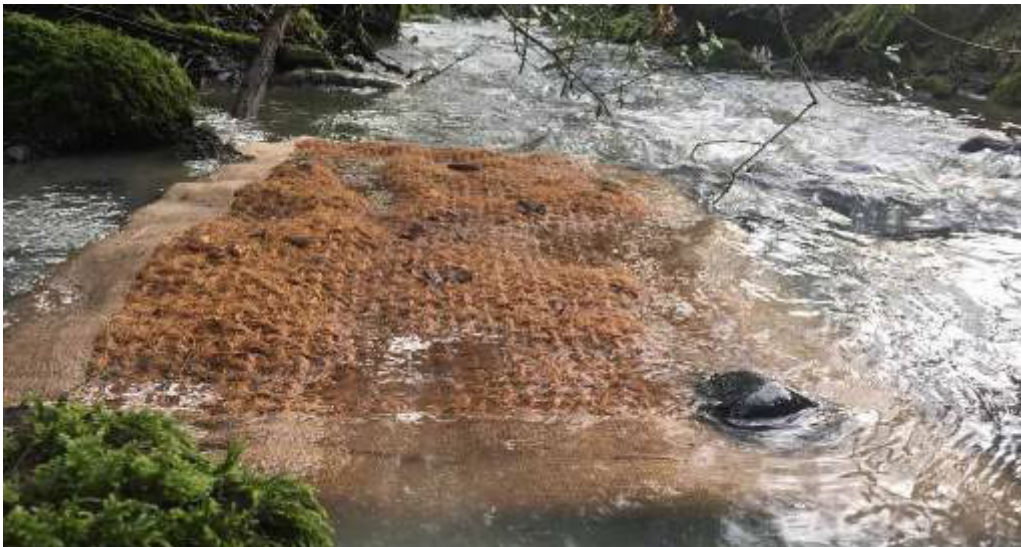
Placement of silt matting to capture settled silt downgradient within a surface watercourse  
(image courtesy of Frog Environmental)

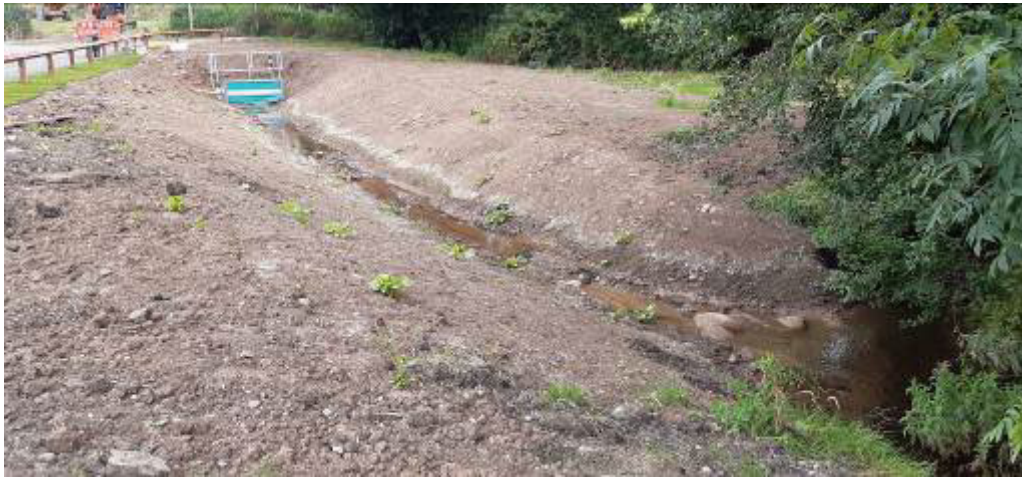
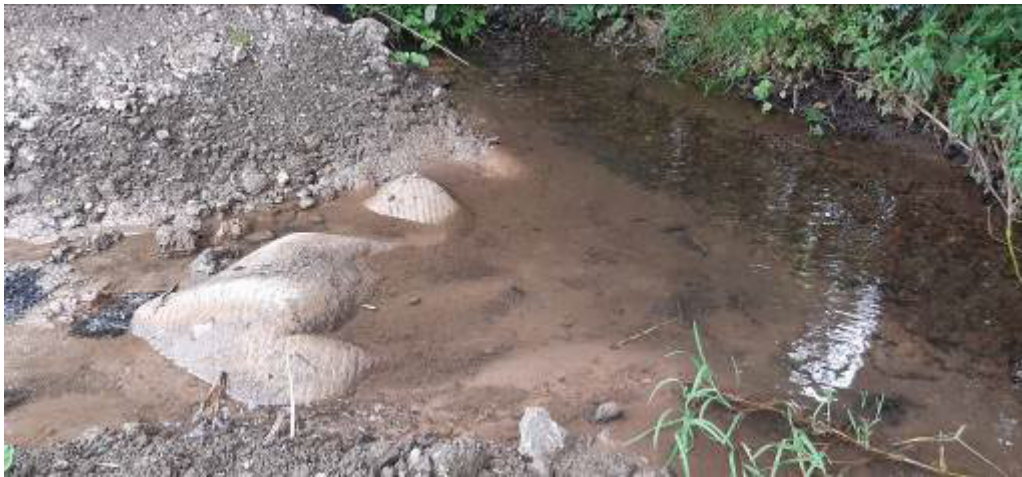
Silt matting installed along the base of an unsurfaced swale to capture settled suspended solids prior to discharge into a surface watercourse

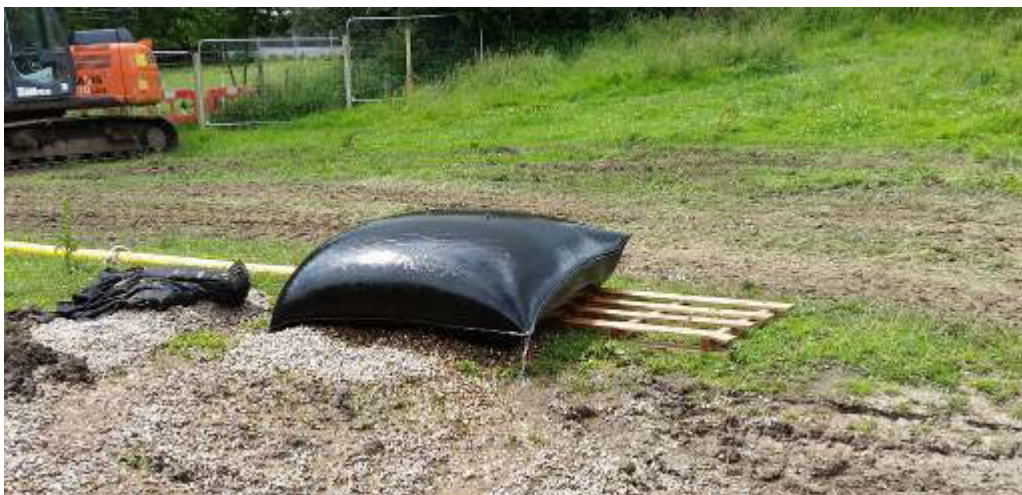
Dewatering bag used to treat water pumped from excavations. Dewatering bag is placed upon a pallet for ease of movement, onto clean gravel to dissipate the flow and prevent scouring, in a vegetated area for infiltration.

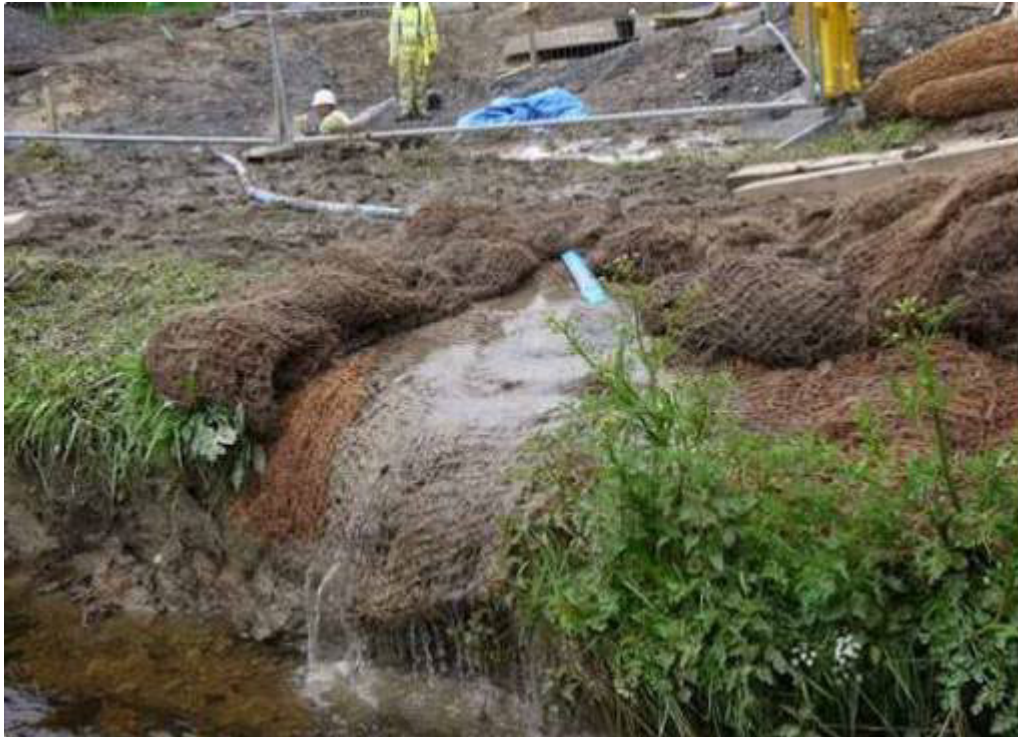
Utilisation of flocculant treated silt matting (Floc Mat) to treat water pumped from excavations  
(image courtesy of Frog Environmental)

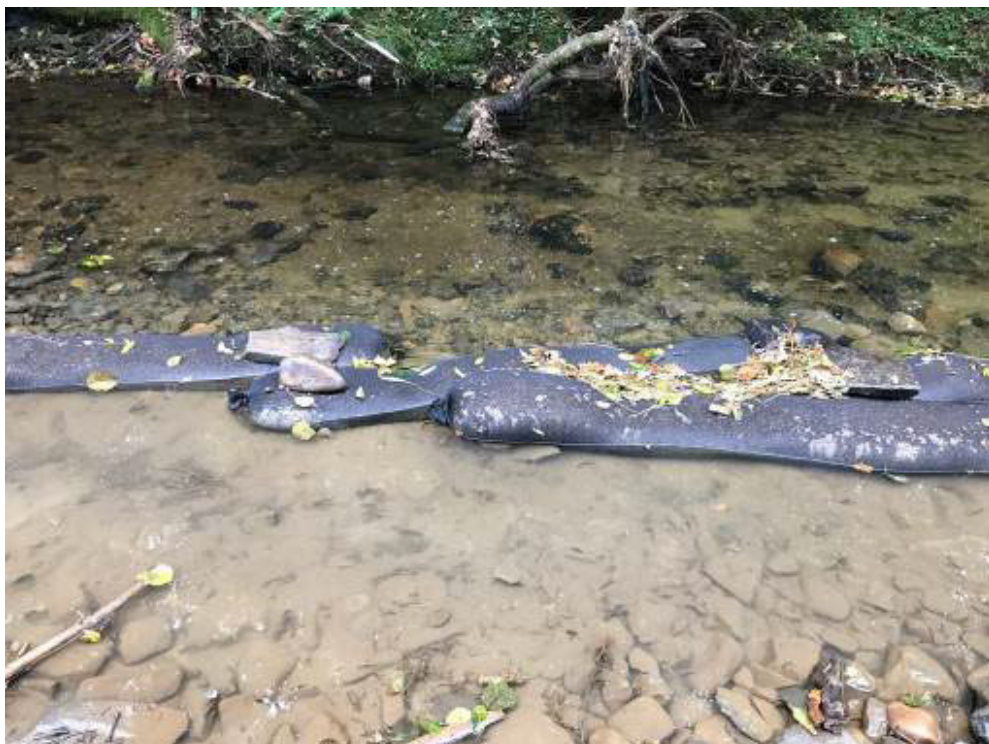
Silt Wattles utilised to separate clean and silty water within a watercourse  
(image courtesy of Frog Environmental)

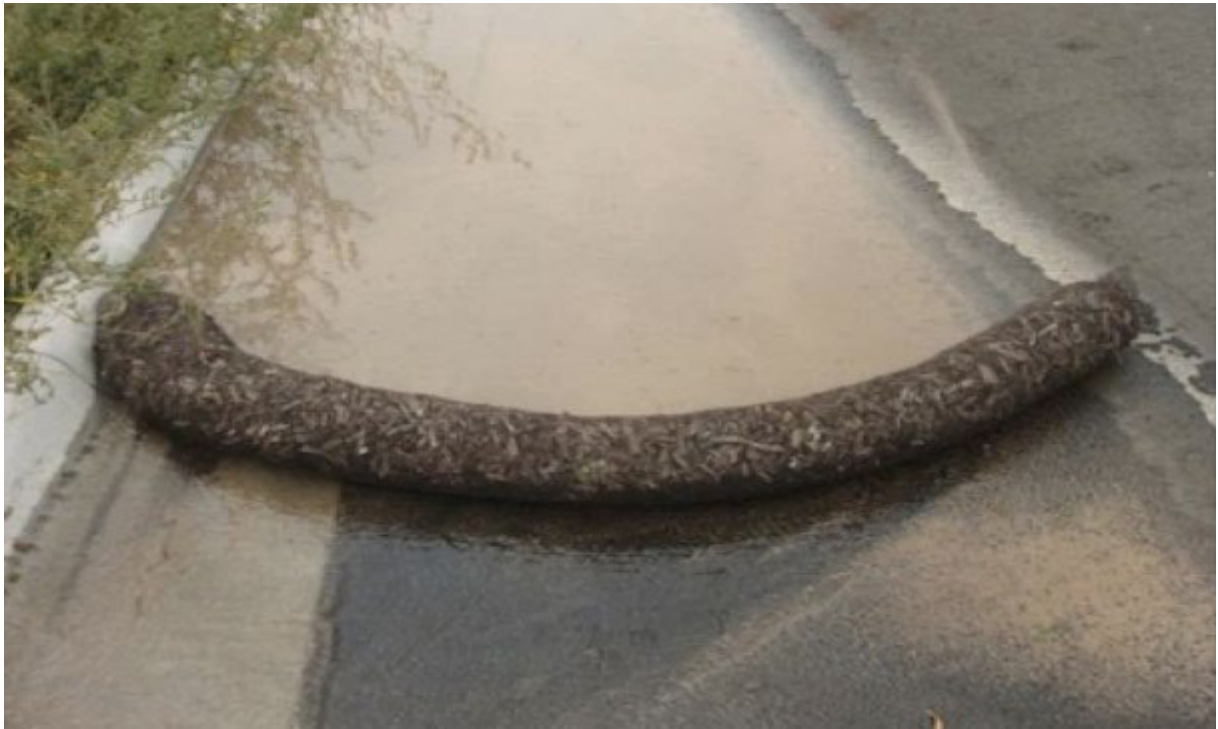
Silt Wattles utilised to intercept silt laden run-off on a road  
(image courtesy of Frog Environmental)

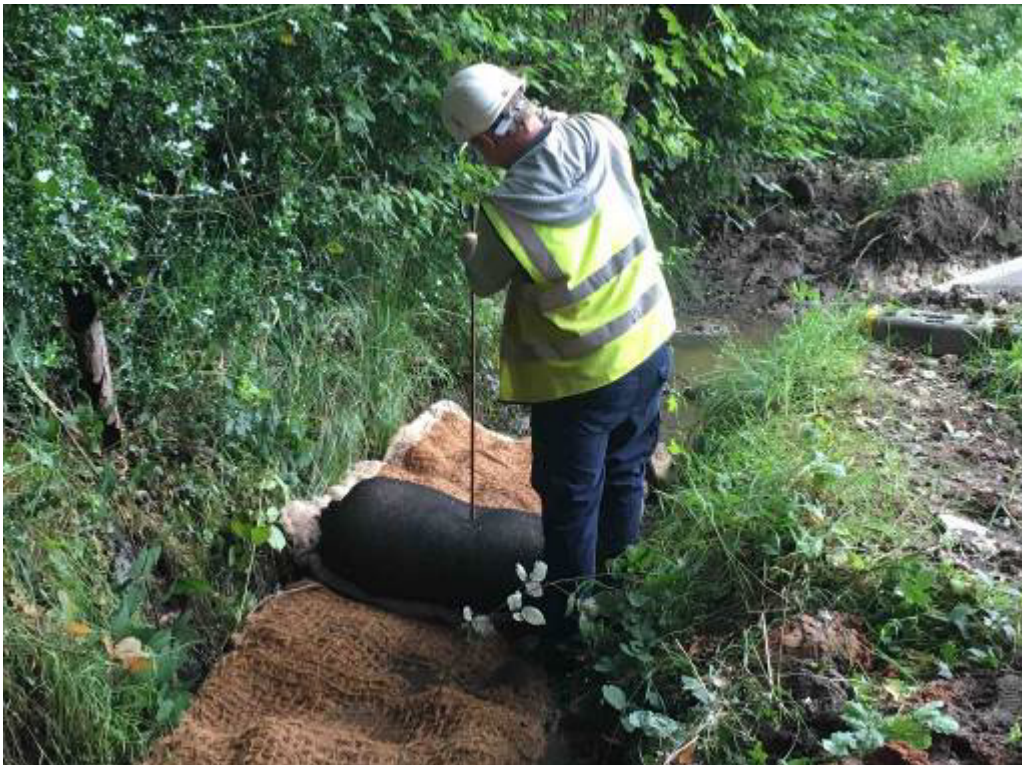
Silt matting and Silt Wattles deployed within a surface watercourse. Silt Wattles create a check dam promoting settlement of suspended solids, which is captured by the silt matting.  
(image courtesy of Frog Environmental)

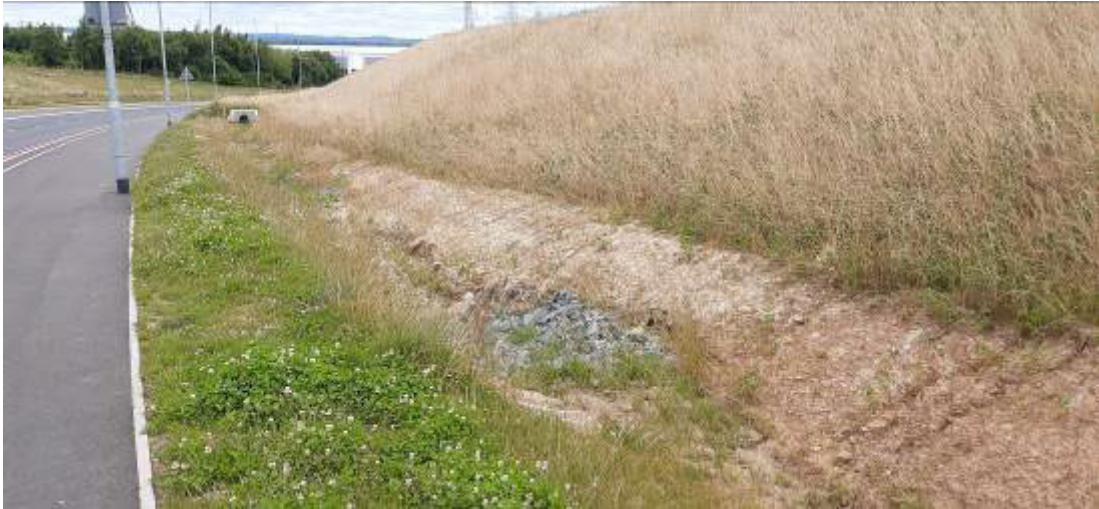
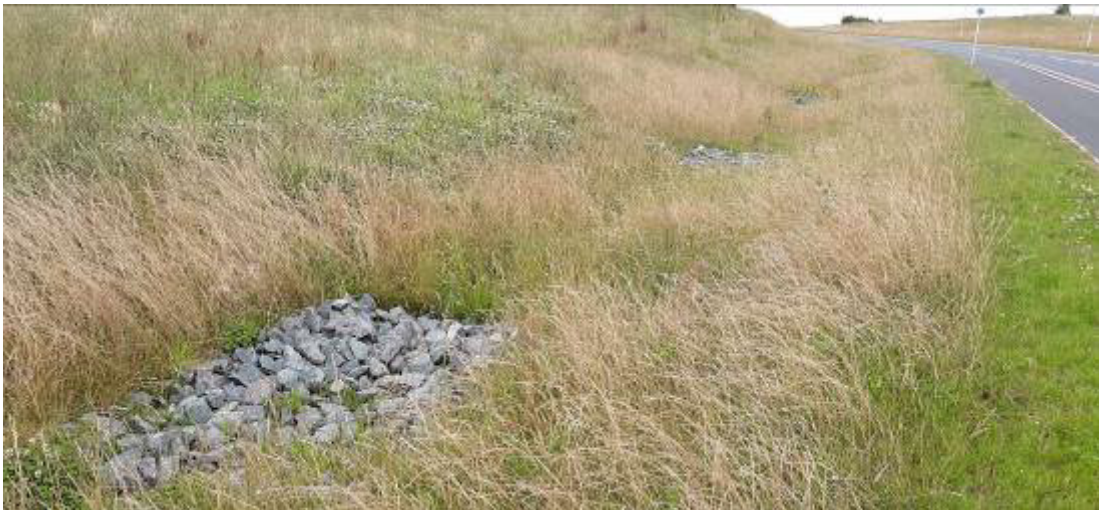
Coarse stone used to create periodic check dams (in conjunction with a geotextile) to reduce scouring within a swale until vegetation establishes.

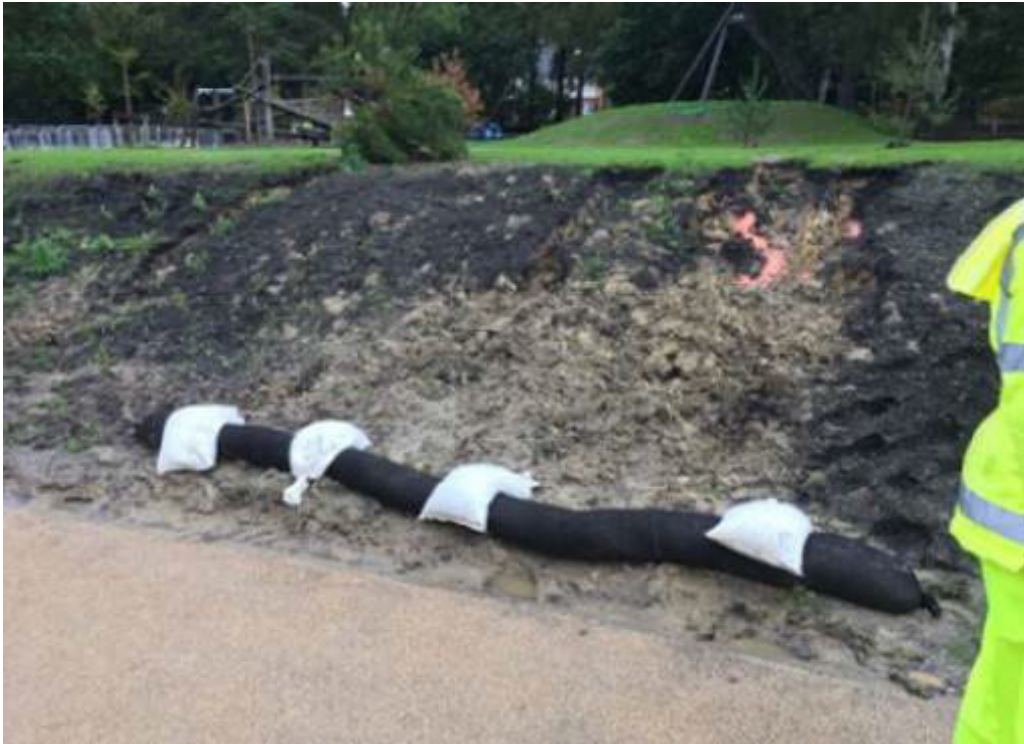
Silt Wattles utilised to intercept silt laden run-off from an unsurfaced slope  
(image courtesy of Frog Environmental)

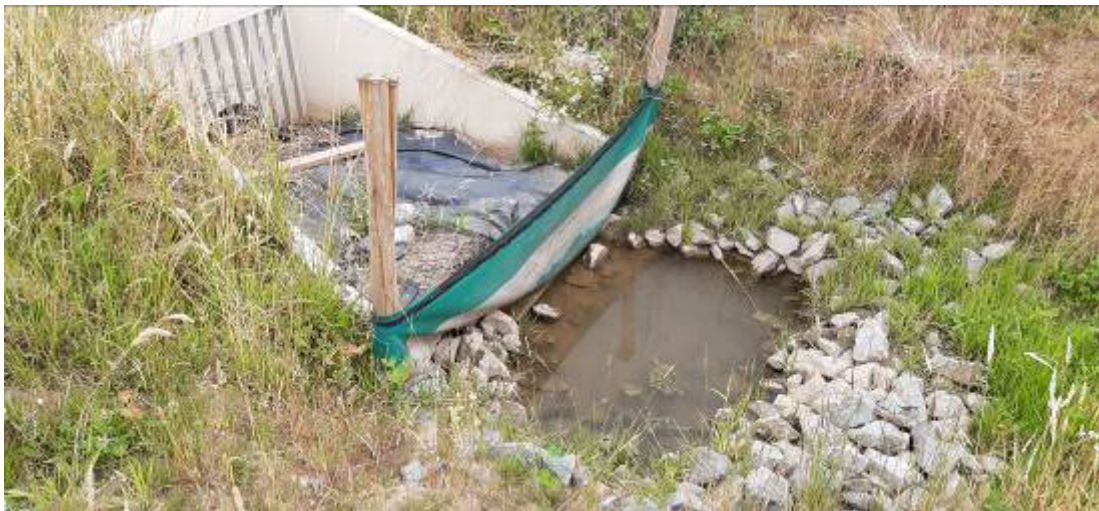
Silt fencing and straw bales installed across an inlet headwall within an attenuation basin, to promote settlement of silt within the concrete apron (where it can more easily be removed) prior to discharge into the attenuation basin. Coarse stone installed to dissipate flow and prevent scouring, and further promote settlement at the headwall.

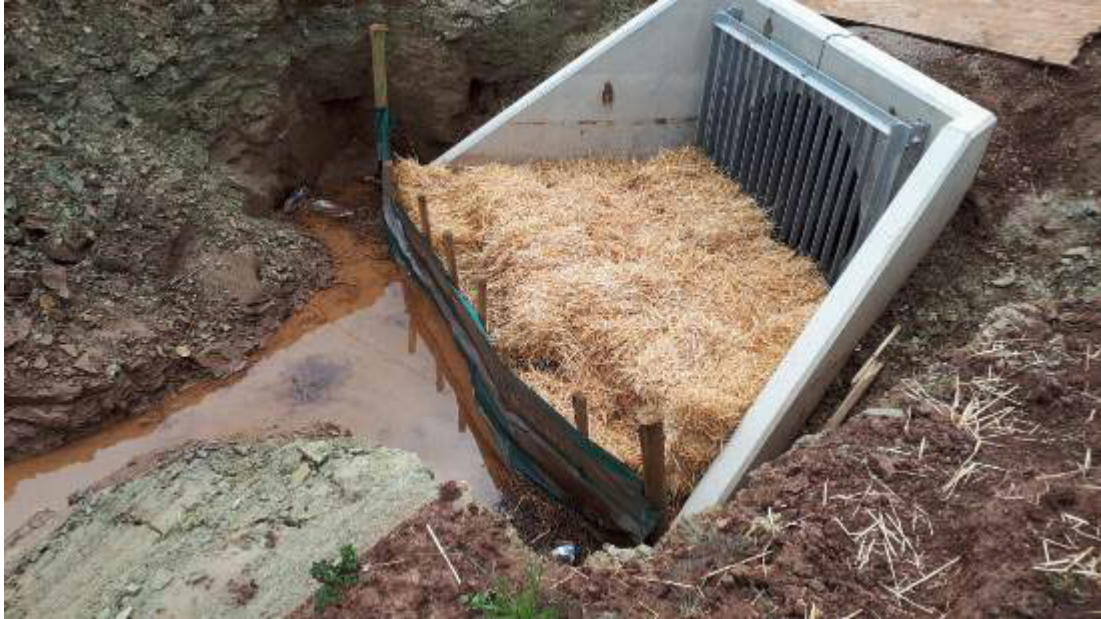
Silt fencing and straw bales installed across an outlet headwall within an attenuation basin, to promote settlement of silt within the basin prior to discharge into the surface watercourse

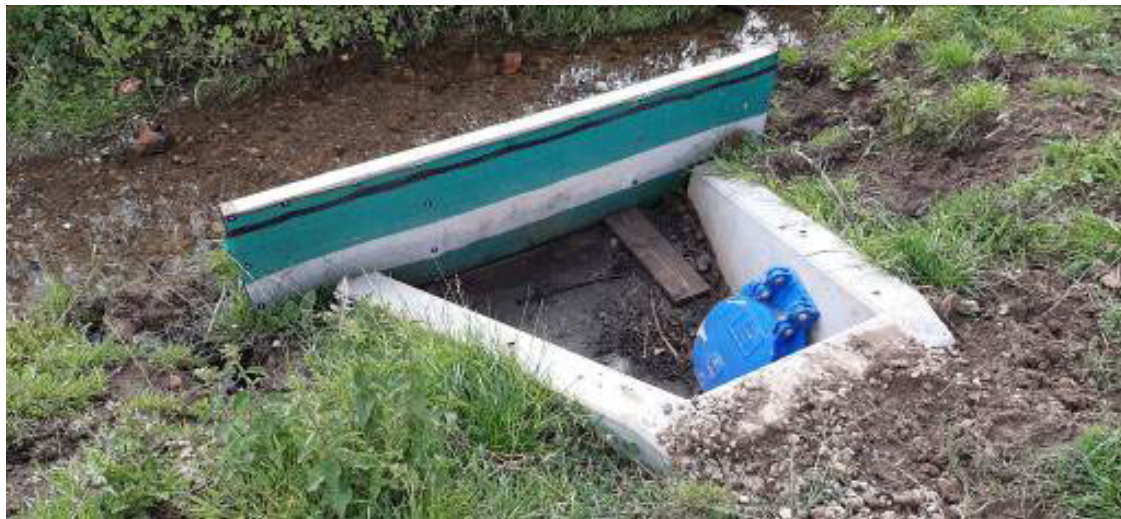
Silt fencing installed across an outfall headwall, to promote settlement of silt within the concrete apron prior to discharge into the surface watercourse (in the event of breach of other control measures)

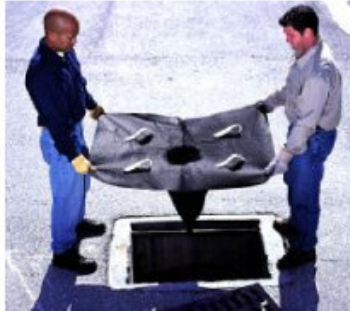
### Hy-Tex Ultra Drain Guard for Drainage Gully Sediment Control

Ultra Drain Guards are designed to remove oil and sediment pollution from surface water running into gully drains from surrounding construction sites, farms, industrial estates, or other areas prone to storm water pollution or cleaning operations.

Ultra Drain Guards are made from a high permeability non-woven polypropylene geotextile that trap solids and oils but allow water to drain through and also incorporate bypass ports to further maintain flow into the drain.

6. The Ultra-Drain Guard filters are designed to be used for 3 to 6 months under normal conditions.
7. Where heavy contamination is present the unit will have a reduced life expectancy. When the unit has collected about 6 inches of sediment it is recommended that it be replaced. The unit should also be replaced if free oil can be seen floating and is not being absorbed. The Ultra-Drain Guards should be inspected on a regular basis.
8. Dispose of unit in accordance with applicable environmental laws and regulations. The user is solely responsible for compliance with maintenance and disposal laws and regulations. The manufacturer or seller assumes no responsibility for proper or improper maintenance or disposal.

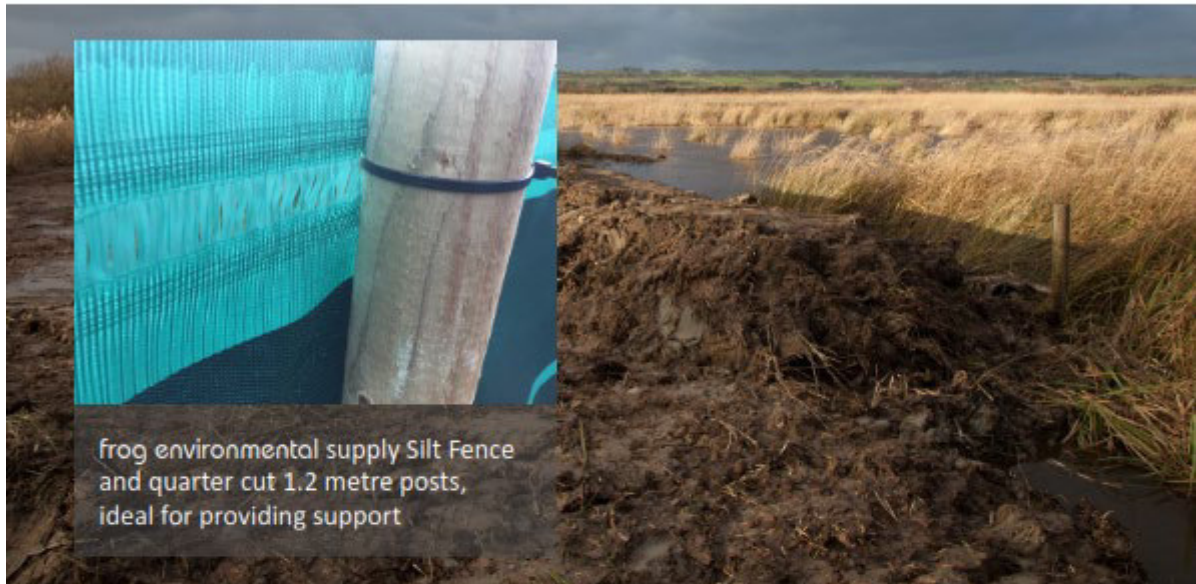
temporary silt control barrier

frog environmental supply Silt Fence and quarter cut 1.2 metre posts, ideal for providing support

Silt Fence is inexpensive to buy and install, but it must be correctly positioned and maintained for it to be an effective pollution control measure.

If stakes are broken or gaps appear between the fence and the ground, then the fence should be re-trenched. Accumulated silt must be removed regularly from Silt Fence, typically when it reaches a third of the way up the fence.

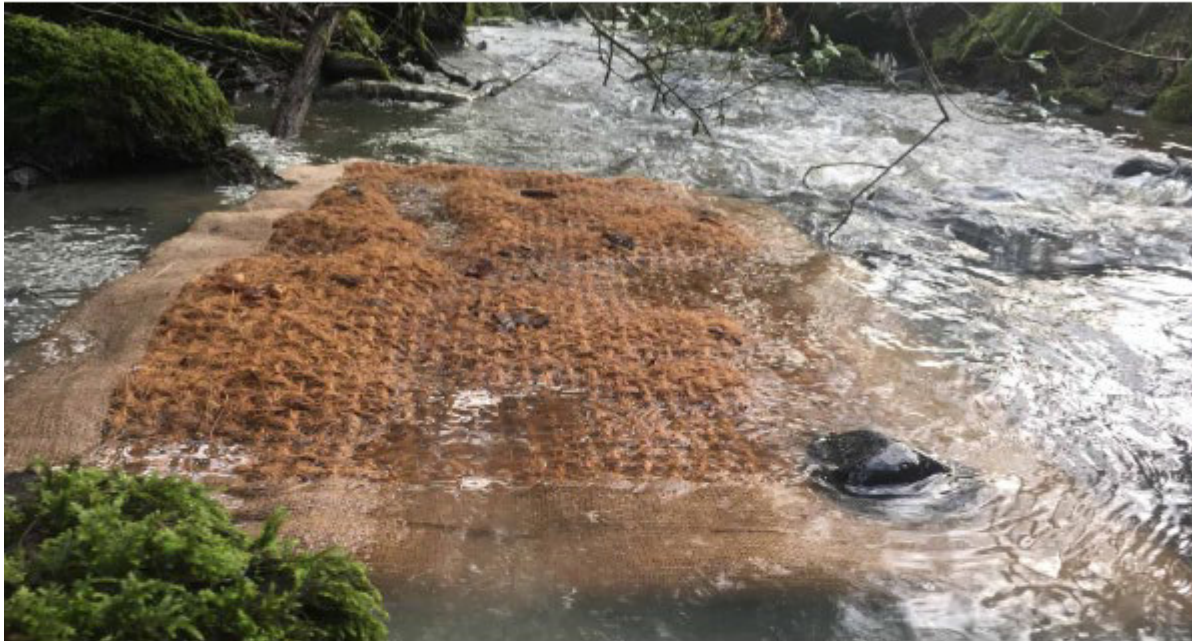
**SiltMat**  
silt capture mat

**SiltMat is a fully biodegradable mat that captures and prevents sediment resuspension.**

The mats can be placed in natural or artificial channels, ditches or directly on land to trap suspended sediments.

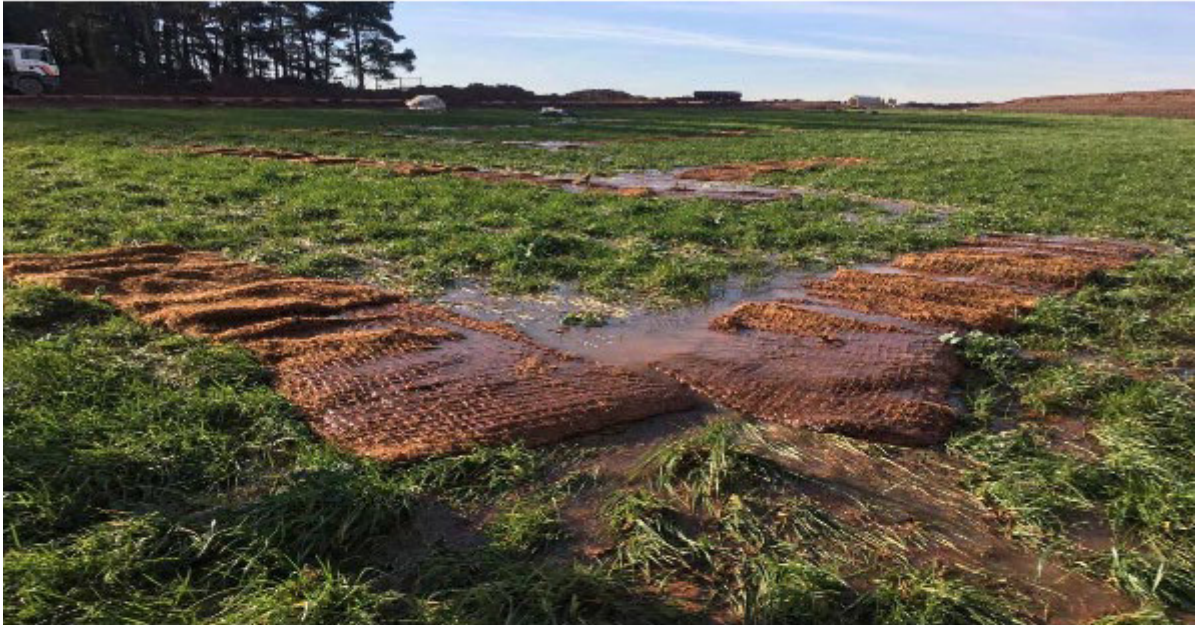
water treatment mat

#### **Floc Mat™ is a versatile silt control device**

A mat created to treat and capture fine silts and suspended particles in construction site run off.

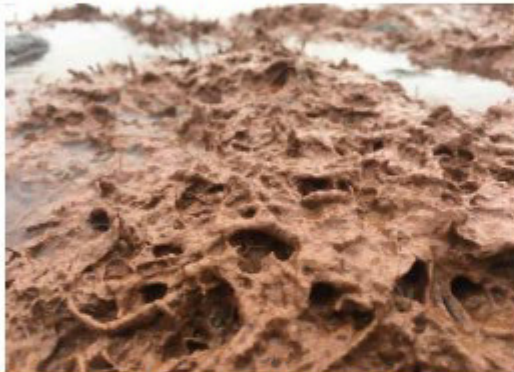
*Close up FlocMat showing accretion of silt*

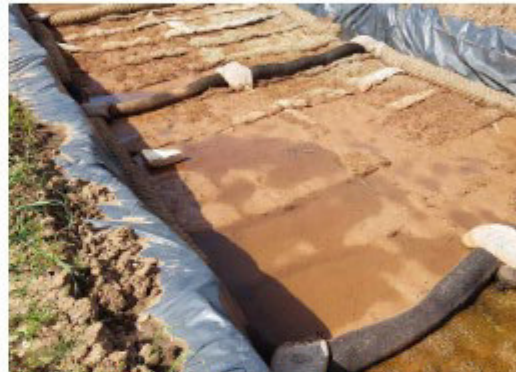
*Deployed in Silt Capture Channels with Silt Wattles*

When deployed in a Silt Capture Channel the Floc Mat provides a safe, low carbon and easy solution to support the removal of suspended solids and associated pollutants from construction site run off.

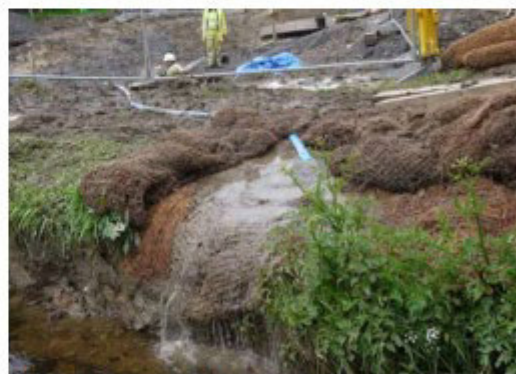
*Deployed to treat muddy excavation water*

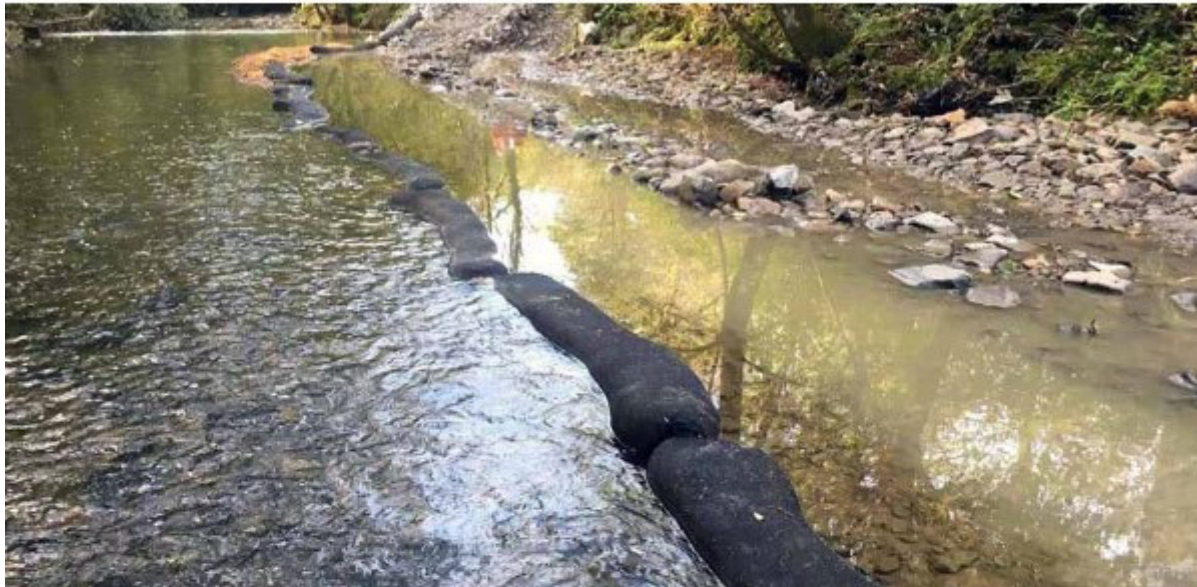
**Silt Wattle**  
silt control sausage

**Silt Wattles are a versatile silt control device.**

- Silt Wattles can be used to reduce silt release into watercourses from construction sites and deployed directly in channel to reduce movement of suspended silts.
- The tough exterior netting means they can be left for months on site with out degradation, whilst the biodegradable treated wood fibre continues to slow the flow and trap silt particles.
- Silt Wattles mould to the shape of the river bed or ground and can be joined end on end or pyramided to help clean dirty water.
- Wattles are highly versatile and can be weighted or staked in position depending on bed/ground conditions and flows.
- Silt Wattles can be joined end of end to create temp low flow channel and protect rivers from pollution arising from bank works.

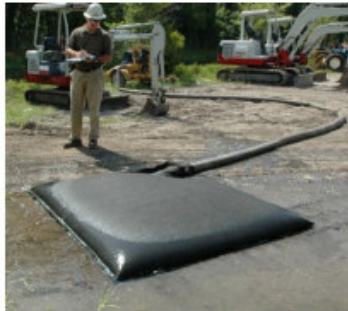
### Hy-Tex Ultra Dewatering Bags for Pumped Sediment Control

Hy-Tex Ultra Dewatering Bags provide an effective way to collect harmful sediments from dirty water pumped out of excavation works (such as foundations, pipe line construction, water, sewer and utility trenches, waterways and lakes) that would otherwise pollute the surrounding environment.

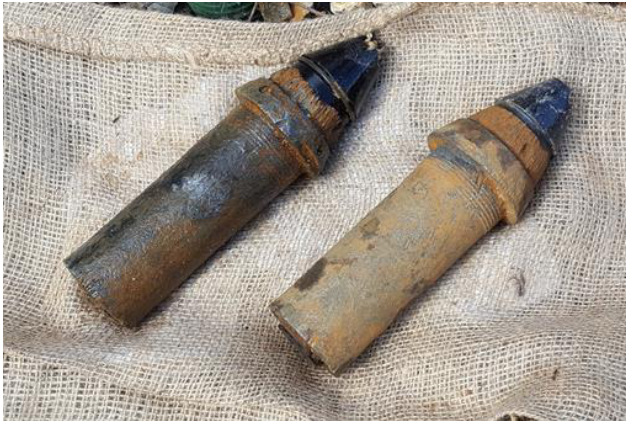
Typical shell and rocket fuzes (Above left Proximity Fuzes found by MACC in 2017)

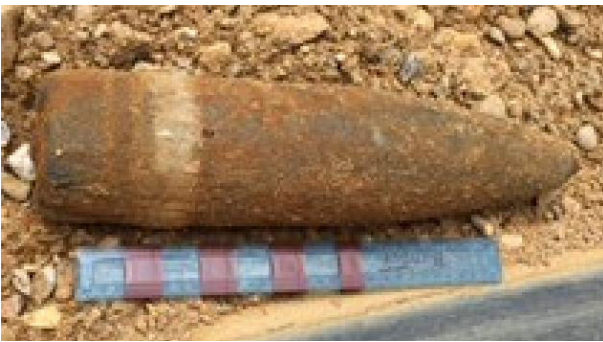
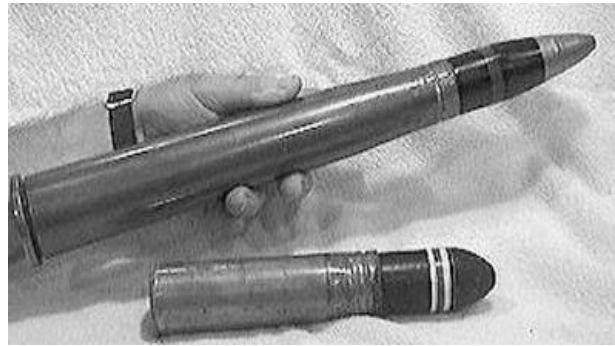
Typical shells (Above left 3.7" Shell found by MACC in 2017)

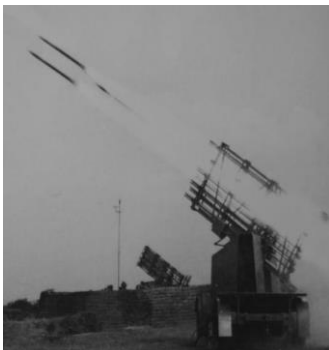
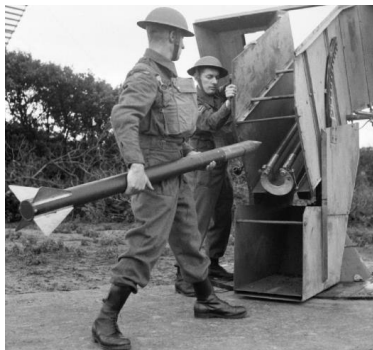
Typical rockets
