# River Marchnant Intake Flow Split Weir

Geomorphology Impact Assessment

North Midland Construction Plc

Final report

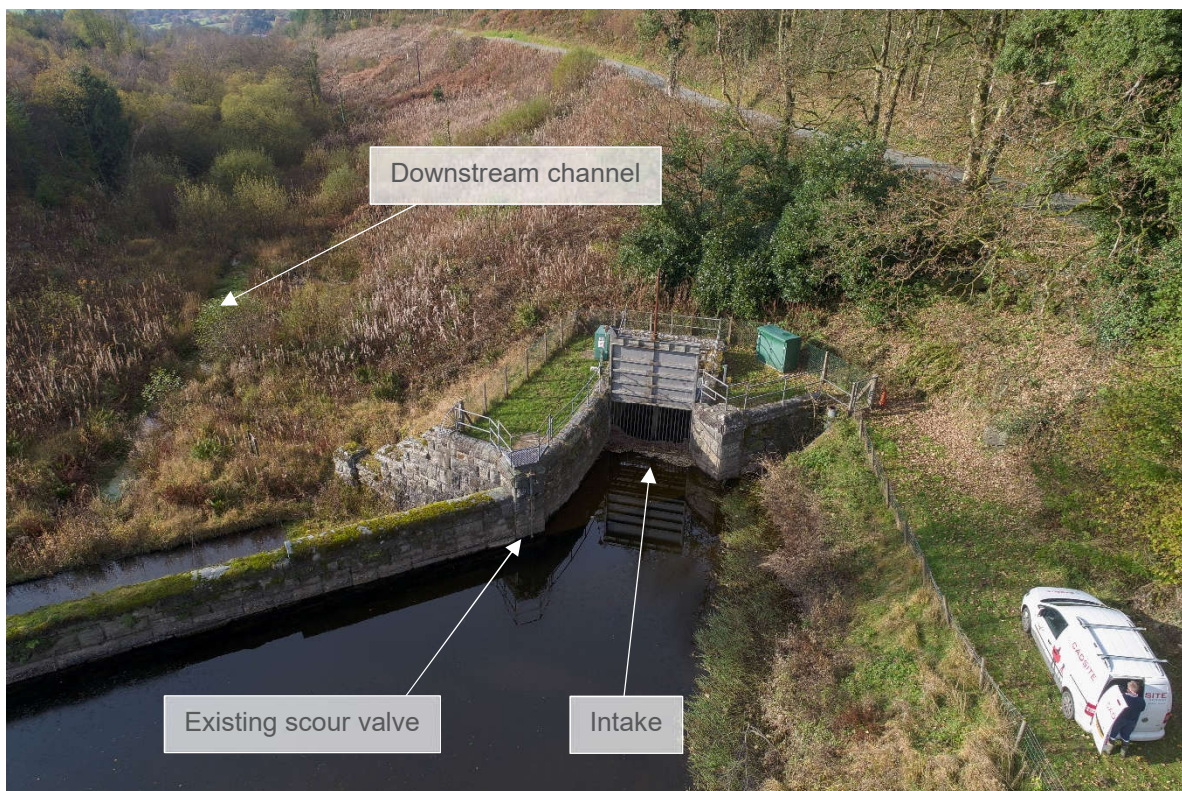
**Figure 2-1 – Intake on the River Marchnant (Source: North Midlands Construction 31/10/18)**

As part of this development two intakes were constructed on the Afon Cownwy (inflow to the south) and the River Marchant (inflow from the north) to direct flow into the reservoir. The Marchnant intake consists of a weir located on the Afon Marchnant (NGR: SJ 0420 1979), which diverts flows via an intake structure directly into a 2.2 km long diversion tunnel for transfer to Lake Vyrnwy. The intake is shown in Figure 2-1 below.

The tunnel is 2.1m in diameter and brick lined, running at a slope of approximately 0.0007 m/m. The tunnel is estimated to be part-full at 3.5 m<sup>3</sup>/s and head losses increase markedly when full, this limits the maximum tunnel capacity to about 4.5 m<sup>3</sup>/s once surcharged (Jacobs, 2017).

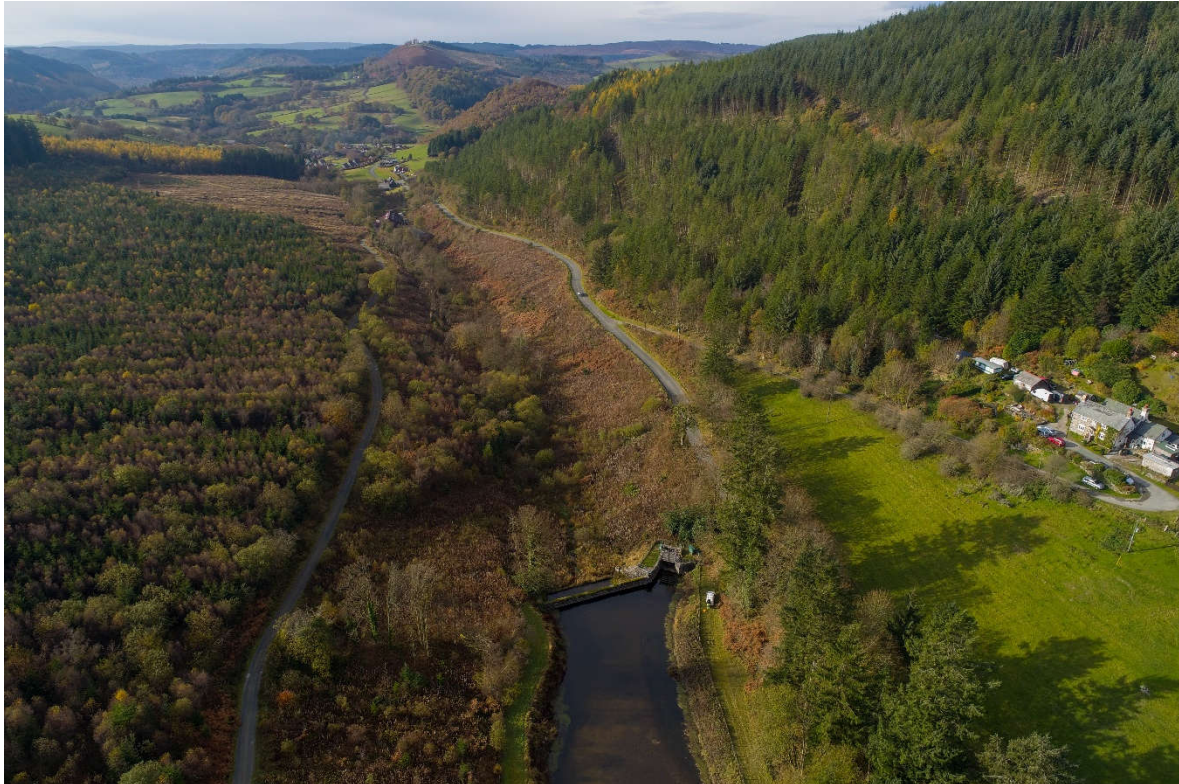
**Figure 2-2 – Drone image of catchment (Source: North Midlands Construction 31/10/18)**

The site lies within the foothills of the Cambrian Mountains south east of Snowdonia National Park. The Marchnant catchment is surrounded by well forested rolling hills, a wide valley and gentle valley sides. The upstream section of the catchment is occupied by wide flood plain and agricultural land which quickly becomes more constrained and taken over by large wooded areas. The gradient of the Marchnant is averaged at 0.02. The topography of the River Marchnant catchment looking upstream from the River Vyrnwy is shown in Figure 2-2.

Downstream of the weir through reach MAR003 (see Figure 2-2), and despite limited access, it was difficult to identify a defined channel. There was no flowing water at the time of the survey, and by all accounts the Marchnant does not spill often, except during significant flood events (see Section 2.2). The water that was present suggested good groundwater connection, but was ponded and accumulating some localised ochre coloured deposits (assumed to be iron, although the water body is also known to be failing due to copper pollution, see Section 2.3.5), as well as algae and other organic matter (ATT14\_Photo1). The bed was not visible, although some gravels were noted along the shallower margins. The channel here was devoid of any morphological form and was densely overgrown, and (along with weir pool, MAR002) was classified as a sink. Observations from a separate aquatic ecology survey suggested a slightly more defined and flowing channel (albeit no more than 1.0 m wide) did form 100-150 m downstream of the weir, and the substrate comprised primarily silt, with large amounts of woody material present too.

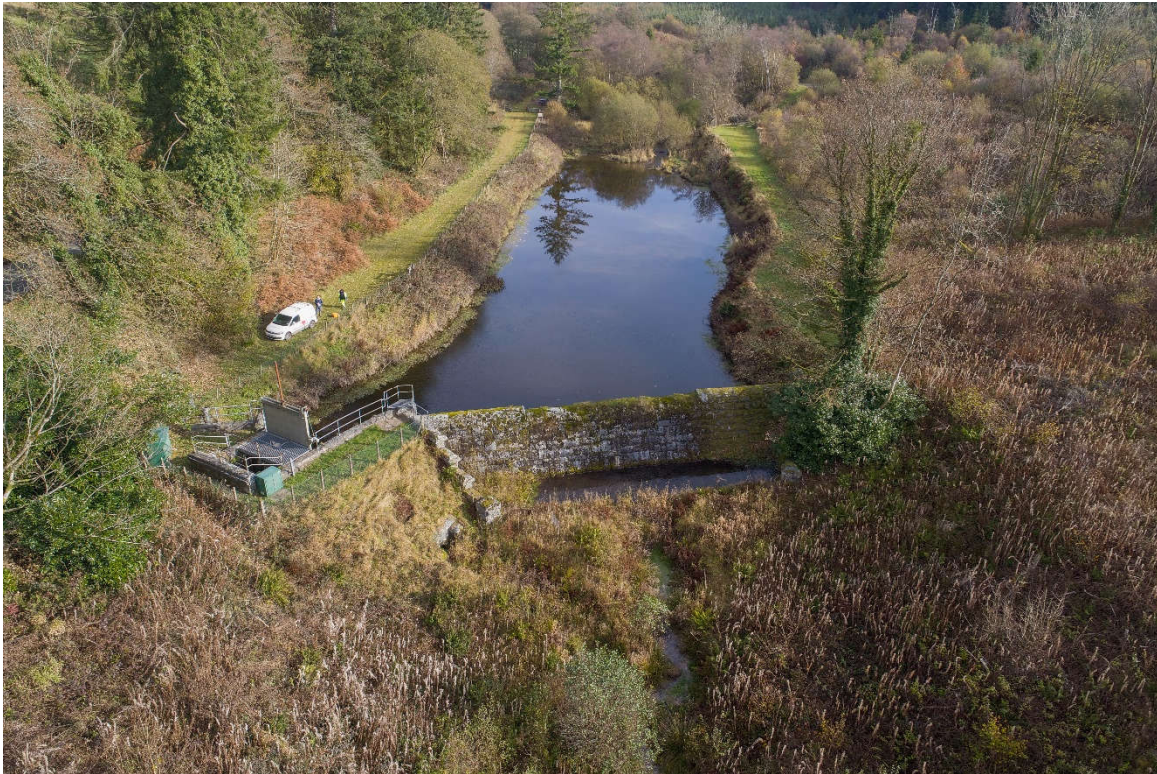
**DJI\_0252-HDR** – Drone image taken looking upstream showing the stagnant channel immediately downstream, the weir structure and the weir pool (MAR002 and MAR003) (Source: North Midlands Construction 31/10/18).

The form of the 'natural channel' does not appear to have been considered as part of the design, except for the inclusion of scour protection downstream of the diversion channel. As part of the works the downstream channel should be cleared of vegetation (and contaminated sediment as necessary) to enable a free-flowing channel upon reconnection. Potential for importation of the substrate to form the bed should be considered depending on the extent of any removal (if any, depending on contamination). This is recommended to extend at least as far as the nearest incoming tributary, approximately 100 m downstream.

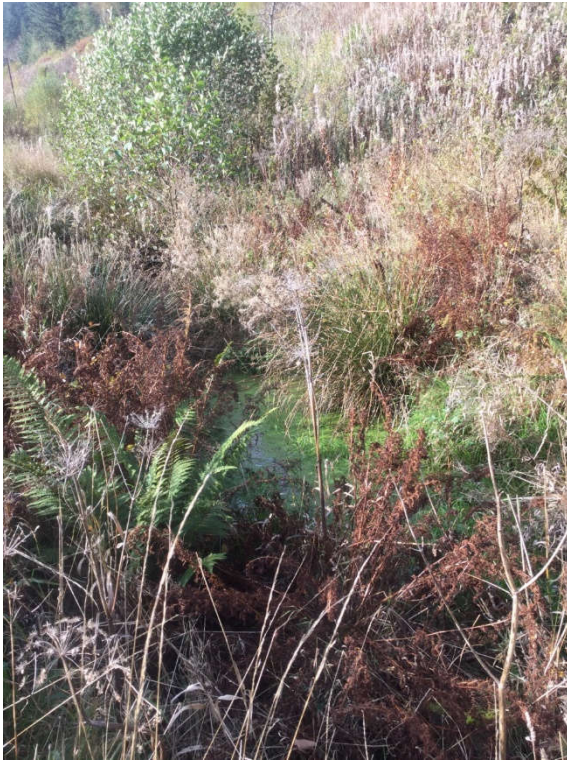
**ATT14\_Photo1** – View downstream of weir showing stagnant, ponded water (MAR003).

The observed ochre deposits suggest poor water quality and potentially contaminated sediments downstream of the weir. Therefore, an assessment of potential contamination is strongly recommended prior to reconnection.

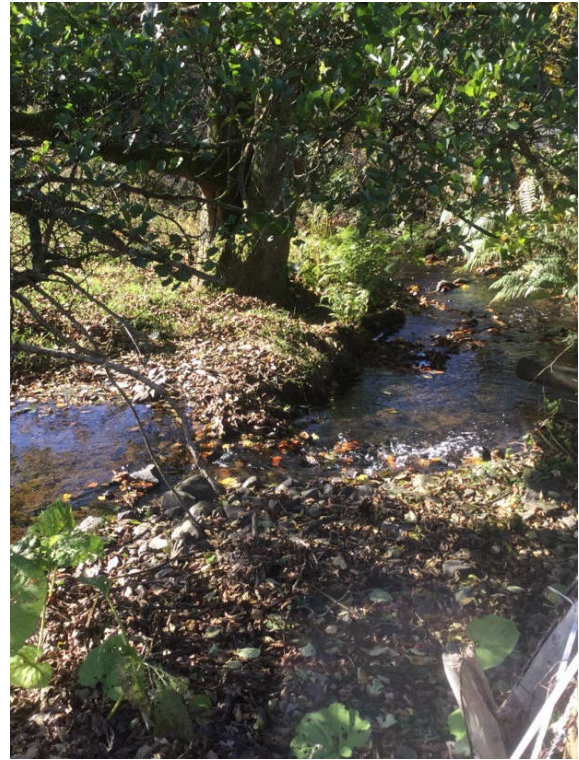
Downstream of the culverted section leading into the village (MAR004) the channel recovered some flow. The channel here was much narrower than observed upstream of the weir, approximately 1.0 m wide, but possess similar diversity in flows, with coarse gravel/cobble substrate, but overall quite limited in morphological diversity and therefore classified as a transfer.

**ATT27\_Photo1** – Downstream view along reach through village of Abertridwr (MAR005).

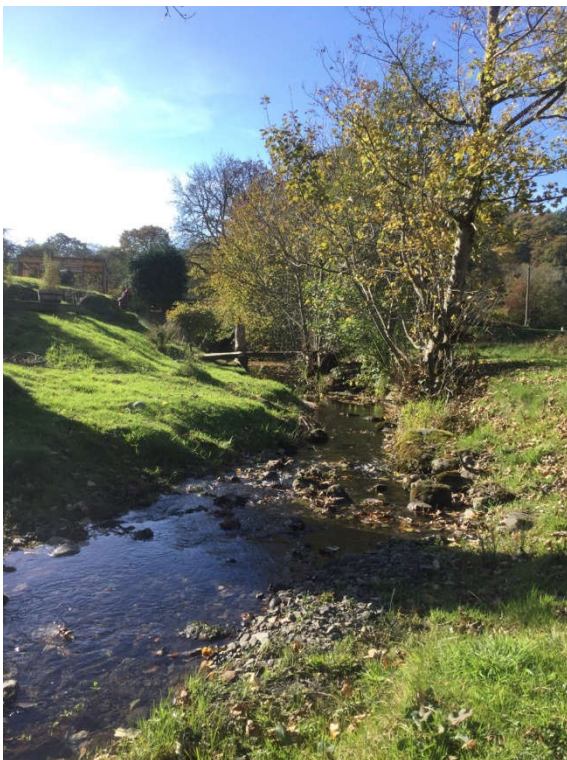
As the woodland is replaced by pasture, the channel gradually developed an asymmetrical, two-stage cross-section, with frequent gravel bars through MAR005 (ATT28\_Photo2). Riffles and pools create diverse flows, with a noticeable increase in fine sediment overlaying the coarse substrate in the pools and other areas of slacker flow. There were some signs of potential previous scour indicating potential for lateral adjustment (supported by the historical mapping, see Section 2.3.6). However, these features appear to be relic and no longer active. The channel was generally considered relatively stable. That said, the reach was classified as a sink due to the gravel deposits.

**ATT29\_Photo2** – Flows recover downstream of the culverted section through the village of Abertridwr. Increase gravel deposits and an open, wider floodplain (MAR005).

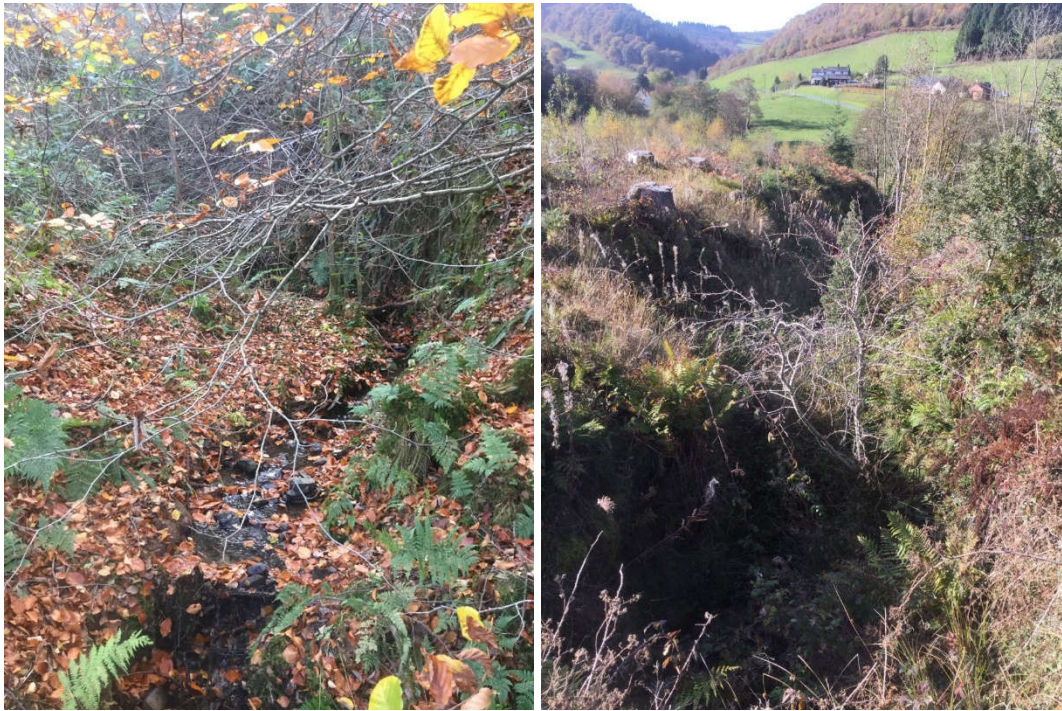
**Figure 4-3 – Photographs of incoming tributaries**

The extent of the abstraction impact downstream is uncertain as access along the channel was not possible due to the unsafe ground conditions and dense vegetation. There is a tributary that enters approximately 100 m downstream from the left-hand bank with some limited flow input (see Figure 4-3) and other observations from an ecological walkover support a channel beginning to form around this location. Given the relative size of the River Vyrnwy it is considered the overall extent of impact from the proposed works would not extend beyond the confluence with the River Marchnant.

*Left: approximately 100 m downstream of weir entering from left-hand bank (ATT16\_Photo1)*

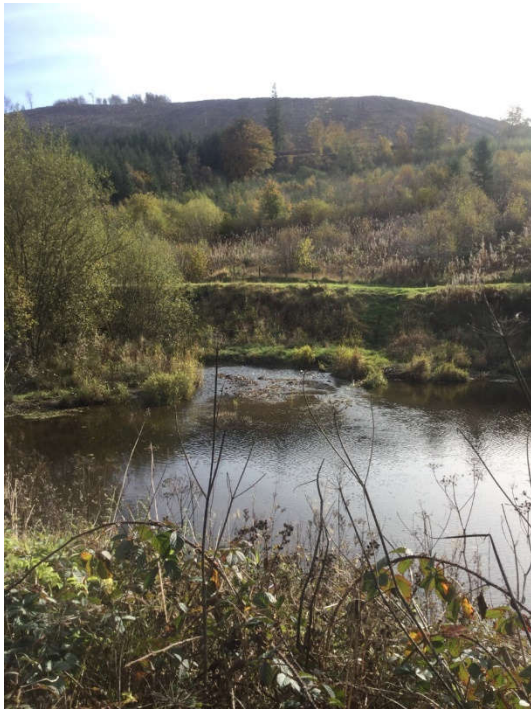
**Figure 5-1 – Photograph of accumulating coarse sediment within the weir pool**

Following consultation with NRW, consideration of a sediment management plan was requested. The increase in flow will provide additional suspended/finer sediments, however the coarser sediment is likely to drop out into the weir pool as is the case in the current scenario (see Figure 5-

1). Therefore, there is still potential for the channel to be starved of coarse sediment with an increased likelihood of mobilisation due to higher flows downstream.

The establishment of a sediment management plan is currently outside the scope of this assessment. However, consultation with Severn Trent Water and NRW should be undertaken to ascertain the extent of the continued maintenance commitments. This could include the periodic translocation of coarse sediments from the weir pool downstream along the Marchnant, enabling the natural redistribution of the coarse sediment. The regularity of the sediment translocations may depend on the rate of deposition in the weir pool and extent of sediment being mobilised downstream. Therefore, a monitoring plan is recommended during the first 1 to 3 years following the establishment of the works, using fixed-point photography and potentially bathymetry to measure the rate of deposition within the weir pool. The rate of sediment transport is dependent on the types of flows experienced, in particular high flows events. Therefore, any observations during the monitoring should also take into account the preceding flow conditions.
