Compliance Assessment Report CAR_NRW0045691

Permit being assessed: AN0106601

For: TRETOWER STW TRETOWER CRICKHOWELL, held by DWR CYMRU
CYFYNGEDIG

Type of assessment carried out: Site Inspection, Reason: Routine.

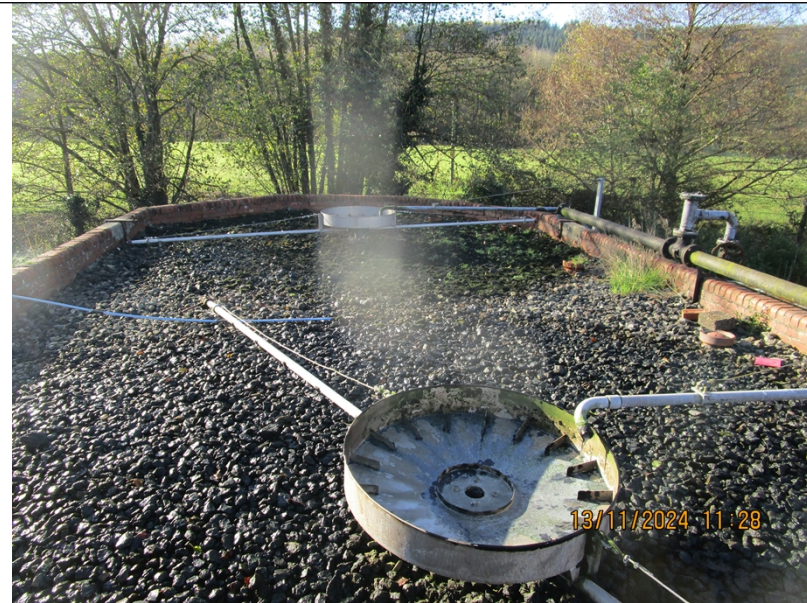
The works contains two filter bed of stone media contained in one large housing. On arrival at the works the filter arms were not rotating, as the pump had not sent flows to the filter beds. Each filter bed centre column has water paddles in place which use the pressure of the flows to power the arm rotation.

Once the pump sent flows to the filters, the rotation arms were moving freely and unhindered. There were no signs of ponding on either of the filter beds. The second filter had a slight coverage of moss and some vegetation growth, however this did not appear to be preventing ample distribution onto the filter media. This may have been as a result of the filter being recently out of service. The second distribution system had recently been removed from service for maintenance. This has since been restored and was clearly operational.

Overall, the filter beds at the works appeared to be in good working order and the filter bed outfall channel appeared to be flowing clear of any solids or signs of problems.

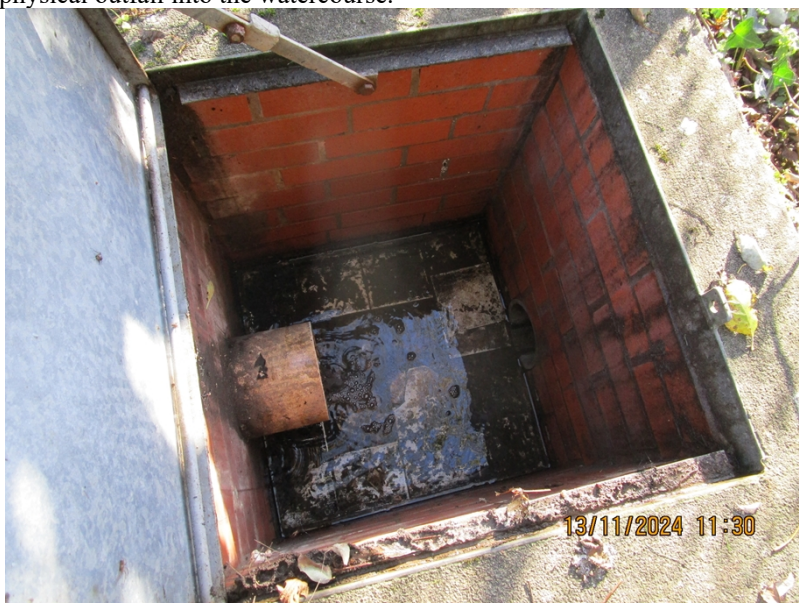
There is a small sampling chamber/ inspection chamber located after the humus tank, which can be accessed by lifting a chamber cover. This chamber be used to collect a representative sample of the effluent; however, the site does not currently have any OSM sampling requirements.

At the time of inspection, the effluent within the chamber appeared clear, and there were no signs of sewage fungus growth or significant solids passing through to the outfall. There is a sign in place to indicate the sample point, near the physical outfall into the watercourse.

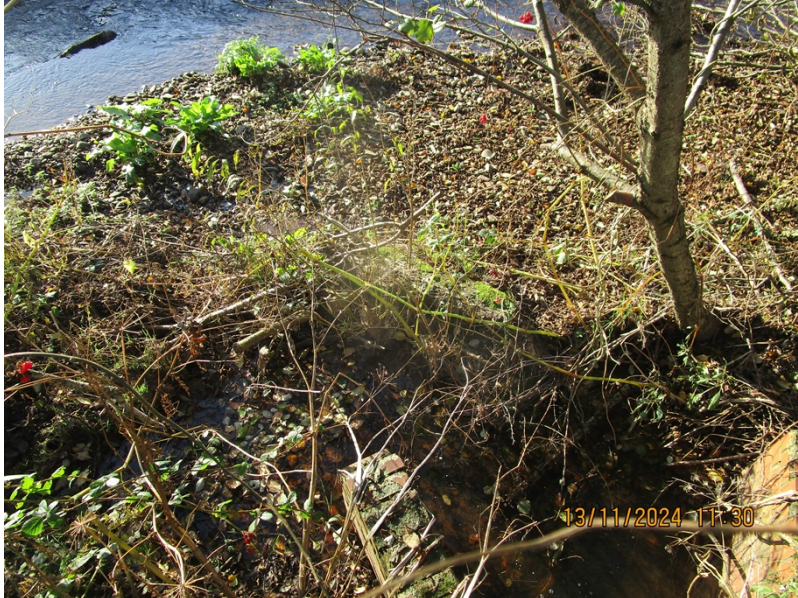
The physical outfall into the receiving watercourse was inspected, and there were no signs of discolouration or fungus build up around the outfall chamber. The currently outfall location does not discharge the effluent directly into the flow of the river. Currently the effluent is held back by gravel/land and makes its way to the main flow of the river filtering through the gravel. This appears to be as a result of the river changing its course. During high flow events this may be directly into the main flow of the watercourse. However, in drier times this could result in effluent not reaching the watercourse, and therefore not receiving dilution. This could also lead to effluent pooling behind the land and becoming stagnant. It would be advisable to investigate options for changing the outfall to ensure effluent reaches the main flow of the river. This is not a noncompliance against the permitted conditions and is not currently causing any problems. The Rhiangoll is a main river so any physical works within or alongside the river may require a Flood Risk Activity Permit.

Investigate options for ensuring that the effluent from the works enters the main flow of the river. Provide details of the investigation and any outcomes/plans for works by 13/12/2024.
