Compliance Assessment Report CAR_NRW0045689

Permit being assessed: AC0098201

For: CWMDU STW CRICKHOWELL ,, held by DWR CYMRU CYFYNGEDIG
At: CWMDU STW CRICKHOWELL ,, CRICKHOWELL ,, CRICKHOWELL ,,
CRICKHOWELL ,, ,.

Type of assessment carried out: Site Inspection, Reason: Routine.

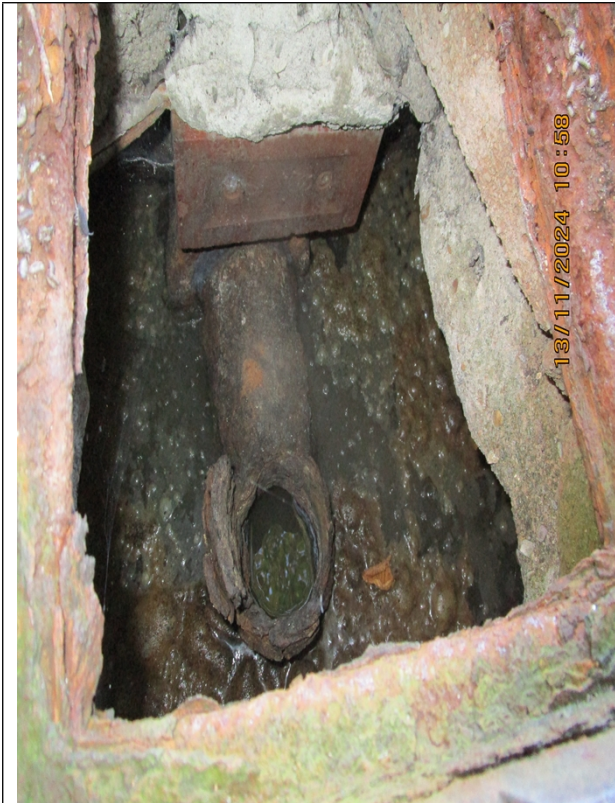
The flows into the works flow directly into a rectangular covered primary settlement tank. It is my understanding that the tank has a lower outfall pipe, to retain surface solids within the tank. The tank had a visual build up of solids and sum on the surface within, and the pipe visible at the outfall end appeared rusty and degraded. It is not clear if this is affecting the treatment process. There were some slight solids present within the outfall channel, but not a significant amount.

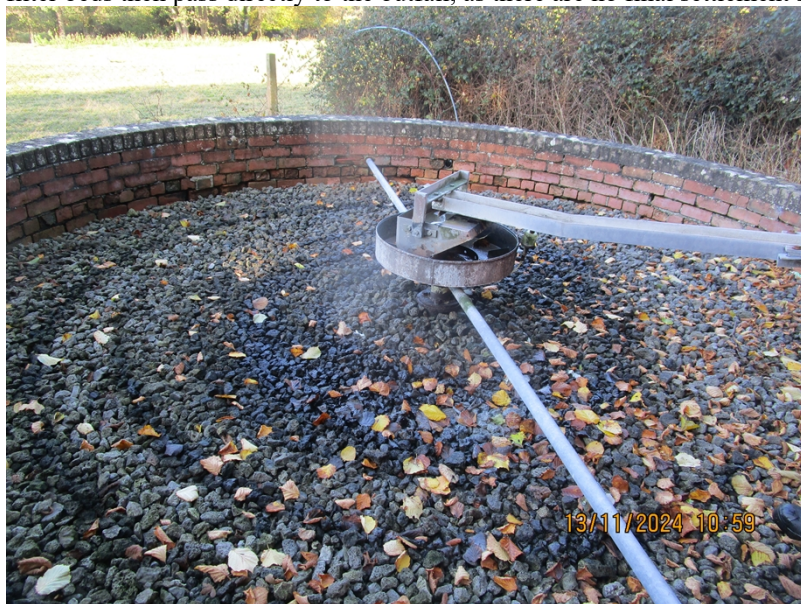
The works contains a single filter bed of stone media. On arrival at the works the filter arm was not rotating, as the tipper unit had not discharged. Once the tipper activated, the rotation arms were moving and unhindered. There were no signs of ponding or vegetation present on the surface of the filter media. There were some dry patches visible on the filter media, however this likely a result of low flows and intermitted discharges across the filter media.

Overall, the filter bed at the works appeared to be good working order and operating as designed. The flows from the filter beds then pass directly to the outfall, as there are no final settlement systems in place at this works.

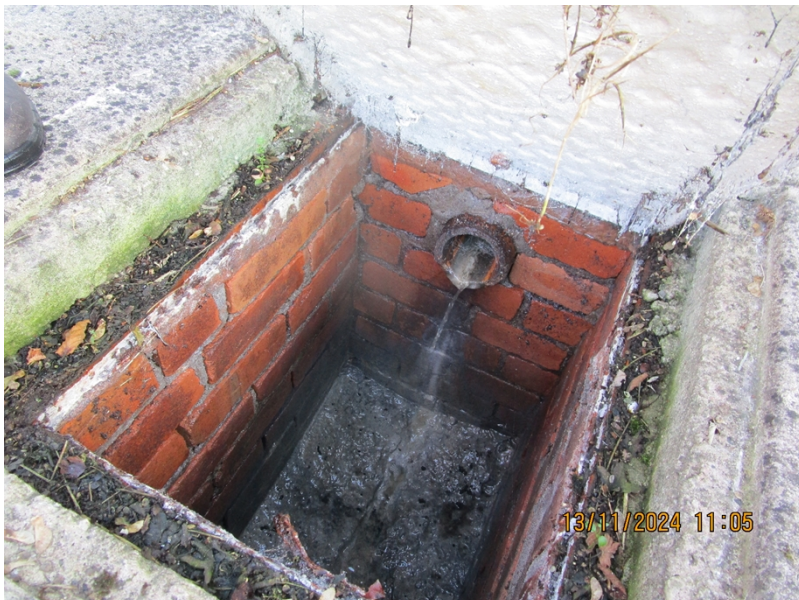
There is a small outfall chamber, which can be accessed by lifting a chamber cover, allowing for visual inspection of the effluent. This chamber could also be used to collect a representative sample of the effluent, if required. However, there are currently no OSM sampling requirements at this works.

At the time of inspection there was a visible build-up of sewage fungus present on the base of the pipe and within the outfall chamber. The presence of fungus growth within the pipe and outfall channel indicate that effluent has been passing through which has not been adequately treated. Without any further treatment or settlement this effluent passes directly to the receiving watercourse. This would have a negative impact on the receiving environment and is therefore a breach of condition 7 of the permit.

This has been classified as a category 3 noncompliance, as this could potentially have a minor impact on the receiving watercourse.

Investigate the cause of the sewage fungus build up within the outfall chamber and take appropriate steps to clean up the outfall and prevent further pollution to the receiving environment. Please provide details of the investigation, actions taken and evidence to show a clean-up has been completed, by 31/12/2024
