# Marine Characterisation Research Project (MCRP)

## 22UK1877\_Morlais\_Report\_of\_Survey\_Summer23

### MORLAIS VESSEL TRAFFIC SURVEY METHODOLOGY AND GUIDELINES OF SURVEY – SUMMER 2023

Report Number: 22UK1877  
Issue: 01  
Date: 11 December 2023

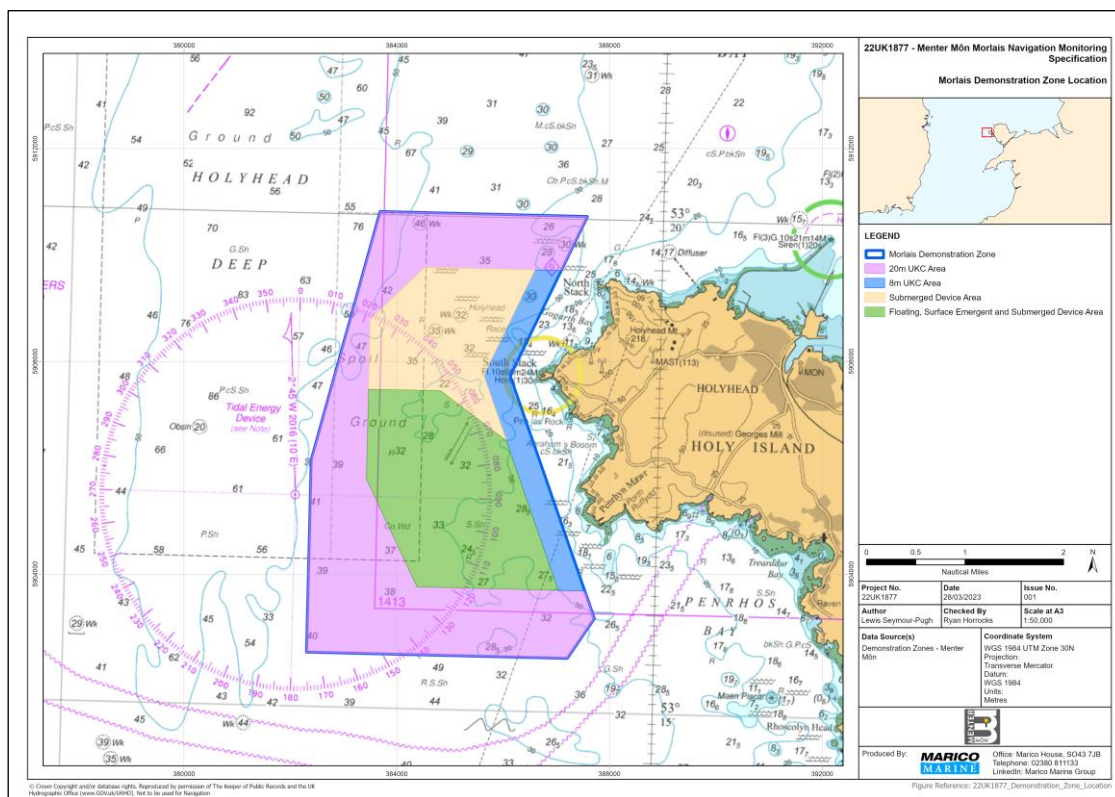
*Figure 1 – Morlais Demonstration Zone as per the Marine License.*

The MDZ is shown below in **Figure 1**.

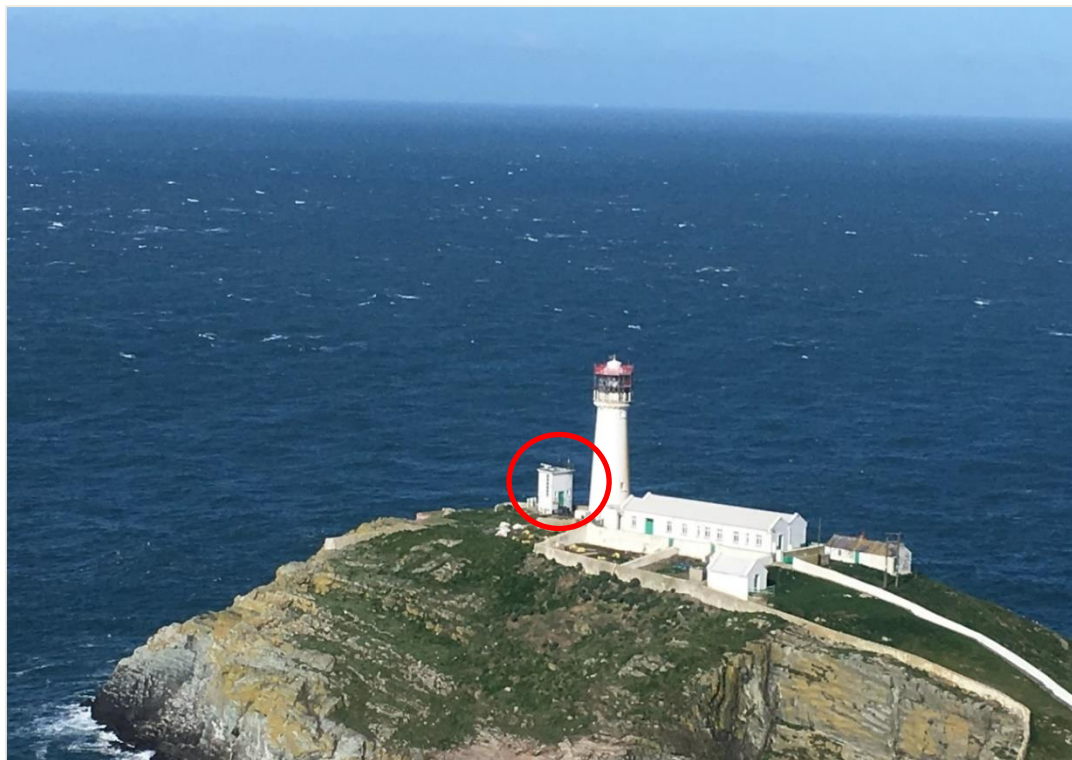
*Figure 3: Position of survey equipment.*

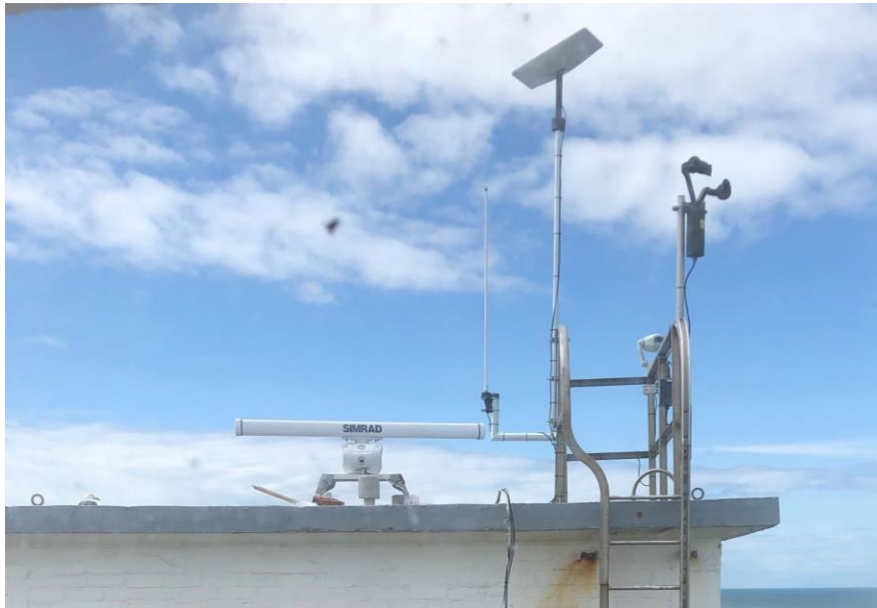
*Figure 4: Equipment in position on fog house roof.*

- a Simrad HALO-6 Pulse compression RADAR:
  - Antenna size: 6 ft. (1.8 m);
- CCTV Camera:
  - a Predator PTZ Camera PRED60-28-G-W 28 x Optical Zoom 360Vision CCTV With Wiper;
- Marine VHF Antenna (for AIS);
- StarLink satellite broadband equipment;
- Equipment Box comprising:
  - Desktop PC with data recording software;
  - SR162 Professional AIS receiver;
  - Uninterruptible Power Supply Unit;
- Installation Materials.
- Survey processing:
  - Wärtsilä Navi-Harbour WebVTS 5.0 system.

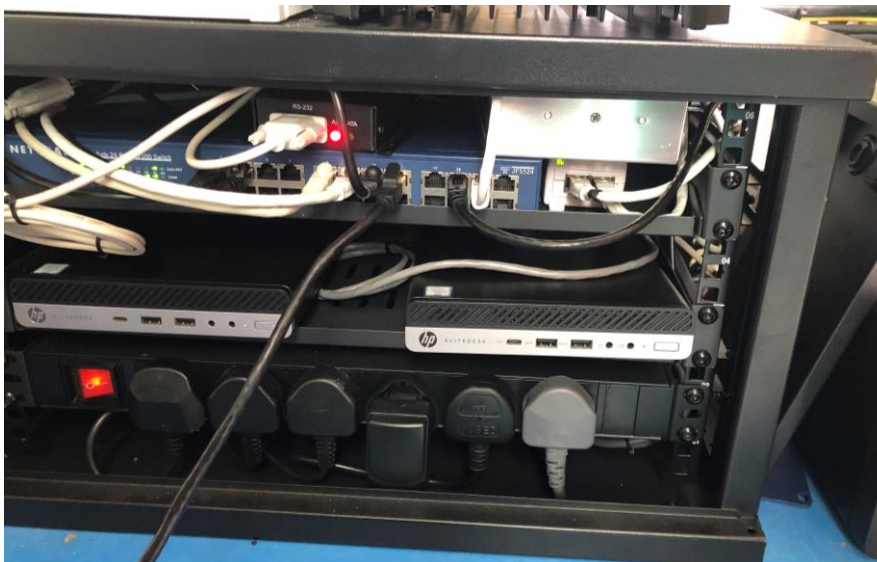
*Figure 5: Survey computer stack.*

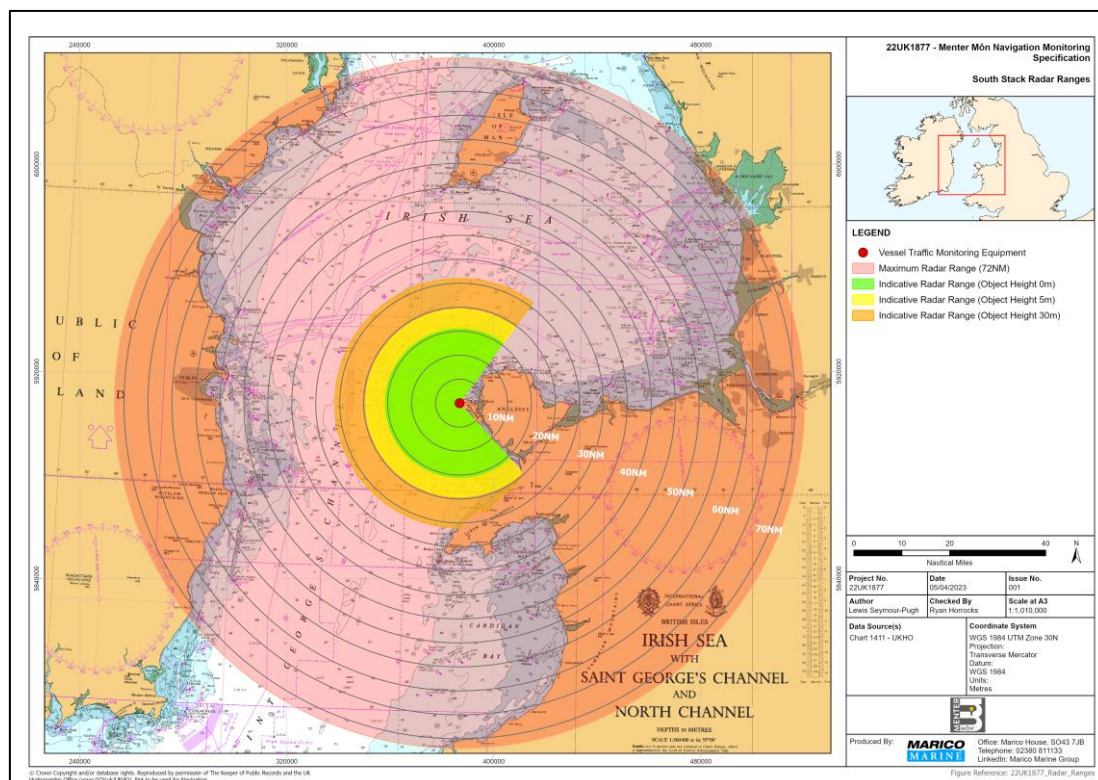
*Figure 6: South Stack Modelled Radar Ranges.*

It should be noted that the high scanner height and steep sided cliff resulted in a blind spot at the base of the cliffs where vessels hugging the coast and well inshore of the development area would not always be detectable.

Coverage of the X-Band radar has been modelled using the Cambridge Pixel SPX Tool and indicative radar coverage is shown in **Figure 6**.

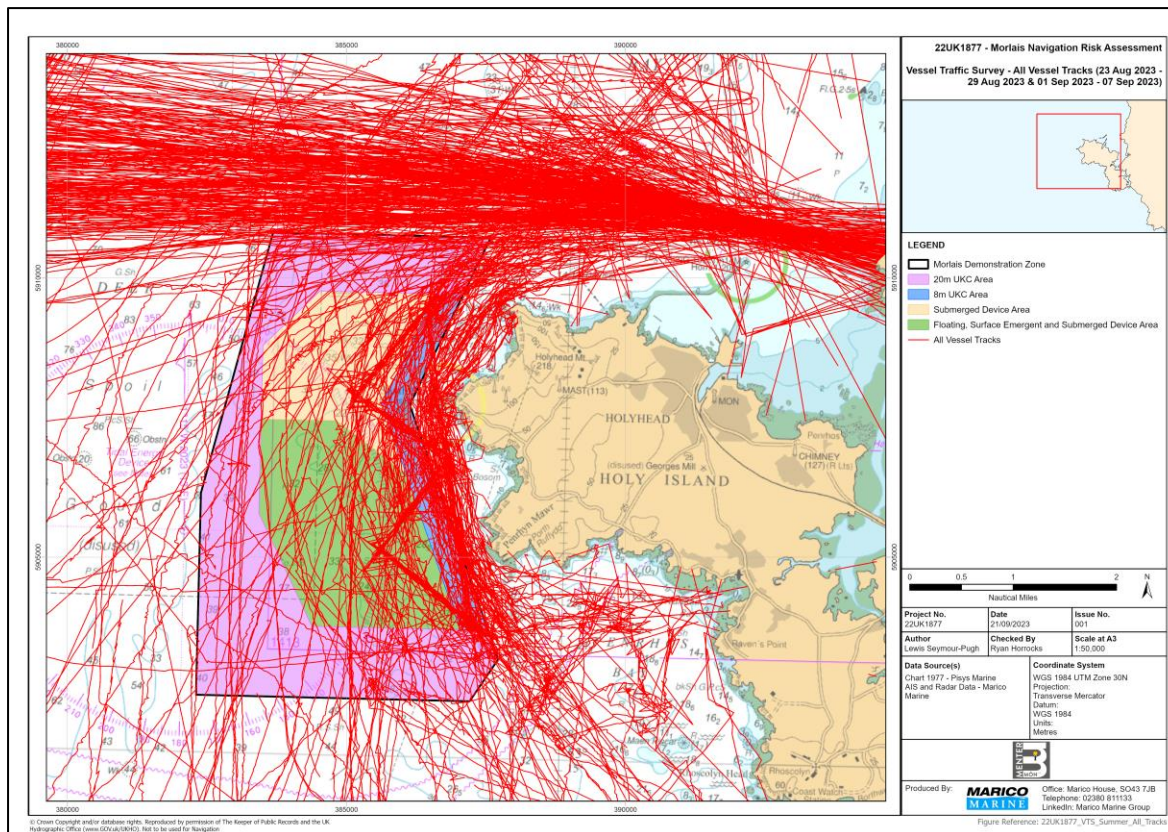
*Figure 7 – All Vessel Tracks*

Figure 7 provides the overview traffic of total vessel data across the two-week summer survey. Figure 8 shows specifically the non-AIS targets collected by radar.

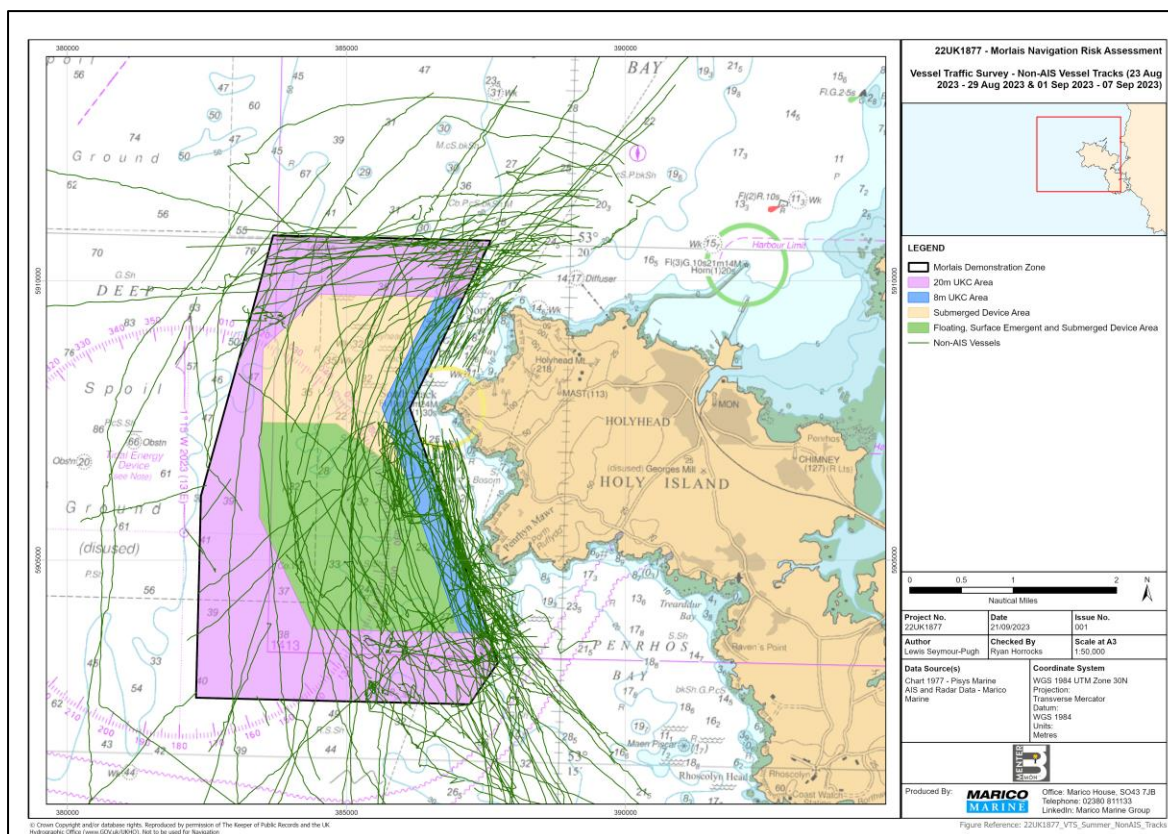
Figure 8 – Non-AIS (radar) Vessel Tracks

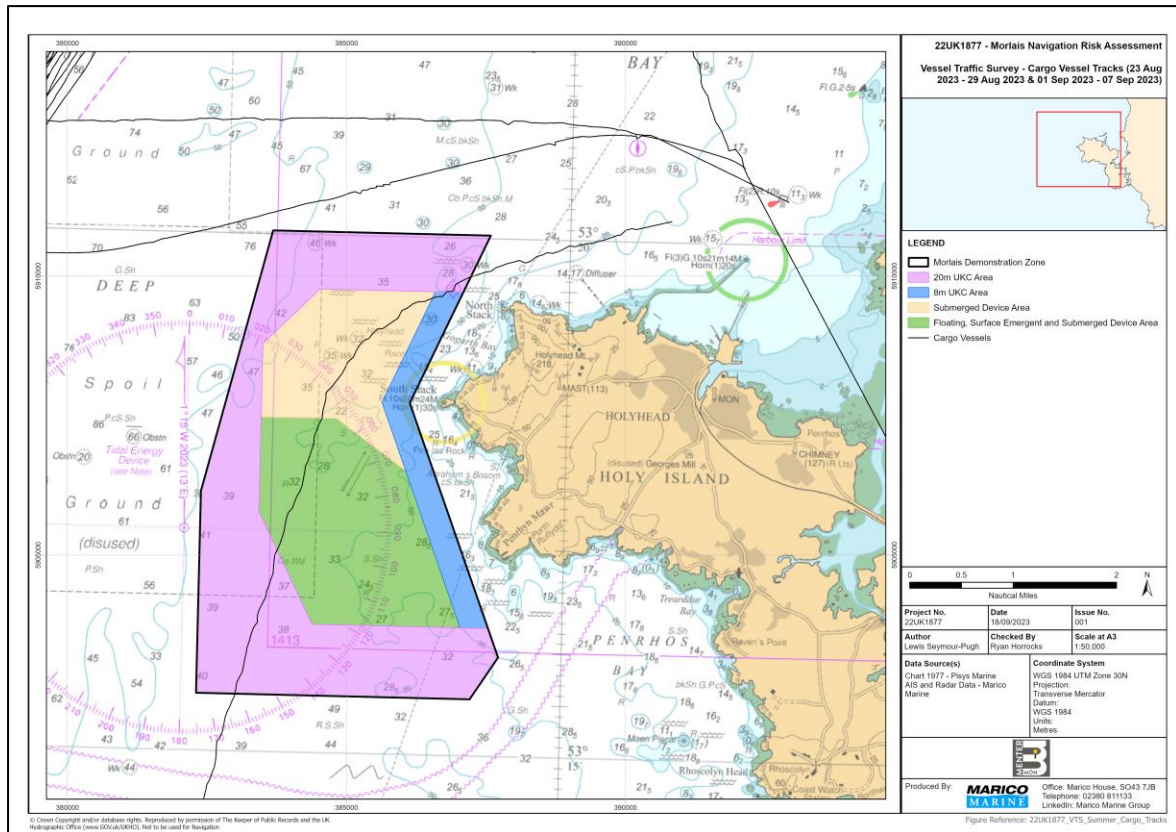
Figure 9 – Cargo Vessel Tracks

The following figures demonstrate the numbers of tracks of each specific vessel type that were present during the survey period and transited in or around the demonstration zone.

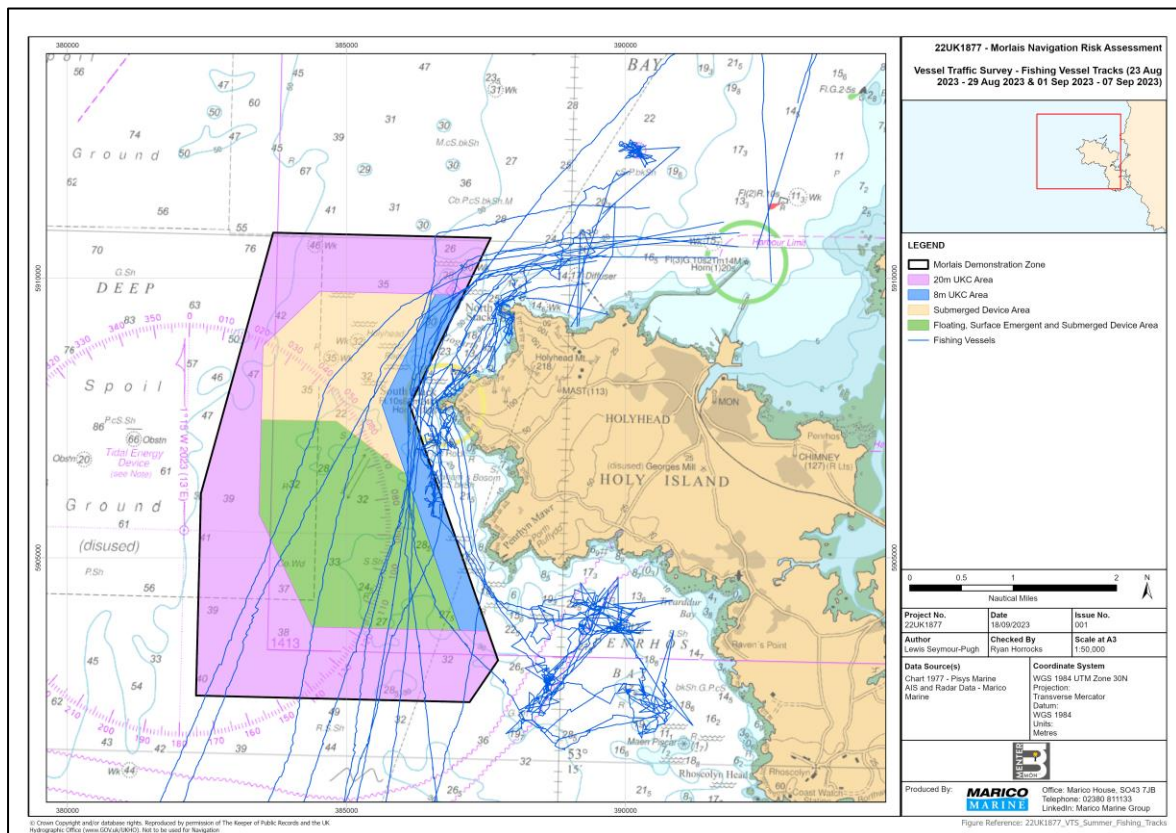
Figure 10 – Fishing Vessel Tracks

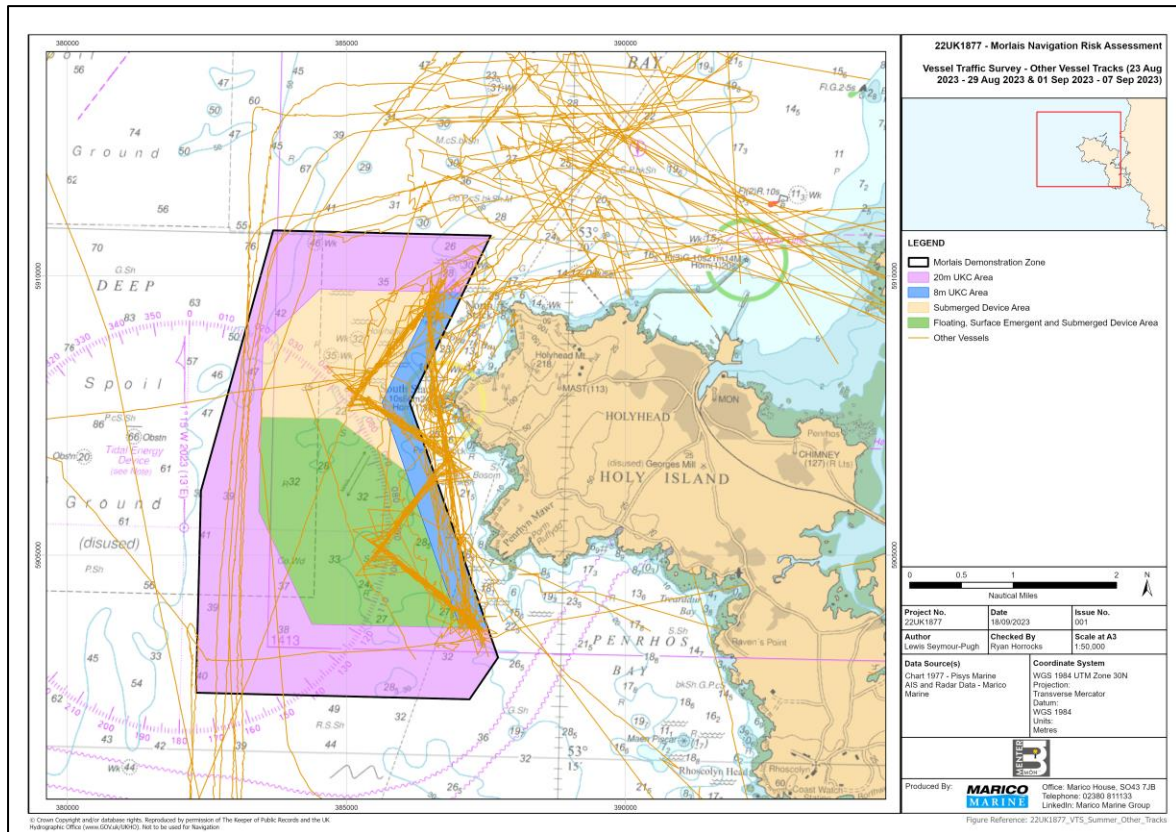
Figure 11 - Other Vessel Tracks

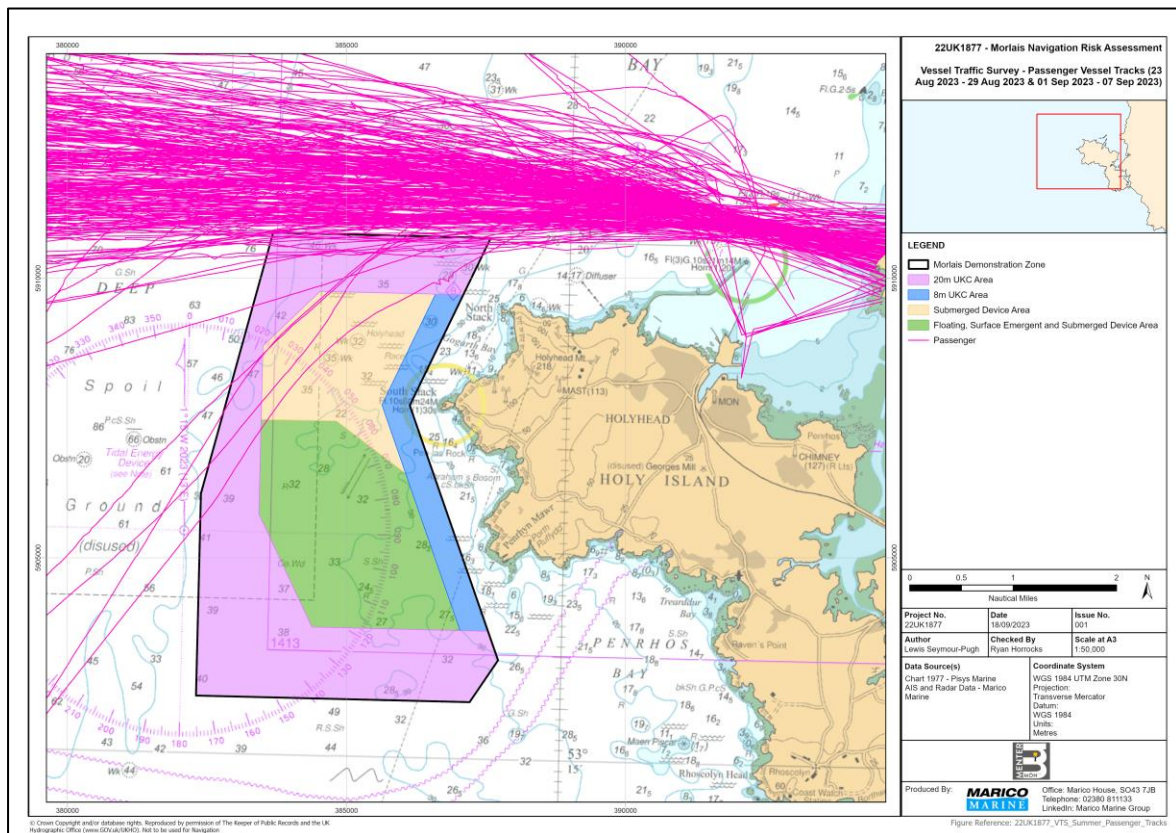
Figure 12 - Passenger Vessel Tracks

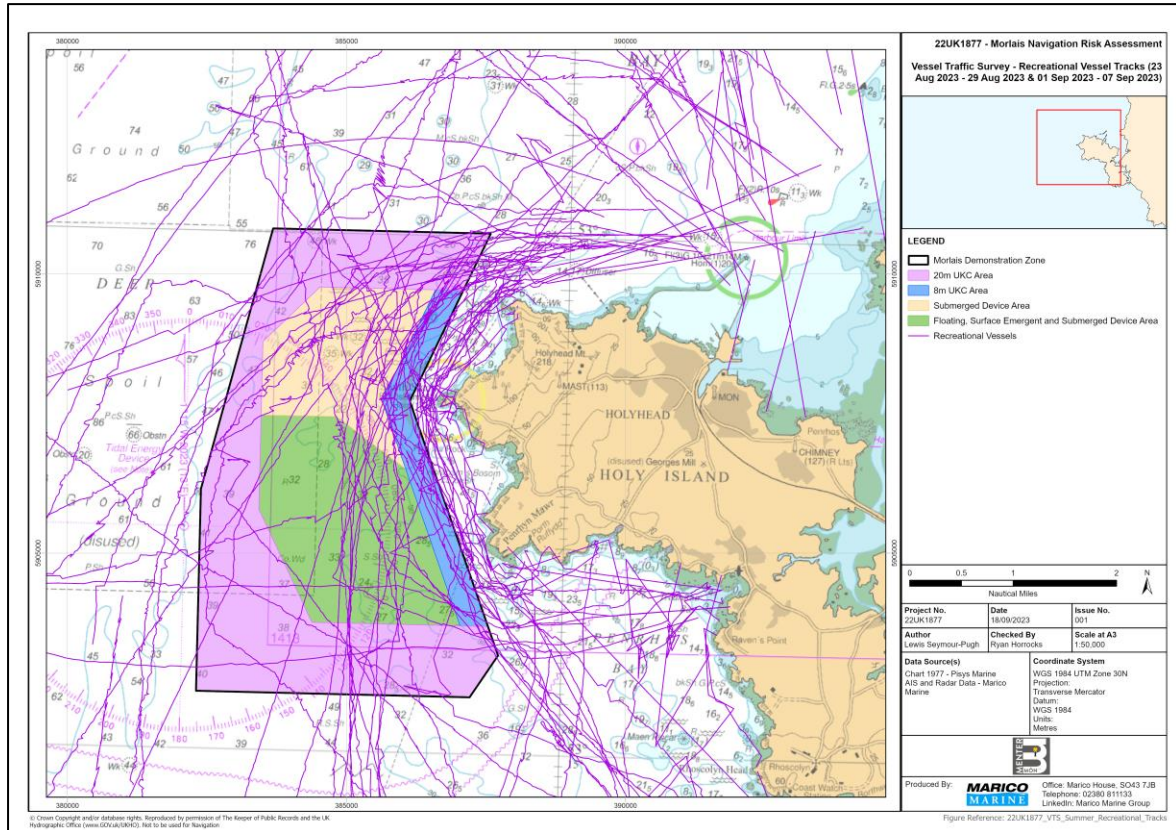
Figure 13 – Recreational Vessel Tracks

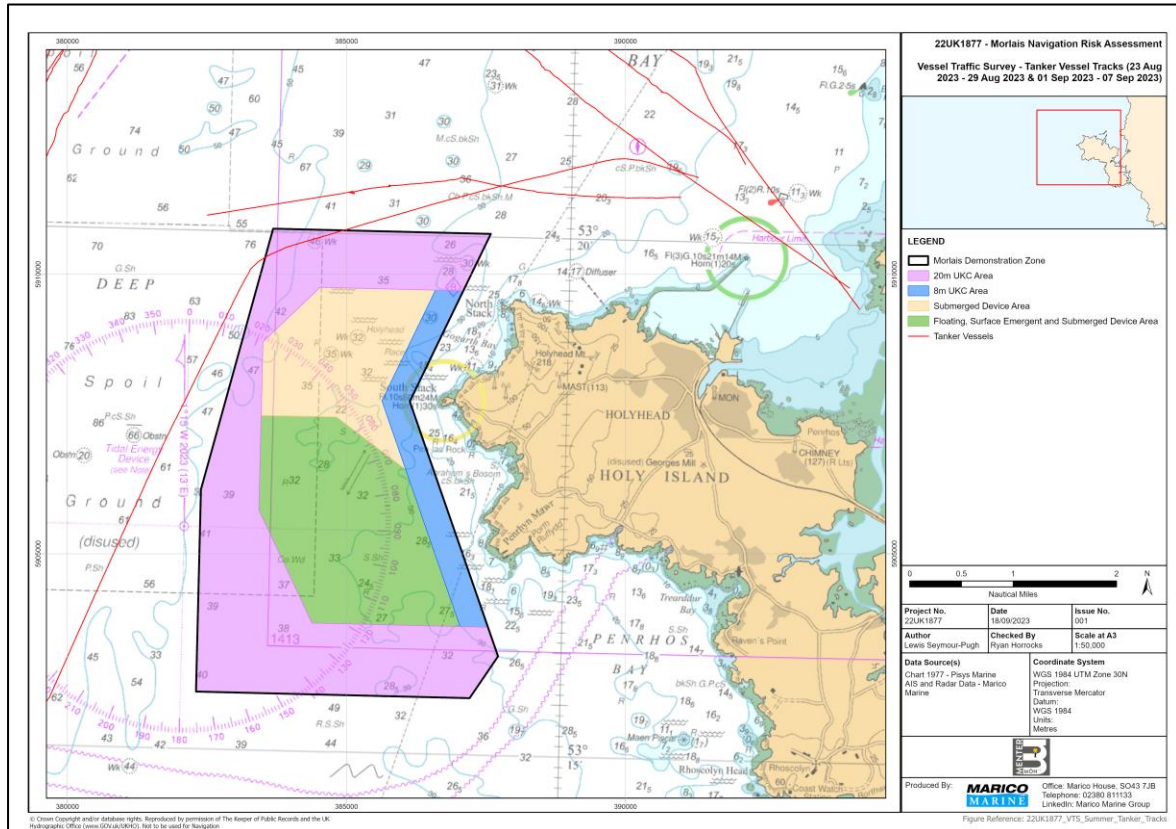
Figure 14 – Tanker Vessel Tracks

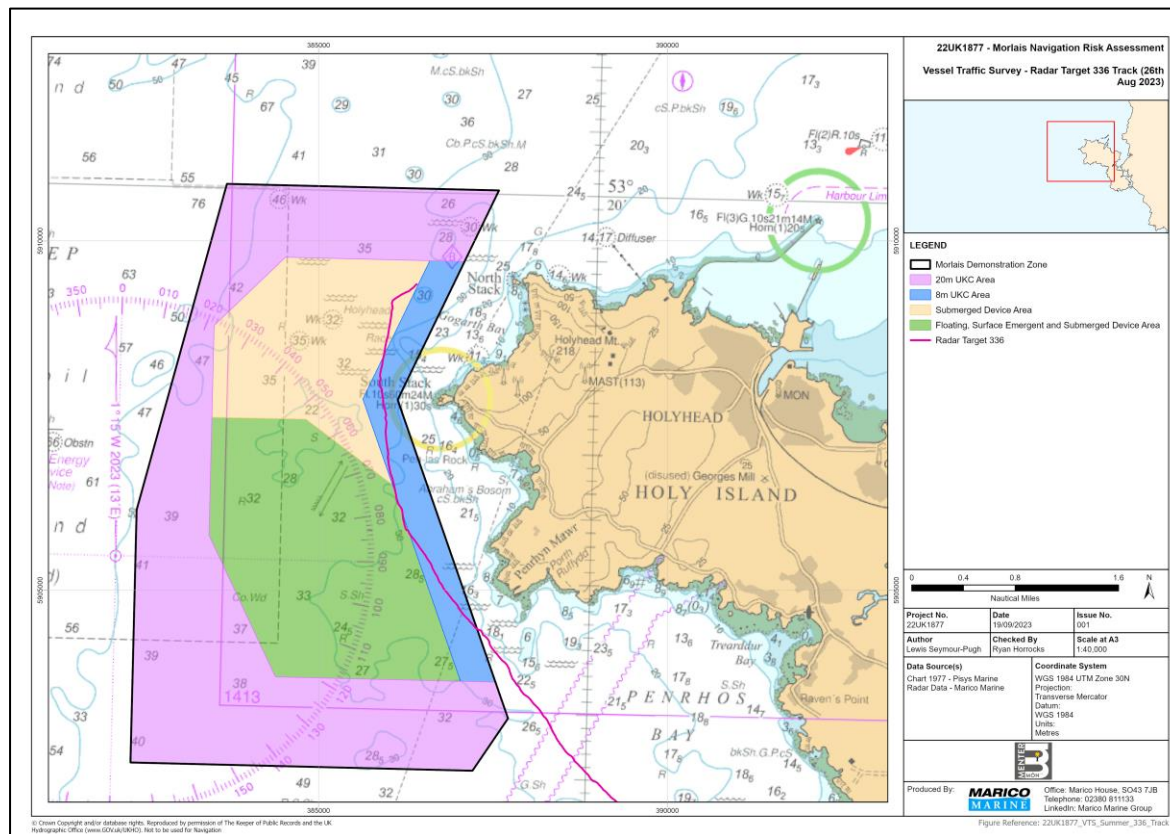
*Figure 15 – Radar Target 336 Track*

Radar targets were marked and recorded within both the NaviHarbour software and Visual Records Log to provide both geospatial data and images of radar vessels, as seen in **Figure 15** and **Figure 16**.

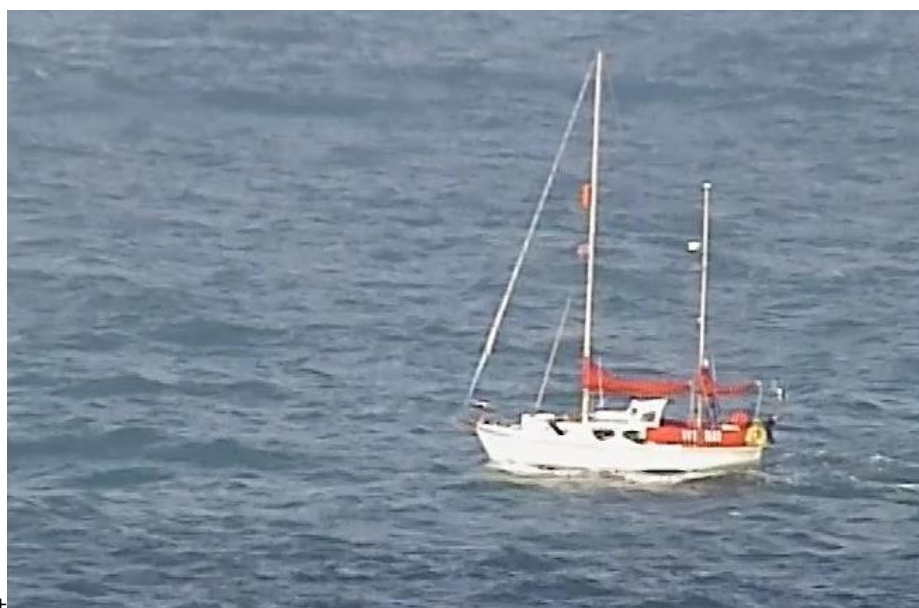
*Figure 16 – CCTV Image of radar Target 336*
