Compliance Assessment Report CAR_NRW0038876

Permit being assessed: AW1002101

For: GLASBURY STW GLASBURY NR HAY ON WYE, held by DWR CYMRU CYFYNGEDIG

Type of assessment carried out: Site Inspection, Reason: Routine.

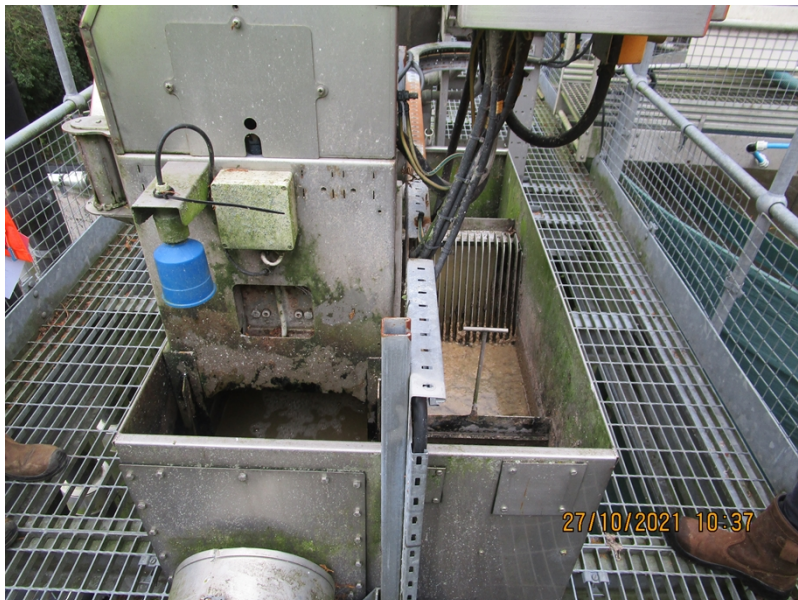
The incoming flow to the site is pumped up to the inlet point, where telemetry is in place to monitor flows. The inlet is clearly marked and was clear of blockages, the main screen is enclosed and has a 6mm aperture. There is a bypass screen (to the right) which is approximately 1 inch in aperture, this is used when the main screen is out of use or in the event of a failure.

Both screens lead to a macerator. Following the macerator is the storm weir. There is EDM equipment in place to monitor storm discharges, this appeared in working order.

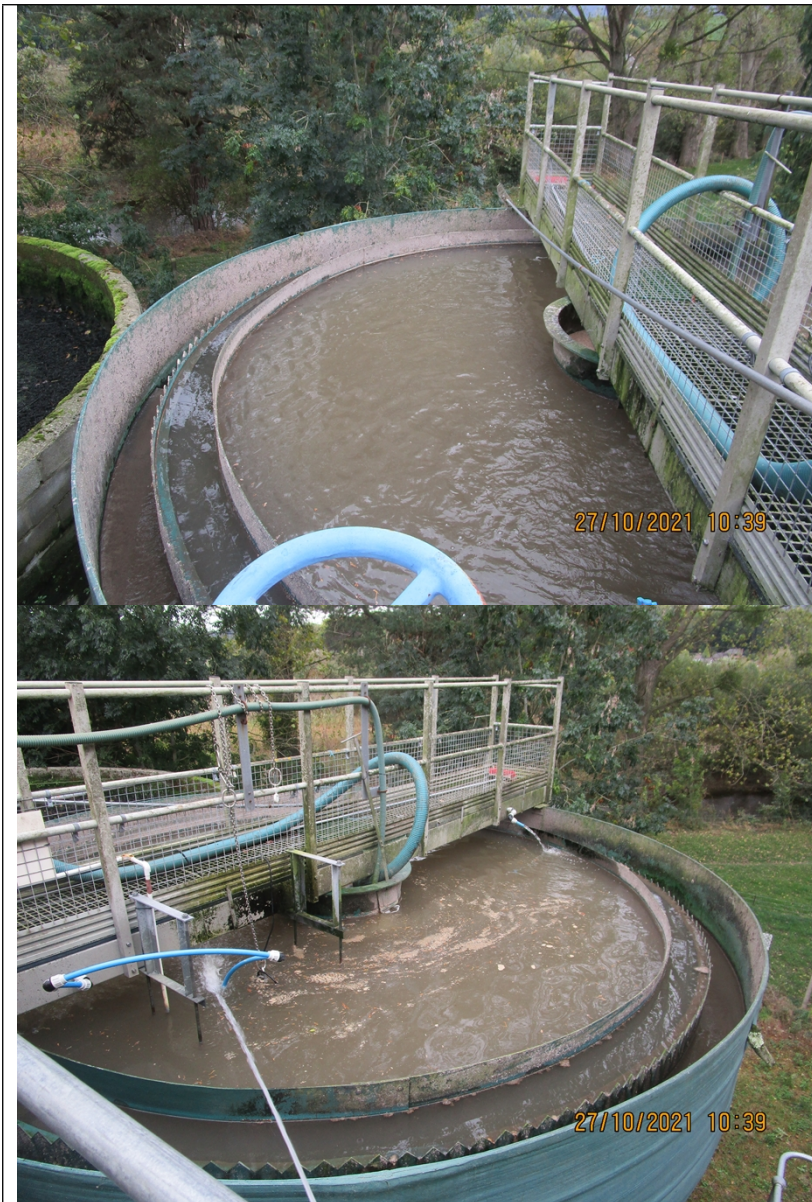
The primary settlement tank appeared to be operating effectively. There were no signs of significant solids passing into the outfall channel. The tank itself had two hoses spraying the surface of the water. On questioning this was to keep movement within the solid matter, encouraging more solids to sink. This is because the primary tank design does not have a rotating scum scraper.

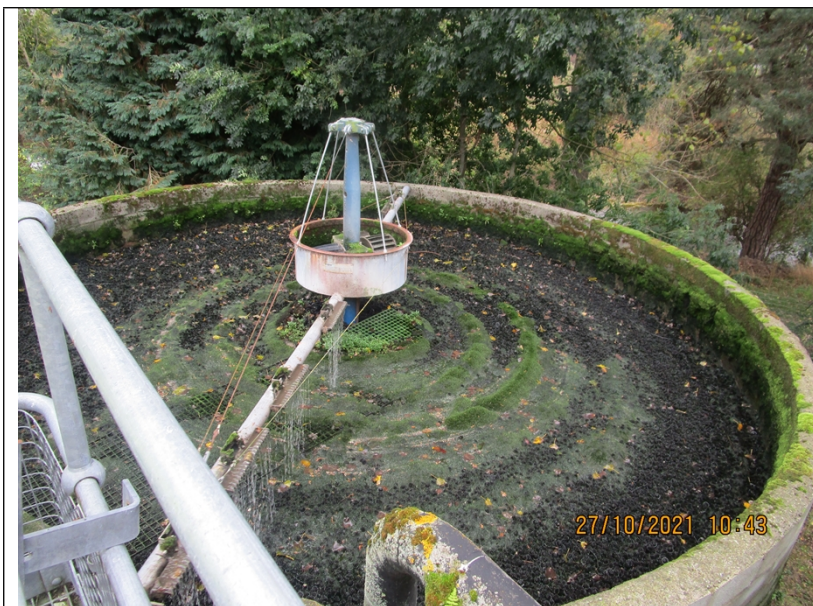
There is a single filter bed which contains plastic filter media. The rotation arm was moving in a free and unhindered manner. The distribution points on the arm were clear of debris and water was flowing freely. The filter media had a build up of vegetation in several places, although it did not appear to be hindering water filtering into the plastic media. On questioning about removal and maintenance. I was advised that only certain areas of the filter bed are safe for access.

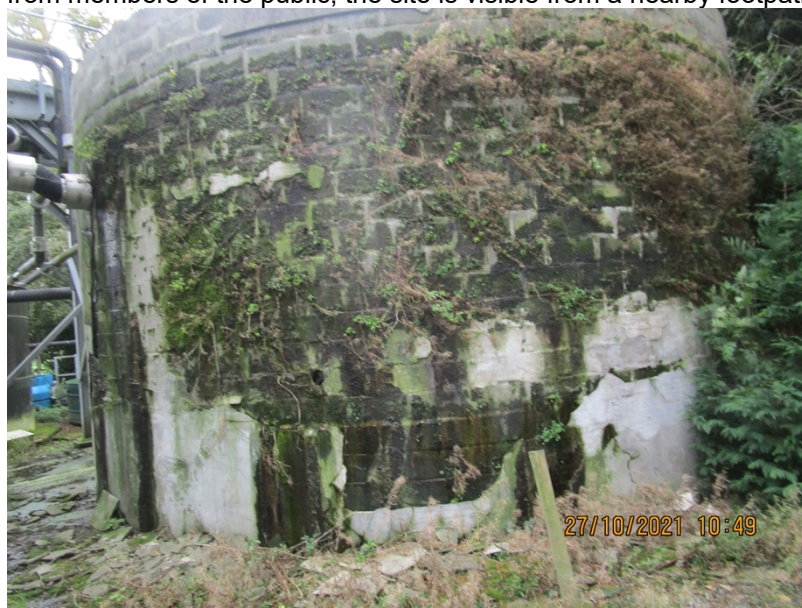
The external walls of the filter bed appear to be in need of maintenance. A render which had been previously installed has cracked and fallen away in many places. The outer wall has vegetation growth and appeared wet during the visit. It is not clear if the moisture present is from the tank leaking, or from rainfall and vegetation. I was advised that DCWW are looking into possible solutions, as the visual appearance is causing complaints from members of the public, the site is visible from a nearby footpath.

The works visually is in need of some maintenance and updating, specifically the filter bed housing. Despite its appearances, the treatment process is working accordingly and producing effluent within consented limits.

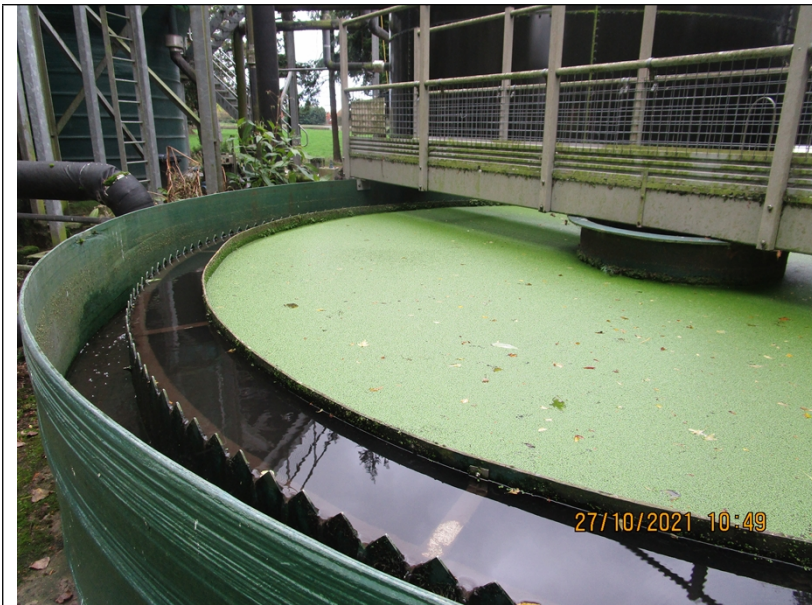
The humus tank appeared to be operating effectively and there were no signs of solids in the outfall channels. There is a thin covering of duckweed present on the surface of the humus tank, however this does not appear to be hindering its operation and is contained within the scum board. The effluent within the outfall was clear and there were no signs of concern.

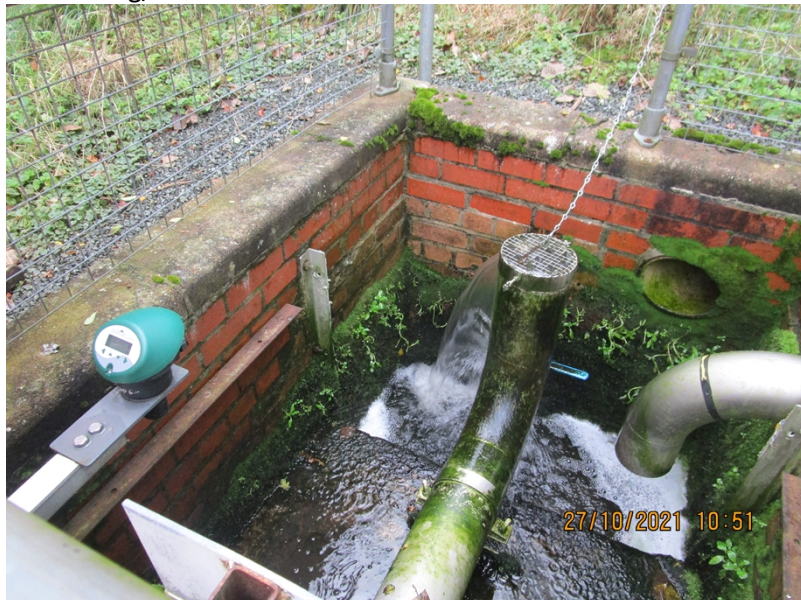
The final effluent from the humus tank passes through a Magflow flow meter, which appeared to be operating as required and accessible for inspection. The sample point is clearly marked with appropriate signage including the NGR. A list of permitted limits was always present for operatives to check whilst on site. The inspection chamber and outfall was clear of debris and effluent was flowing freely to the outfall.

An on site effluent sample was taken by Brian Barrel at 11:00, which was within consented limits
