Client: North Midland Construction Plc (NMC) and Natural Resources Wales (NRW)
Project Number: 5168368
Project: Cownwy & Marchnant Intake Design

System and Habitat Descriptions

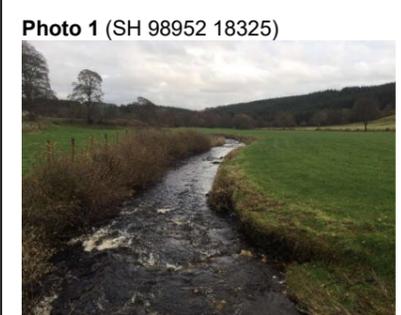
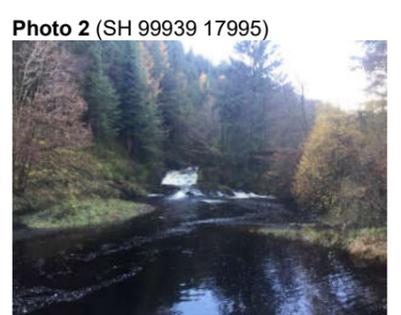
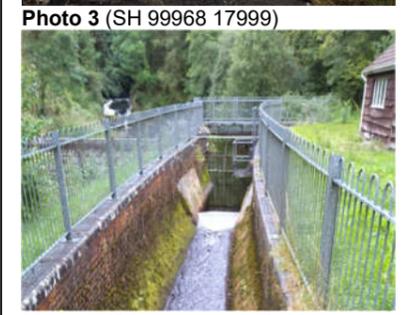
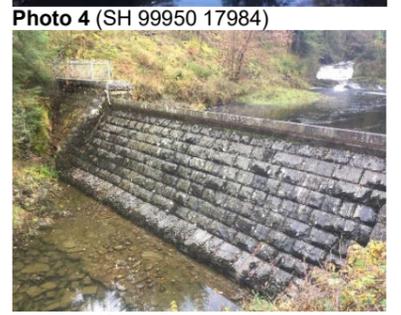
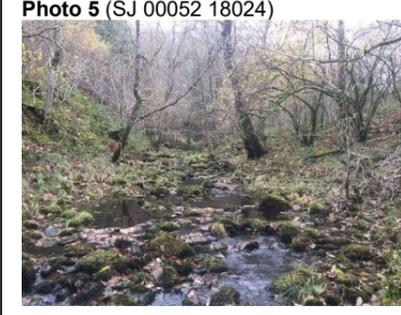
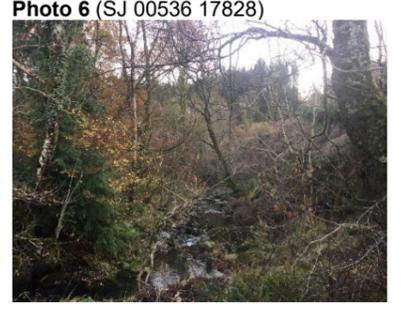
Afon Cownwy:
Structures: The existing Cownwy intake consists of a diversion weir (Photo 4) on the River Cownwy at the location shown in Figure 1. The weir diverts flows along an open brick abstraction channel into a 1.98km long diversion tunnel for transfer to Lake Vyrnwy. The diversion weir has a spillway (approximately 20m wide) which has been designed to spill water during high return periods to the downstream Afon Cownwy when inflow rates exceed the storage volume and intake structure capacity. The proposed works involves demolition of an approximately 10m length of the existing abstraction channel and replacement with a new reinforced concrete rectangular channel and weir structure. The new structure will consist of a bifurcating rectangular channel which will split flow between the diversion tunnel and the Afon Cownwy in a 75%:25% split respectively.

Habitats: The upstream reach of the Afon Cownwy (above the weir pool) is located within a wide unconstrained valley (Photo 1) and flows through grazing pasture. The watercourse is fast-flowing, approximately 6m wide (wetted width) with predominantly cobble substrates. Limited aquatic vegetation is present within the upper reach which is typical of high gradient systems. Downstream, the valley narrows and steepens, leading to a change from farming to forestry land uses. Flow is diverted from the River Cownwy at SH 99946 17986 and discharged via a tunnel to Lake Vyrnwy, resulting in all of the watercourse flow being removed from the downstream reach under normal flow conditions. The impounding weir structure and its associated diversion channel culvert, constructed in the late 1800s, has led to the formation of a large weir pool. This weir pool (Photo 2) consists of deep water and marginal shelves which are vegetated with grasses, herbs and small patches of marginal macrophytes. Large gravel deposits were recorded where the Afon Cownwy entered the weir pool and similarly, where the Nant y Ceunant Du tributary entered the pool on the left bank. These gravel bars were vegetated, indicating that they were established and stable. Immediately downstream of the weir pool the watercourse channel is characterised by stagnant pools of water within the wide river bed (approximately 10m wide; Photo 5). The bed substrate is dominated by coarse sediment (pebbles, cobbles and boulders) with limited gravels and finer material. Boulders were typically covered in moss, indicating that high flows are rare. Further downstream there is flow accretion from the surrounding catchment and watercourse begins to visibly discharge (Photo 6), however it is still significantly influenced by the reduced flow caused by the

diversion to Lake Vyrnwy. Limited aquatic and marginal macrophytes were observed within the channel and its corridor, likely to be a result of heavy shading caused by the dense tree cover and the setting within the wider catchment.

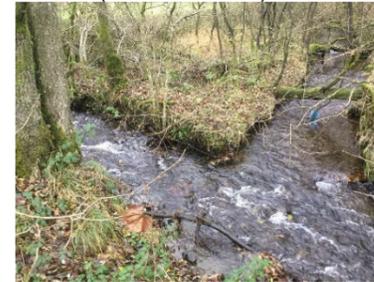
Photo 8 (SJ 04385 19915)

Upstream of the weir pool the watercourse channel is approximately 3m wide and comprised of cobble, gravel and pebble substrates (Photos 8 and 9). The River Marchnant is joined by another similarly sized tributary approximately 20m upstream of the weir pool (Photo 9). No fish, marginal or aquatic macrophytes were observed upstream of the weir pool during the survey.

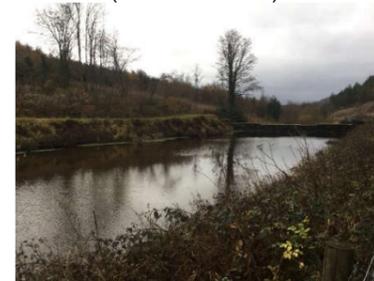
Photo 10 (SJ 04290 19855)

The rectangular weir pool is defined by steep sides and a large area of open water (Photo 10). The margins have several areas of marginal macrophyte cover. A large gravel deposit is located on the north eastern side of the weir pool where the River Marchnant enters. A noticeable lack of gravel and other coarser substrates is present downstream of the weir.

Weir Pool Habitat	<p>The weir pool is a manmade feature created by flow impoundment at the weir structure and as such is not characteristic of natural standing water body habitats within the area. However, the pool has been part of the landscape for over 100 years and therefore is likely to provide important still water habitat for species within the area. The pool itself supports macrophytes, although these were limited to floating leaved rooted species.</p> <p>The weir pool is isolated from the downstream watercourse system due to the presence of the weir structure and the diversion of flow to Lake Vyrnwy. Consequently, colonisation by migratory and other fish species from downstream is likely to be impeded.</p>	No	No	Yes	<p>Since the weir pool is not expected to be lost as a result of the works it is not considered to be a constraint.</p> <p>However, a WMS should be produced that contains appropriate procedures and measures that act to protect the pool and its habitats from disturbance and reduce the risk of pollution spills and fine sediment mobilisation during construction works.</p>

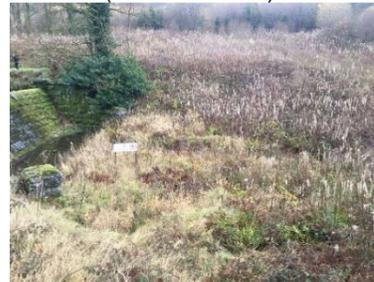
Photo 11 (SJ 04195 19826)

Immediately downstream of the weir and associated intake structure, the watercourse corridor is located within a steep sided valley, which has been clear felled making way for densely vegetated scrub, rushes, ferns, bramble and grasses, as well as emerging young trees (Photo 11). At this location the watercourse channel is poorly defined, instead the area is more typical of wetland habitat, with pooling water promoting the growth of rushes, sedges and ruderal herbs.

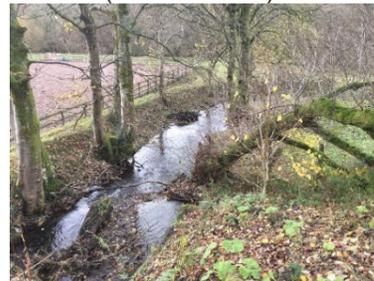
Photo 13 (SJ 03296 18916)

Further downstream, near the village of Abertridwr, the valley widens. Here the watercourse is more characteristic of the wider catchment, with small gravel deposits and a mixture of flow types, however, the flow appeared still significantly reduced compared to what would be expected if flows were not being diverted at the upstream weir structure (Photo 13).
