# HYDROLOGICAL/HYDROGEOLOGICAL RISK ASSESSMENT

Aberthaw Quarry, East Aberthaw, Rhoose, Barry CF62 3ZR

JFR2782

JFR2782 Aberthaw Quarry HRA ver1 rev7

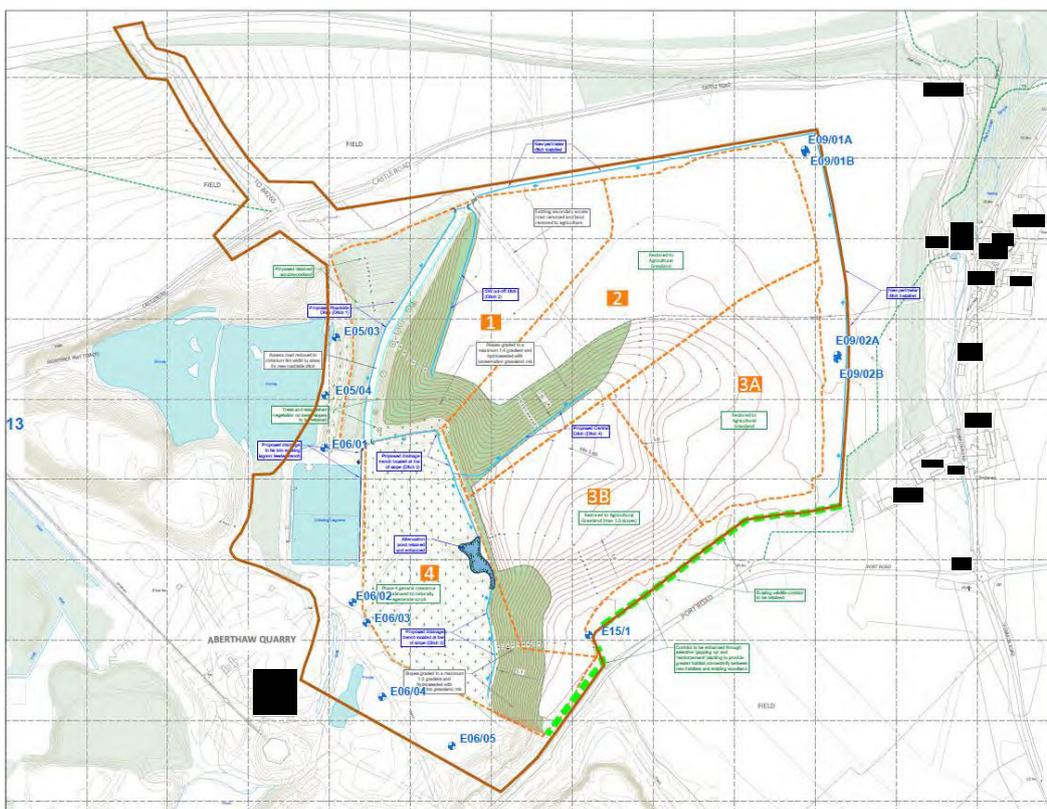
**Figure 1. Site Location Plan**

- 2.1.4 Phase 4 has not received any PFA as the Aberthaw power station ceased operating earlier than its original projected closure date of 2024.
- 2.1.5 The Site is irregular in shape and is bounded to the north, east and west by agricultural land and to the west by the remaining areas of Aberthaw Quarry. A site location plan is presented in Figure 1 indicating the Environmental Permit (EP) boundary under consideration.

- 
- 2.1.6 The topography indicates relatively high ground elevations of c. 40 to 46 mAOD to the southeast and east boundaries of the landfill site, with ground elevations of c.36 to 40 mAOD near the north western entrance to the site. The ground generally reduces in elevation from east to west, with elevations of c. 20 to 26 mAOD near the settlement pond and cement works lagoon near the western boundary of the site.

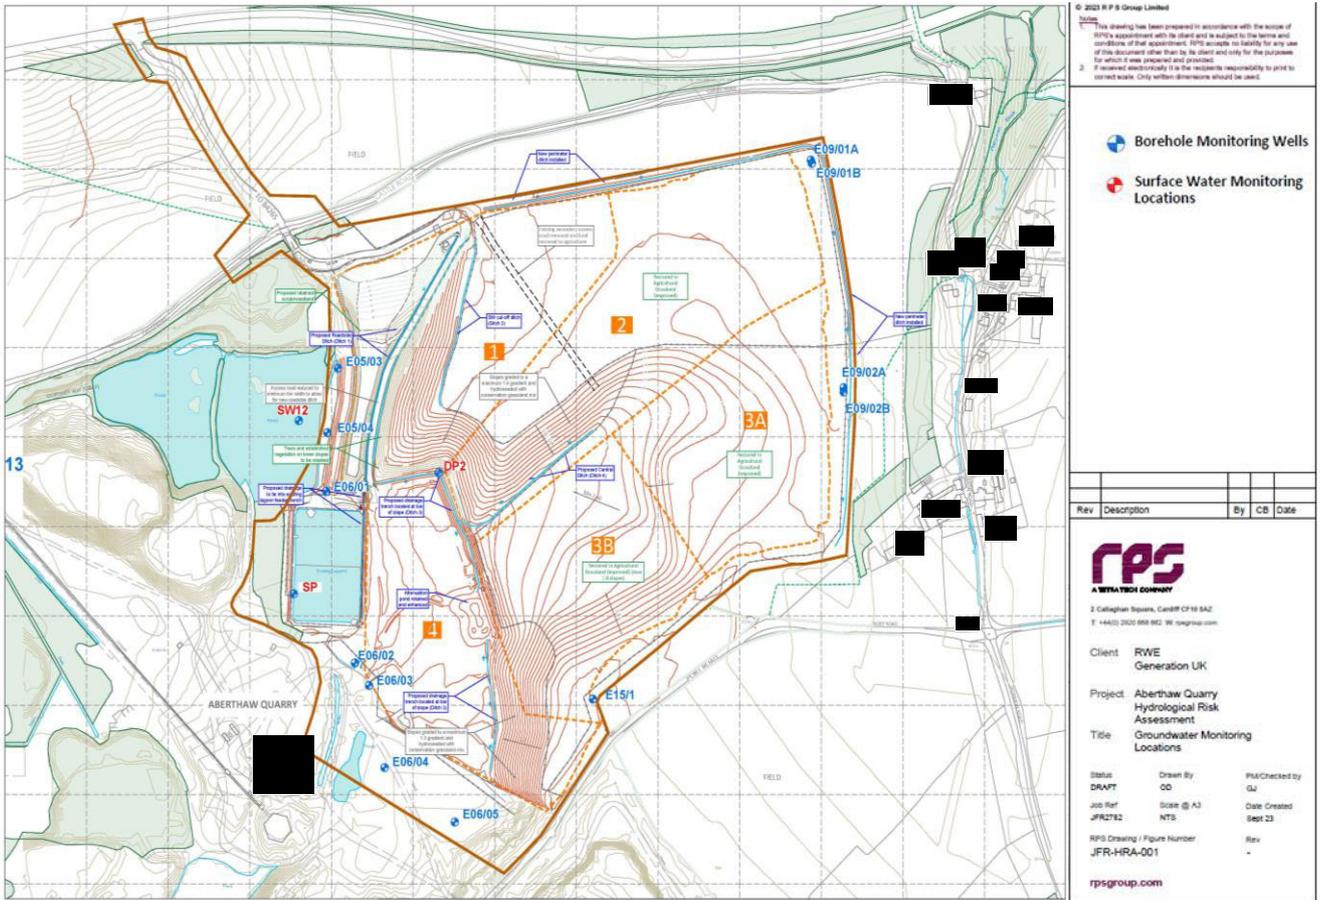
Figure 2. Surface Water and Borehole Monitoring Locations

Note Surface water monitoring point SW13 to the west of the Aberthaw Quarry has not been included in the monitoring as this was removed in 2013 following agreement with NRW (please see section 3.1.36).

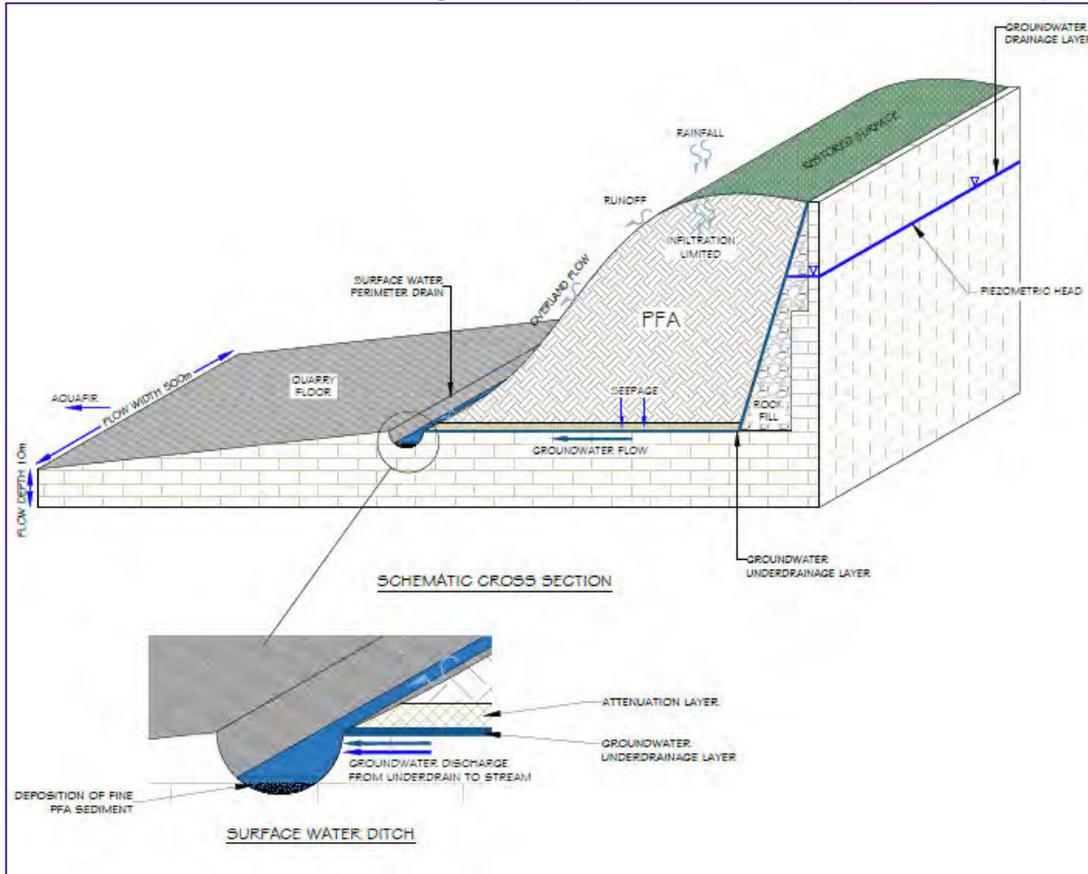
**Figure 3. Cross Section of Landfill Drainage with respect to Groundwater (Caulmert, 2018)**

4.3.7 It is noted that this basal groundwater drainage blanket layer is connected to a 300 mm drainage layer on the batters of the quarry to facilitate the discharge of collected groundwater into a permitted surface water drain installed along the southwestern boundary of the site prior to the waters being discharged into the settlement ponds. The fall of the base of the quarry was designed to direct any infiltrated water to a central spine and discharge to the surface water drain along the southwestern boundary.

4.3.9 It understood that unlined surface water drainage channels located throughout the site will collect shallow groundwater flow from within the drainage blanket layer and overland flow from across the surface of the landfill site. The restored surface of the landfill site is suggested to allow limited infiltration of rainfall into the landfill mass.

(Caulmert, 2018)

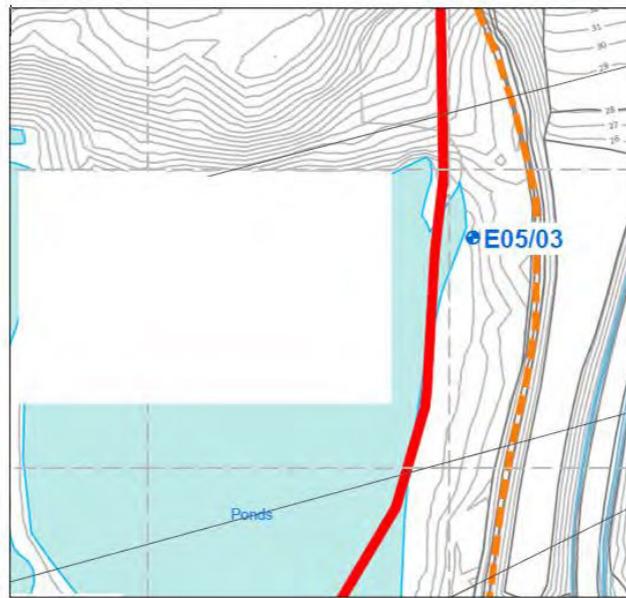
**Figure 4. Borehole E05-03 and Lagoon Location**

- 4.4.11 Concentrations of molybdenum recorded in sampled waters from E05-03 appear likely to be consequence of a preferential pathway, via fractures in the limestone, from the lagoon to the borehole.

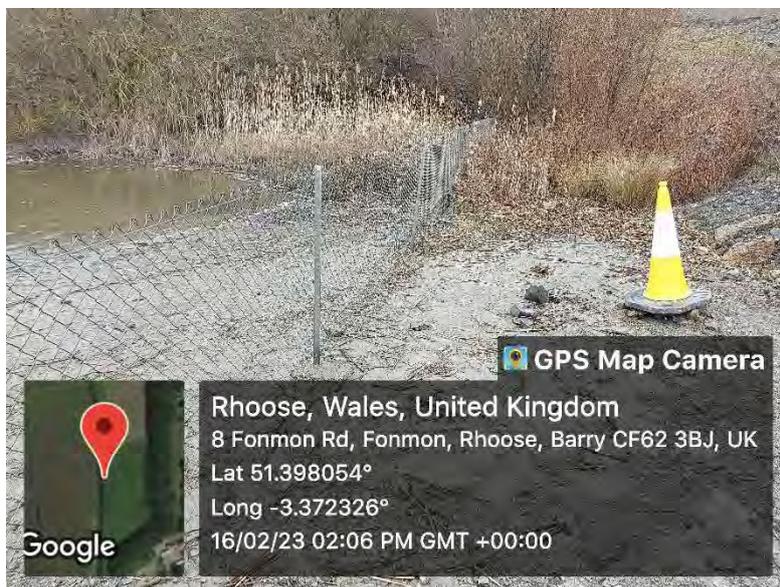
**Figure 5. Borehole E05-03 area of flooding from adjoining open body of water**

In addition to the above contaminant pathway there is evidence of the area around borehole E05-03 being periodically flooded from the adjacent lagoon. Figure 6 show an area of flooding to the immediate west of borehole E05-03. Under such conditions it is considered that there is the potential of lagoon water to directly recharge waters in the borehole via any failures in the annular seal around the cased section of the installation.

- 6.1.2 Borehole location E05-03 is located in the north-eastern corner of the beach to the east of the cement works lagoon. At the time of the visit, it was evident that the water level was raised above ground level within its raised metal cover at approximately 0.25 m above ground level. It was also evident that the metal cover was in poor condition, being heavily rusted with no top. Rusted metal was evident in the water that was present above ground level.

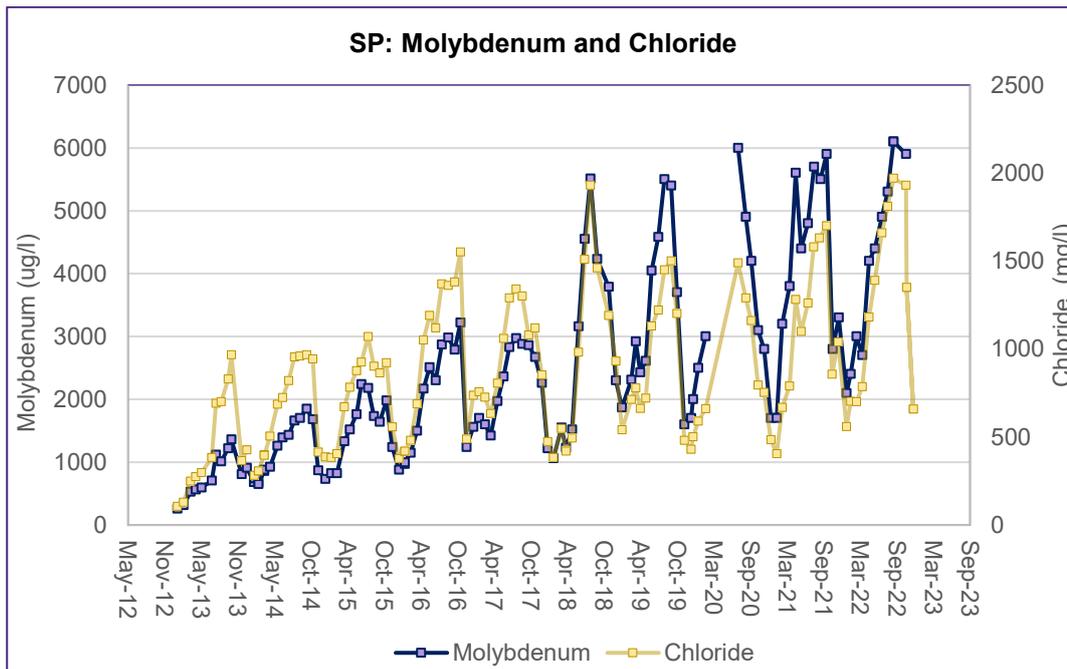
**Figure 6: Molybdenum & Chloride: SP**

- 5.4.15 Molybdenum concentrations have fluctuated but shown an increase over the monitoring period at reaching 6,100 µg/l at SP and 7,100 µg/l at DP2 in August 2022. A more gradual increase was observed at SW12 with lower concentrations, and a maximum concentration of 3,740 µg/l in July 2020. A graph of chloride and molybdenum concentrations at SP is shown in Figure 7.

- 5.4.18 Time series data for surface waters indicates cyclical peaking and troughing of concentrations, with peaks occurring in July/August when dry weather is expected and there is less dilution of PFA species. During drier periods, PFA surfaces may also be prone to heightened runoff following intense summer rain fall events. This may lead to small and localised erosion features (rills) being developed in exposed PFA surfaces and the mobilisation of PFA species into the surface water drainage system.

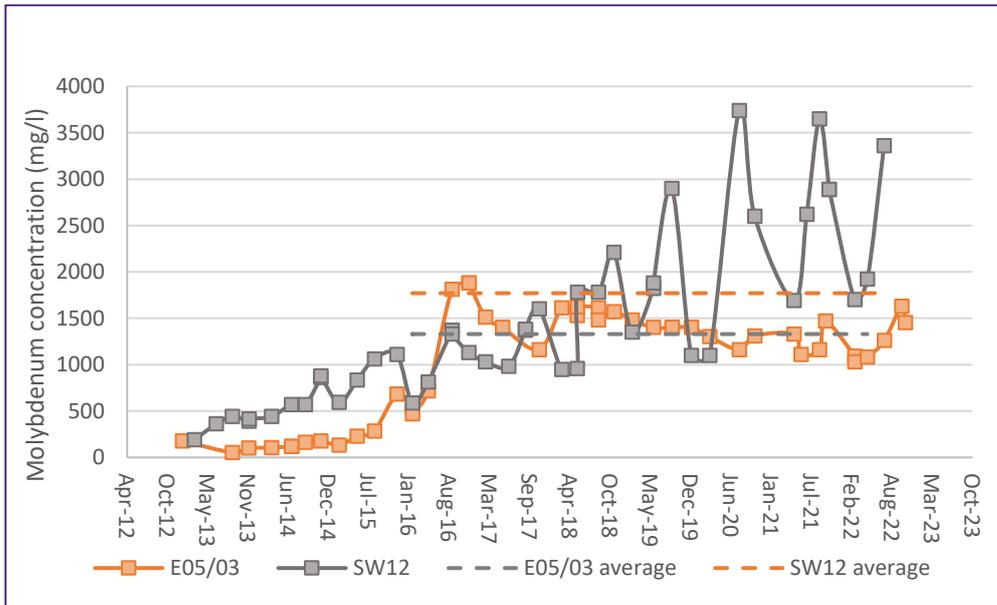
**Figure 7. Molybdenum: Borehole E05-03 & SW12**

- 5.5.3 Molybdenum concentrations at borehole E05-03 have gradually increased from a maximum of 177 µg/l in 2013 to a peak of 1,880 µg/l in November 2016. The results then have shown a gradual reduction down to concentrations of 1,080 µg/l by April 2022 before increasing to 1,630 µg/l in October 2022. With regard to surface water location SW12, the results have appeared to be higher than those for E05-03, with concentrations ranging from 190 µg/l in February 2013 to a peak of 3,740 µg/l with significant fluctuations.

5.5.4 The higher concentration of molybdenum in the surface water monitoring location initially indicates that the lagoon is the principal source of the elevated concentrations identified in the monitoring point E05-03. A replacement borehole was installed at 05/03 in January 2015 and water quality data from this new borehole has recorded a steep increase in Molybdenum concentration from Q4 2015. This suggest there being a significant degree of hydraulic connectivity between the lagoon and local shallow groundwater monitored at this location.

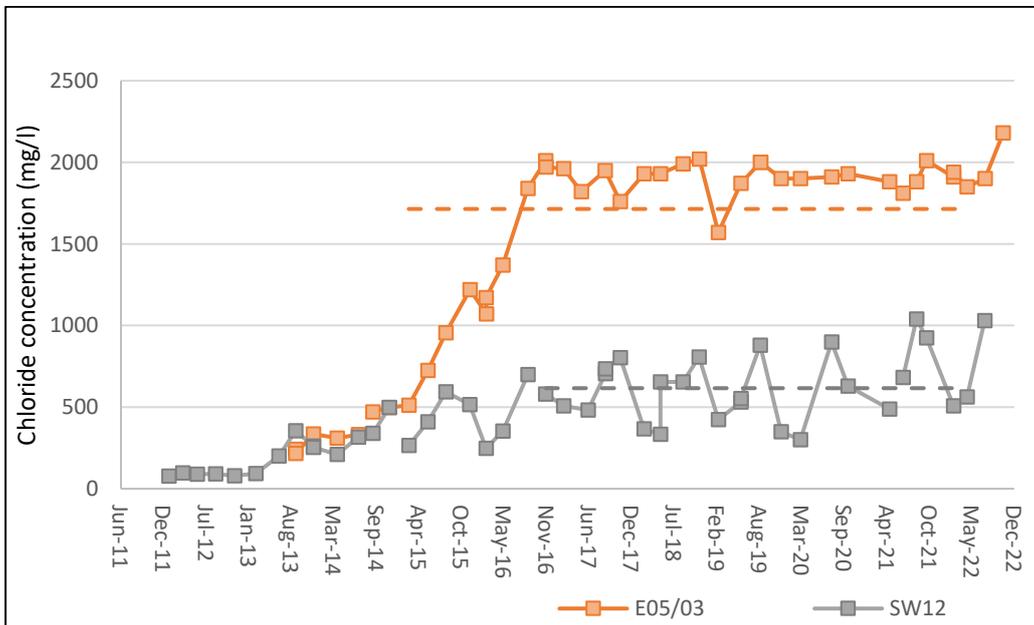
**Figure 8. Chloride: Borehole E05-03 & SW12**

5.5.5 As is discussed in Section 5.5, the chloride concentrations are anomalous at borehole E05-03 with significantly higher concentrations than the neighbouring water feature at SW12. The concentrations at DP2 and SP had higher fluctuating concentrations than SW12, but the average concentrations were significantly lower than for borehole E05-03. The concentrations have remained relatively stable at a high level between 2020 and 2022 although have shown some increase between July and October 2022.

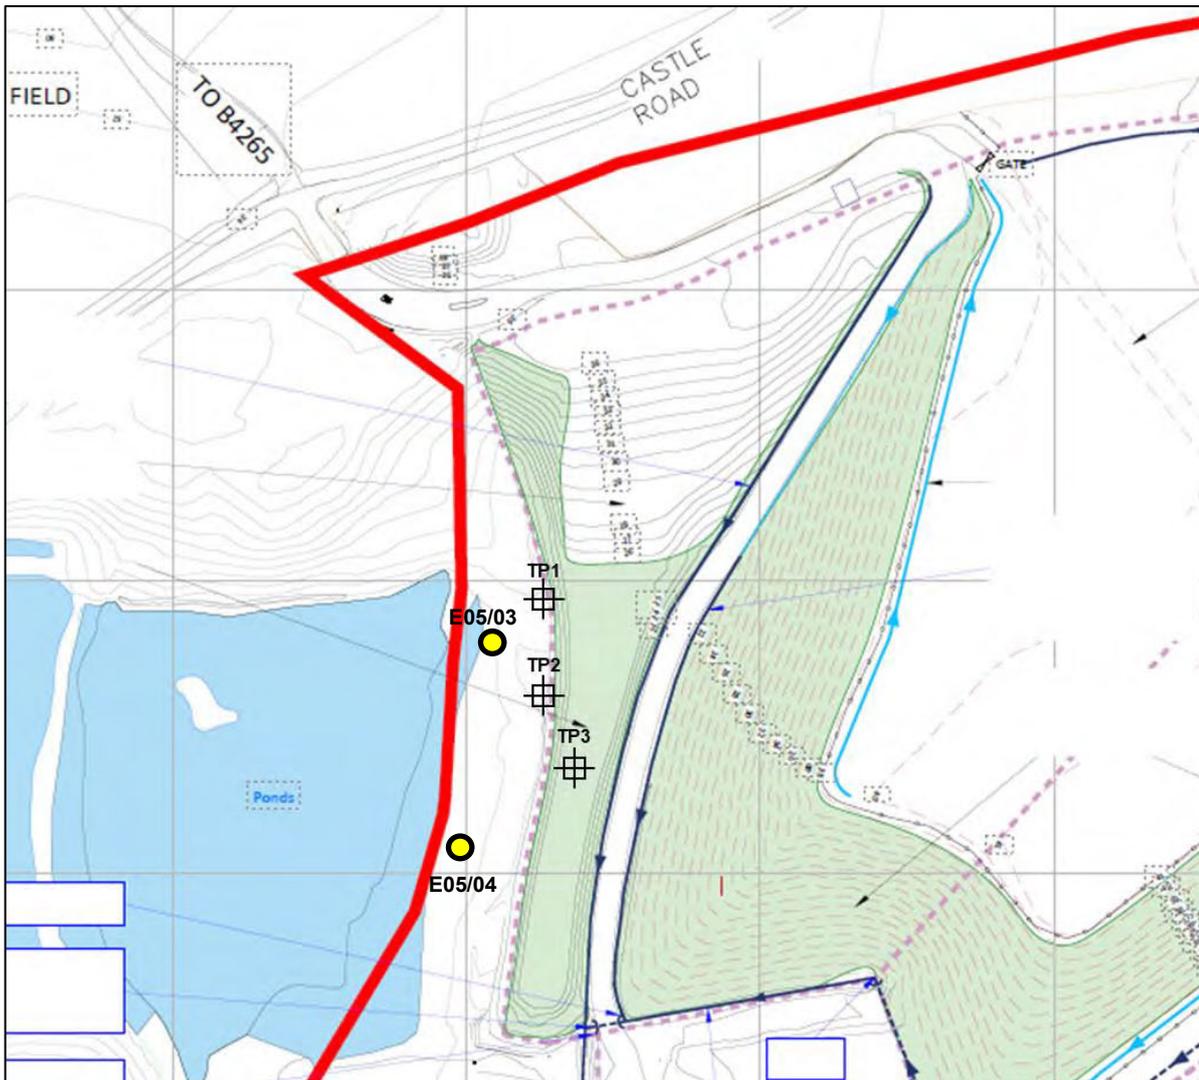
**Figure 10: Trial Pit Locations**

- 6.2.13 The laboratory analysis results are presented in Appendix C. Borehole logs from the ground investigation are presented in Appendix D.
