**ERW FAETHLON**

**HEP**

**TYWYN**

**ECOLOGICAL SURVEY**

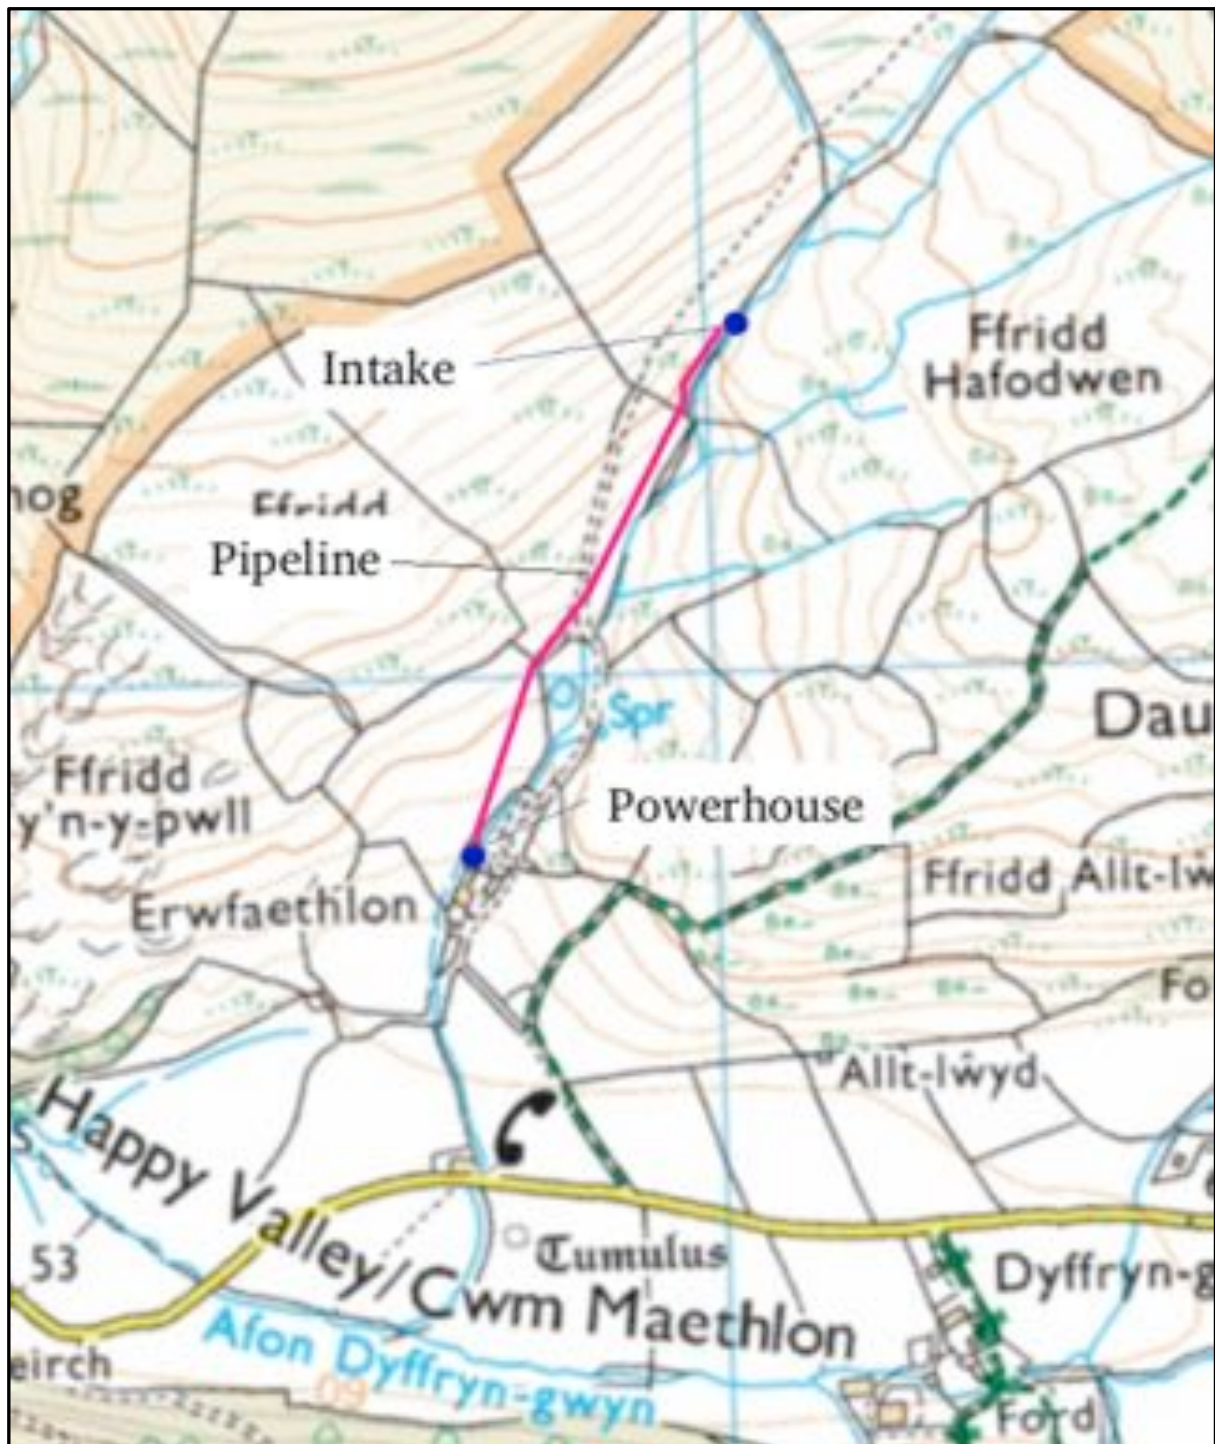
Map 1: The layout for the scheme (pipeline in red).

The layout for the scheme is shown in **Map 1**. The Intake Weir is to be located at SN 63014 99318 at a height of 162 metres asl (**Photo 1**) and the Turbine House will be located at SN 62769 98862 at a height of 81 metres asl (**Photo 5**) (**Map 1**). The site for the scheme is located within the Snowdonia National Park but outside any statutory nature conservation designations.

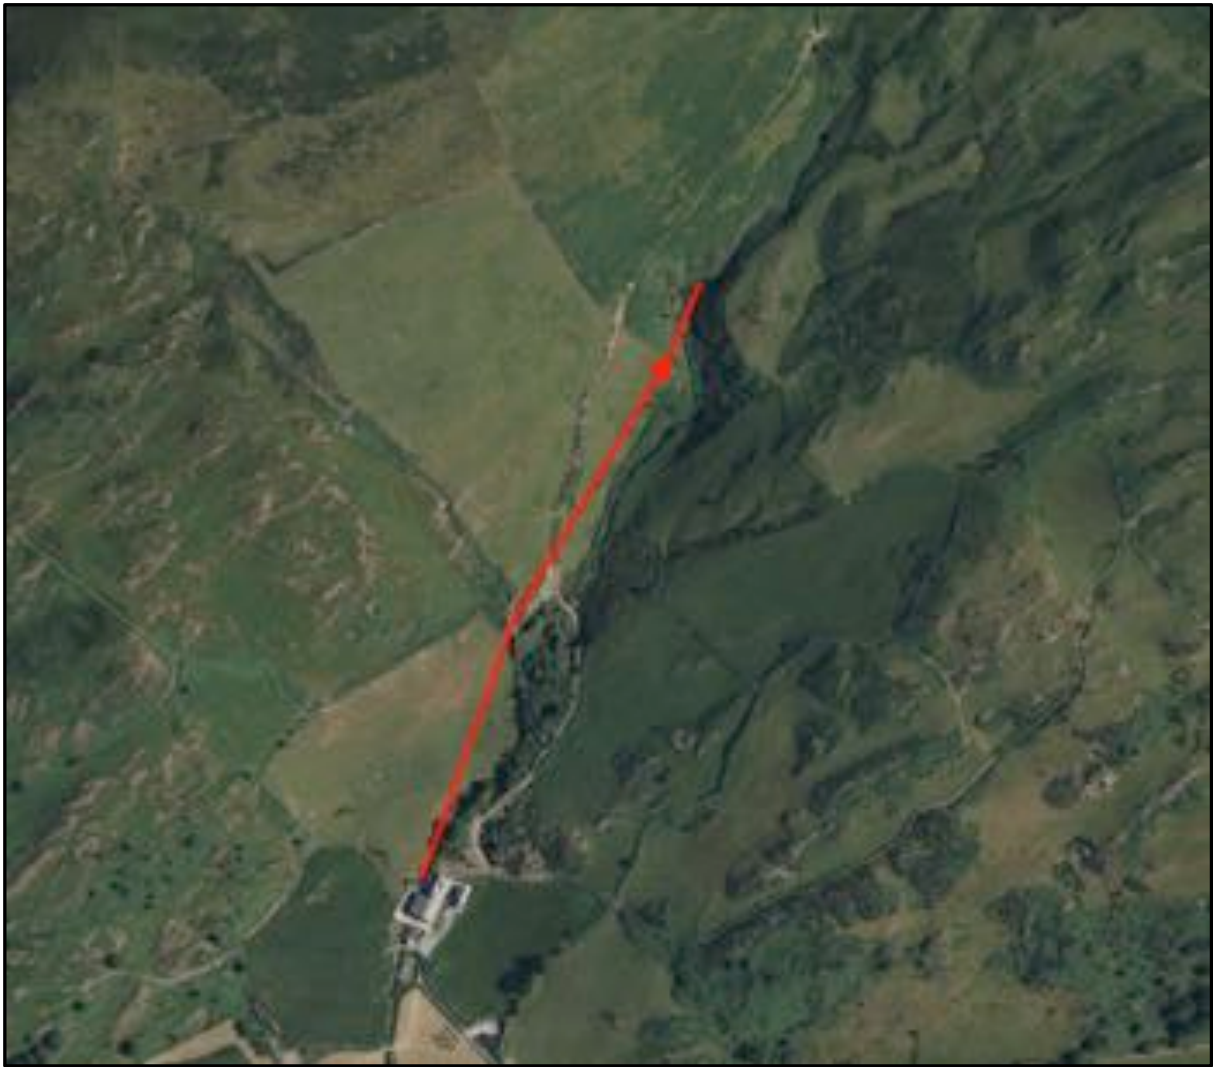
**Map 2: Aerial view of the penstock route. It mainly passes through Improved pastures.**

As a generality, the entire penstock route except for a very small section will be buried through sheep and cattle grazed pastures that have all been reseeded since 2016. The uniformity of the vegetation cover can be seen in the aerial photo shown in **Map 2**.

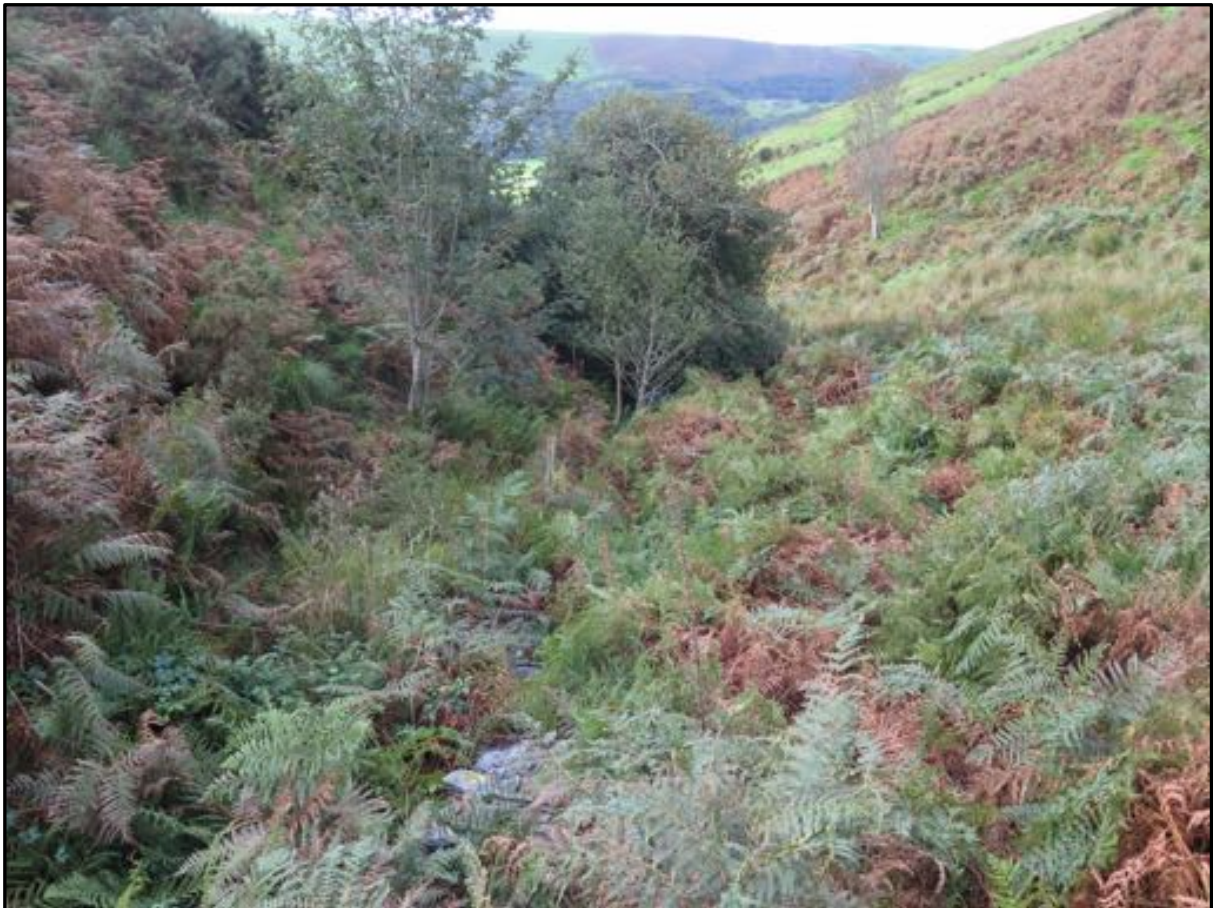
The Intake (**Photo 1**) is located within a narrow riparian strip which is fenced out both sides from the adjoining pastures. The penstock passes through an area of dense Bracken (*Pteridium aquilinum*) and Bramble (*Rubus fruticosus agg*) before passing through a fence. The sward here corresponds to **NVC: W25 *Pteridium aquilinum*-*Rubus fruticosus agg*** underscrub, reflecting the lack of grazing along the riparian zone of the stream. Other species noted here, sometimes over-topping the dense Bracken and Bramble are *Molinia caerulea*, *Sorbus aucuparia*, *Ilex aquifolium*, *Juncus effusus*, *Digitalis purpurea*, *Dryopteris filix-mas*, *Ulex gallii*, *Urtica dioica*, *Vaccinium myrtillus*, *Cirsium palustre*, *Agrostis capillaris*, *Stellaria alsine*, *Deschampsia cespitosa*, *Chrysosplenium oppositifolium* (in flushes), *Blechnum spicant* and the bryophytes *Thuidium tamariscinum*, *Polytrichastrum formosum*, *Dicranum scoparium* and *Hypnum jutlandicum*.

**Photo 1: Once beyond the Intake Weir, the penstock passes through a riparian zone dominated by Bracken and Bramble**

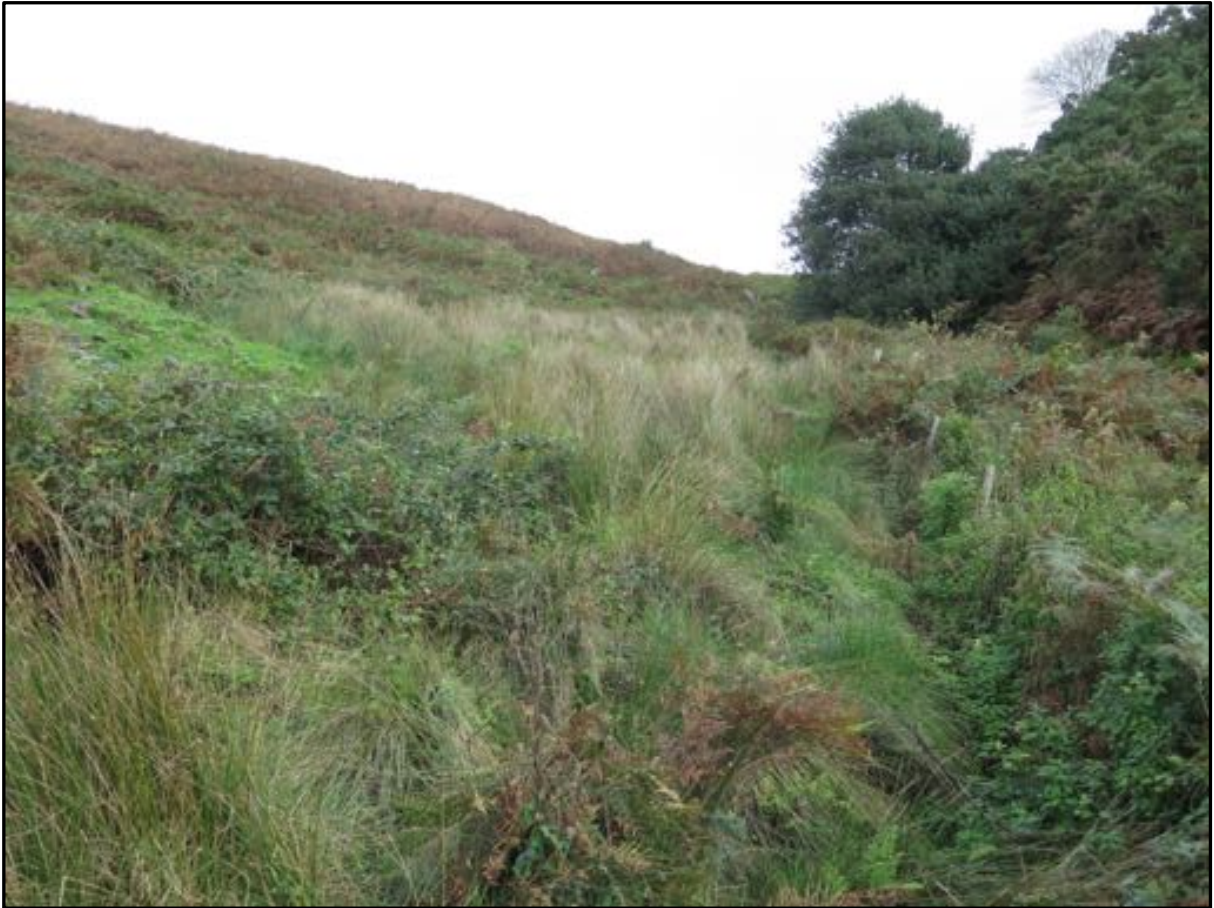
The penstock then heads south parallel to the stream through a slightly wetter area with much the same vegetation (**Photo 2**) although the sward is dominated by *Juncus effusus* and *J. acutiflorus*. The ground is a mosaic of **NVC: W25** and **M23 *Juncus effusus/acutiflorus-Galium palustre*** rush-pasture with, additionally, *Galium palustre*, *Angelica sylvestris*, *Potentilla erecta*, *Carex panicea*, *Cardamine pratensis* and *Vaccinium oxycoccus*. Bryophytes are represented by *Pleurozium schreberi* and *Calliergonella cuspidata*.

This fifty-metre sward is arguably the most interesting vegetation along the entire penstock route. It is more or less fed by groundwater seepage from the steep slope to the west. Since the ground is so flushed and the steep slope makes access by machinery very difficult, this short section of the penstock will be laid on the ground surface, thus causing minimal damage to the vegetation and its dependent hydrology. The slight break of slope along this section will mean the over ground pipeline will be virtually unseen from any viewpoint across Cwm Maethlon, so there will be no landscape implications. The very low grazing pressure here will allow the vegetation to grow over the pipeline very quickly, further hiding it from view.

**Photo 2: The penstock will be over-grounded along this fifty-metre wetland section.**

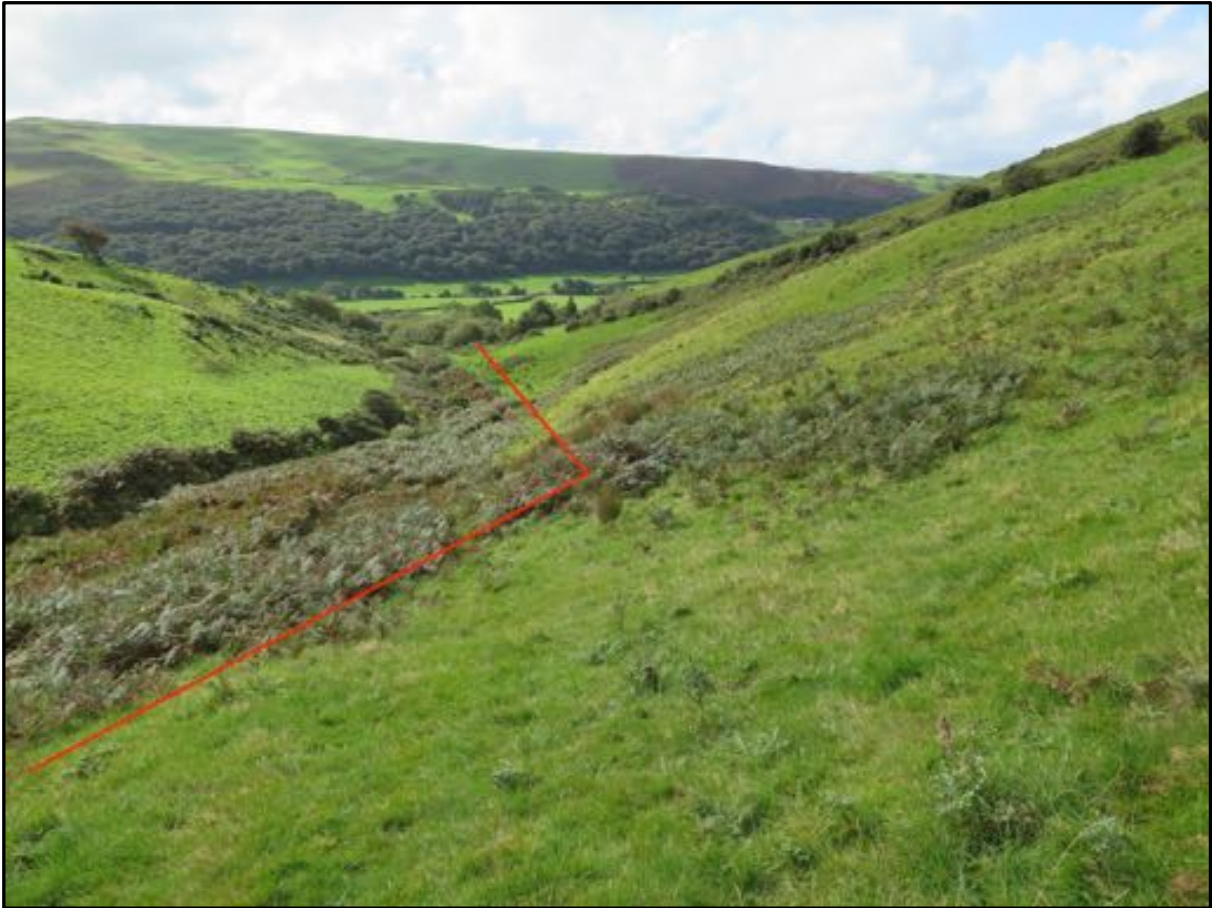
Once through the next fence, the penstock will be buried roughly parallel to the stream (**Map 1**) through a sheep and cattle grazed improved pasture of very little floristic interest (**Photo 3**). The sward is dominated by *Lolium perenne* and *Trifolium repens* with rarely *Taraxacum officinale* agg., *Cirsium arvense*, *C. vulgare*, *C. palustre*, *Deschampsia cespitosa*, *Geranium dissectum*, *Urtica dioica*, *Holcus lanatus*, *Juncus effusus*, *Festuca ovina*, *Ranunculus repens*, *Agrostis capillaris*, *Cerastium fontanum*, *Rumex acetosella*, *R. obtusifolius*, *Cynosurus cristatus*, *Danthonia decumbens*, *Achillea millefolium*, *Plantago major* and, very occasionally, *Prunella vulgaris*. The field is clearly a sown *Lolium perenne* ley which, in some areas is reverting to **NVC: U4 *Festuca ovina*-*Agrostis capillaris*-*Galium saxatile*** acid grassland, especially where Bracken is re-invading.

**Photo 3: The penstock will be buried (red line) through this improved pasture.**

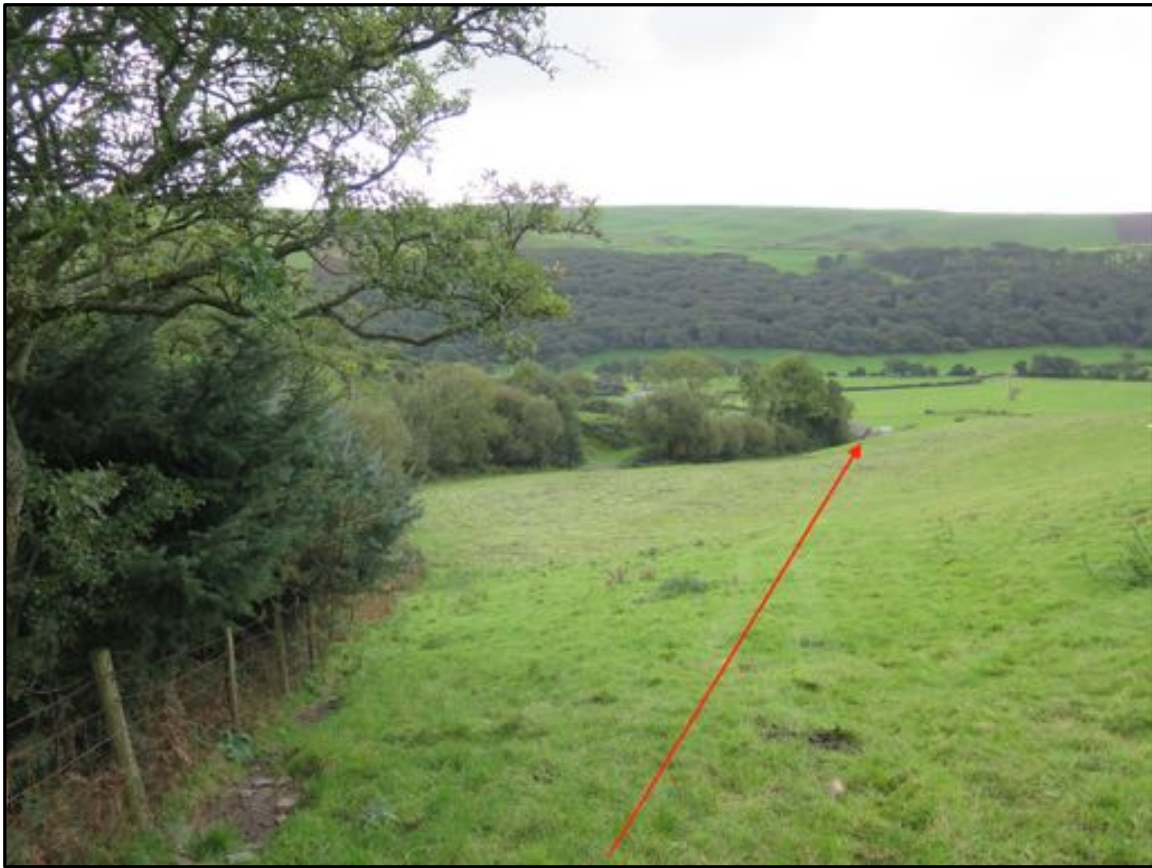
Once through this field, the penstock will be buried in the track for a short distance (*Polygonum aviculare* and *Filago vulgaris*) and then across another improved pasture (**Photo 4**) before passing through a low hedge, over the stream and into the Turbine House next to a small barn (**Photo 5**). The flora in this field is identical to the field above it having been reseeded at the same time. The hedge has only developed since the riparian zone was fenced out and includes young *Salix cinerea*, *Fraxinus excelsior*, *Crataegus monogyna*, *Corylus avellana*, *Acer pseudoplatanus*, *Rubus fruticosus* agg and *Sambucus nigra*. The hedgerow will be allowed to regrow once the penstock has been built through it. However, since the penstock is so narrow, threading it through the hedge is unlikely to create much damage to it.

**Photo 4: The penstock buried through the next improved pasture.**

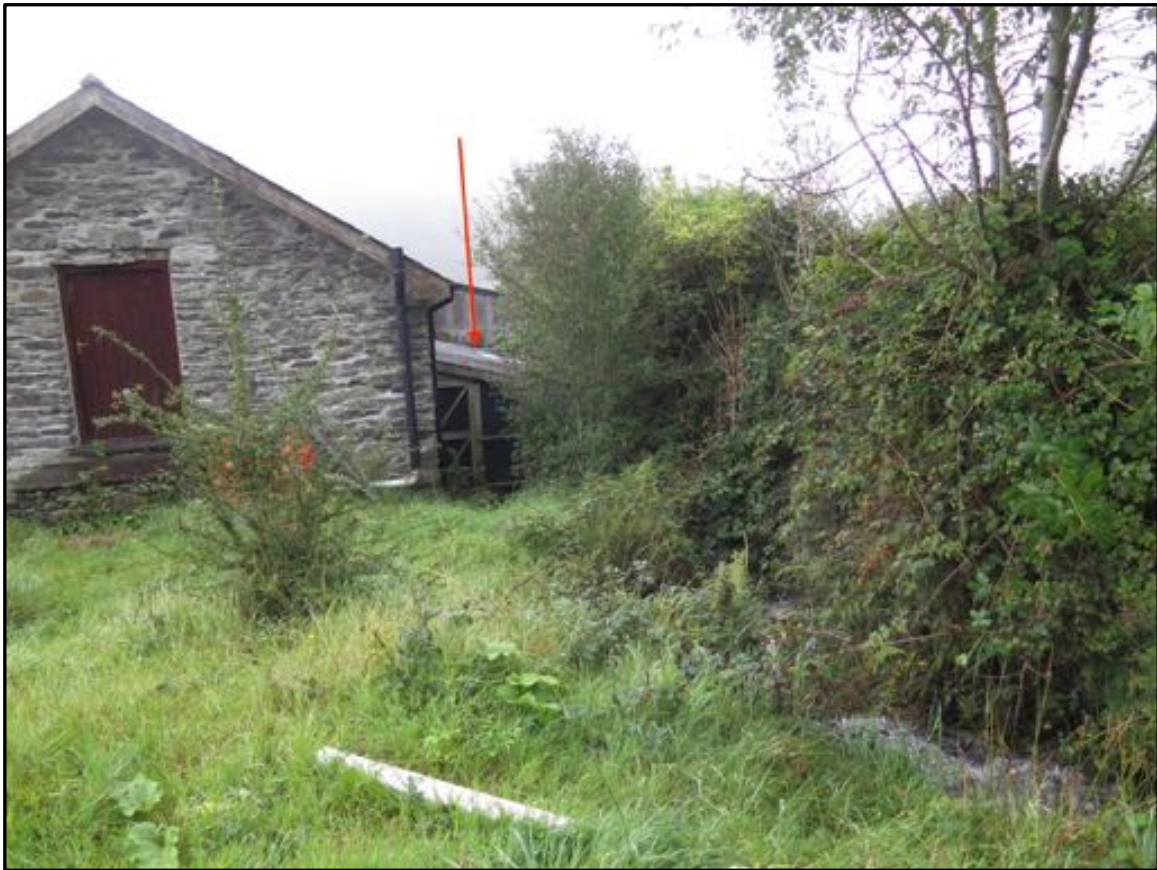
**Photo 5: The penstock will be threaded through the hedge (right) and into the small Turbine House which will be sited next to the shed arrowed.**

The small stream is generally only half a metre wide, widening to about one metre wide at the Turbine House (**Photo 5**). Since most of the stream and its narrow riparian zone is fenced out from grazing along almost its length, the bankside vegetation has generally over-topped the stream so it is difficult to gain access to survey its in-stream bryophyte flora. Coupled with the profusion of Bramble growth in the riparian zone (and the spate conditions at the time), the survey was by force limited to very small areas where access to the stream was possible.

This will be limited to a wire going through the wall into the meat unit which is just next door to the Turbine House (**Photo 5**). Here it will connect to the existing electrical system without need for any outside work or structures. Thus, there will be no impact on vegetation or any fauna.

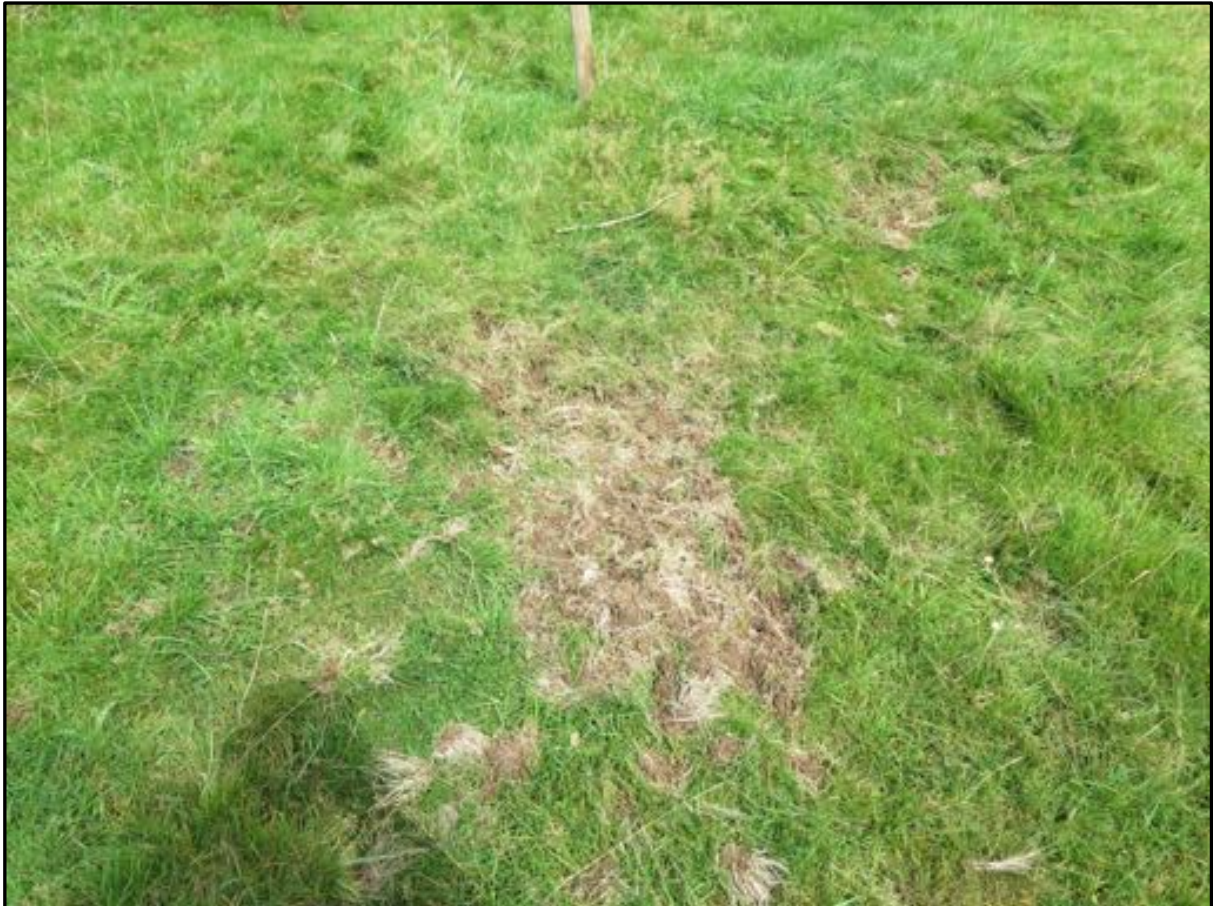
No signs of setts were noted during the survey. However, that Badgers frequent the area was shown by a small area of grassland that had been characteristically dug up by a Badger feeding, probably, on Tipulid or ground beetle larvae at SN 62970 99242 (**Photo 6**). This area is close to the route where the penstock will be buried across the top pasture.

**Photo 6: The small area of grassland where a Badger had recently been feeding.**

Though Badgers certainly feed within the study area, their presence will not be deleteriously affected by the proposed HEP scheme.
