# Construction & Environmental Management Plan

**Northern Gateway Phase 2, Deeside**

TG Report No. 13933\_R01c\_LCD\_HM

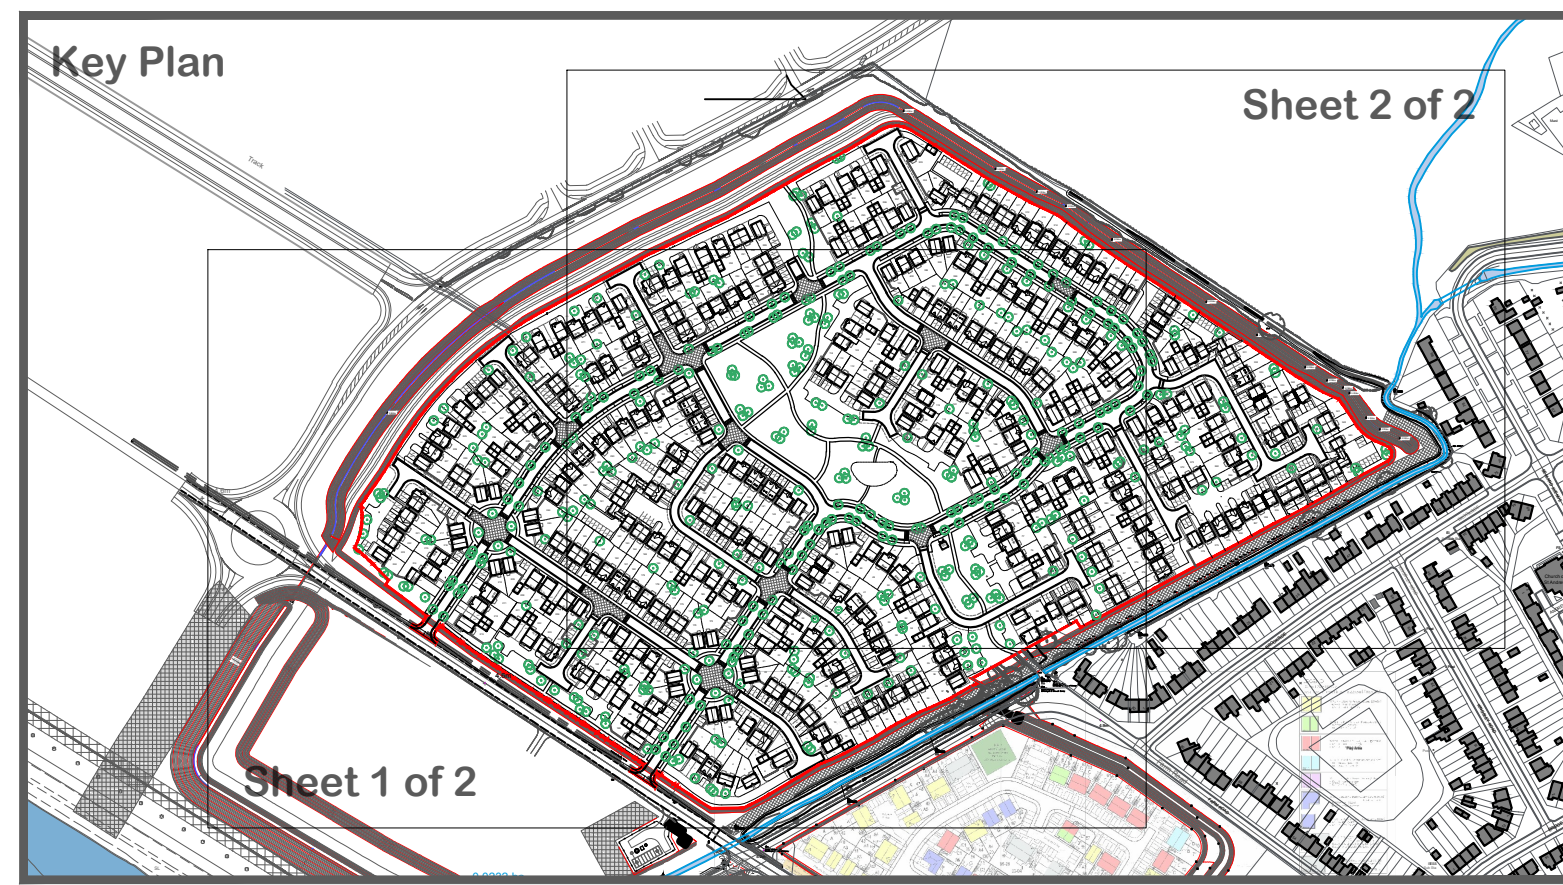
# Appendix 1: Overall Planning Layout

- 1.9. Detailed landscape plans are yet to be produced, however, an overall sketch layout produced by Astle Planning & Design Limited is provided in **Appendix 1** (ref. PL03\_A). The works have been approved for outline planning for employment and residential use (Planning ref: 057404) and this CEMP is to be revisited once final masterplans have evolved prior to the submission of the Reserved Matters application. Northern Gateway Phase 2 work area is hereinafter termed 'the site,' with the wider development area being termed 'the wider site'.
- 1.10. To assist in the preparation of this CEMP, a number of ecological surveys were completed within the site during 2020 and 2021 and are discussed in **Section 2** of this report.

## PLANNING LAYOUT - OVERALL

- 1.7. The proposed scope of works in relation to this submission for discharge of the above conditions comprises the construction of residential units within the site (see **Appendix 1**) with associated access, landscaping and infrastructure. The enabling works for the site would precede the application sought in this document and would provide all of the necessary works to Garden City Drain to enable this application, along with associated landscaping, utilities connections and provision of swales.

- 2.1 A Review of the Ecological Assessment Report, Tyler Grange report – 10647\_R01 was undertaken, in conjunction with the overall planning layout (see **Appendix 1**) to identify which ecological features could potentially be affected by the enabling works.
