Order Details: 278157460_1_1
Customer Ref: PN214233
National Grid Reference: 327930, 184100
Slice: A
Site Area (Ha): 16.79
Search Buffer (m): 1000

Newport Quinn SDD RFO, Celtic Way, Celtic Lakes,
NEWPORT, NP10 8BE

Project:	NEWPORT QUINN SDD RFP	Title:	Section Line	Unit 1B Borders Industrial Park River Lane Saltney Chester CH4 8RJ	Phone: 01244 671117 Email: mail@geotechnics.co.uk www.geotechnics.co.uk

Project : Former Quinn Radiator Factory Site, Newport, Wales

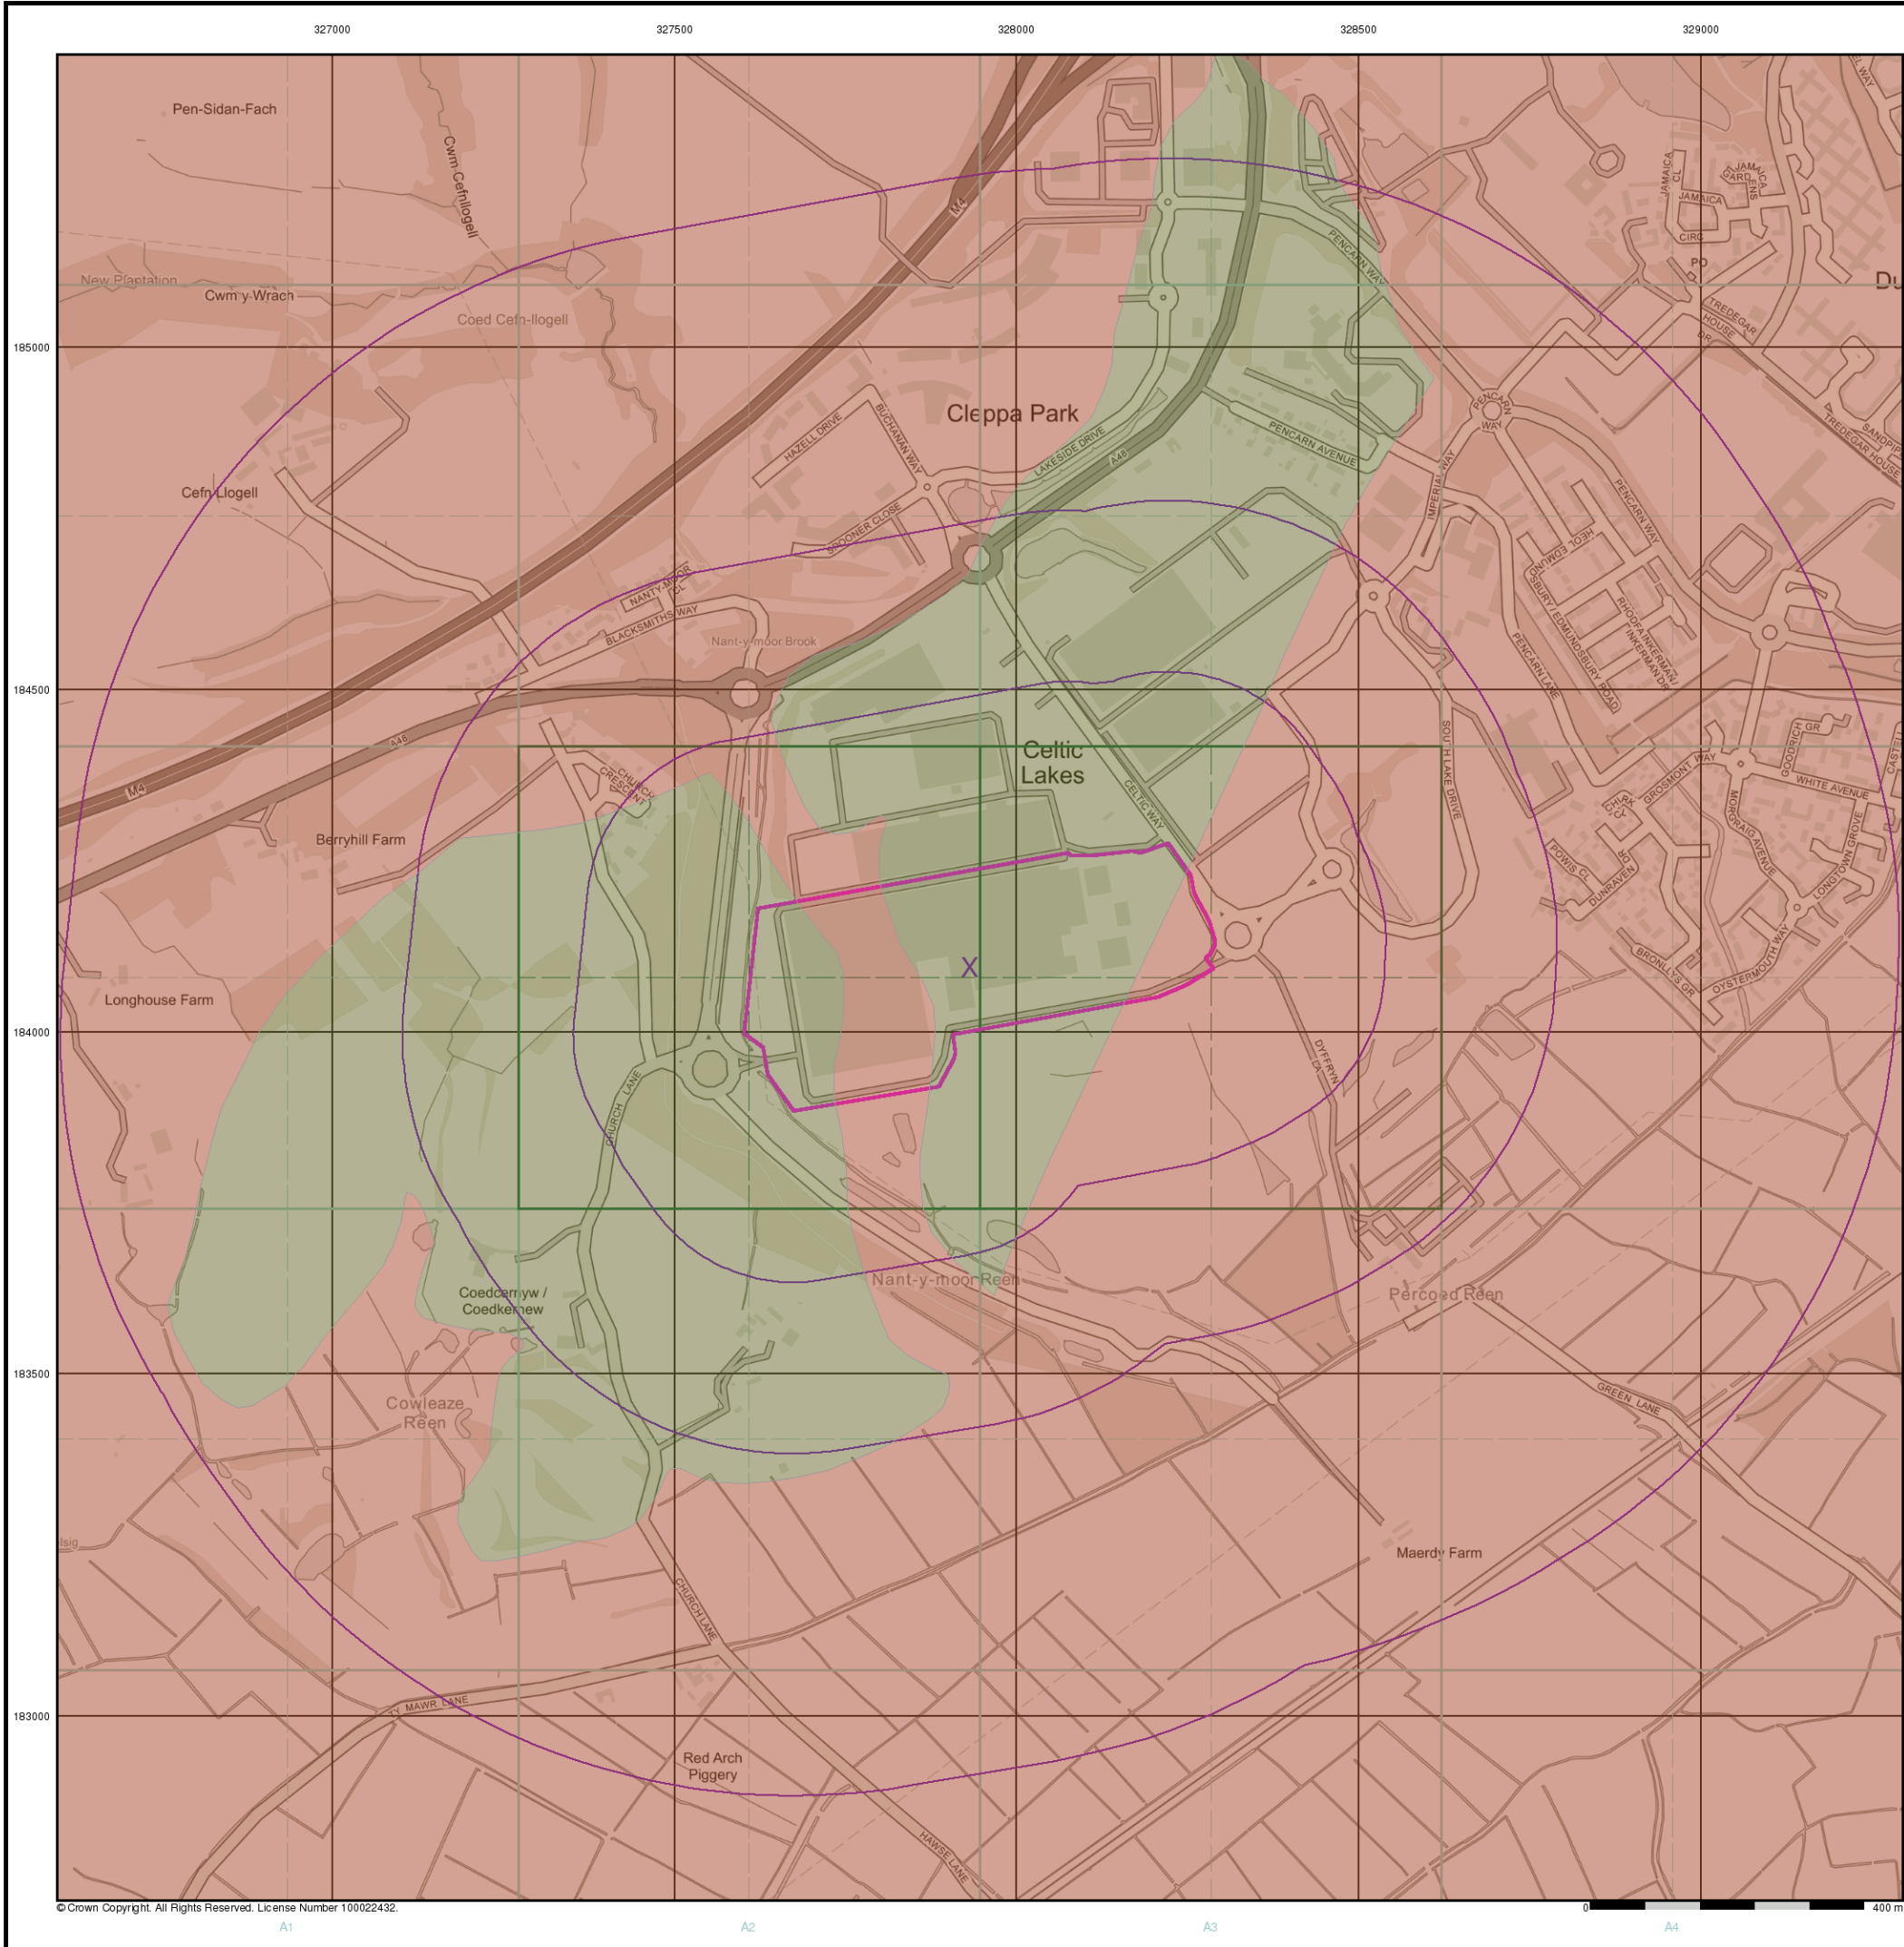
Estimated Soil Chemistry Chromium - Slice A

Estimated Soil Chemistry Chromium

Chromium Concentrations mg/kg

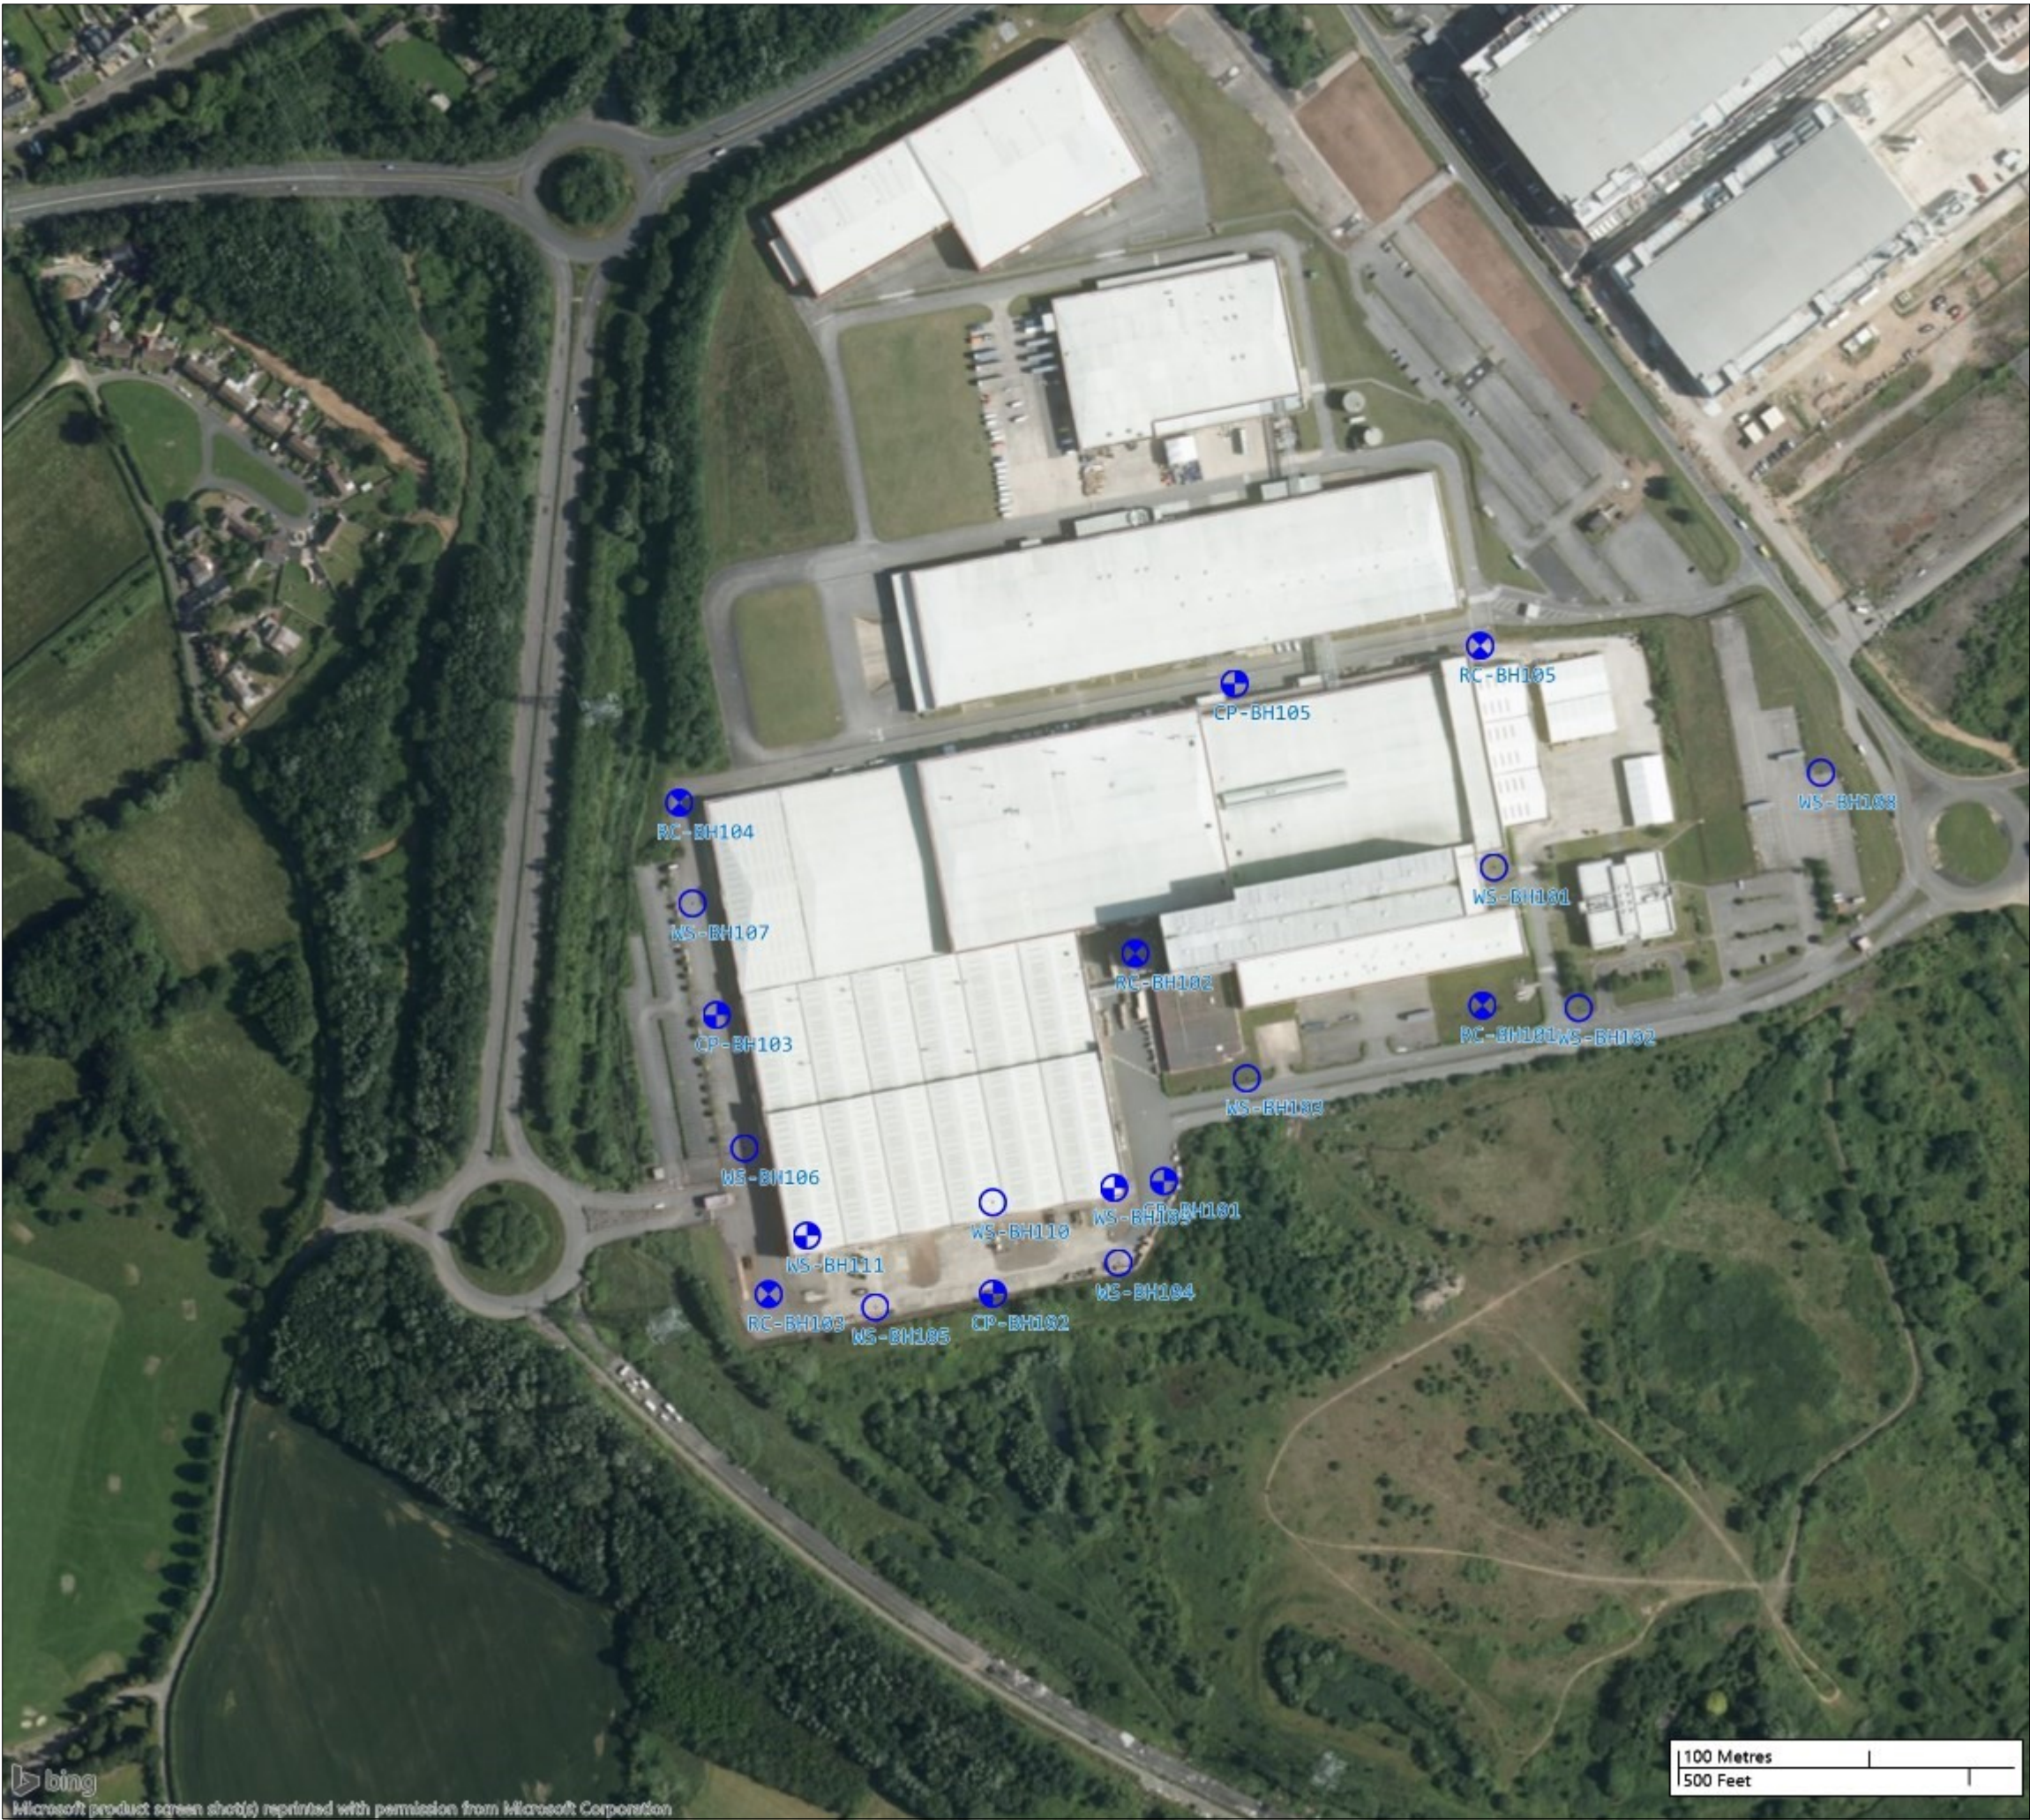
Exploratory Hole Location Plan

- Key
- Locations By Type - Empty
 - ⊕ Locations By Type - CP
 - Locations By Type - DS
 - ⊕ Locations By Type - DS+RC

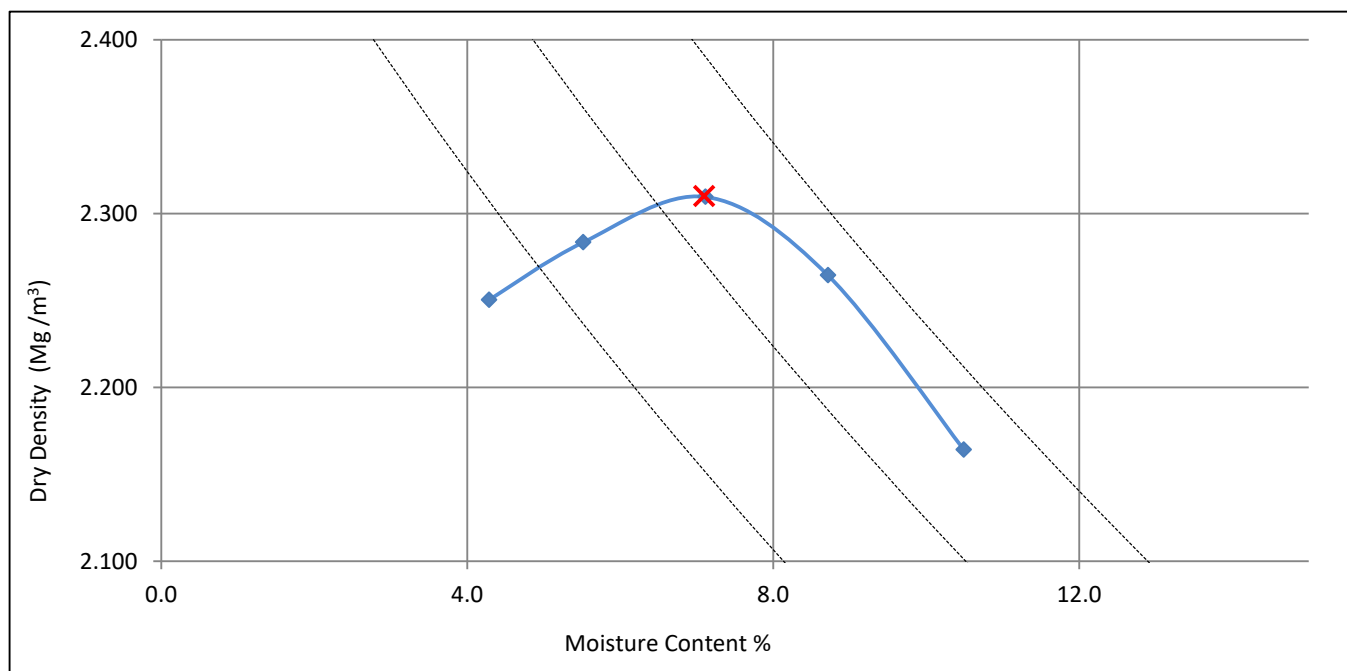
Site Ref / Hole ID:	WSBH108	Depth (m):	0.8-1.2
Sample No:		Sample Type:	Bulk
Sampling Certificate Received:	No	Material Description:	Brown silty sandy GRAVEL with low cobble content
Location in Works:	N/A	Material Source:	Site Generated
Date Sampled:	16 June 2021	Material Supplier:	Site Generated
Sampled By:	Geotechnics	Specification:	BS1377
Date Received:	16 June 2021	Date Tested:	25 June 2021

Test Method:	BS 1377: part 4: 1990: clause 3.3, 2.5kg rammer in a 1 litre mould
Preparation:	Original sample was oven dried @ 105 oC, single specimen tested

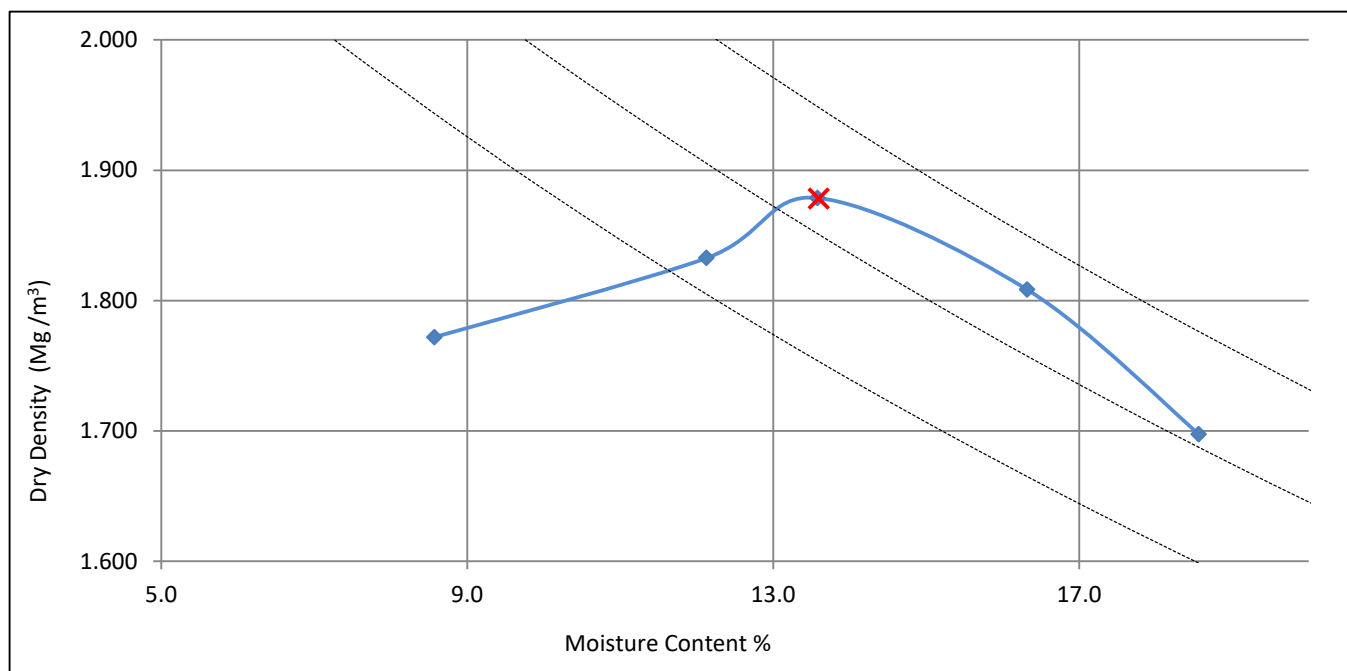
Site Ref / Hole ID:	WSBH109	Depth (m):	1.2-1.7
Sample No:		Sample Type:	Bulk
Sampling Certificate Received:	No	Material Description:	Brown very gravelly sandy CLAY
Location in Works:	N/A	Material Source:	Site Generated
Date Sampled:	16 June 2021	Material Supplier:	Site Generated
Sampled By:	Geotechnics	Specification:	BS1377
Date Received:	16 June 2021	Date Tested:	25 June 2021

Test Method:	BS 1377: part 4: 1990: clause 3.3, 2.5kg rammer in a 1 litre mould
Preparation:	Original sample was oven dried @ 105 oC, single specimen tested

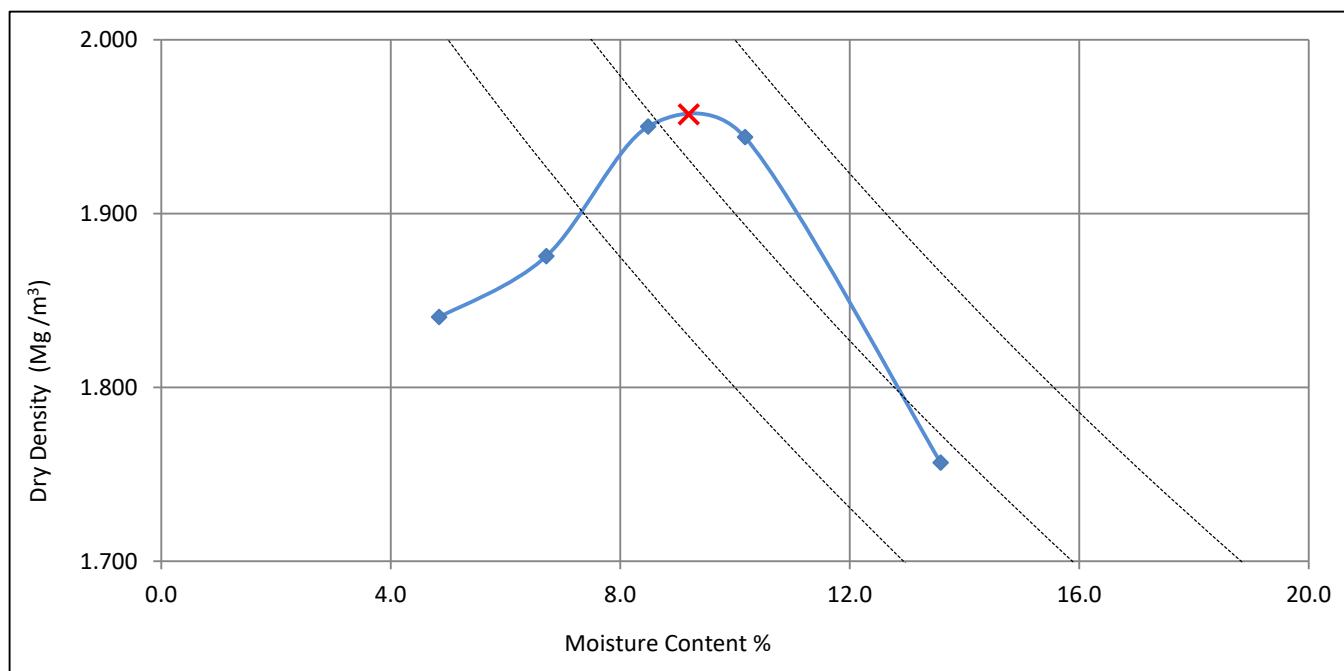
Site Ref / Hole ID:	WSBH110	Depth (m):	0.4-0.8
Sample No:		Sample Type:	Bulk
Sampling Certificate Received:	No	Material Description:	Grey & black sandy GRAVEL
Location in Works:	N/A	Material Source:	Site Generated
Date Sampled:	16 June 2021	Material Supplier:	Site Generated
Sampled By:	Geotechnics	Specification:	BS1377
Date Received:	16 June 2021	Date Tested:	25 June 2021

Test Method:	BS 1377: part 4: 1990: clause 3.3, 2.5kg rammer in a 1 litre mould
Preparation:	Original sample was oven dried @ 105 oC, single specimen tested

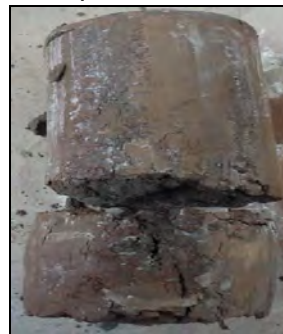
Site Name	Newport Quinn SDD RFP
Soil Description	Brown fine to medium gravelly silty CLAY
Date Tested	26/06/2021

Moisture Content (%)	30
Bulk Density (Mg/m^3)	1.77
Dry Density (Mg/m^3)	1.36
Specimen Length (mm)	210
Specimen Diameter (mm)	105
Cell Pressure (kPa)	60
Deviator Stress (kPa)	67
Undrained Shear Strength (kPa)	34
Failure Strain (%)	9
Mode Of Failure	Brittle
Membrane Used/Thickness	Rubber/0.3mm
Rate of Strain (%/min)	1.43

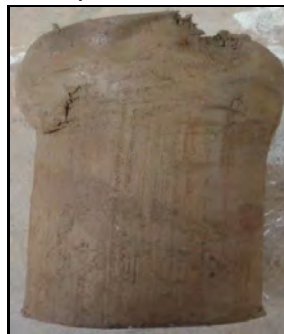
Site Name	Newport Quinn SDD RFP
Soil Description	Brown fine to medium gravelly sandy silty CLAY
Date Tested	26/06/2021

Moisture Content (%)	25
Bulk Density (Mg/m^3)	1.81
Dry Density (Mg/m^3)	1.46
Specimen Length (mm)	210
Specimen Diameter (mm)	105
Cell Pressure (kPa)	100
Deviator Stress (kPa)	60
Undrained Shear Strength (kPa)	30
Failure Strain (%)	9
Mode Of Failure	Plastic
Membrane Used/Thickness	Rubber/0.3mm
Rate of Strain (%/min)	1.43

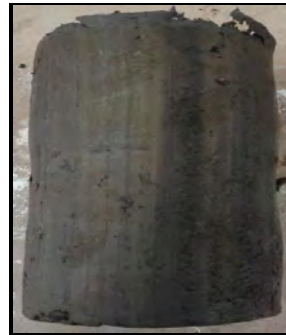
Moisture Content (%)	51
Bulk Density (Mg/m ³)	1.94
Dry Density (Mg/m ³)	1.28
Specimen Length (mm)	210
Specimen Diameter (mm)	105
Cell Pressure (kPa)	30
Deviator Stress (kPa)	50
Undrained Shear Strength (kPa)	25
Failure Strain (%)	9
Mode Of Failure	Plastic
Membrane Used/Thickness	Rubber/0.3mm
Rate of Strain (%/min)	1.43

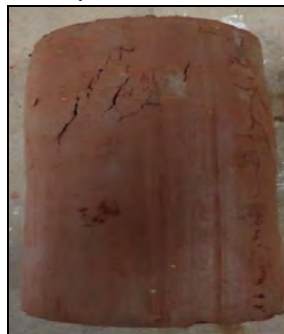
Moisture Content (%)	16
Bulk Density (Mg/m ³)	2.08
Dry Density (Mg/m ³)	1.80
Specimen Length (mm)	210
Specimen Diameter (mm)	105
Cell Pressure (kPa)	60
Deviator Stress (kPa)	270
Undrained Shear Strength (kPa)	135
Failure Strain (%)	9
Mode Of Failure	Brittle
Membrane Used/Thickness	Rubber/0.3mm
Rate of Strain (%/min)	1.43

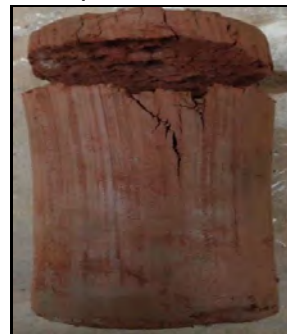
Contract Number	54502	Borehole/Pit No.	RC-BH103
Site Name	Newport Quinn SDD RFP	Sample No.	
Soil Description	Brown silty CLAY	Depth Top (m)	3.20
		Depth Base (m)	3.80
Date Tested	26/06/2021	Sample Type	UT
		Technician	Daniel B

Moisture Content (%)	16
Bulk Density (Mg/m ³)	2.21
Dry Density (Mg/m ³)	1.91
Specimen Length (mm)	210
Specimen Diameter (mm)	105
Cell Pressure (kPa)	60
Deviator Stress (kPa)	196
Undrained Shear Strength (kPa)	98
Failure Strain (%)	6
Mode Of Failure	Brittle
Membrane Used/Thickness	Rubber/0.3mm
Rate of Strain (%/min)	1.43

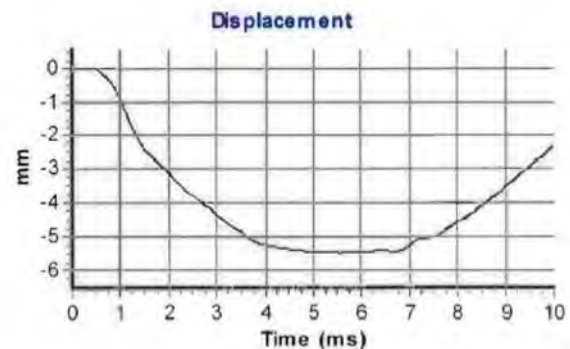
Mass and drop supplied by client

Area of Rod A (mm^2): 970
Theoretical Energy E_{theor} (J): 473
Measured Energy E_{meas} (J): 334
