Compliance Assessment Report CAR_NRW0045987

For: Creigiau Wastewater Treatment Works, held by DWR CYMRU CYFYNGEDIG

Type of assessment carried out: Site Inspection, Reason: Routine.

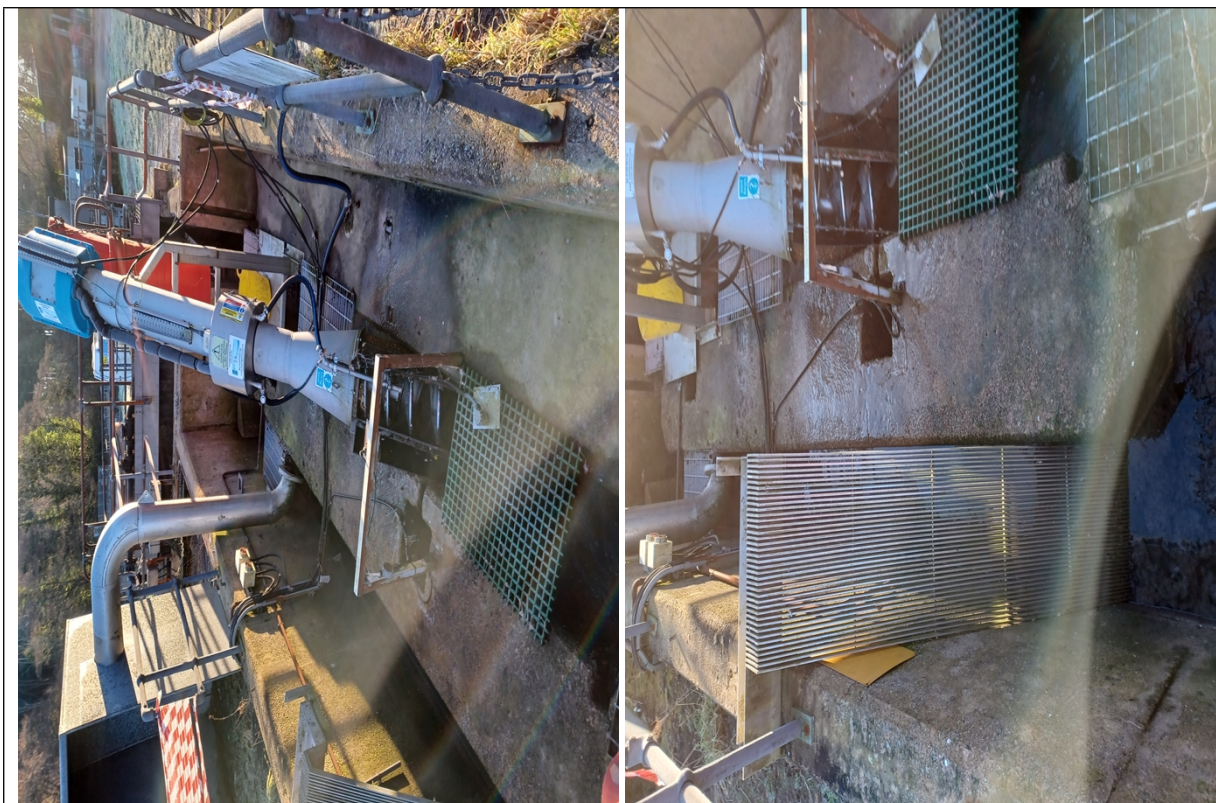
Currently the site is operating on a hired-in inlet screening system due to the existing being beyond repair and has been for some time. Operatives have suggested the best course of action to be purchasing that which is already installed on-loan at the site, however are awaiting confirmation on the plan of action. **We strongly advise that a permanent solution is implemented as soon as possible to prevent any possible impacts on the treatment capacity/operation of the site.**

The on-loan screen is self-cleaning and contains a compactor for screened rag/solids (pictured left). The outside is then sprayed down daily by the Site Operator, as is the storm channel. There is also a bar screen in place to redirect flows into in the event of a blockage or power cut (pictured right).

3. We strongly advise that a permanent inlet screening solution is implemented as soon as possible to prevent any possible impacts on the treatment capacity/operation of the site.

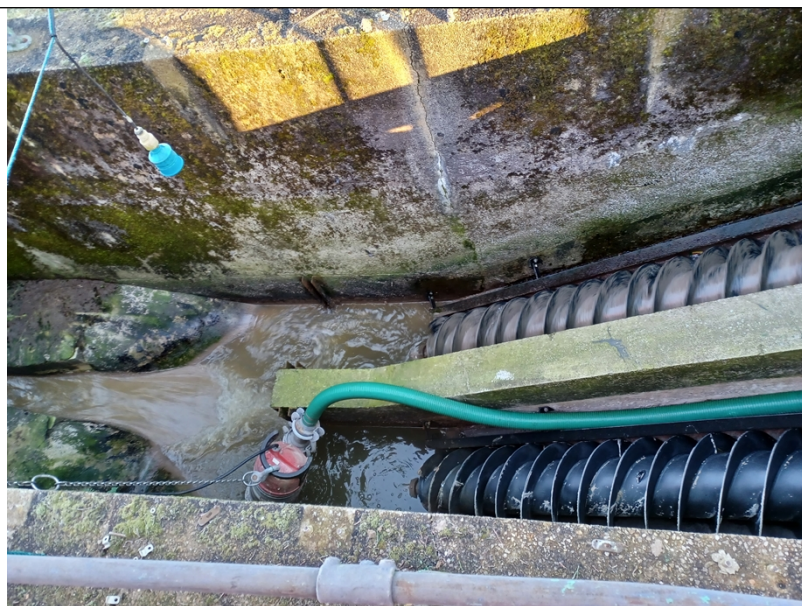
From here, two large Archimedes screws transport the flow up-hill to the treatment tank which have recently been replaced, however one is currently offline due to the new gearbox having been stolen just before Christmas. They are designed to act as Duty and Assist so this is not affecting treatment capacity, but is putting a strain on the power demand of the site so a diesel generator is currently powering the treatment tank to accommodate for this. The planned site upgrades intend to include increased electrical resilience for the site going forward.

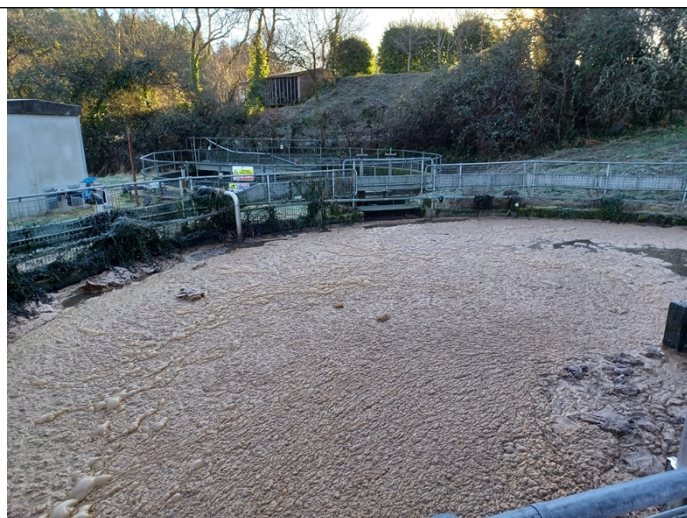
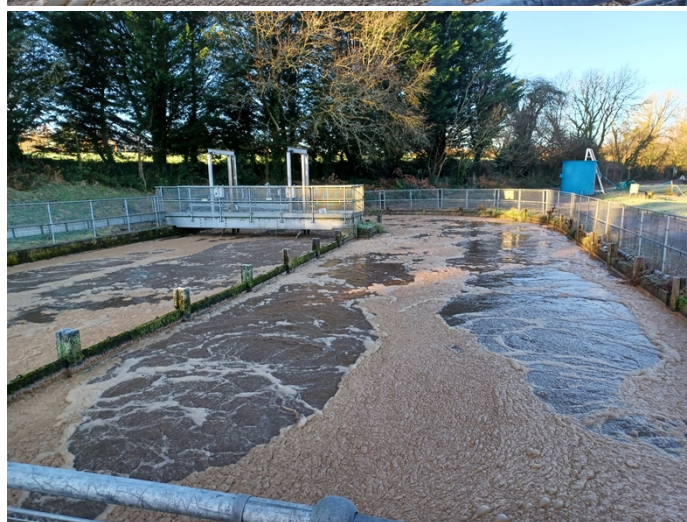
There is no primary settlement at this site besides the post-screen grit, but the aeration lane is supported by biological treatment in the form of activated sludge which is recirculated until eventually being diverted to the sludge storage tank for transfer to Cardiff AD plant. There are 4 aerators, one always on and the other three switched on/off depending on dissolved oxygen (DO) levels. Manual dosing of sodium carbonate is also done as required to manage the pH requirements of the permit. All appeared to be functioning well, including the sludge return.

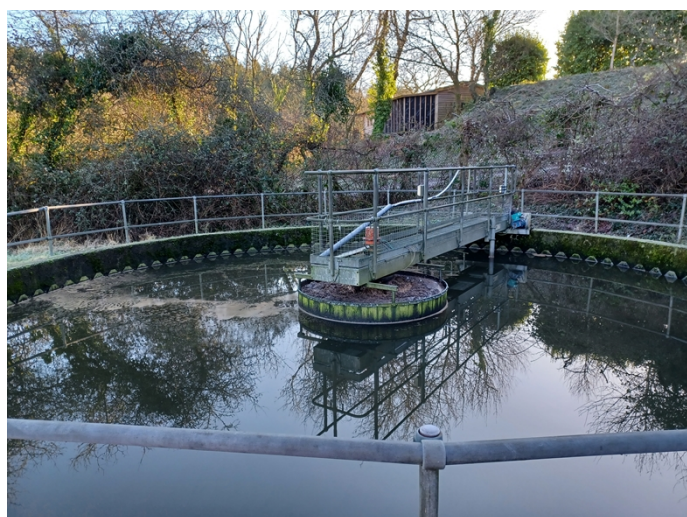
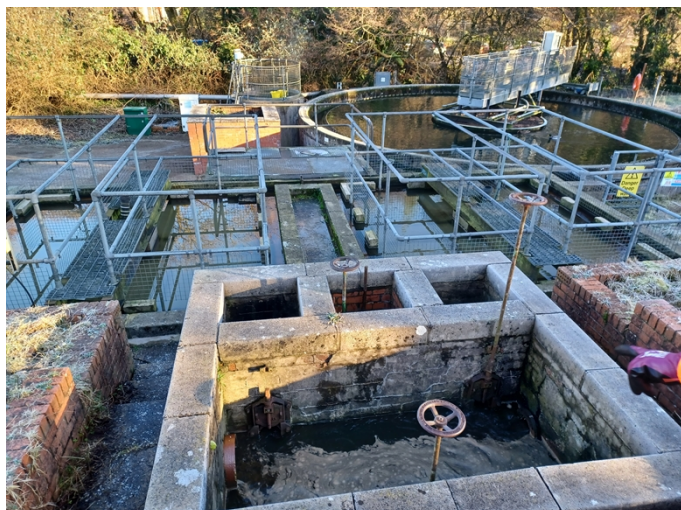
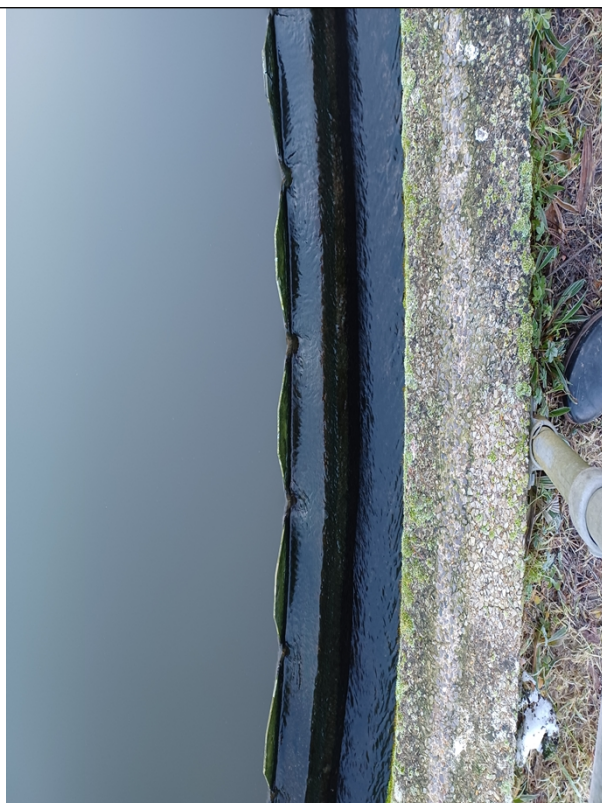
There are two final settlement tanks at this site, each with two additional clarifier tanks for further settlement. The sludge blanket is manually assessed daily; at the time of visit there did not appear to be an issue and tanks operating effectively.

Left: FST 1, immediately after aeration tank. Right: FST 1's clarifiers in foreground, FST 2 in background. Below: weir within FST 1.

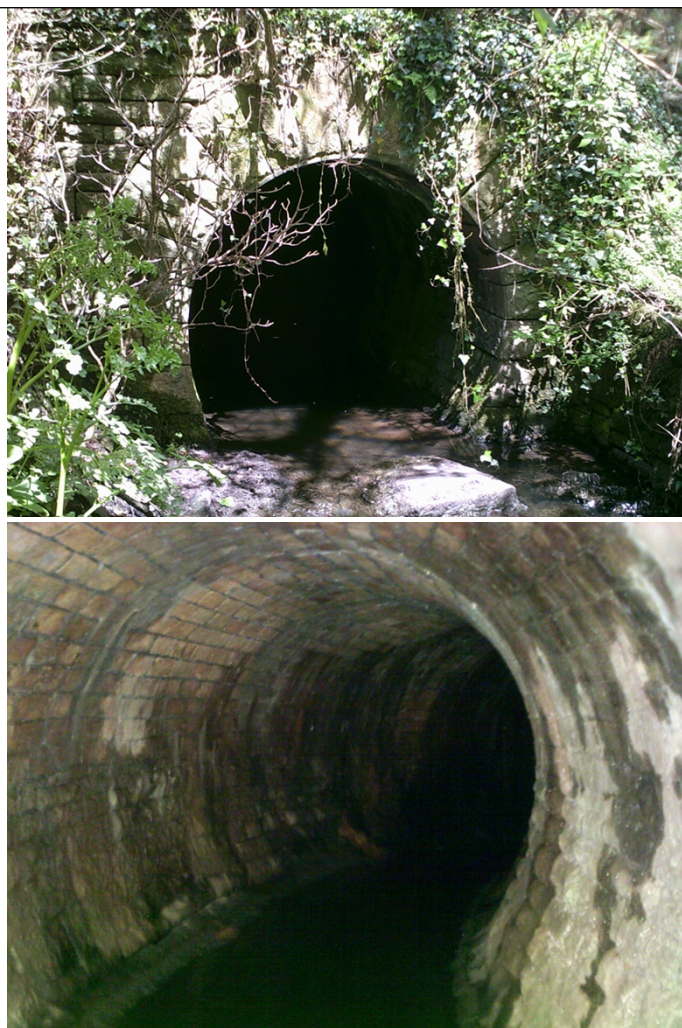
Officers attempted to assess the outfall south of Canada Lake, but were unable to access it safely due to it discharging inside of a tunnel. Dŵr Cymru Operatives sent the below photo from their most recent inspections, conducted in 2023:

The outfall review report found the section attached to the treatment works, the "purpose built steel platform and its concrete benching", to be in good condition. The final discharge point at the base of Canada Lake lies within a brick/stonework tunnel upon which it enters the Nant y Glaswg. This is a confined space and as such is inaccessible by DCWW without appropriate risk assessment.

5. Despite its access challenges, we expect regular inspections of the outfall as standard practise - with associated risk assessment - and for these to be recorded appropriately for reference. Please ensure this is done on a regular basis.
