Stability Assessment  
at

Cambrian Quarry,  
Gwernymynydd,  
Mold

Interpretative Report

Project Number : PN122722

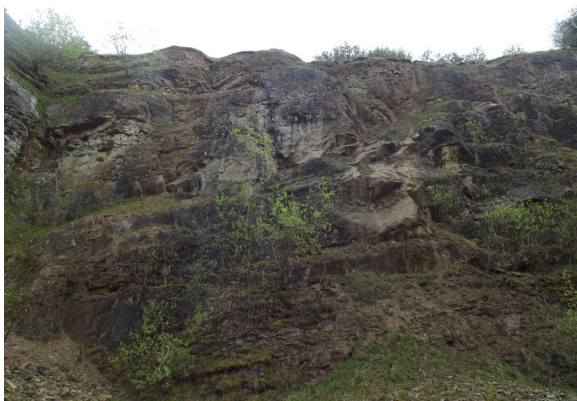
Plate 1: Southern quarry high wall

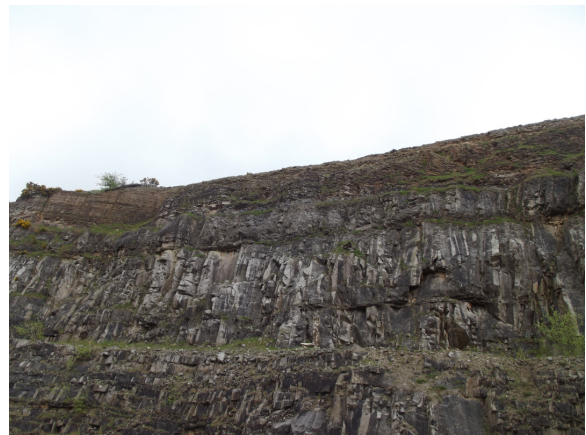
Plate 2: Eastern quarry high wall

It should be noted that two minor failures were witnessed from the eastern quarry high wall during the period of site survey work. Whilst these were of relatively small extent (and followed the wettest April on record for the UK), they present clear evidence of ongoing instability of the eastern high wall.

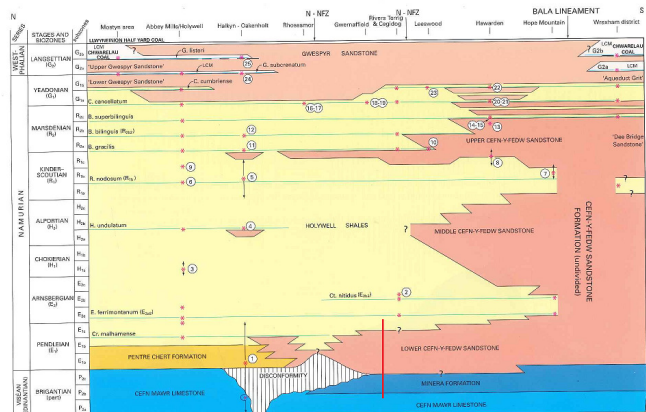
Figure 1: Extract from BGS Memoir

The lithologies of the Cefn-y-Fedw Sandstone (and associated Pentre Chert Formation), the Minera Formation and the Holywell Shales are fully described in the BGS Memoir. The amount of detail is beyond the scope of this report. The following figure however is taken from that document. Geotechnics Ltd have added the approximate horizon of the Cambrian Quarry outcrop by the position of the vertical red line. This figure is also reproduced in a more legible format in Appendix 4.

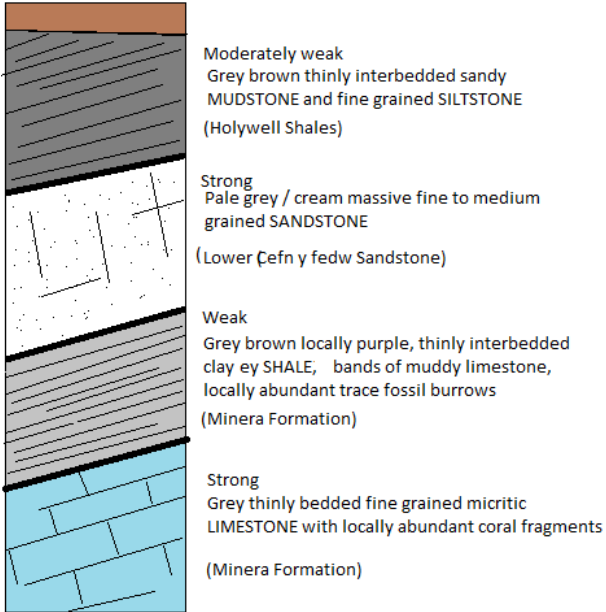
Figure 2: Summary of Local Geology

The general dip of the strata is to the east (i.e. the rocks young in an easterly direction).

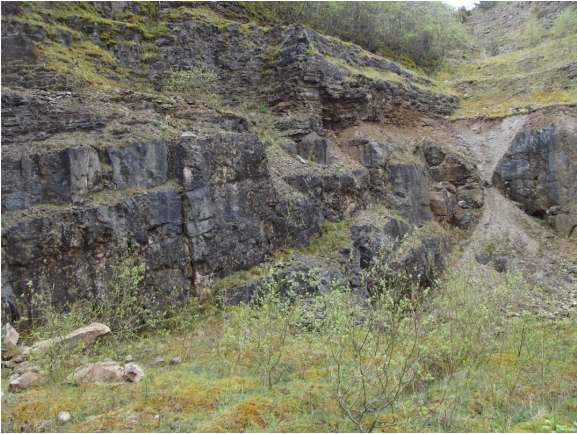
Plate 3: Minera Formation (limestone) exposed in south-western corner of quarry – dip to the east (towards the camera)

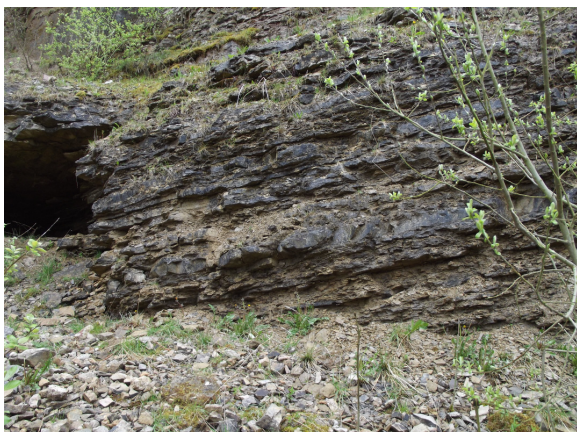
Plate 4: Uppermost Minera Formation ("Passage Beds") exposed in south-eastern corner of quarry

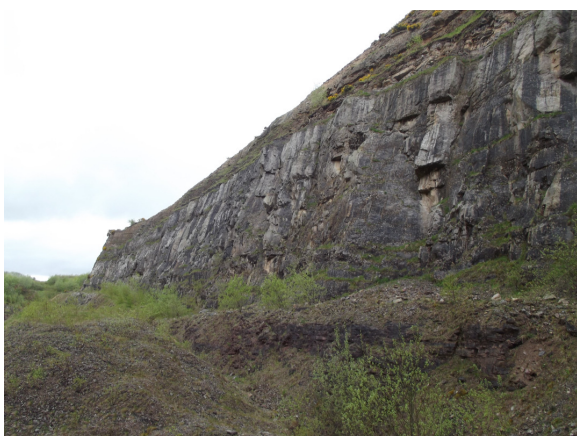
Plate 5: Lower leaf of the Cefn-y-Fedw Sandstone exposed in the southern quarry high wall

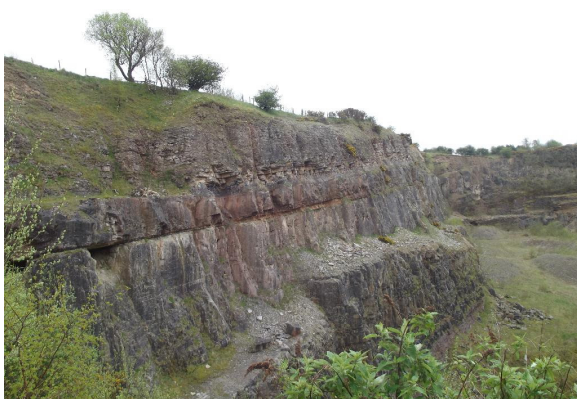
Plate 6: Transition from Lower Cefn-y-Fedw Sandstone to overlying thinly bedded Holywell Shales

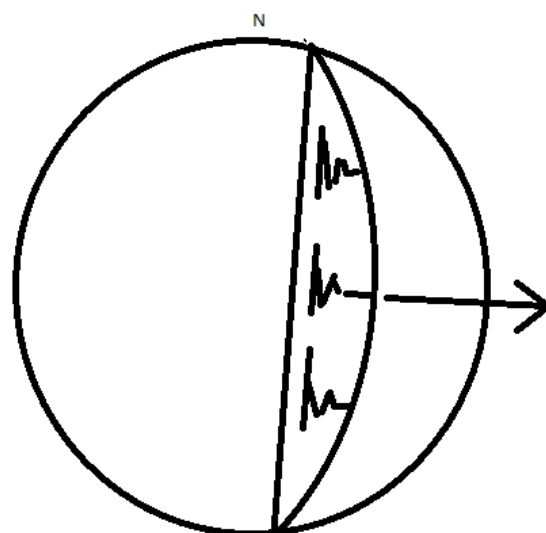
Any plane in 3D space can be represented on a two dimensional surface by a stereographic projection on a projected hemispherical grid. Conventionally in geological and geotechnical design a lower hemispherical projection is utilised. This can be thought of as being the lower half of a ball, with the intersection that a plane in 3D space makes with the perimeter of the ball marking out a great circle, as indicated in the following sketch.

Fig 3: Lower Hemisphere Great Circle

Thus a relatively steeply dipping slope (dipping in a direction just south of due east in this case), subtends a unique great circle on the projected lower hemisphere. Furthermore, it is possible to define a single plane in three dimensional space by a point (termed the pole) which uniquely represents the great circle so defined.

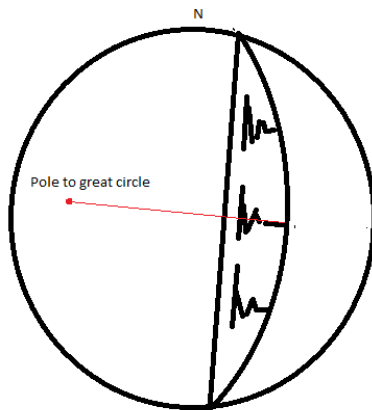
The following plot indicates how the great circle can be represented by a single pole.

**Fig 4: Pole representing a Great Circle as a single point**

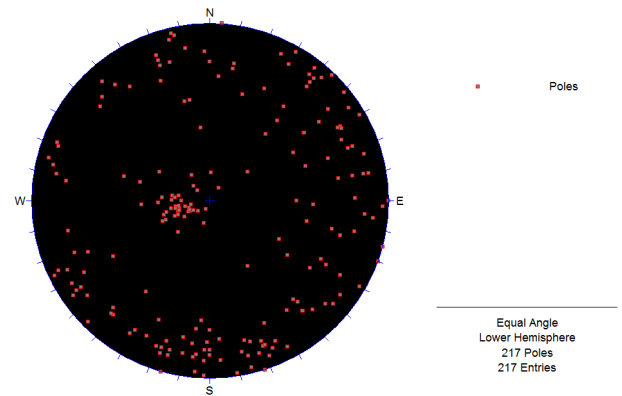
The following lower hemispherical projection shows the combined data for all the joint measurements undertaken at the site, represented as poles to great circles. This indicates a cluster located just to the west of the centre of the plot. This cluster represents the great circles associated with the bedding in the quarry which dips at a gentle angle toward the east.

**Fig 5: Lower hemisphere projection, poles to great circles, all recorded data.**

The somewhat more scattered poles located around the perimeter of the projection record the presence of much more steeply dipping joints (vertical joints plot on the outside of the circle, with a great circle running through the centre of the projection).

This figure, along with subsequent contoured plots are reproduced for clarity, at larger scales in Appendix 5.

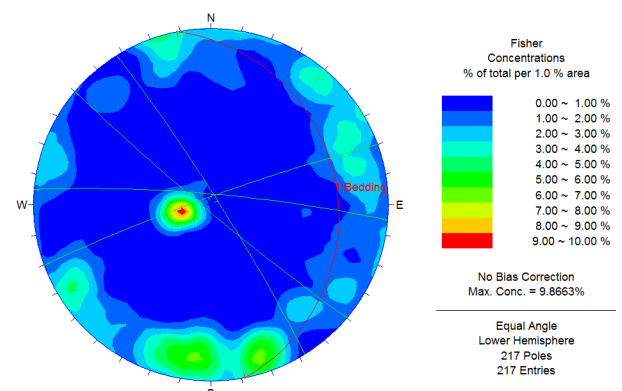
The data can be made more meaningful to work with by contouring the degree of clustering to identify the major joint sets present. This has been done in the following plot:

**Figure 6: Contoured plot with mean great circles of cluster concentrations added**

This allows the locus of the major joint concentrations to be established. In this case it is apparent that there are five major joint sets present comprising the shallow dipping bedding which dips towards the east (shown in red) and four steeply dipping (near vertical) joint sets.

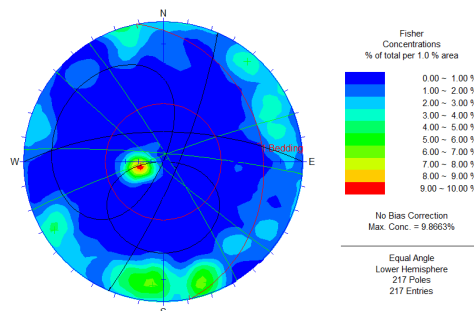
The following plot shows the daylight envelopes for the two main slopes plotted with the joint set data as defined in Figure 6 and a friction circle, representing a friction angle on joint surfaces of 45°. Instability would be anticipated for planar failures at locations where pole concentrations fall inside the daylight envelope but outside the friction circle. There are no recorded occurrences of this type of failure.

Similarly for wedge type failures it would be anticipated that failures could be anticipated where the intersection of two planes (i.e. the location where the two great circles cross) lies inside the daylight envelope and outside the friction circle. Again, there are no such occurrences.

**Figure 7 Wedge Analysis**

However, it can be seen that the intersection of two planes in the south-eastern quadrant does lie within the daylight envelope of the north facing southern slope. This suggests that given enough variation within the data set it could reasonably be anticipated that a small number of problematic wedges may be encountered associated with two steep joints dipping to the north east (Joint Set ii) and southwest (Joint Set iv), respectively. A number of such wedges can be seen in the photograph below.

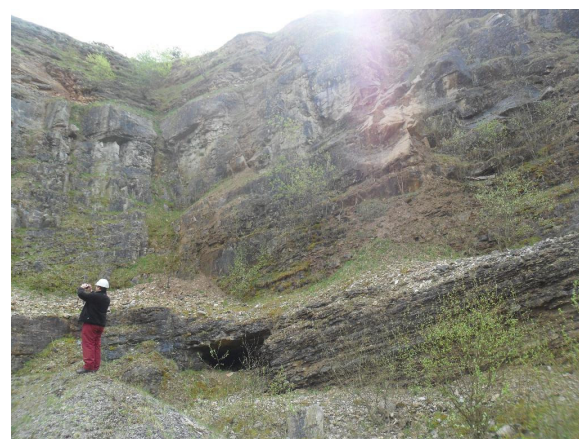
**Plate 7: Potential wedge and planar failures in southern (northerly facing) slope.**

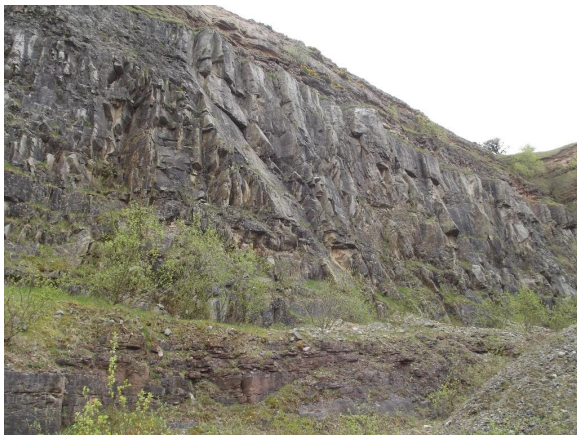
As with any statistical treatment there needs to be some caution in interpretation to ensure that the statistical values calculated are representative of the key data. With respect to slope stability it is important that single discrete discontinuities that are “counted out” by the contouring process are checked for by visual inspection. In this case it is apparent that in addition to the potential wedge failures identified above, there are a number of discrete potential failures apparent in the eastern high wall which are of concern. Some of these features, which are apparent primarily in the Cefn-y-Fedw Sandstone, are shown in the following photograph:

Plate 8: Adversely orientated steeply dipping joint causing potential significant instability issues

These joints are orientated at about  $82^\circ$  from the horizontal towards  $280^\circ$  from North, and were not identified as a major joint set in the statistical analysis.

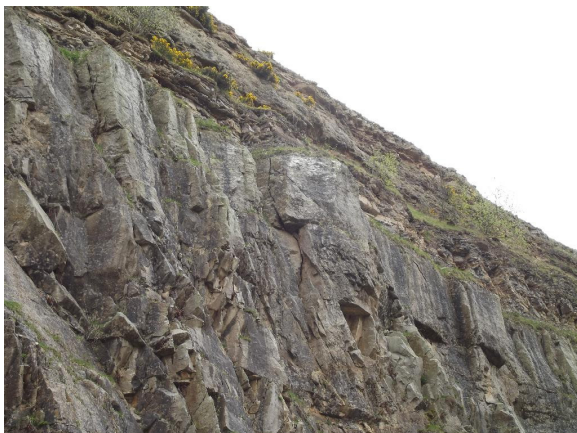
Plate 9: Close-up of Plate 8 showing incipient failure on joint sub-parallel to major problematic feature.

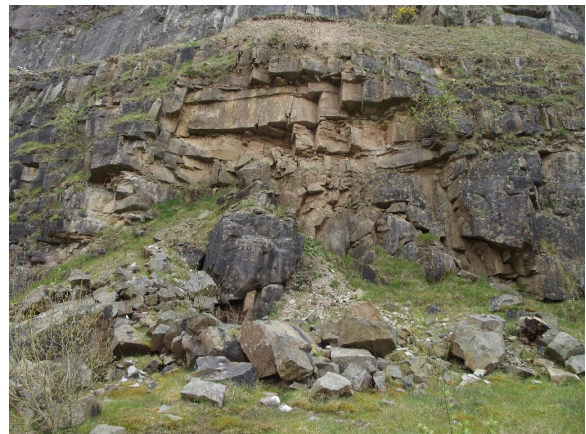
There are many areas on benches and the floor of the quarry where there is evidence of significant rockfall and instability. A selection of photographs illustrating these failures follow. Plates 12 and 13 illustrate a failure mode that is common along the eastern quarry high wall.

Plate 10: Failure associated with locally developed steeply dipping joint set (set only developed at 2-3% significance amongst the data set apparent in Figure 6).

In summary, it is evident that both the southern and eastern quarry high walls are showing signs of recent and potential slope instability. For the most part, failures are likely to be of relatively small volume and associated with weathering. However, there are some locations where there is significant potential for planar and wedge failures to occur. The risks associated with such failures would generally be acceptable in a working quarry or mine environment but are unacceptable with respect to public access and for the long-term maintenance of secure ownership boundaries.

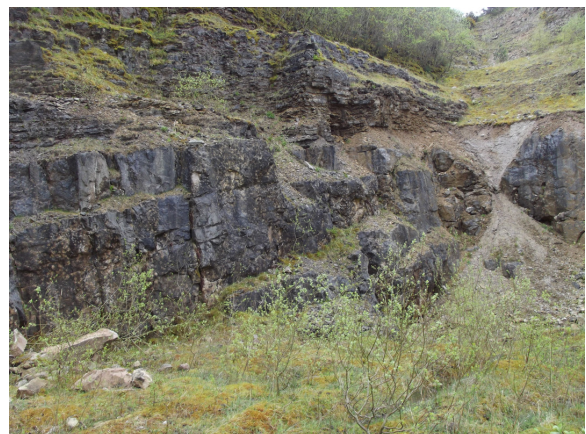
Plate 11: Ravelling failure at face corner

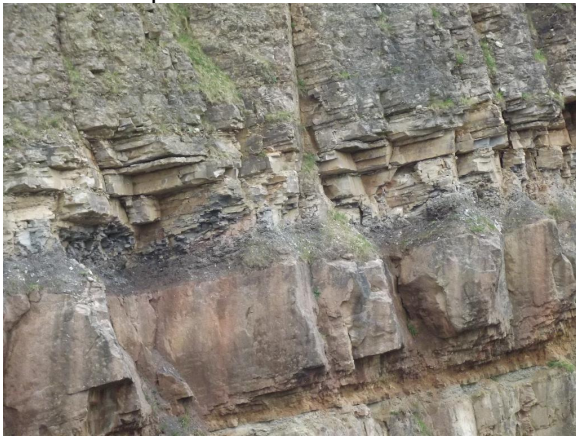
shaly mudstones (possibly the *Cr. malhamense* and *E. ferrimontanum* marine bands indicated on Figure 1). These bands are prone to weathering and are significantly softer than the immediately overlying strata. As can be seen from Plates 8 and 9, preferential weathering of the soft material produces a sequence of overhanging blocks of jointed materials. These overhangs are in rock that is jointed and fractured, and unable to sustain any significant overhang beyond a few tens of centimetres. As the soft horizon is weathered this produces ongoing localised failures above, now evident from the scree collecting on the bench below the slope.

Plate 12: Close-up of preferential weathering along soft shaley bands

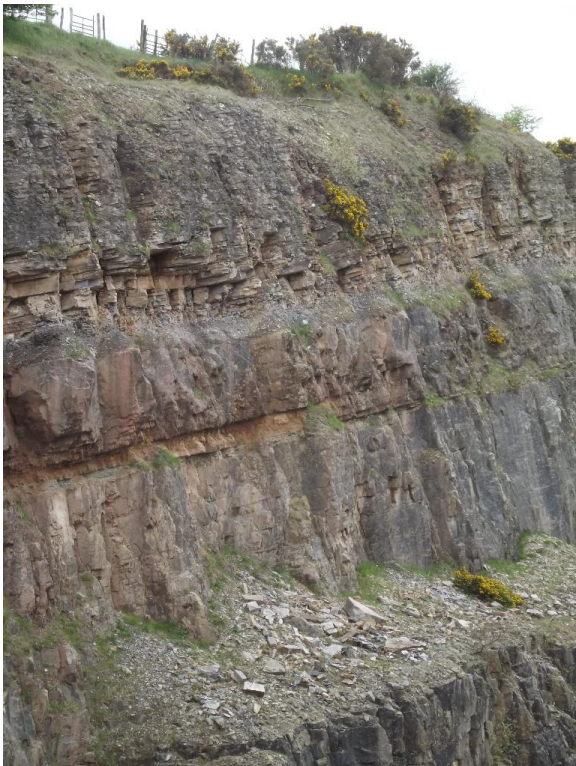
Plate 13: Failed rock forming scree on bench (note close proximity of boundary fence at this location).

It is understood that the crest of the slope along the eastern site boundary lies close to the ownership boundary and consequently close to third party land interests. The stability of the eastern high wall is therefore of concern not only for the current land owners, but also for adjacent land owners.

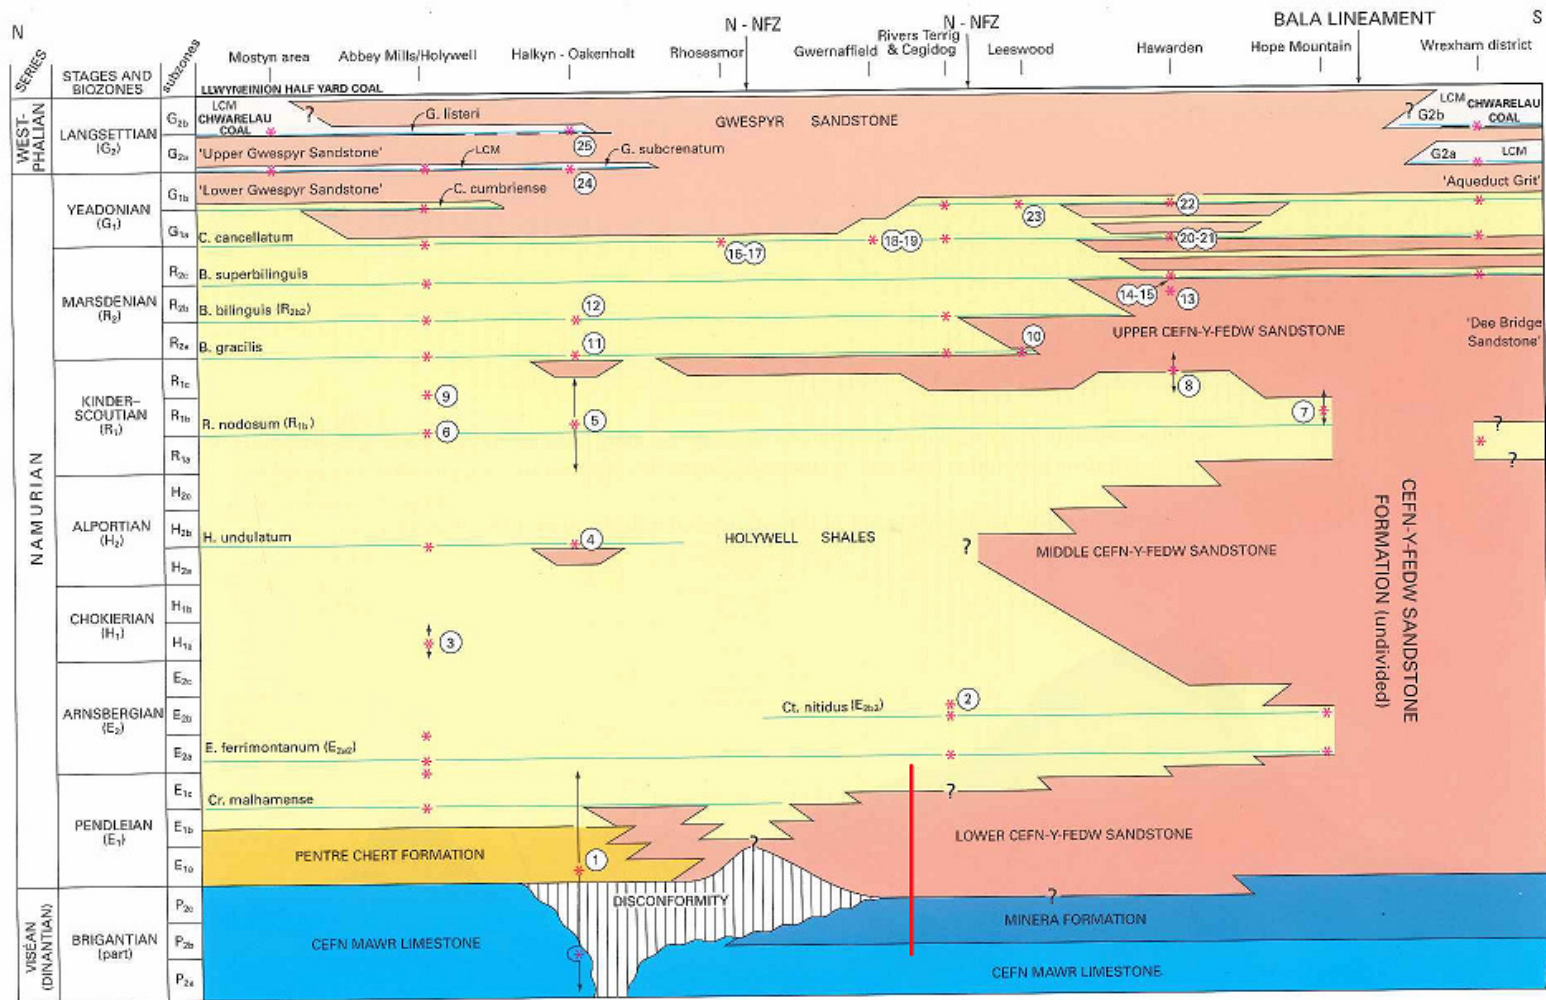
**APPENDIX 4**  
**EXTRACT FROM BGS MEMOIR**

APPENDIX 4: Copy of Figure 1: Extract from BGS Memoir (Approximate position of stratigraphy within the local stratigraphic sequence is shown by the vertical red line)

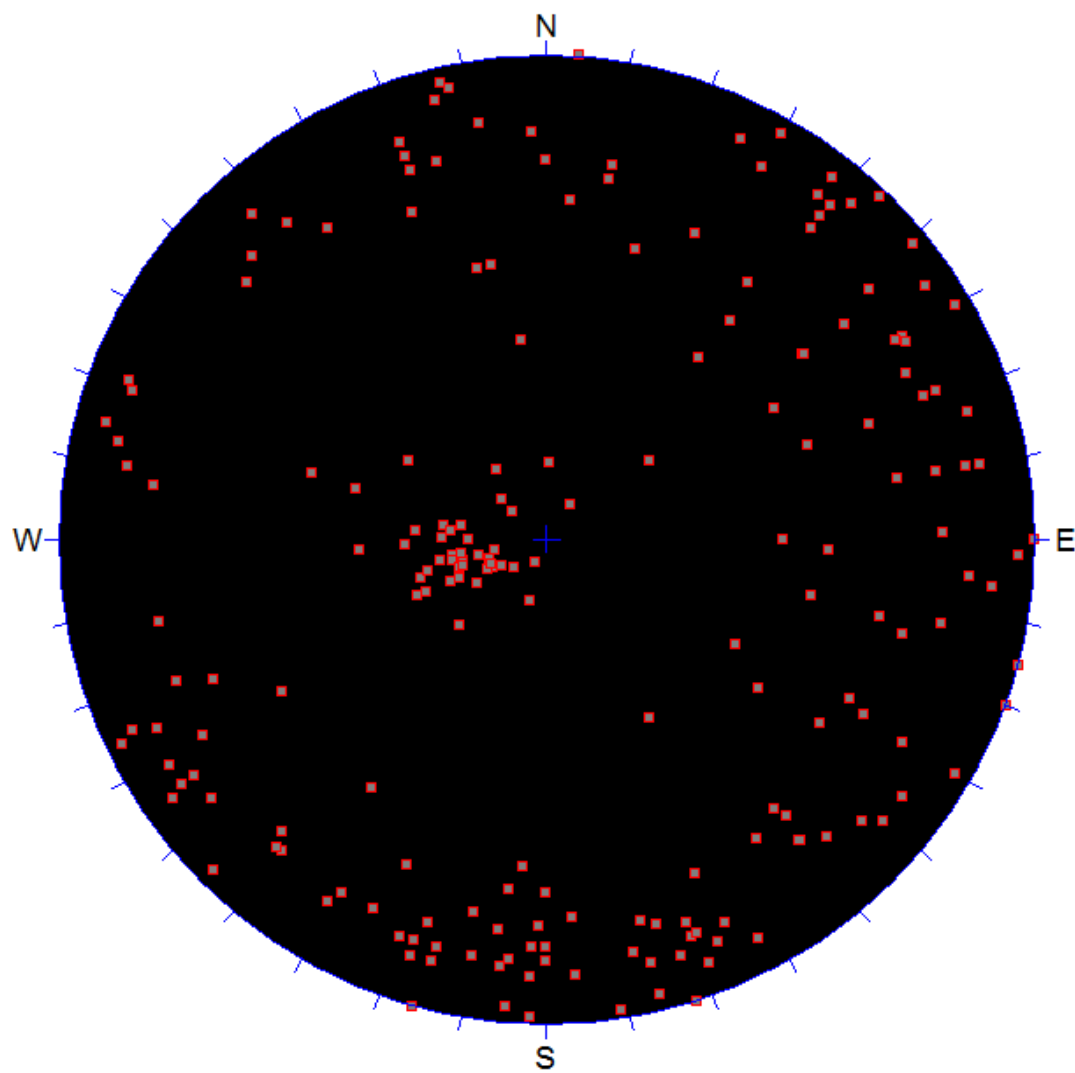
Equal Angle  
Lower Hemisphere  
217 Poles  
217 Entries

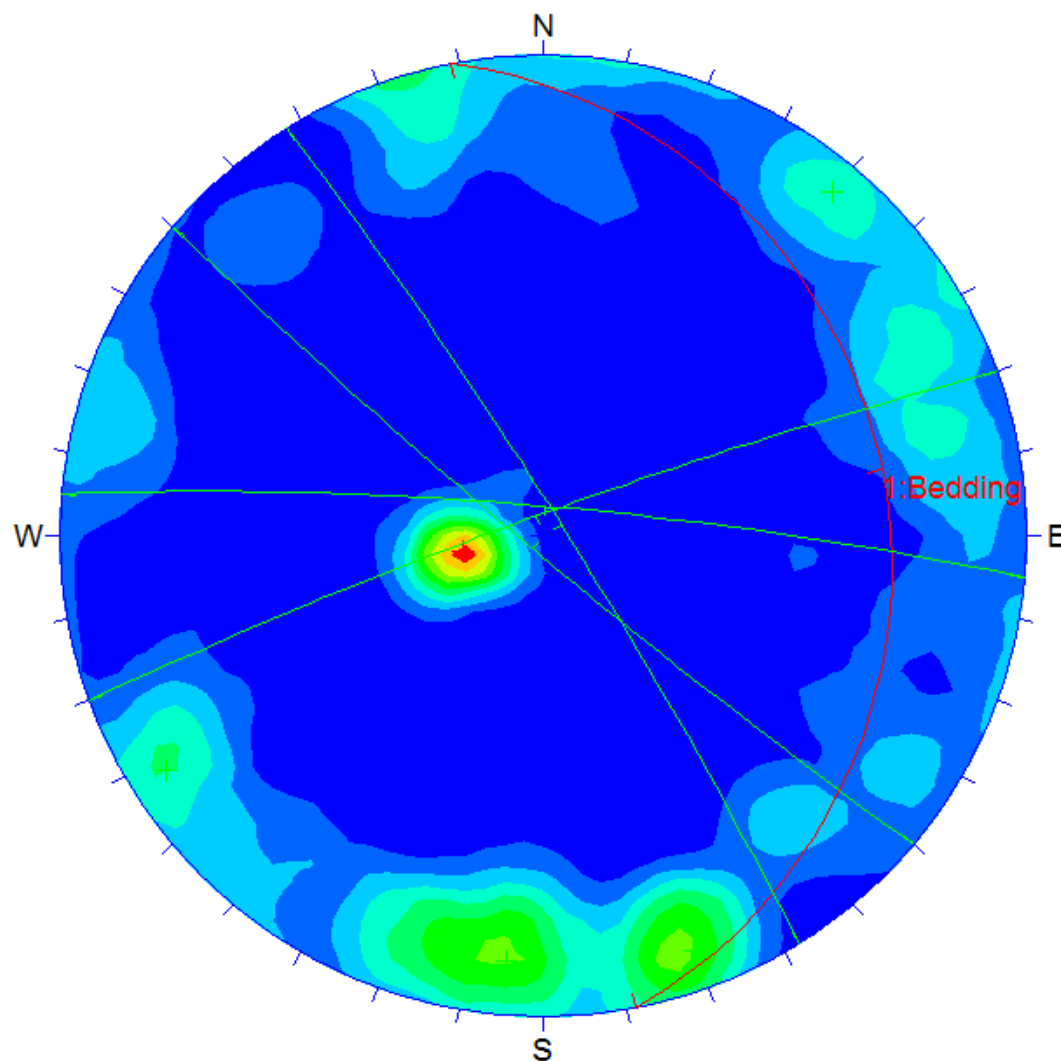
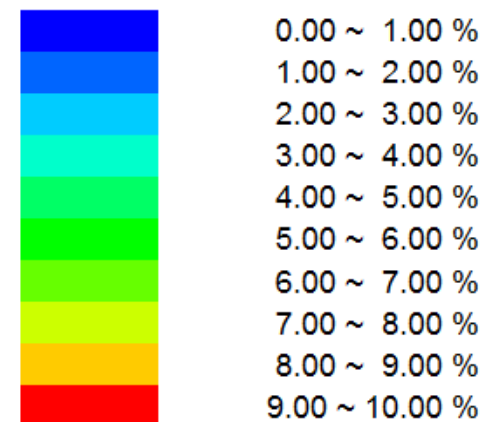
Fisher  
Concentrations  
% of total per 1.0 % area

No Bias Correction  
Max. Conc. = 9.8663%

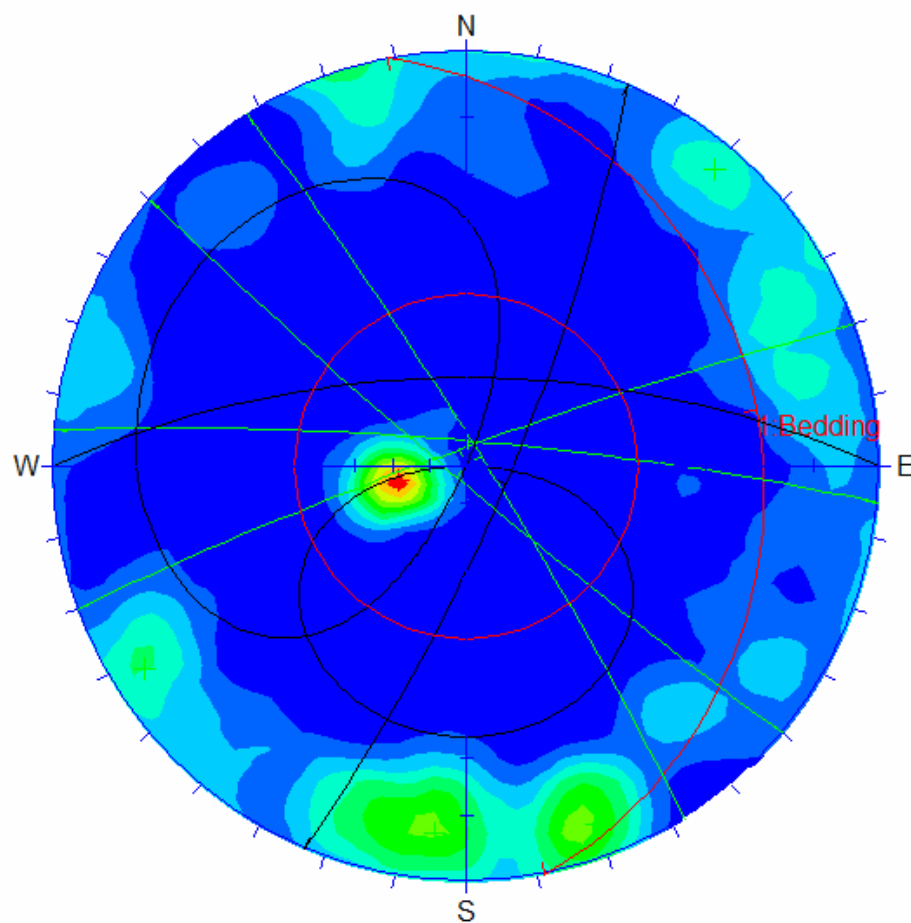
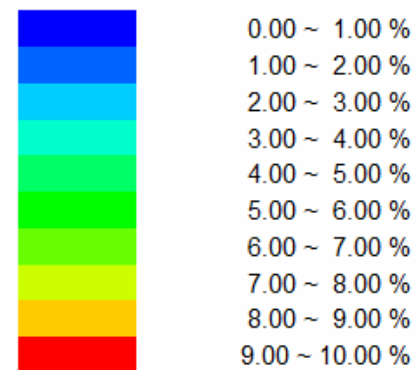
Fisher  
Concentrations  
% of total per 1.0 % area

No Bias Correction  
Max. Conc. = 9.8663%
