Groundwater Risk Assessment

Hendre Farmhouse

Orchard Campsite, Monmouth, NP25 4DJ

Date:	February 2025	
Version:	1	
Project Number:	HYG1354	
Document Reference:	HYG1354 R 250204 WO Groundwater Risk Assessment.docx	
Document File Path:	https://hydrogeoltd-my.sharepoint.com/personal/mike_hydrogeo_co_uk/Documents/Projects/HYG1354/Hendre Farm House/Reports/GWRA/Final/HYG1354 R 250204 WO Groundwater Risk Assessment.docx

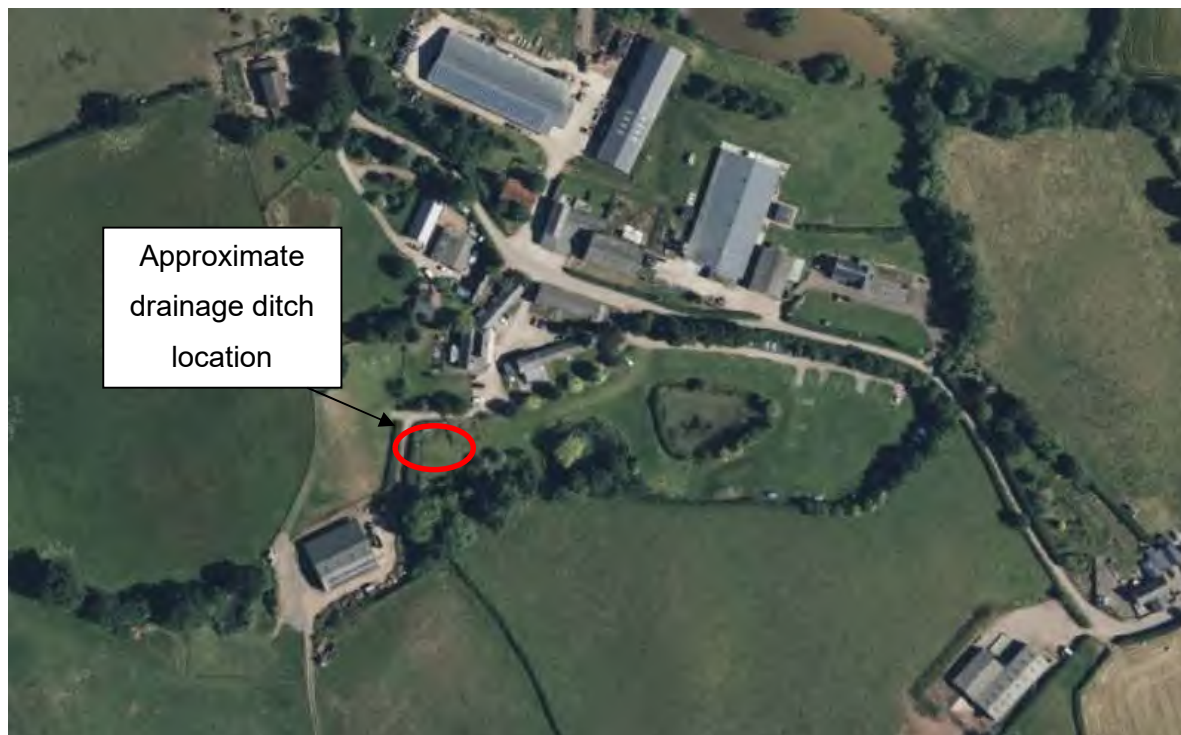
Figure 1-2 – Drainage ditch location

The dwellings and camping facilities discharge to drainage ditch from a package treatment plant (PTP) as shown in Figure 1-2. The PTP is a WPL Diamond DMC9, which is designed to cater for a population of 70 persons, and has a total capacity of 15038 litres. It is capable of producing a final effluent discharge standard of 20mg/L of ammonia and a maximum of 6.6mg/L of phosphate. It is understood that the drainage ditch is gravel filled, ~25m long, ~1m wide and ~0.6m in thickness, positioned just south of the PTP.

The location of the Site has been shown in Figure 1-1 and the sitting of the drainage ditch is shown in Figure 1-2.

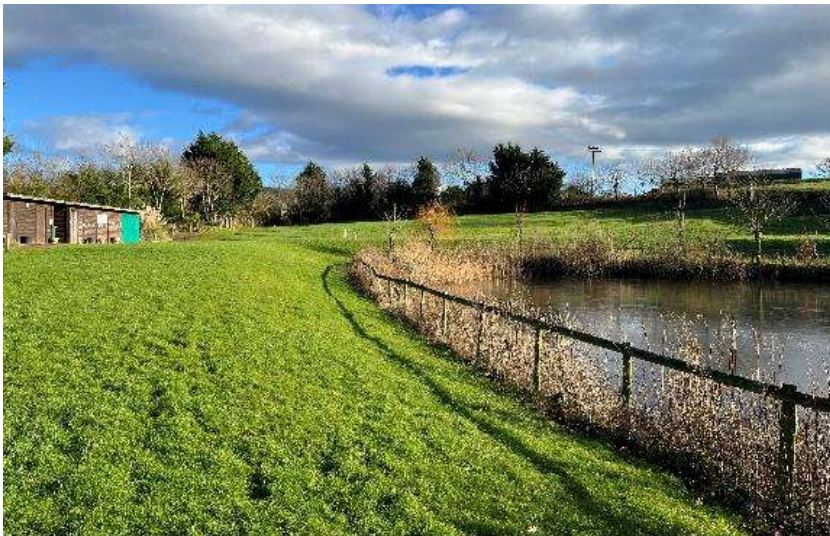
Figure 1-3 – Highest elevation pond

Ordnance Survey and aerial imagery shows a line of 3 no. ponds at the centre of the Site. Moving east to west, the pond levels drop in elevation from 55mAOD to 51mAOD to 48mAOD over a distance of approximately 140m. Information provided by the Site owner state that the ponds are artificial and fed by springs. It is understood they were constructed by the Site owner, with no groundwater encountered during excavation of the ponds. Photographs of the ponds are shown in Figure 1-3 to Figure 1-5.

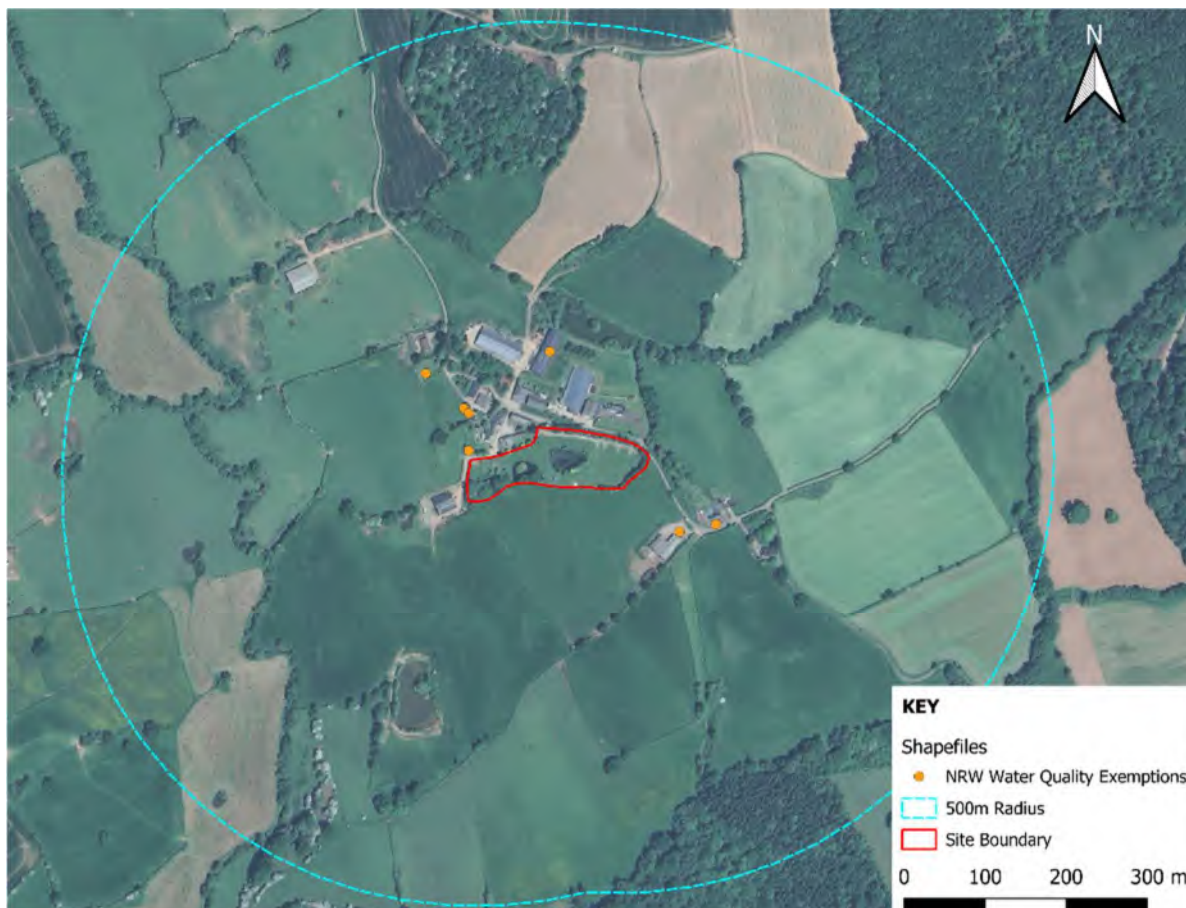
Figure 1-7 – Water quality exemptions within 500m of the Site

There are 7 no. water quality exemptions registered within 500m of the Site. Of which, 5 no. are for discharges $\leq 2\text{m}^3$, and 2 no. are for discharges $\leq 5\text{m}^3$. Their locations are shown in Figure 1-7.

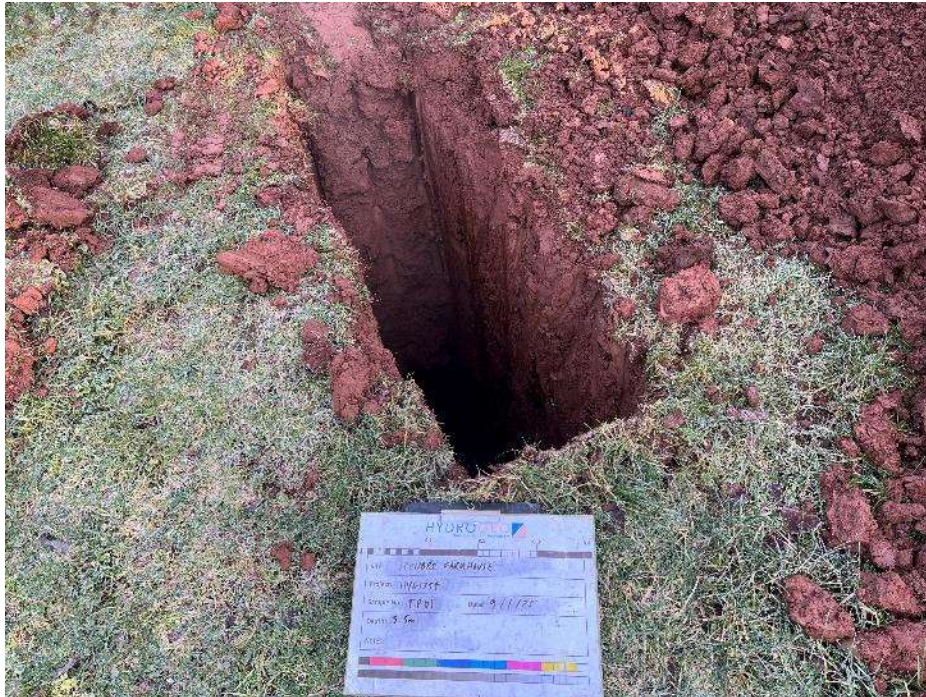
Figure 2-1 TP01 excavation

Trial Pit Reference	Description of Strata
<p>Reference: TP01</p> <p>Length: 2.5m</p> <p>Width: 0.5m</p> <p>Depth (mBGL): 3.5</p> <p>NGR: 345796, 212401</p> <p>Elevation: 51mAOD</p>	<ul style="list-style-type: none"> ▪ 0.00 – 0.12mBGL: Reddish brown silty clayey TOPSOIL with common rootlets; ▪ 0.12 – 2.54mBGL: Reddish brown silty CLAY with common subangular mudstone and siltstone cobbles and boulders, becoming sandier with depth [WEATHERED RAGLAN MUDSTONE FORMATION]; ▪ 2.54 – 3.50mBGL: Greyish brown sandy CLAY with uncommon sandstone and siltstone boulders [WEATHERED RAGLAN MUDSTONE FORMATION]. <p>Water observations:</p> <p>All spoil returned to the surface dry. 30 minutes after excavation of TP01 ceased, a water seepage from the northside backwall of the pit at 2.5mBGL was noted from the contact between the silty CLAY and sandy CLAY horizon. After 2 hours, the minor seepage dried up, leaving the water level in the base of the pit at 3.1mBGL.</p>

TP01 was excavated at the same topographic level as the middle onsite pond, to determine if the water level in the pond is in connectivity with groundwater. The pit was advanced to 3.5mBGL, well below the water level of the pond, with only a water seepage noted towards the base of the pit.

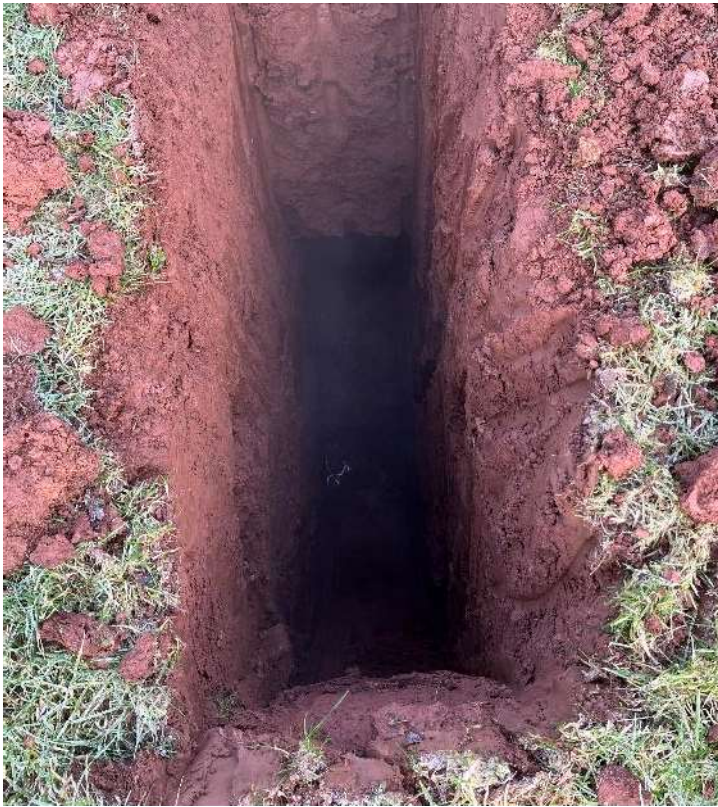
Figure 2-3 TP01 start of water seepage

- TP01: Seepage after 30 minutes at 2.5mBGL from northside backwall of pit at contact between silty CLAY and sandy CLAY horizon. Seepage dry after 2 hours;
- TP02: Seepage noted after 2 hours at 0.9mBGL from westside backwall of pit at the contact between upper sandier and lower siltier horizon. Seepage instantly dry;
- TP03: Seepage noted after 10 minutes at 0.8mBGL from southside backwall of pit at the contact between an upper sandier and lower siltier horizon. Seepage instantly dry.

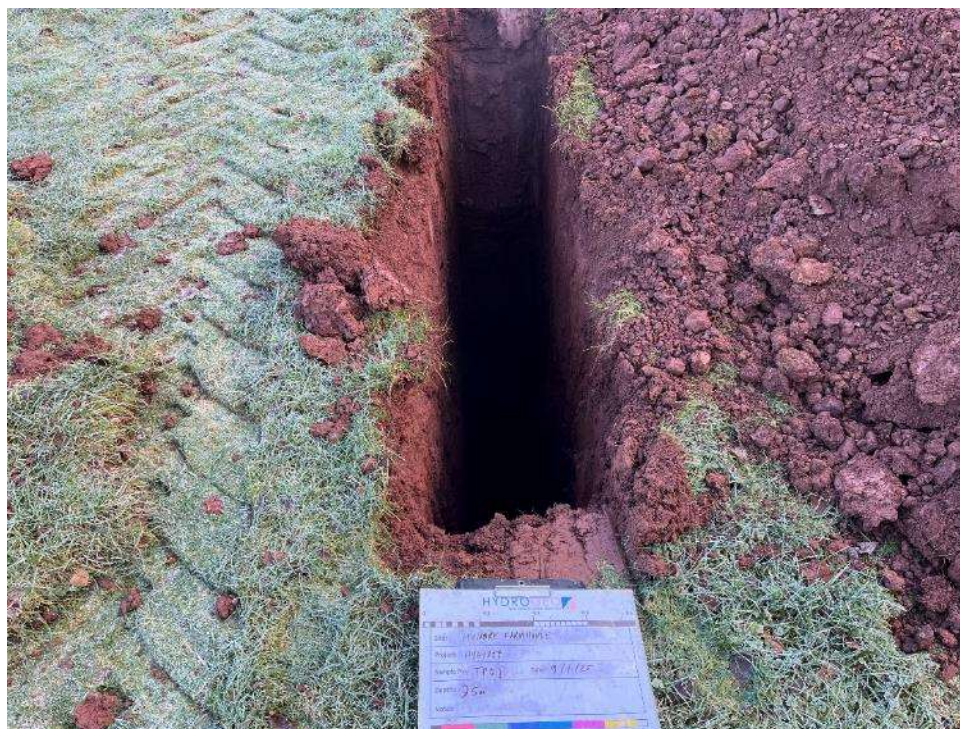
Figure 2-5 TP02 excavation

Trial Pit Reference	Description of Strata
<p>Reference: TP02</p> <p>Length: 2.5m</p> <p>Width: 0.5m</p> <p>Depth (mBGL): 3.5</p> <p>NGR: 345766, 212401</p> <p>Elevation: 50mAOD</p>	<ul style="list-style-type: none"> ▪ 0.00 – 0.17mBGL: Reddish brown silty sandy TOPSOIL with common rootlets; ▪ 0.17 – 3.50mBGL: Reddish brown silty sandy CLAY with frequent subangular to subrounded mudstone and siltstone pebbles, cobbles and boulders, becoming increasingly sandier with depth [WEATHERED RAGLAN MUDSTONE FORMATION]. <p>Water observations:</p> <p>All spoil returned to the surface dry. 2 hours after excavation of TP02 ceased, a water seepage from the westside backwall of the pit at 0.9mBGL was noted at the contact between an upper siltier and lower sandier horizon. The seepage quickly dried up, with minor water sitting in the base of the pit.</p>

TP02 was excavated between the PTP drainage ditch and the topographically lowest onsite pond to observe if a flow of water was present from the drainage ditch to the pond. The water level of the pond is ~2m lower than the surface level of TP02, which was advanced to a depth of 3.5mBGL. No flow of water from the direction (north) of the drainage ditch was observed in TP02 with only a minor water seepage noted.

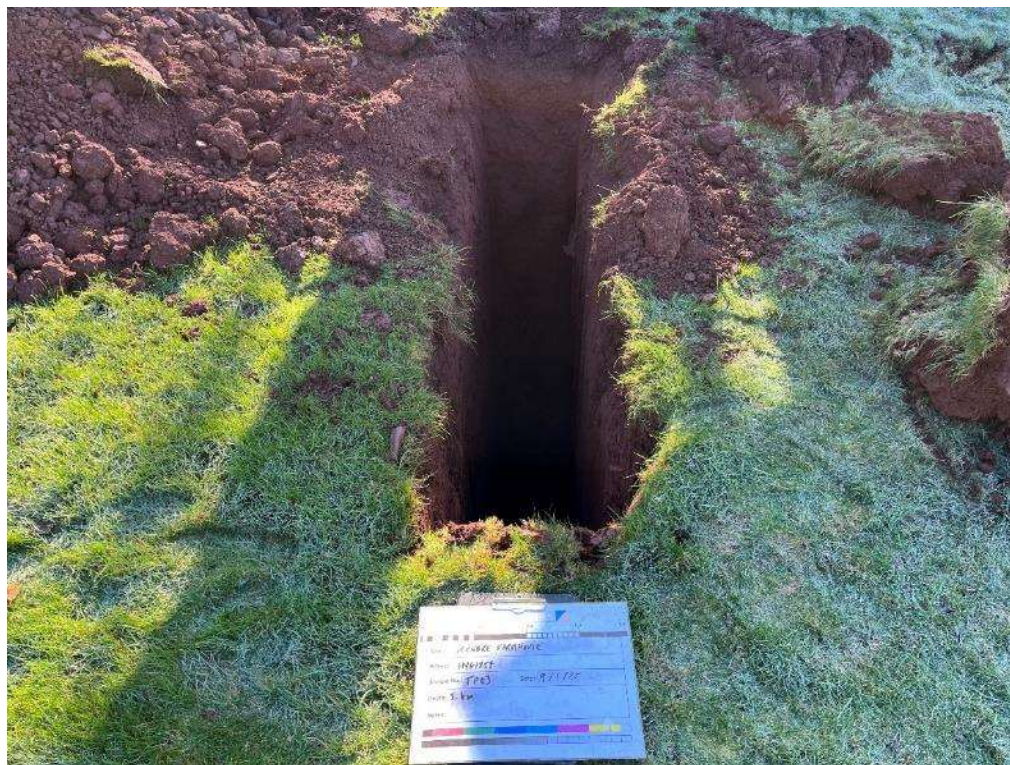
Figure 2-8 TP03 excavation

Trial Pit Reference	Description of Strata
<p>Reference: TP03</p> <p>Length: 2.5m</p> <p>Width: 0.5m</p> <p>Depth (mBGL): 3.6</p> <p>NGR: 345754, 212402</p> <p>Elevation: 50mAOD</p>	<ul style="list-style-type: none"> ▪ 0.00 – 0.20mBGL: Reddish brown silty sandy TOPSOIL with common rootlets; ▪ 0.20 – 3.60mBGL: Reddish brown silty sandy CLAY with frequent subangular to subrounded mudstone and siltstone pebbles, cobbles and boulders, becoming sandier with depth [WEATHERED RAGLAN MUDSTONE FORMATION]. <p>Water observations:</p> <p>All spoil returned to the surface dry. 10 minutes after excavation of TP03 ceased, a water seepage from the southside backwall of the pit at 0.8mBGL was noted at the contact between an upper siltier and lower sandier horizon. The seepage quickly dried up, with minor water sitting in the base of the pit.</p>

TP03 was excavated at the end of the drainage ditch to investigate for seepages associated with flow from the drainage ditch and to investigate for the presence of a continuous groundwater level in continuity with the water level of the lowest pond. TP03 was advanced maximum depth of 3.6mBGL, at the same topographic level as TP02. No flow of water from the direction (east) of the drainage ditch was observed in TP03 with only a minor water seepage noted.

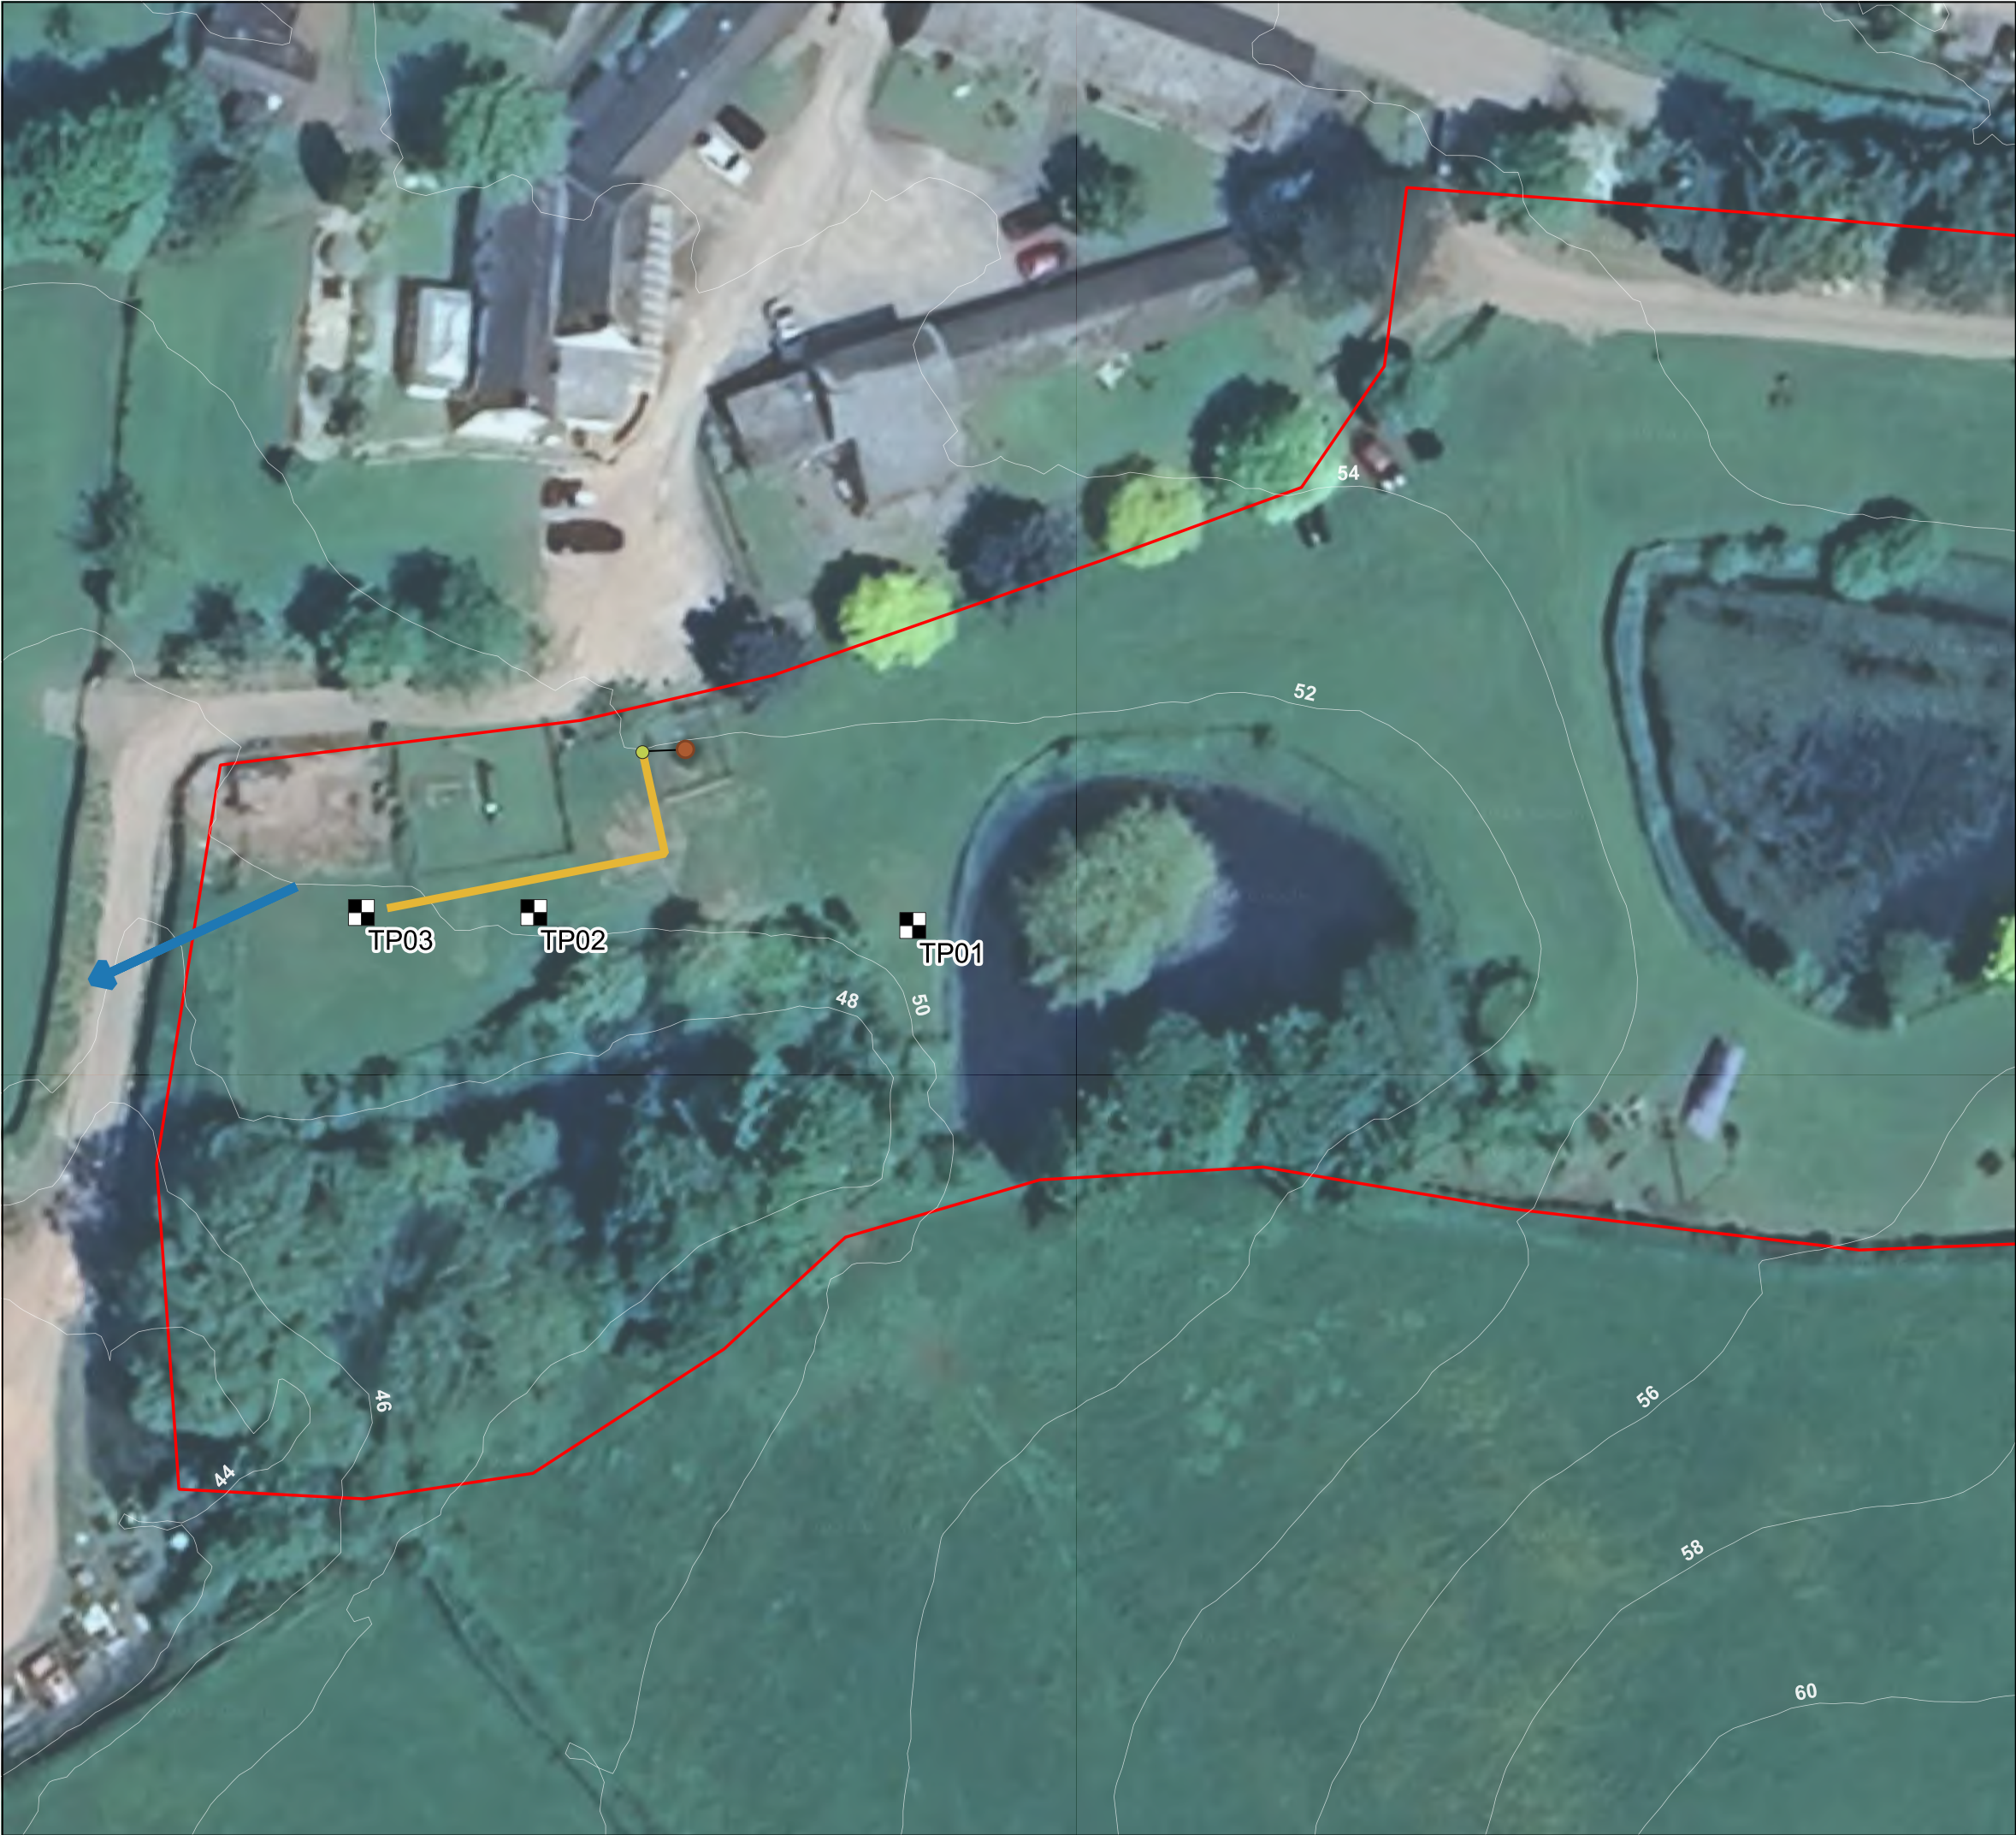
Site investigation plan

DRAWING 1
Site Investigation Plan

The site investigation positions were discussed and agreed with the Client prior to the commencement of works. Drawing 1 shows the site investigation positions.
