# Barmouth North Promenade FAS

Heritage Desk Based Assessment for GI

Reference: BMTH-ARP-EHR-ZZ-RP-OE-000001

P01 | 2025/03/06

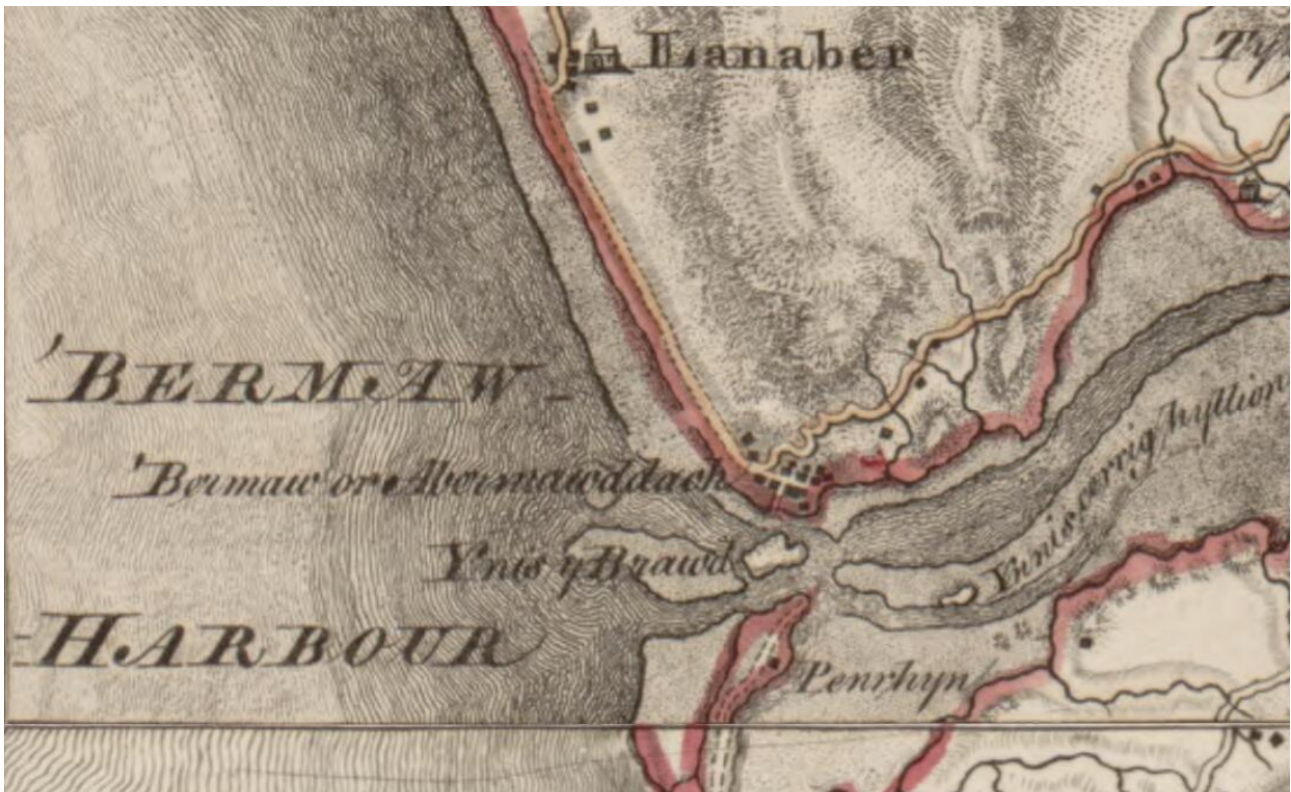
**Graphic 4-1 1795 map of Barmouth by John Evans. Six Counties of North Wales. Print. The National Library of Wales. Reproduced under a Creative Commons license.**

- 4.9.4 The first turnpike roads in north Wales were constructed in 1777. The turnpike road from Barmouth to Llanelltyd to the east was likely built in 1780s or early 1790s and is shown on John Evans' 1795 map of North Wales (Graphic 4-1). This map shows that at this time the town of Barmouth was still focused on land on the western side of the estuary. The map shows that the town comprised a concentration of buildings centred along a long street, likely the present High Street, showing how the town had expanded over the past half century. The beach and beachfront within the site boundary was still undeveloped at this time, although there appears to have been an access track leading from the road across the beach to a square-shaped structure, probably a slipway, likely used as a landing place, closer to the town, likely indicating that activity related to shipping was taking place on the seafront at this time, as well as within the estuary.

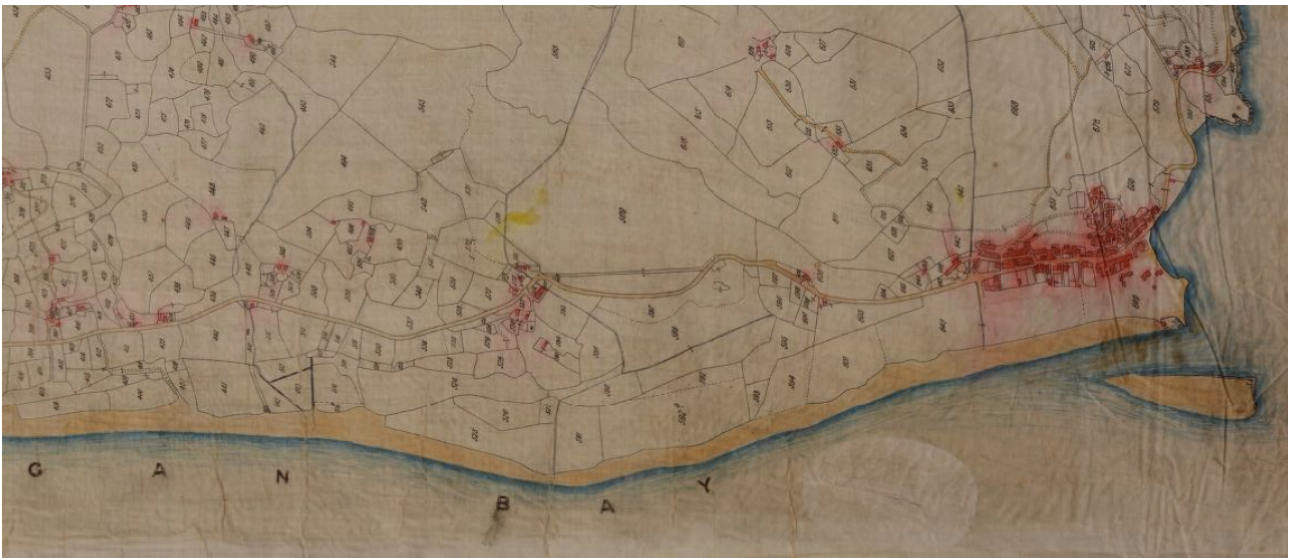
**Graphic 4-2 1844 tithe map of the Parish of Llanaber in Merionethshire, showing the town of Barmouth at this time, and the land within the site boundary. North is to the left. The National Library of Wales.**

- 4.9.14 The 1844 tithe map of the Parish of Llanaber (Graphic 4-2) shows that the town of Barmouth at this time was still focused on High Street, with the beach and seafront within the site boundary remaining undeveloped.

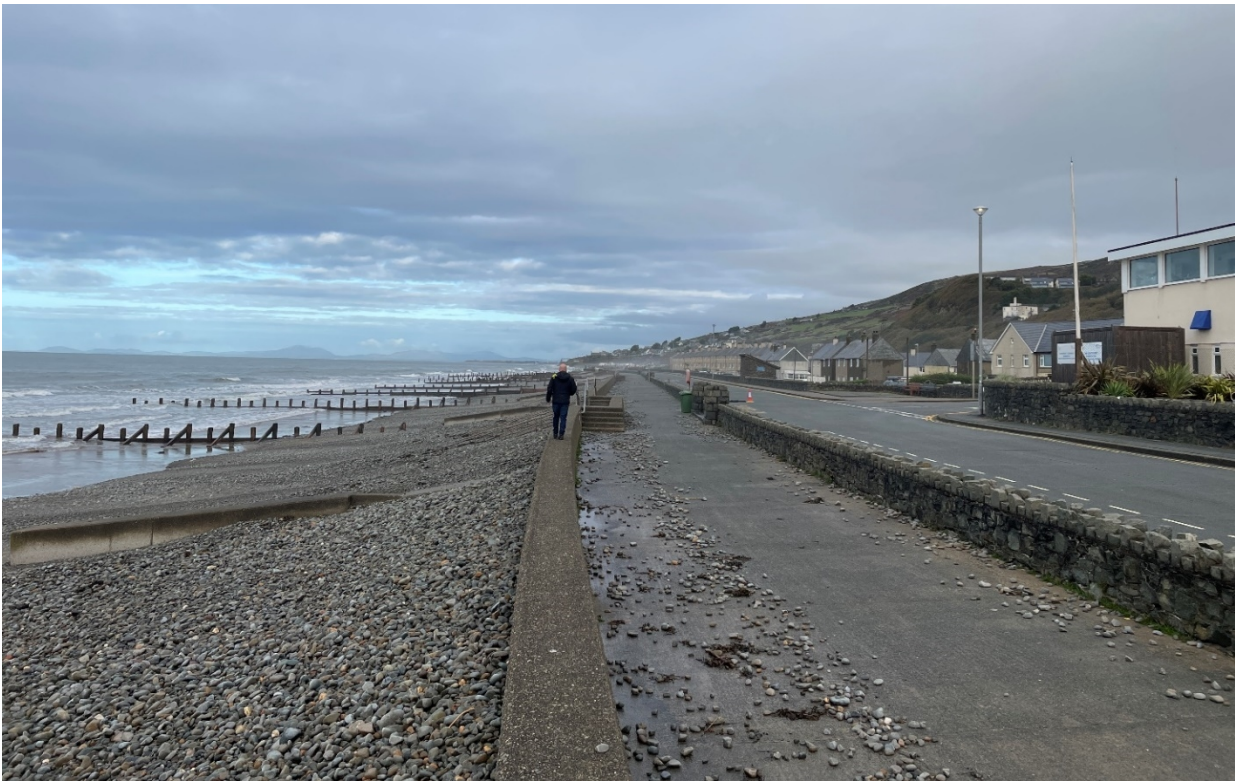
**Photograph 1 View north along the promenade and roadway from the southern end of the site boundary. Shingle is covering the 1930s stone-faced apron wall.**

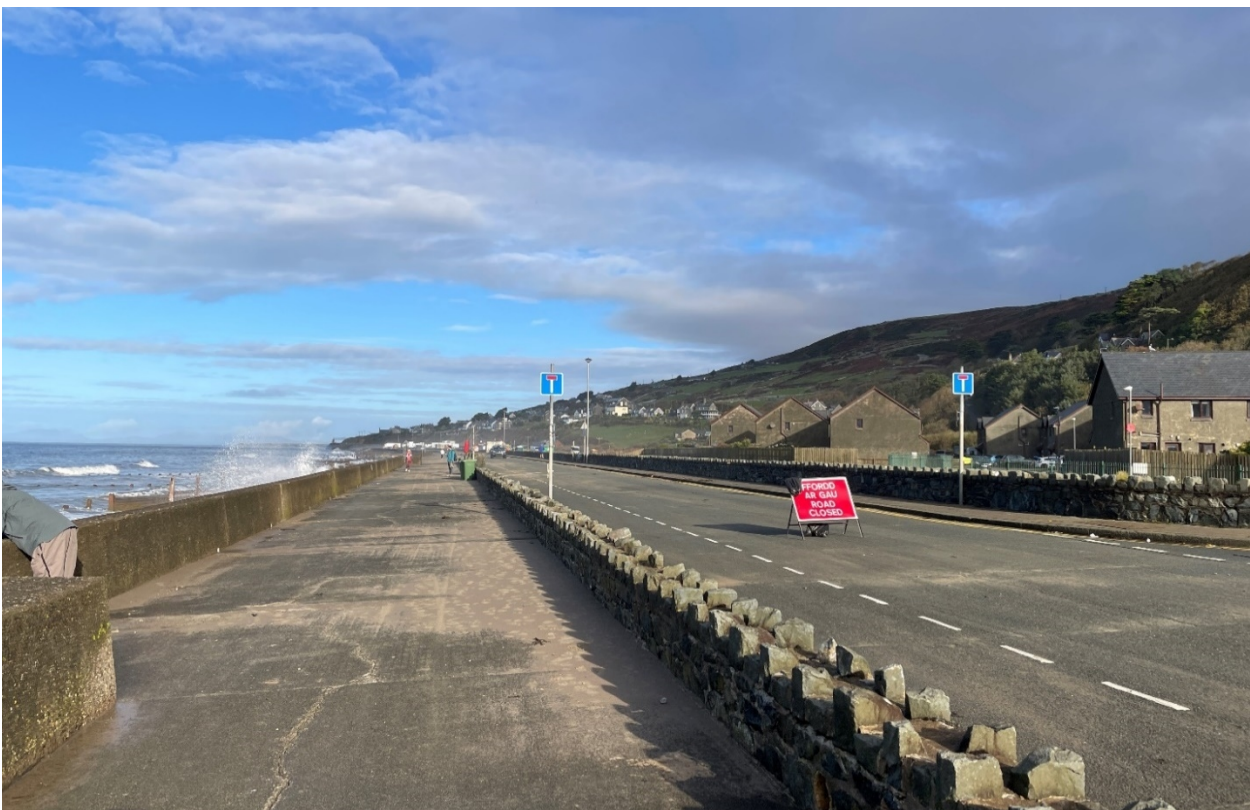
**Photograph 2 View north along the promenade, showing the stone wall (centre) dividing the promenade and roadway, and the 1970s wave return wall (left)**

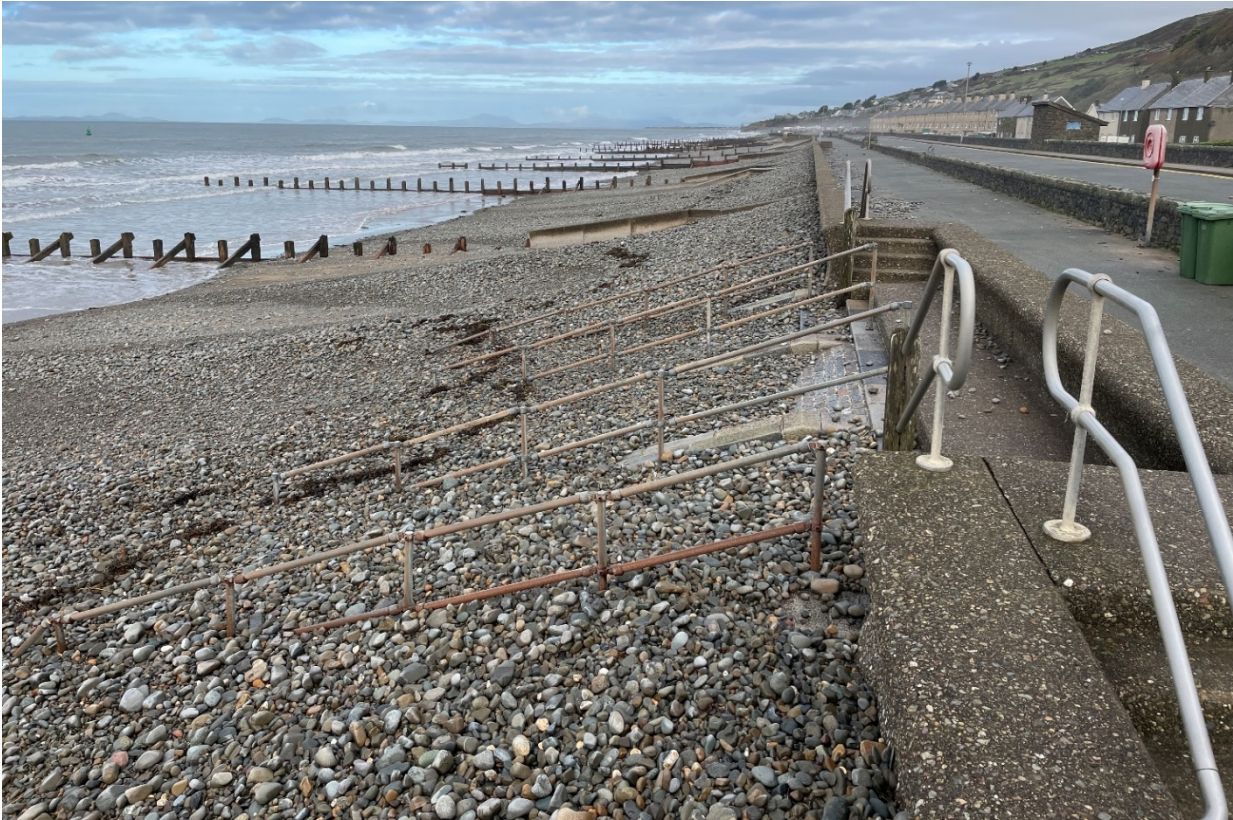
**Photograph 3 View north along the beachfront, showing the 1970s wave return wall, timber groynes, and shingle covering the 1930s stone-faced apron wall and steps down to the beach**

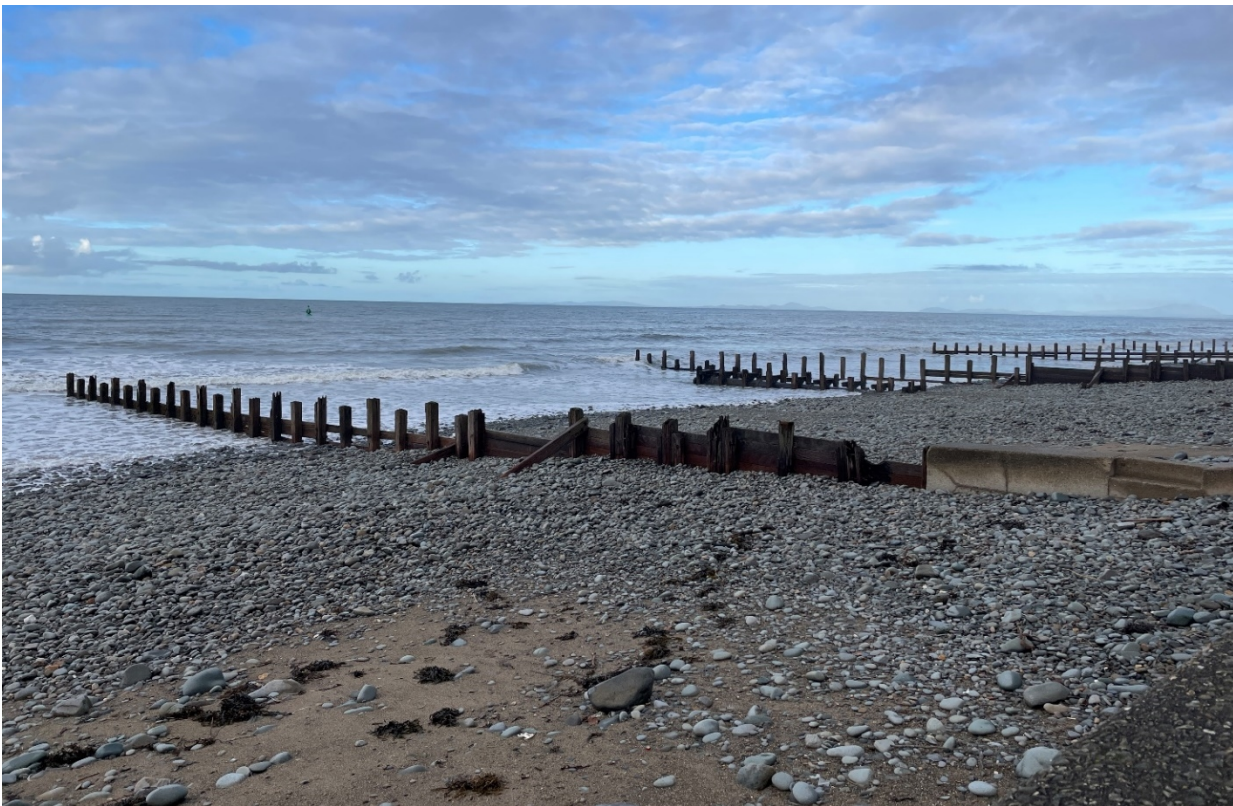
**Photograph 4 View northwest showing the beach and timber groynes**

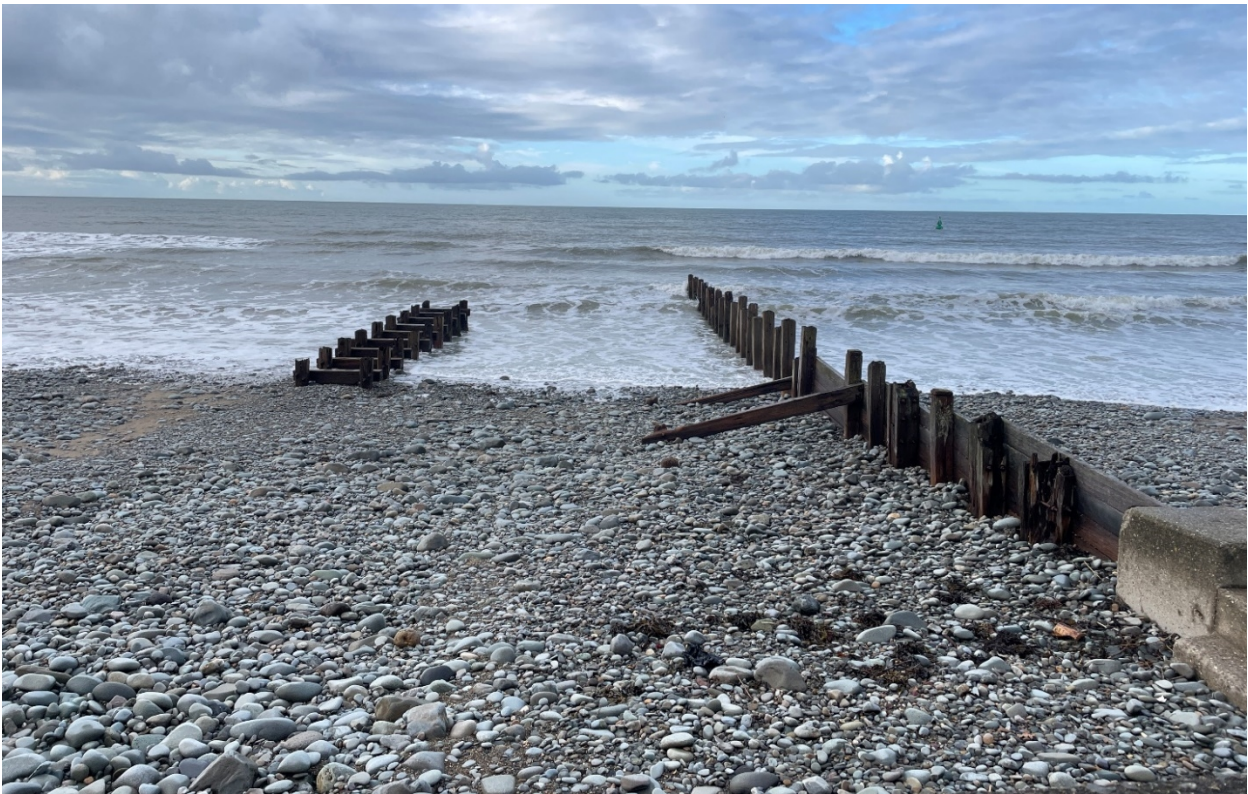
**Photograph 5 View west showing timber groyne (right) and timber cradle (left)**

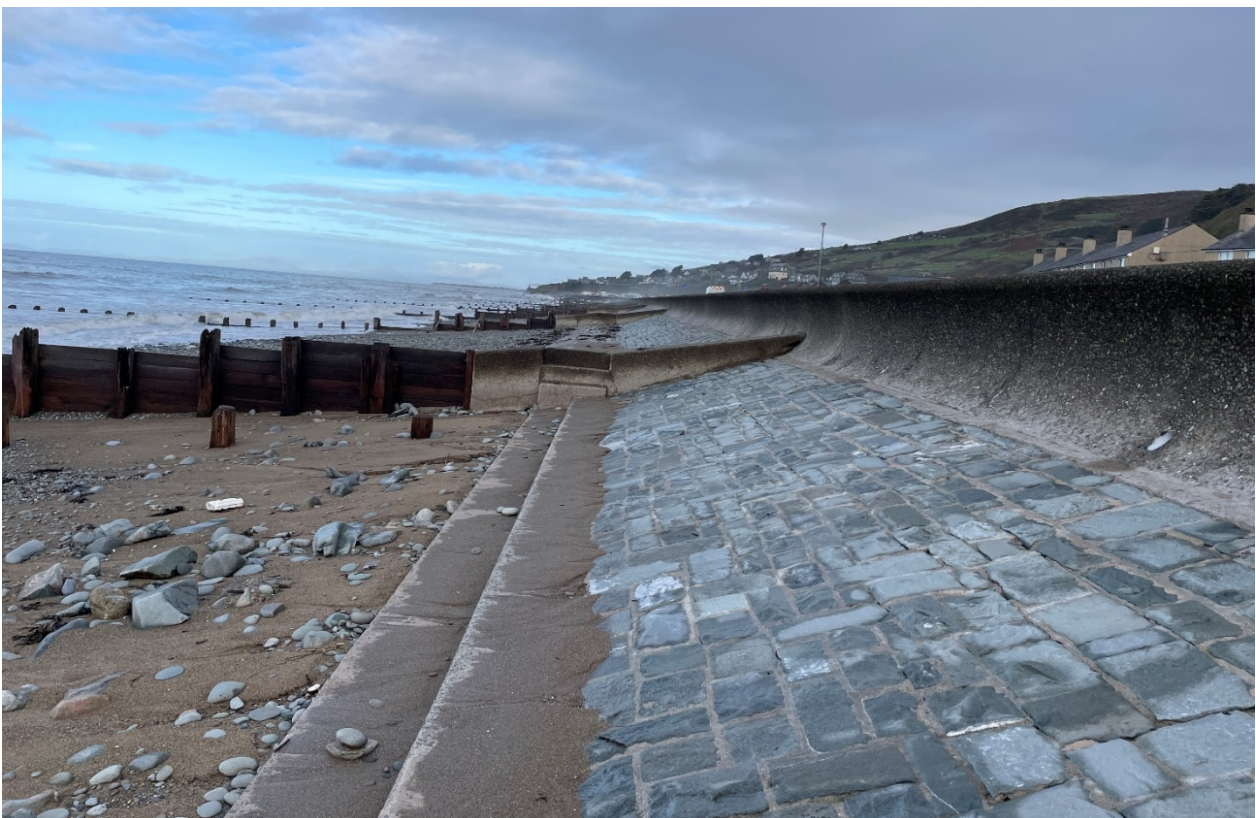
**Photograph 6 View north showing the 1930s stone-faced apron wall**

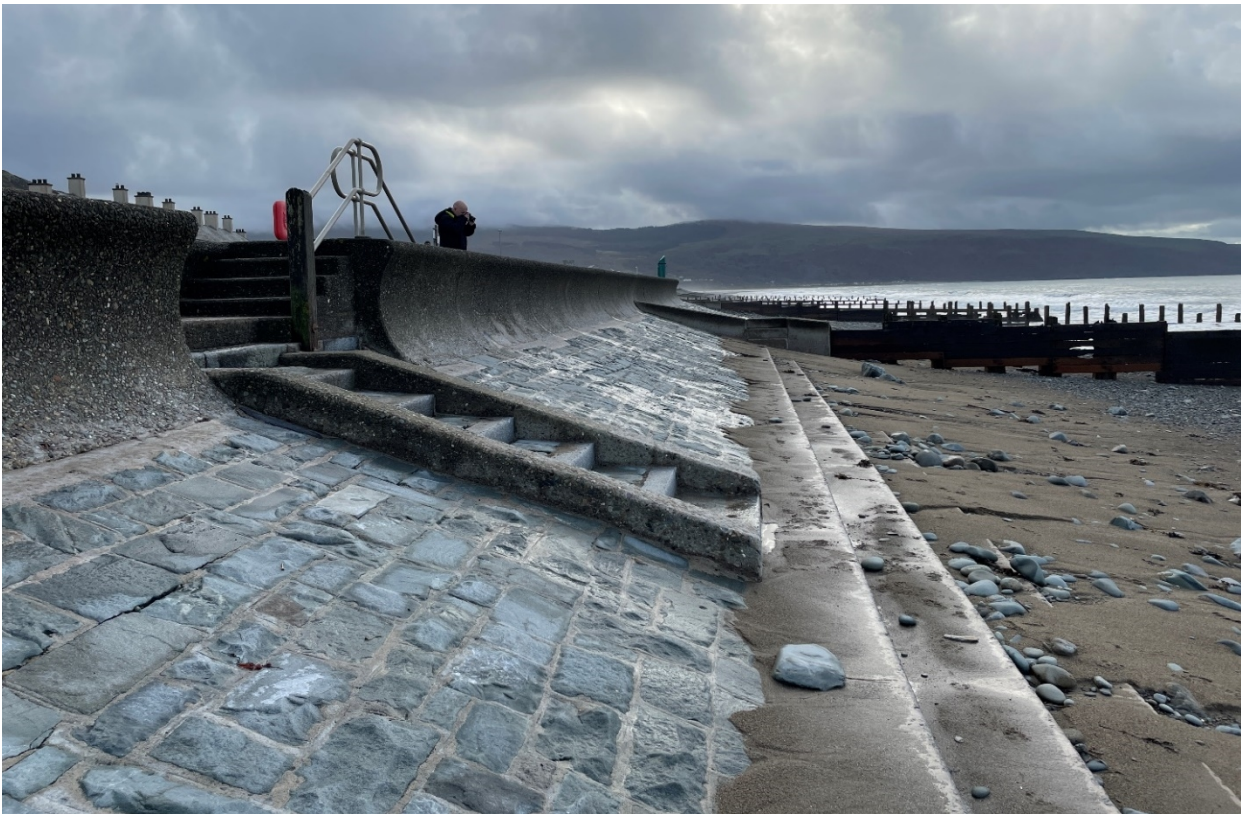
**Photograph 7 View south showing the 1930s stone-faced apron wall and stone steps, 1930s concrete stepped sea wall, and 1970s wave return wall**

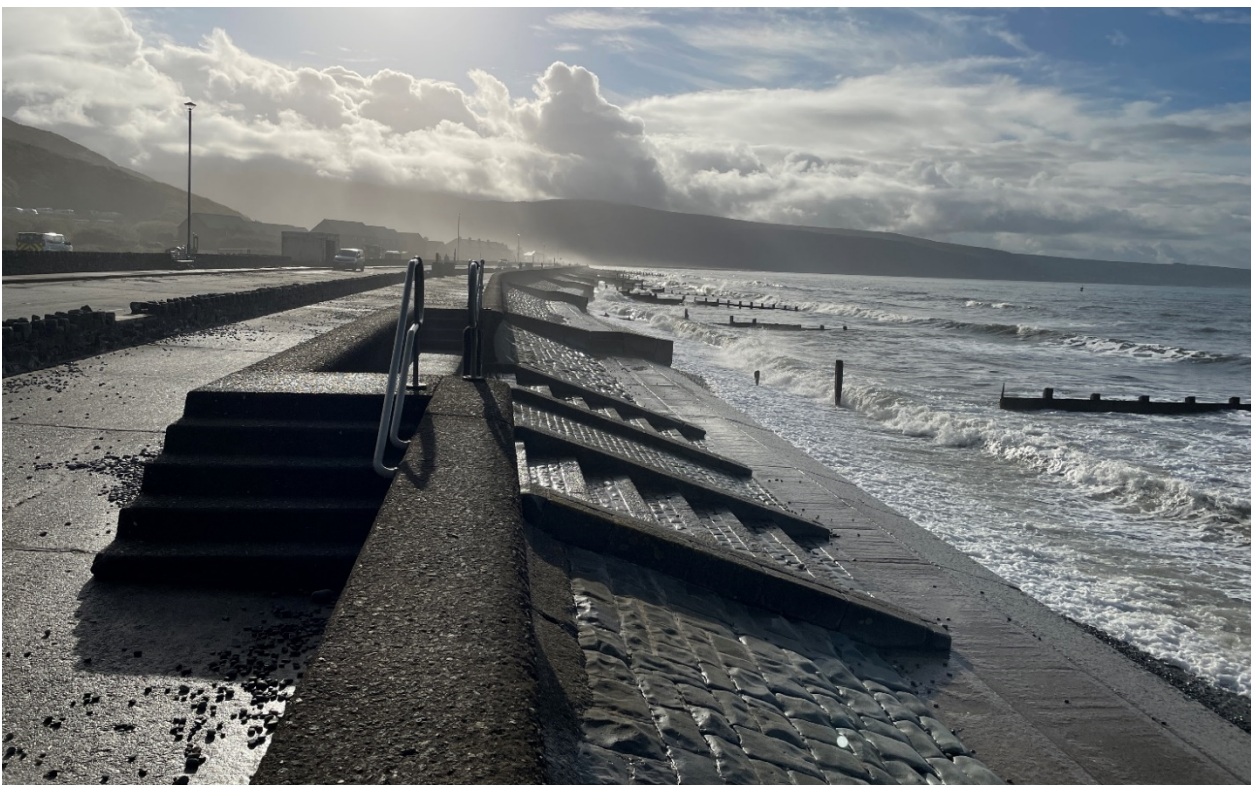
**Photograph 8 View south showing the 1930s stone-faced apron wall and stone steps, 1930s concrete stepped sea wall, and 1970s wave return wall**

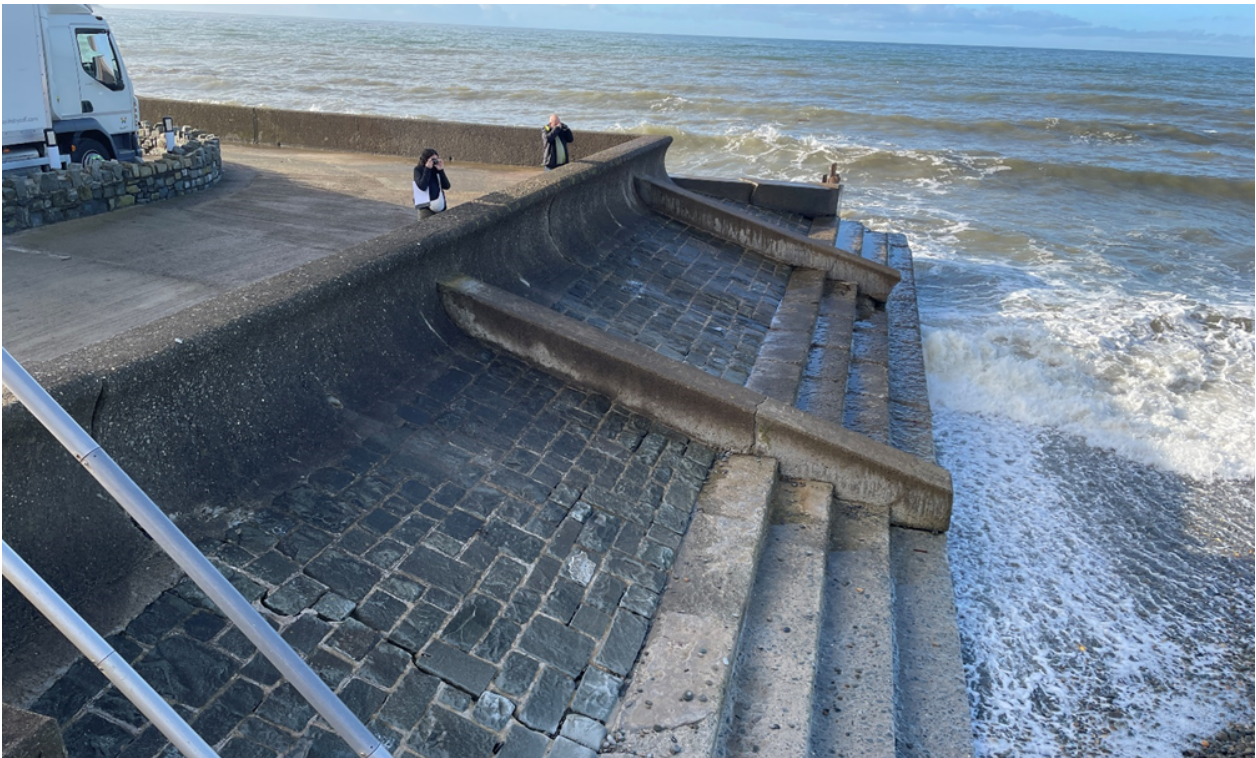
**Photograph 9 View west showing the northern end of the 1930s sea defences, with 1930s stone-faced apron wall and concrete stepped sea wall, and 1970s wave return wall**

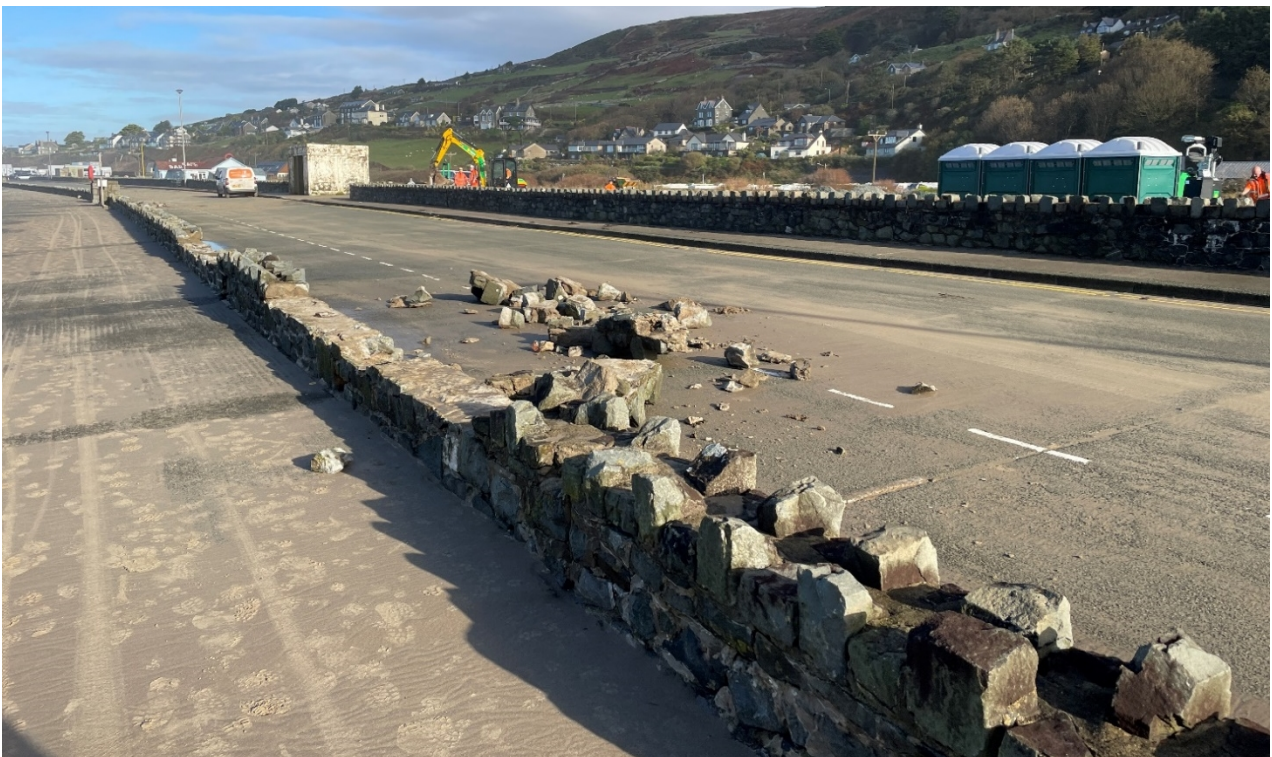
**Photograph 10 View north showing storm damage to the stone wall dividing the promenade and roadway**

- 4.10.41 Damage observed on the site visit undertaken in October 2024 included the collapse of part of the stone wall dividing the promenade from the roadway at the northern end of the site boundary.

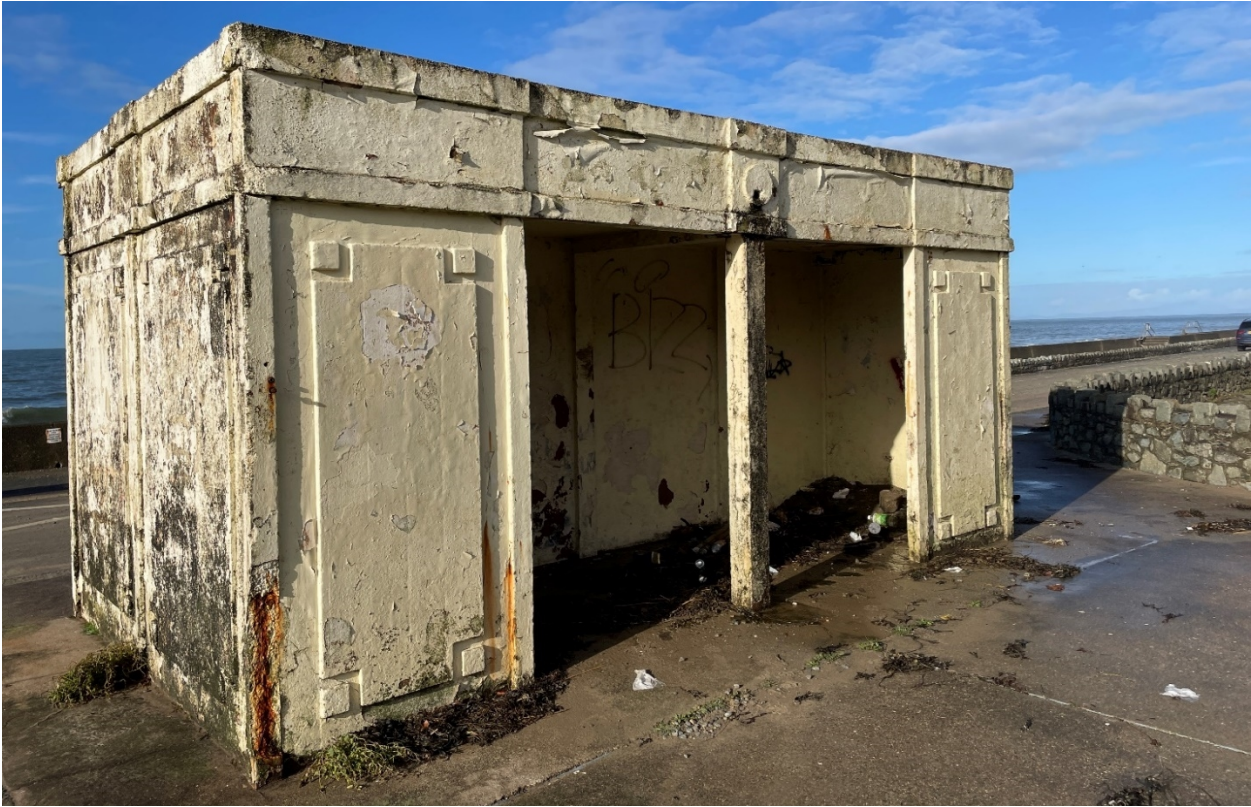
Photograph 11 View west of rear of rain shelter

- 4.12.1 A site visit and walkover survey was undertaken on 21st October 2024. The whole length of the promenade and roadway within the site boundary was walked along by day and at night. The beachfront within the site boundary was also visited, as were the conservation area and listed buildings within the study area. Photographs 1 through to 10 show the existing sea defences, which date from the 1930s through to the 1970s, while photographs 11 and 12 show the likely 1930s rain shelter.

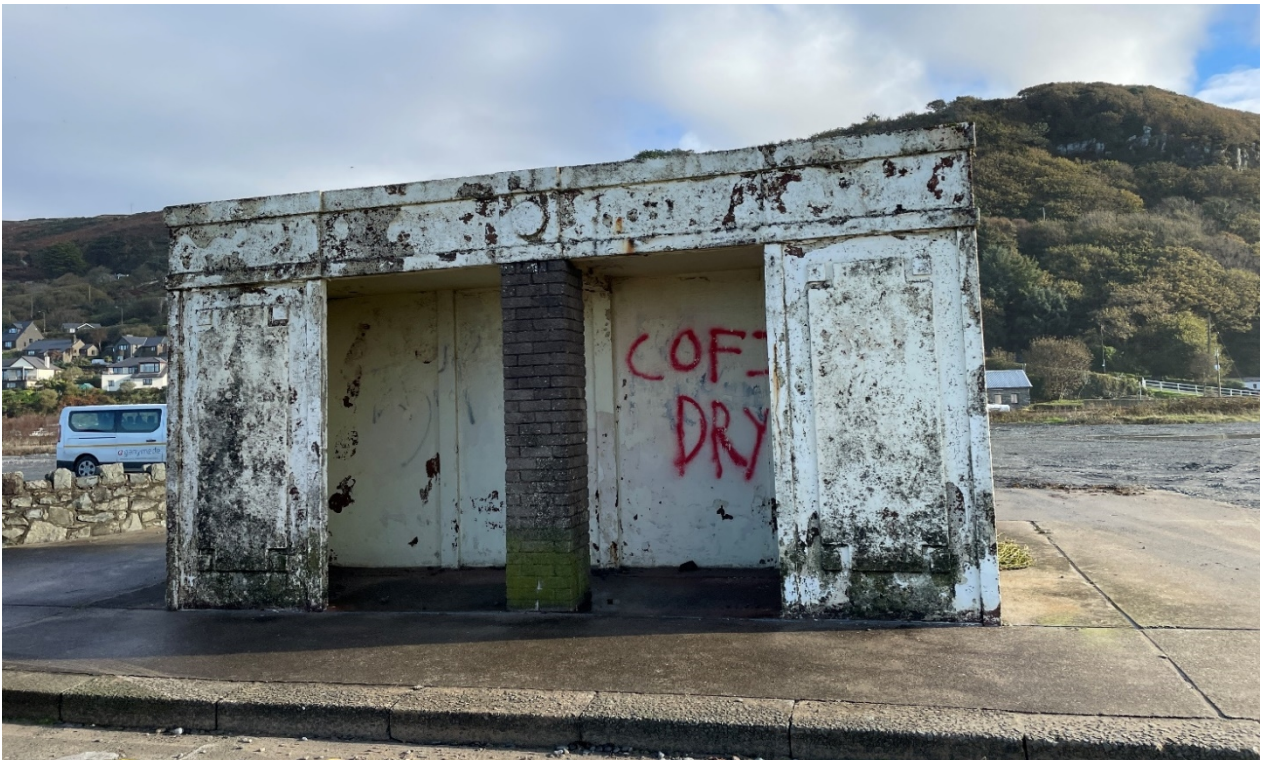
Photograph 12 View east of front of rain shelter
