GEOENVIRONMENTAL GROUND INVESTIGATION

Plot D The Airfields Deeside

4671-JPG-XX-XX-RP-G-0651-S2-P01

December 2022

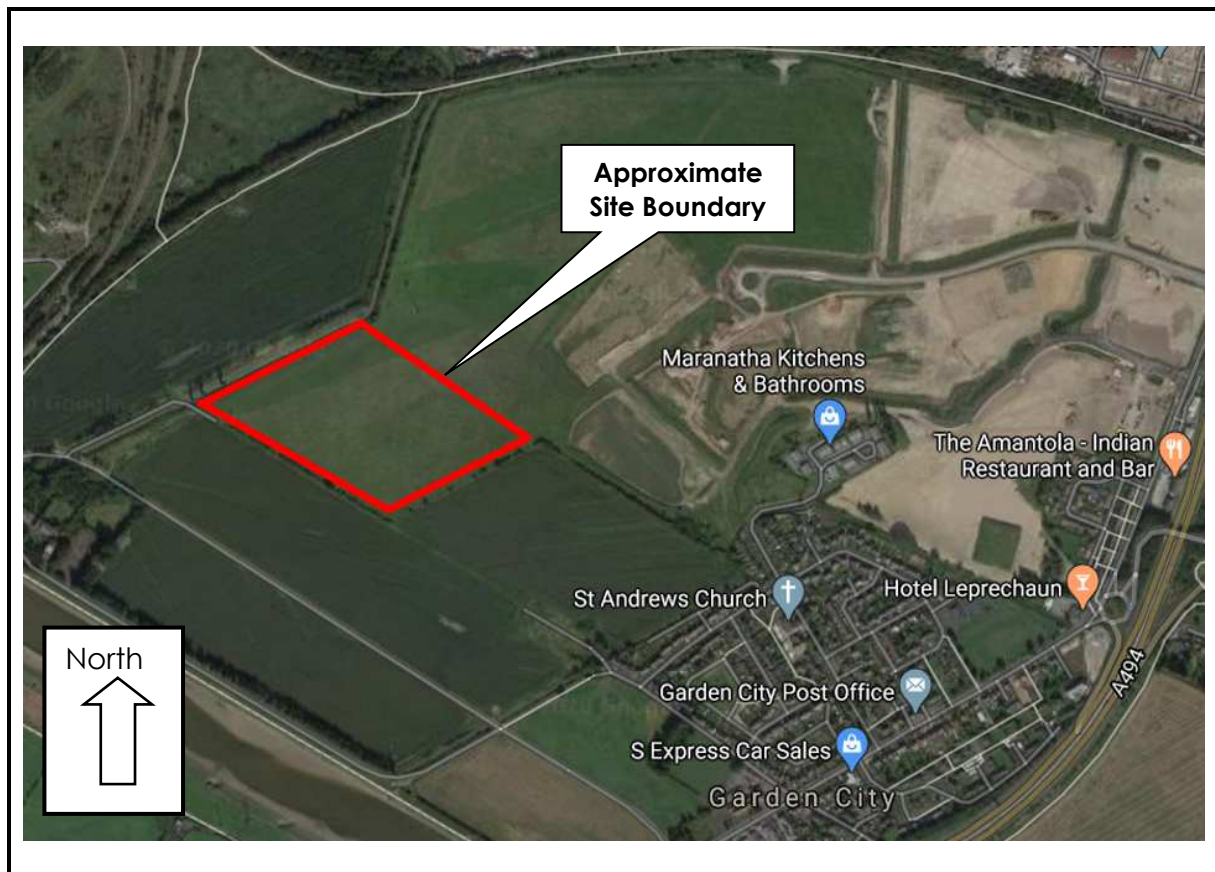
Figure 2 – Aerial Photograph

Site	Plot D, The Airfields, Deeside
Client	Commercial Development Projects Limited
Job Number	4671
Scale	NTS

An aerial photograph of the site is included as Figure 2 in Appendix A

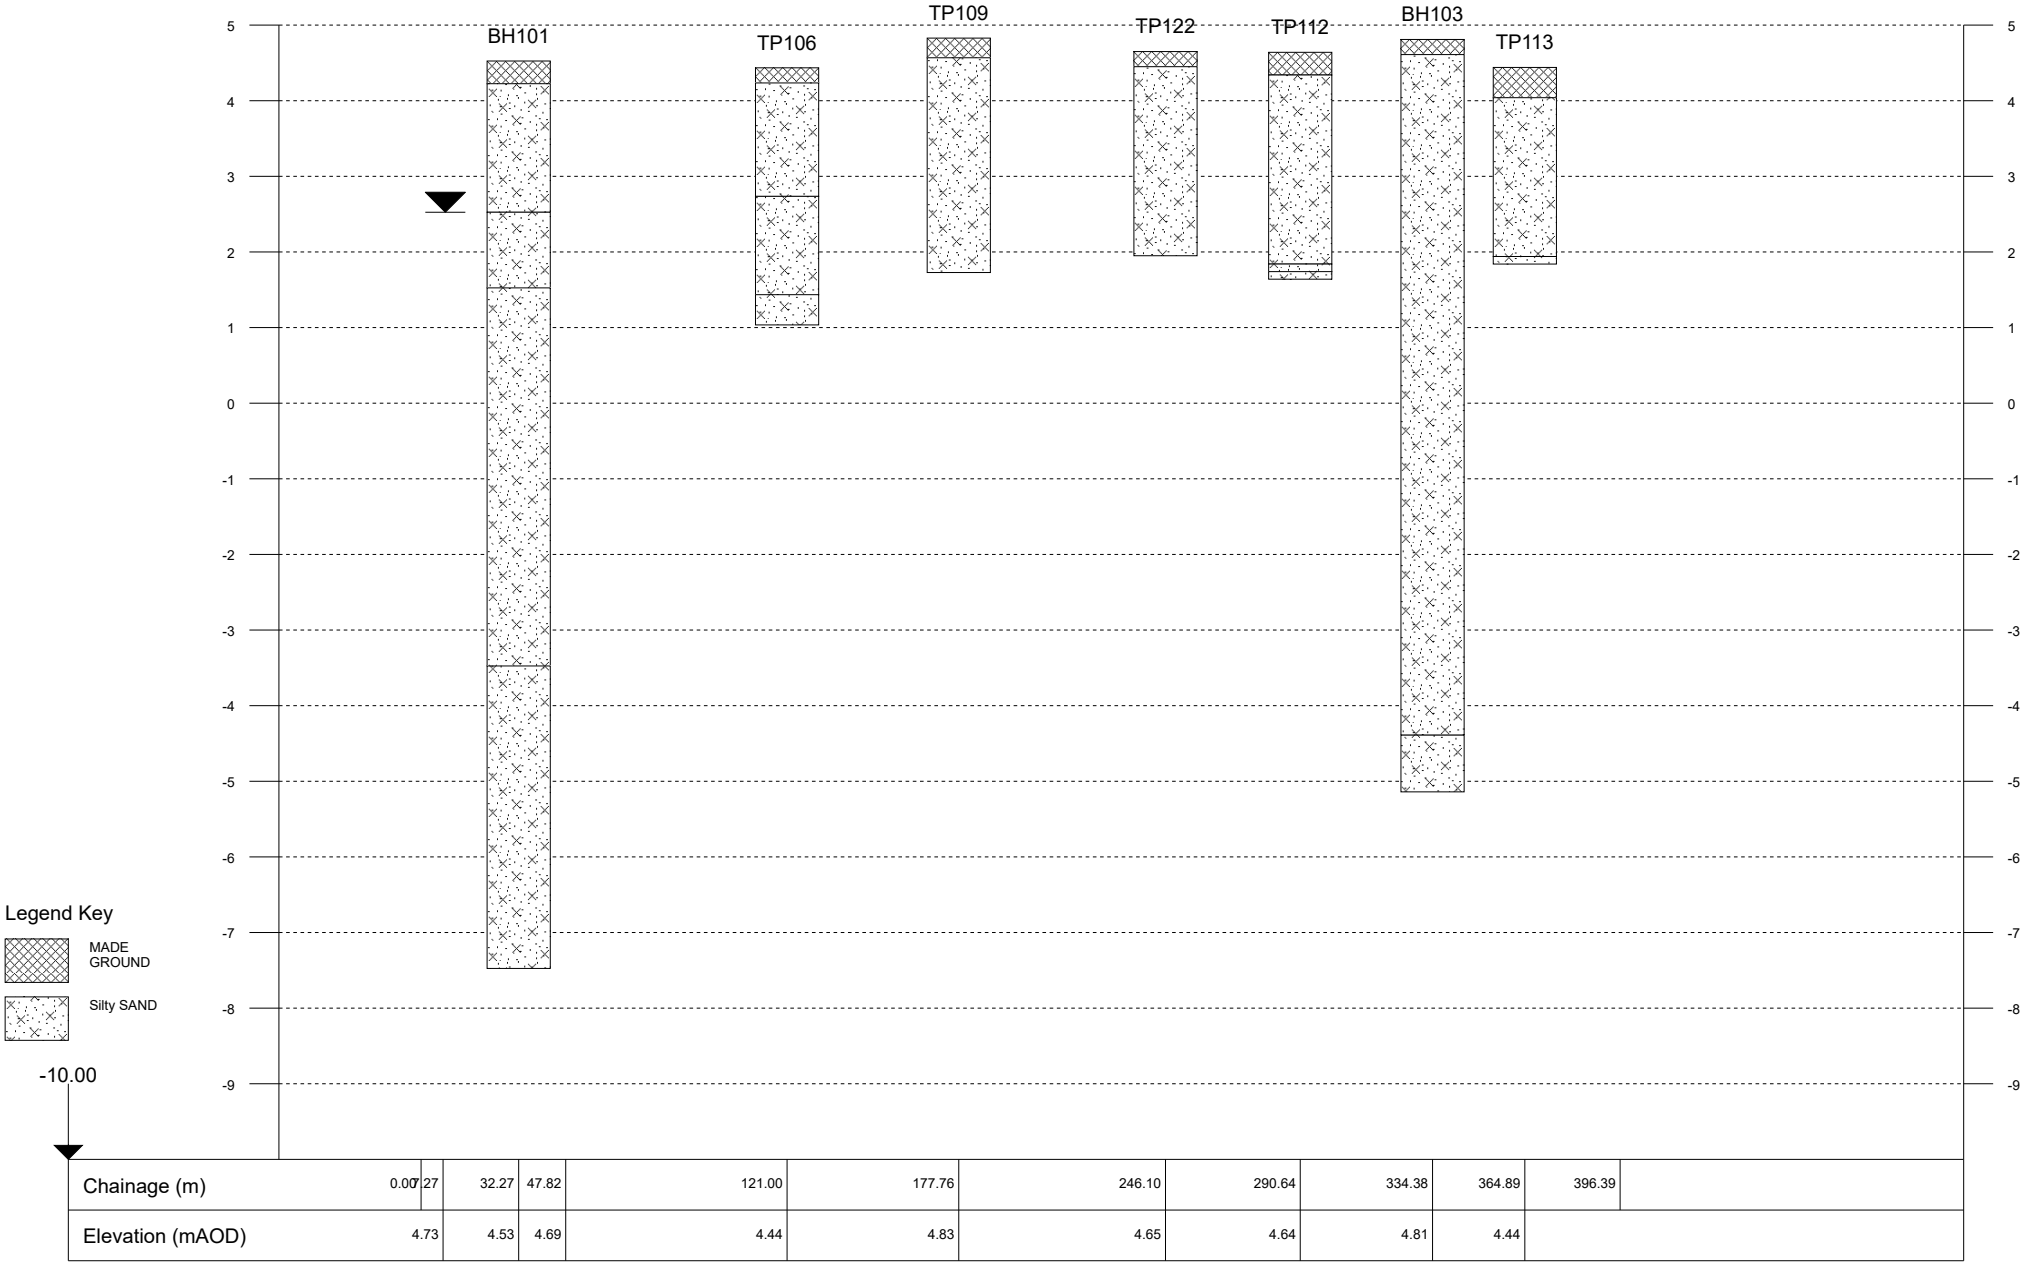
Title: Subsurface Section A-A'
Vertical Scale: 1:100
Horizontal Scale: 1:2500
Engineer: RDM

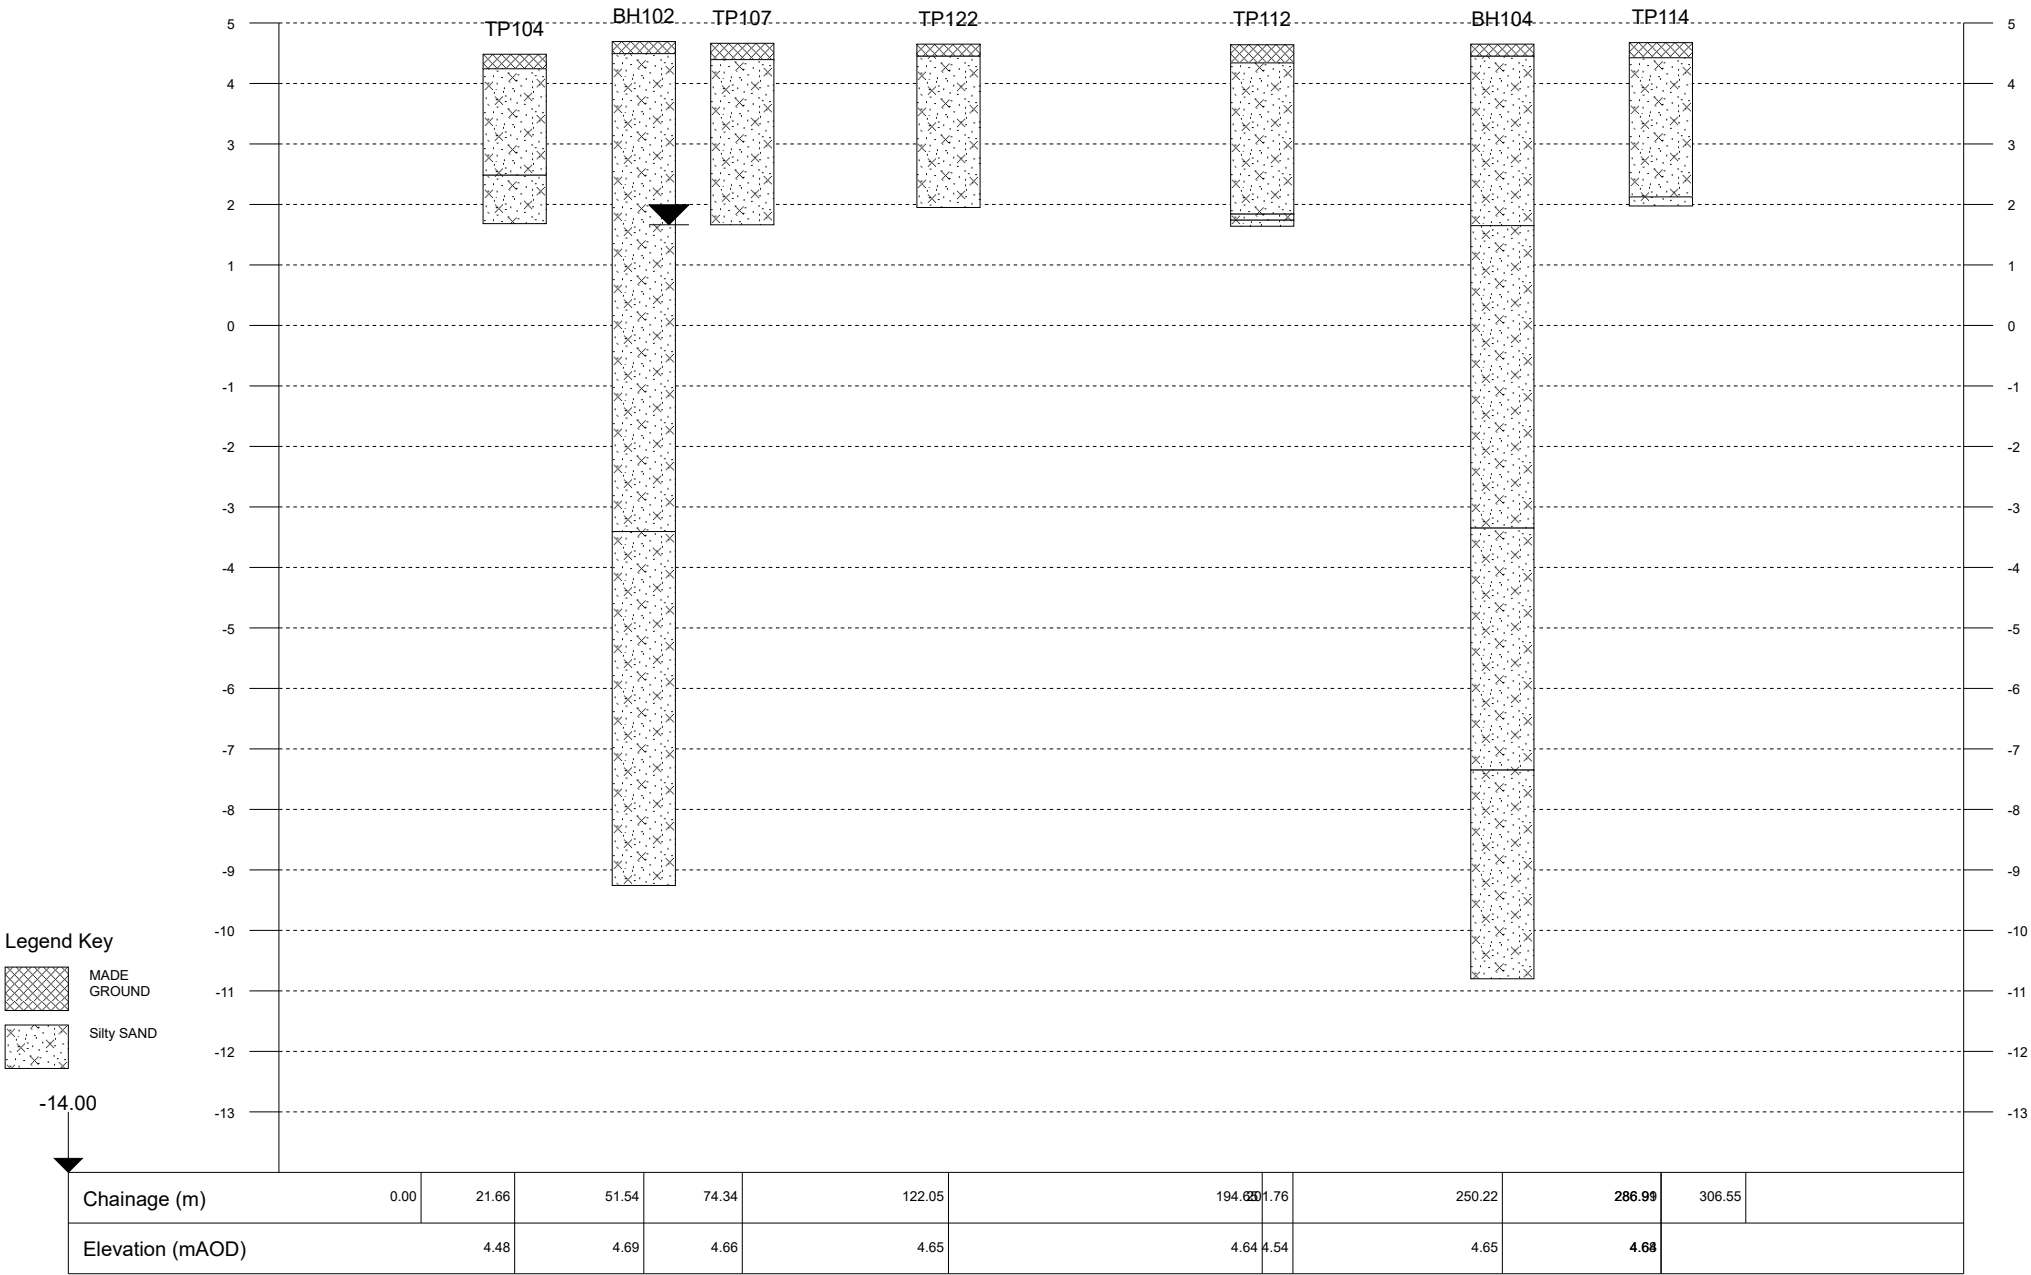
Title: Subsurface Section B-B'
Vertical Scale: 1:125
Horizontal Scale: 1:1750
Engineer: RDM

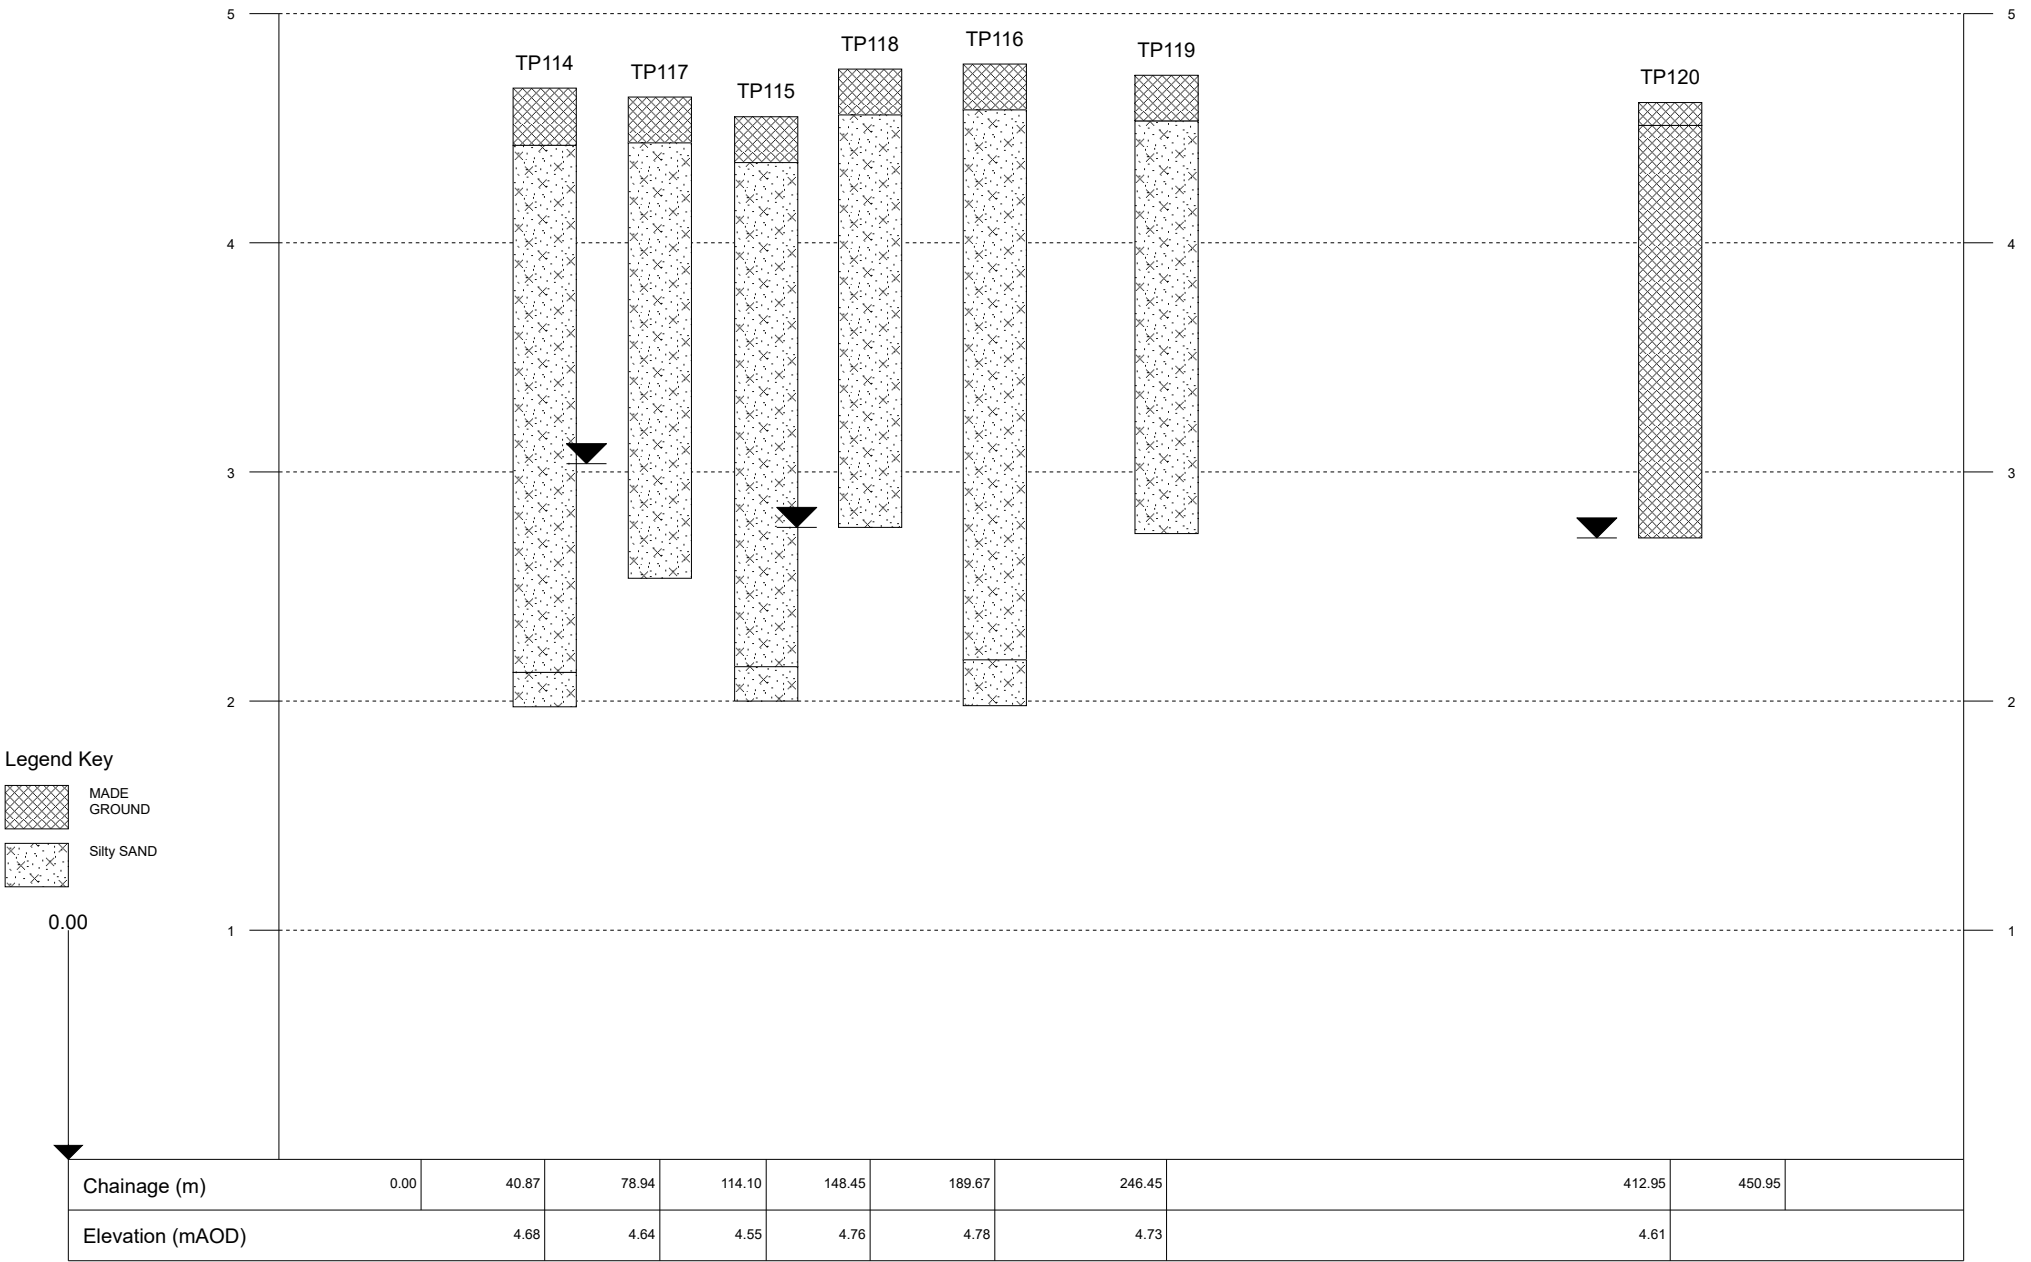
Title: Subsurface Section C-C'
Vertical Scale: 1:33
Horizontal Scale: 1:2500
Engineer: RDM

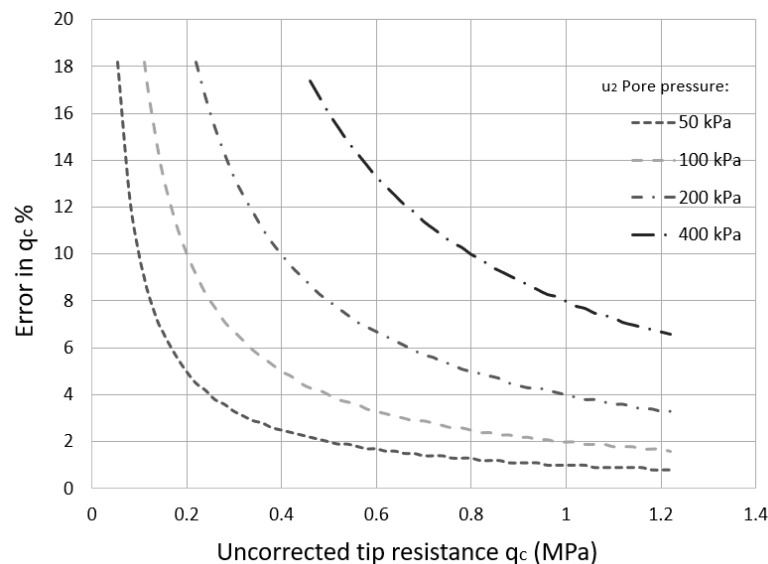
Where a is the 'area ratio' and $(1 - a)$ is the proportion of cross-sectional area between the cone tip and cone body where pore pressures (positive or negative) can act to add or subtract from the total external axial force on the tip. The difference between measured and corrected values is largest in low strength soils with large excess pore pressures. The percentage adjustment is described by the curves in the following chart for alpha factor of 0.8:

Figure 5-1 Uncorrected tip with measured tip resistance

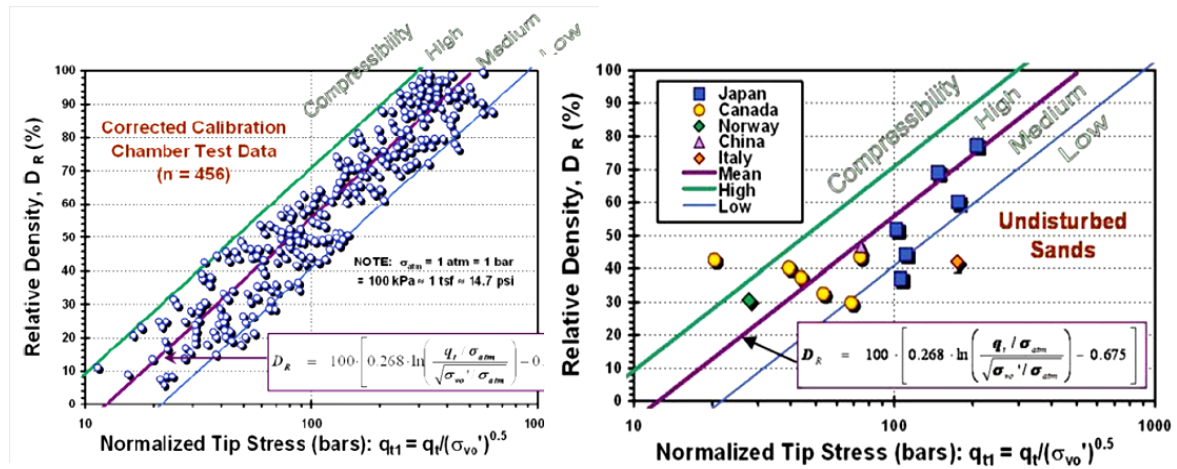
$$D_r = 100 \left[0.268 \cdot \ln \left(\frac{q_t / \sigma_{atm}}{\sqrt{\sigma_{vo}' / \sigma_{atm}}} \right) - k \right]$$

k = Compressibility dependant constant can be taken as -0.675 for medium compressibility (applied value in our interpretation), ≤ 1 for high compressibility and ≥ 2 for compressible sands.

Figure 5-2 Relative density with normalised tip stress and sand compressibility from calibration chamber tests (left) and undisturbed frozen samples (right). Jamiolkowski *et al.* (2001). Reproduced from Mayne (2007).

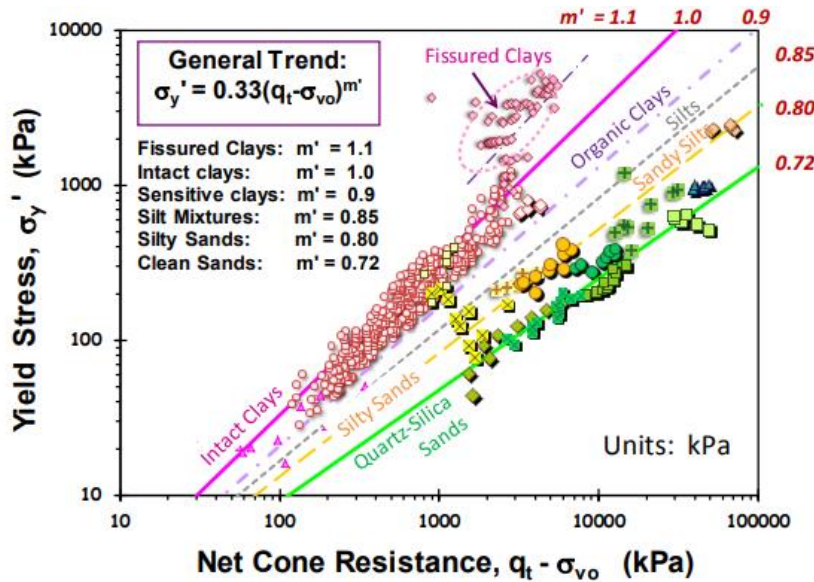
Mayne *et al* found that the trend with mean grain size followed a power law through the addition of exponent m' and that its value can be estimated by relation to soil behaviour type index I_c :

Figure 5-3 Preconsolidation stress with net cone resistance power law, reproduced from Mayne (2014).

An additional σ'_p and OCR was calculated for $m' = 1.1$ to reflect the upper trend for over consolidated fissured clays not captured by the soil behaviour type index I_c

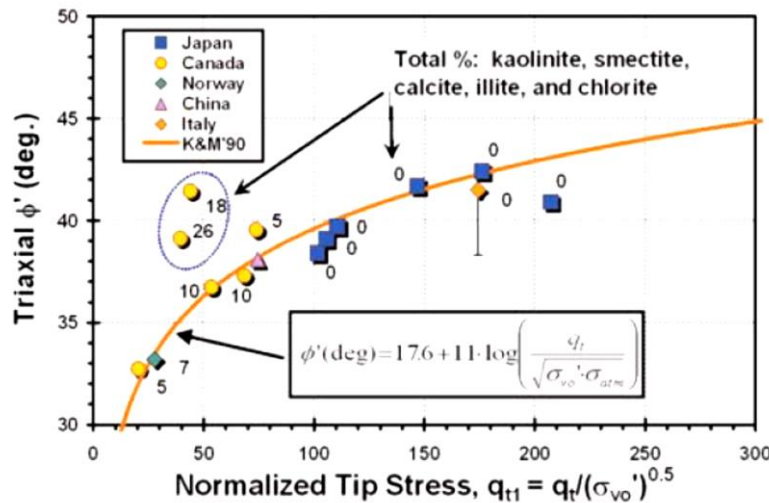
The presence of compressible minerals tends to reduce tip resistance resulting in lower estimate of friction angle, while very coarse (sand) or larger grain size tends to increase tip resistance resulting in higher estimate. High k_0 values will also result in an overestimate of friction angle.

Figure 5-4 Peak triaxial friction angle from undisturbed sands with normalised cone resistance.

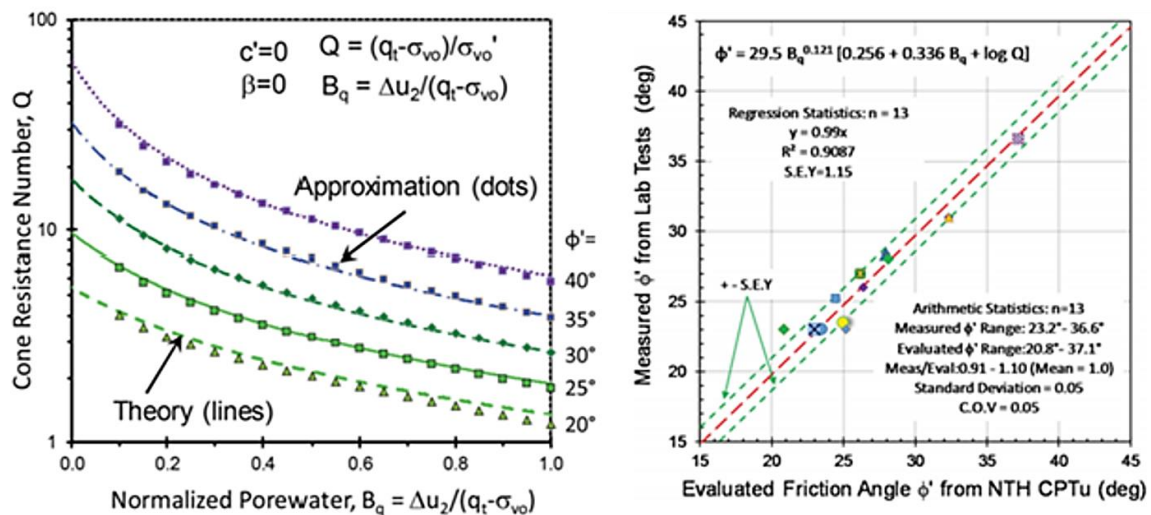
The effective friction angle for fine grained soils was calculated based on the Senneset *et al.* (1988, 1989) method by applying the approximate closed form solution by Mayne & Campanella (2005) as a direct function of the pore pressure parameter B_q and normalised tip resistance Q . The method is applicable where $0.1 < B_q < 1.0$ and $20^\circ < \phi' < 45^\circ$ and generally appropriate for non-cemented NC-LOC soils.

Figure 5-5 [Left] Theoretical curves with function approximation (dots) overlay [Right] calibration data from geotechnical centrifuge tests for a variety of soils. Redrawn from Ouyang & Mayne (2018).

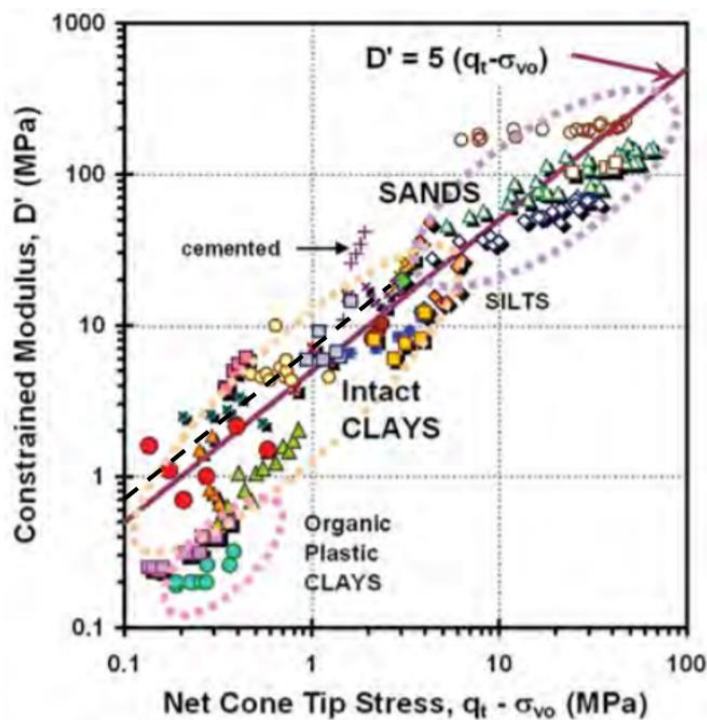
An alpha factor of 8.25 reported by Kulhawy & Mayne (1990) for fine grained soils appears to provide a better fit through the data for intact non-organic clays, reducing to around 1 to 2 for organic plastic clays.

Kulhawy & Mayne (1990) line
for inorganic clays; $8.25(q_t - \sigma_{v0})$

Figure 5-6 Constrained modulus of Mayne (2006). Annotated/redrawn from NCHRP Synthesis 368 (2007).

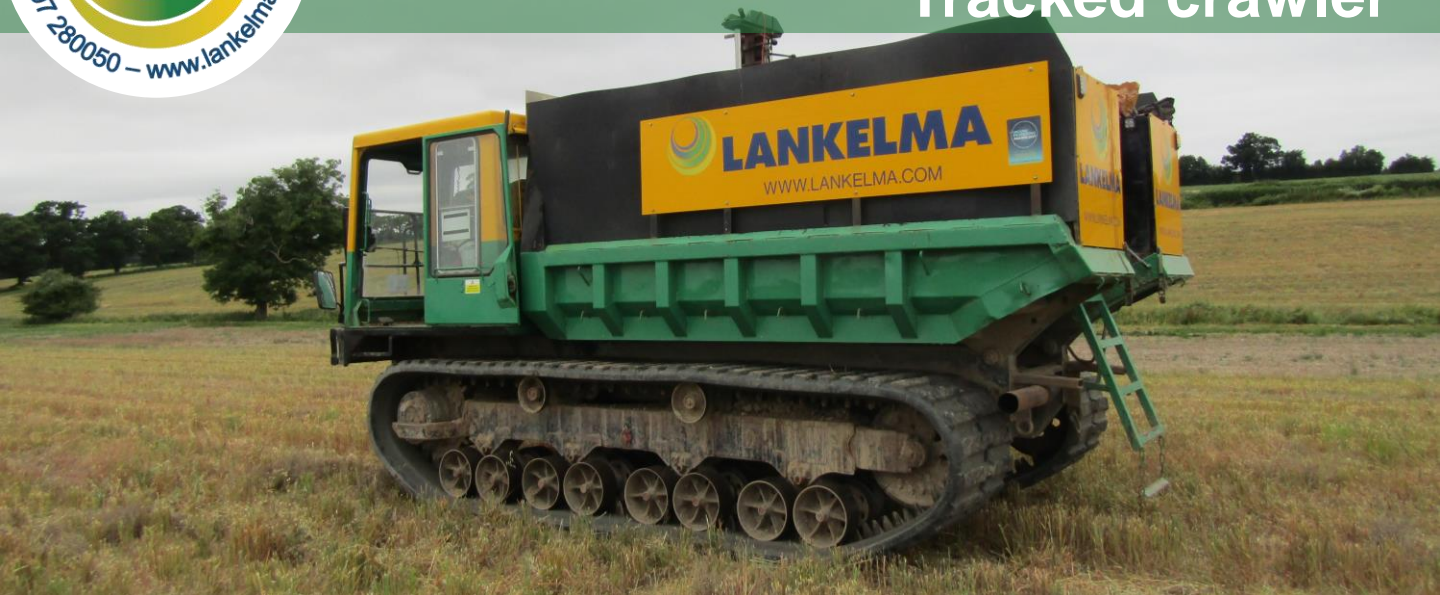
Tracked crawler

Rig weight	18.5 T
Max. operating ram capacity	15 T
Max. travelling speed	15 km/h
Track material	Rubber
Track length	3.40 m
Track width	0.75 m
Max. ground clearance on jacks	0.21 m
Max. ground bearing pressure	Tracking/pushing – 35 kPa Pulling – 63 kPa
Max. testing gradient	Flat – no self levelling
Max. traversing gradient	35 degrees (operator assessed)
Noise output at 2 m	Testing – 74 dBA Driving – 95 dBA
Clamp arrangement	36/55 push-pull clamp
Ram stroke	0.70 m
Max. casing size	55 mm
Fuel type	Biodegradable diesel
Typical production	100m+ of standard CPTu testing per day (depending on site conditions and access)

The low ground bearing pressures, large footprint and high ground clearance of our 'bogskipper' tracked crawler makes it perfect for working on sites with boggy or very soft ground conditions.

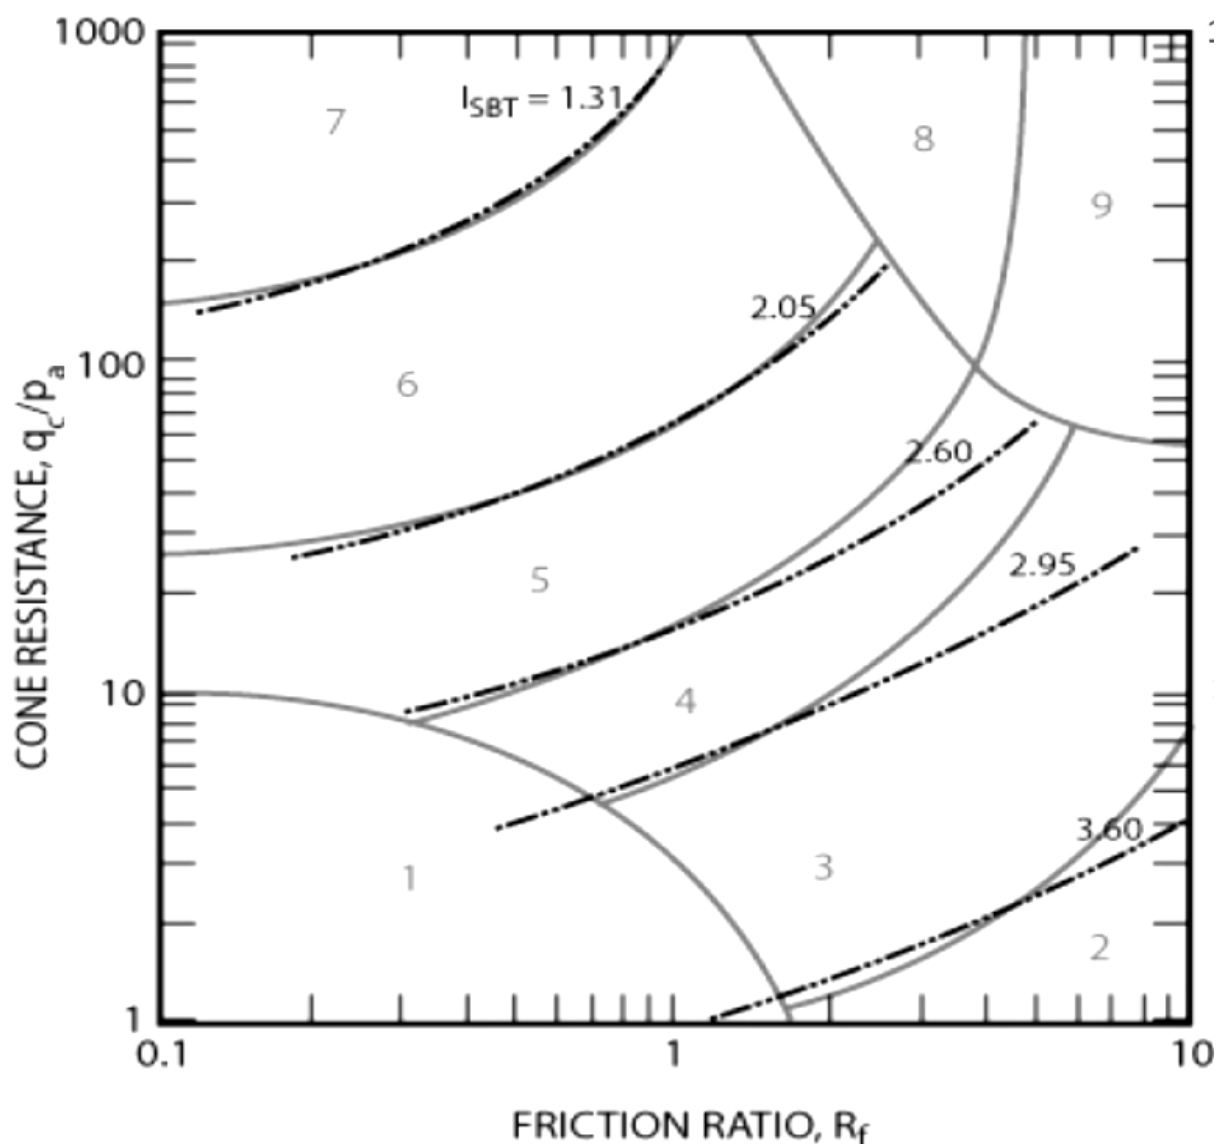
CPT SOIL BEHAVIOUR TYPE CHART

Non-normalised SBT chart by Robertson *et al.* (2010) based on dimensionless cone resistance (q_c/p_a) and friction ratio, R_f , showing contours of I_c index. The chart is also applicable to normalised tip/sleeve values Q_t and F_r .

Zone	Soil Behaviour Type (SBT)	
1	Sensitive fine-grained	6 Sands: clean sand to sandy silt
2	Clay – organic soil	7 Dense sand to gravelly sand
3	Clays: Clay to silty clay	8 Stiff sand to clayey sand*
4	Silt mixtures: clayey silt to silty clay	9 Stiff fine grained*
5	Sand mixtures: Silty sand to sandy silt	*Heavily overconsolidated or cemented

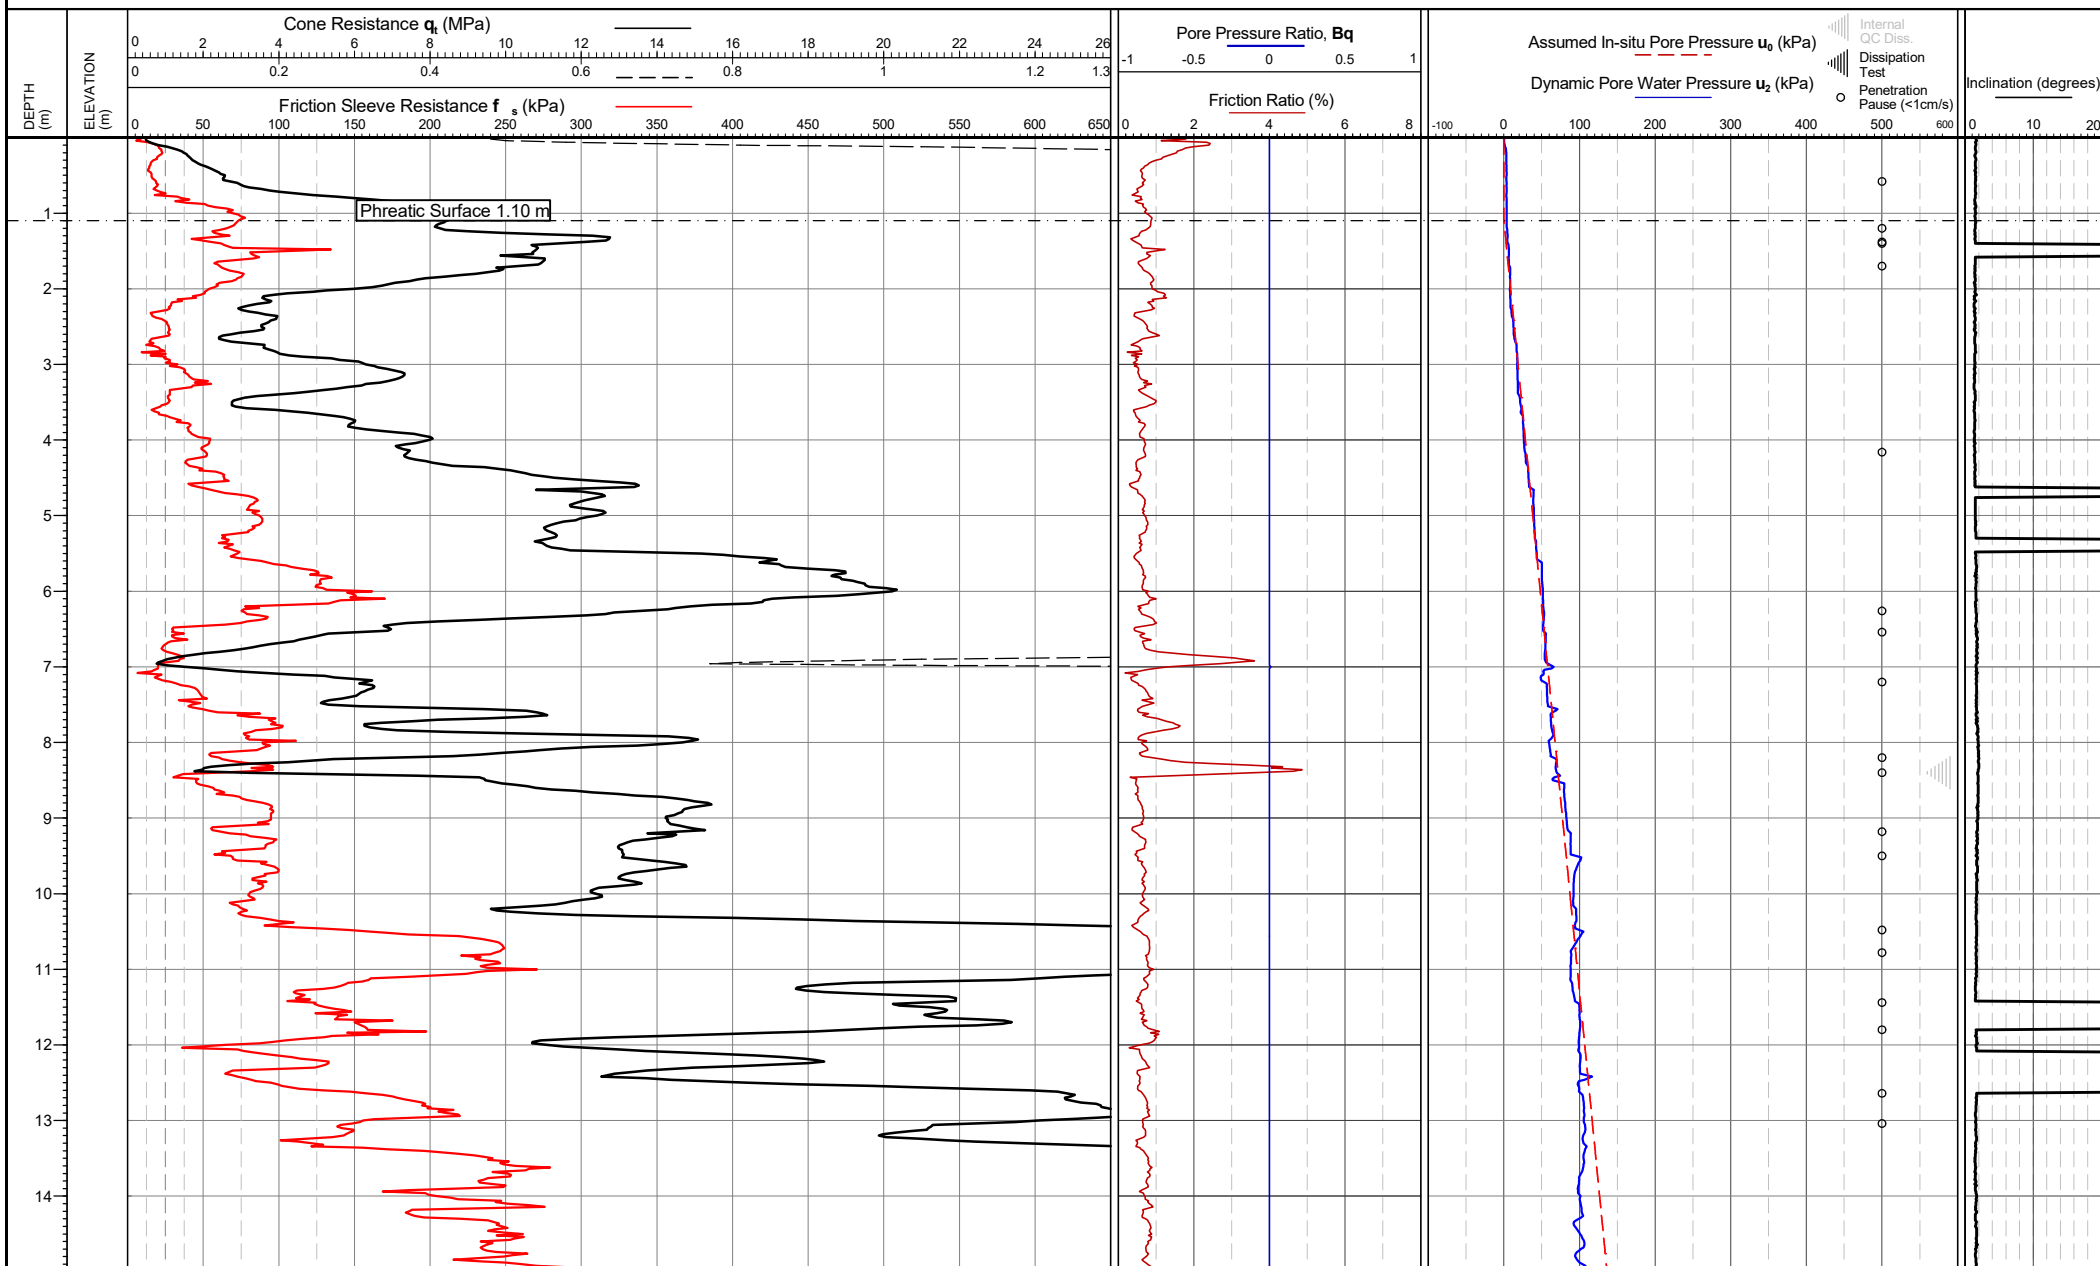
Cone area (mm²): 1500
Cone ID: S15-CFIP.1493
Operator: Jamie Butterworth
Rig Used: UK8
Date of test: 23/03/2020 11:10:00

Zero drift (Pre/post test)
 q_0 (kPa): 22.1
 f_0 (kPa): -0.8 ($f_{s, drift} - q_{c, drift}$)
 u_2 (kPa): 2.6

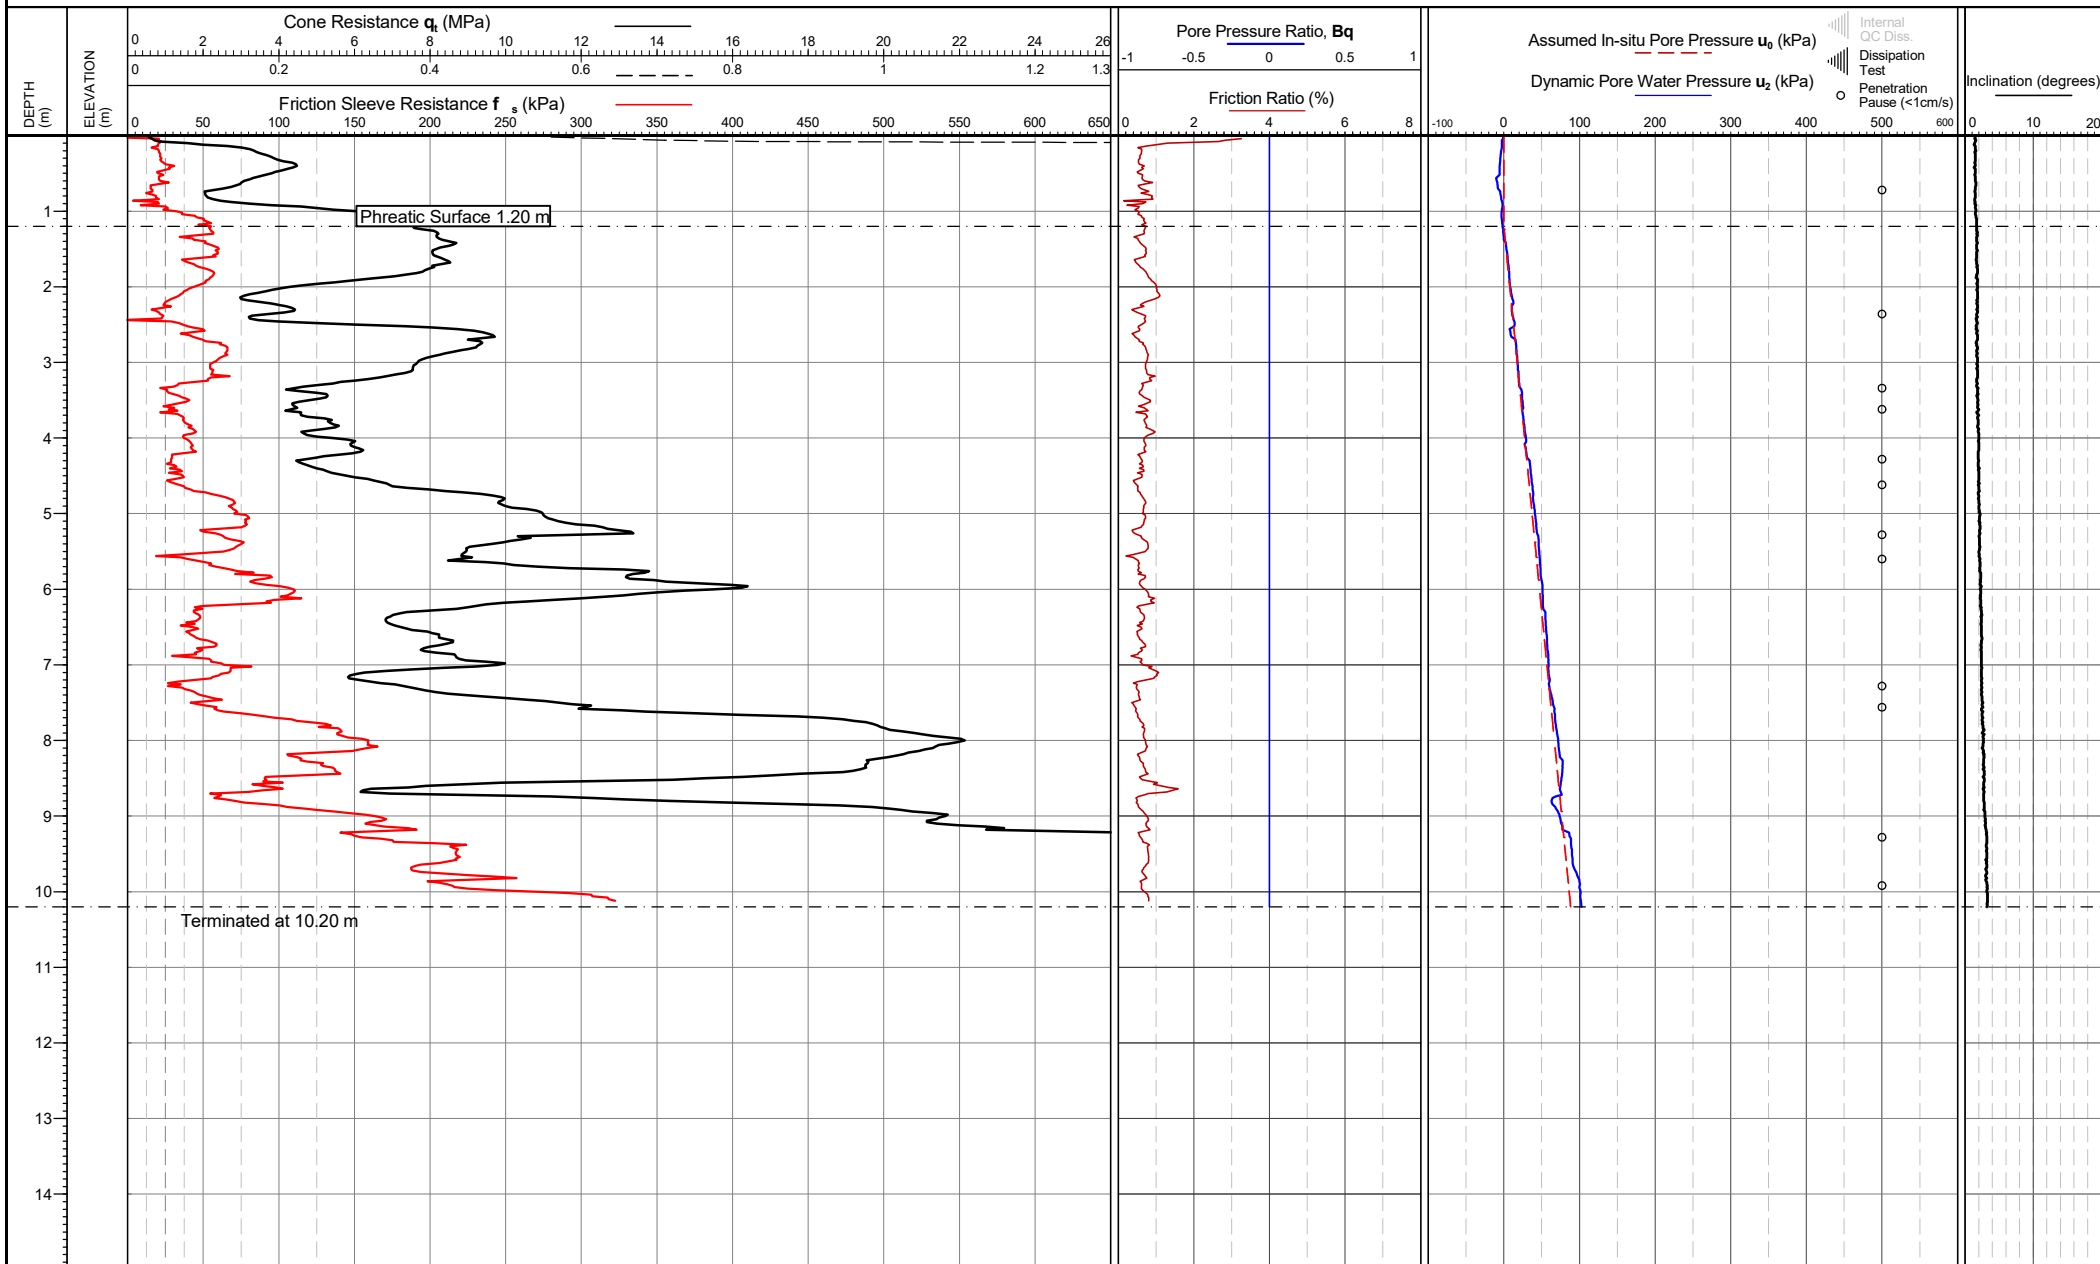
Cone area (mm²): 1500
Cone ID: S15-CFIP.1493
Operator: Jamie Butterworth
Rig Used: UK8
Date of test: 23/03/2020 12:15:00

Zero drift (Pre/post test)
 q_0 (kPa): 11.1
 f_0 (kPa): -2.9 ($f_{s, drift} - q_{0, drift}$)
 U_2 (kPa): 0.5

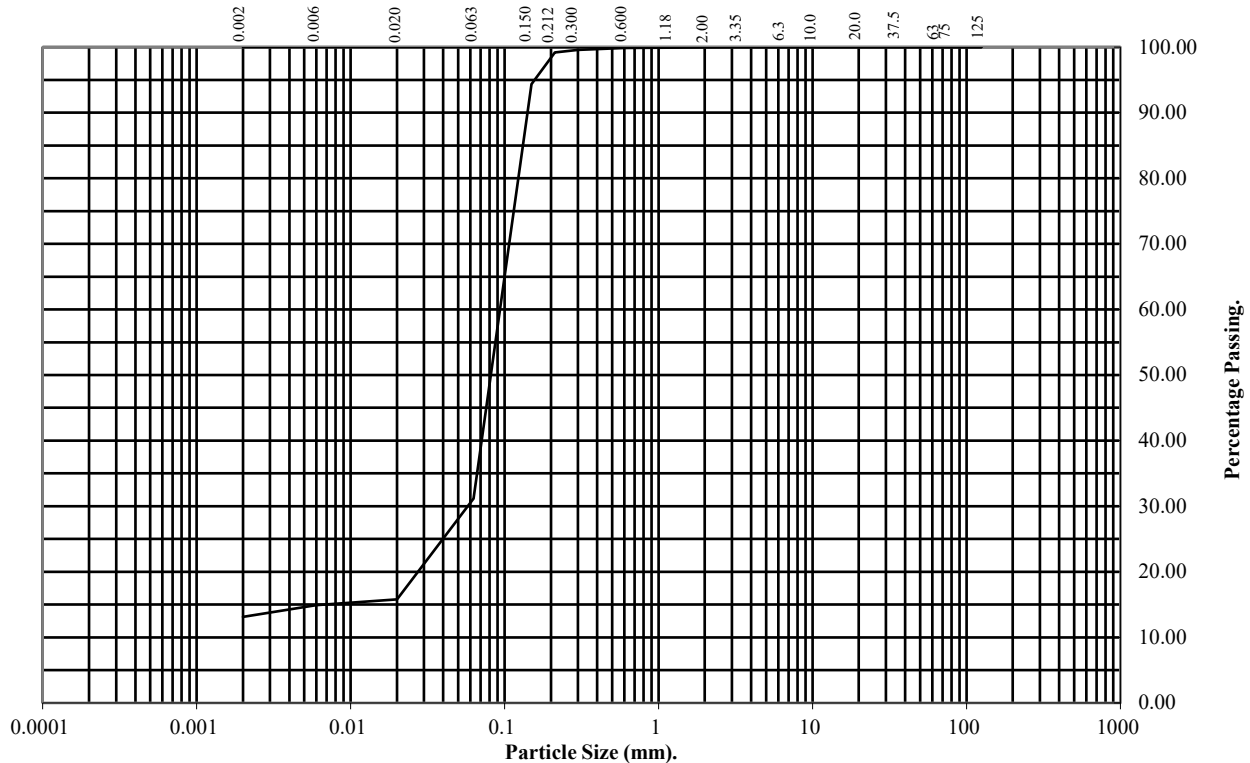
Sample Number: 1 Base Depth(m):

BS Test Sieve (mm)	Percentage Passing
125	100
75	100
63	100
37.5	100
20	100
10	100
6.3	100
3.35	100
2	100
1.18	100
0.6	100
0.3	100
0.212	99
0.15	94
0.063	31

Particle Diameter	Percentage Passing
0.02	16
0.006	15
0.002	13

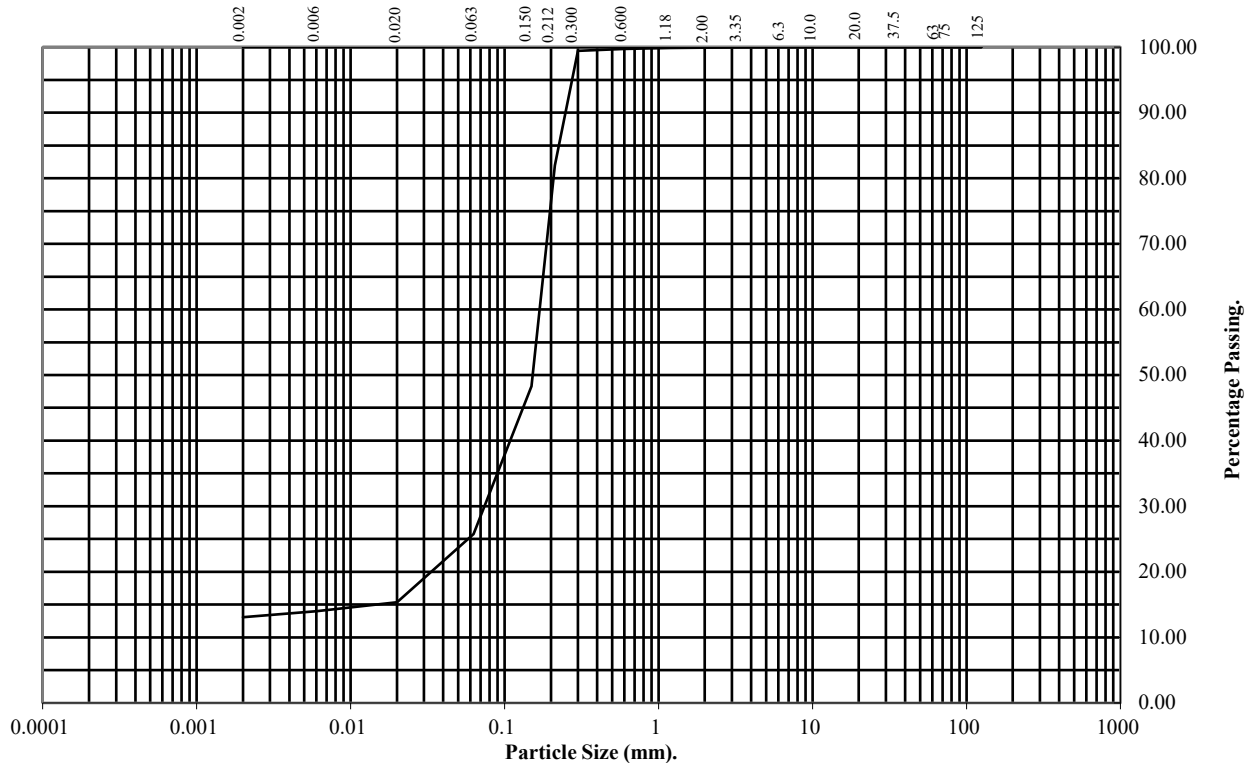
Sample Number: 4 Base Depth(m):

BS Test Sieve (mm)	Percentage Passing
125	100
75	100
63	100
37.5	100
20	100
10	100
6.3	100
3.35	100
2	100
1.18	100
0.6	100
0.3	99
0.212	82
0.15	48
0.063	26

Particle Diameter	Percentage Passing
0.02	15
0.006	14
0.002	13
