GEOENVIRONMENTAL GROUND INVESTIGATION

Plot D The Airfields Deeside

4671-JPG-XX-XX-RP-G-0651-S2-P01

December 2022

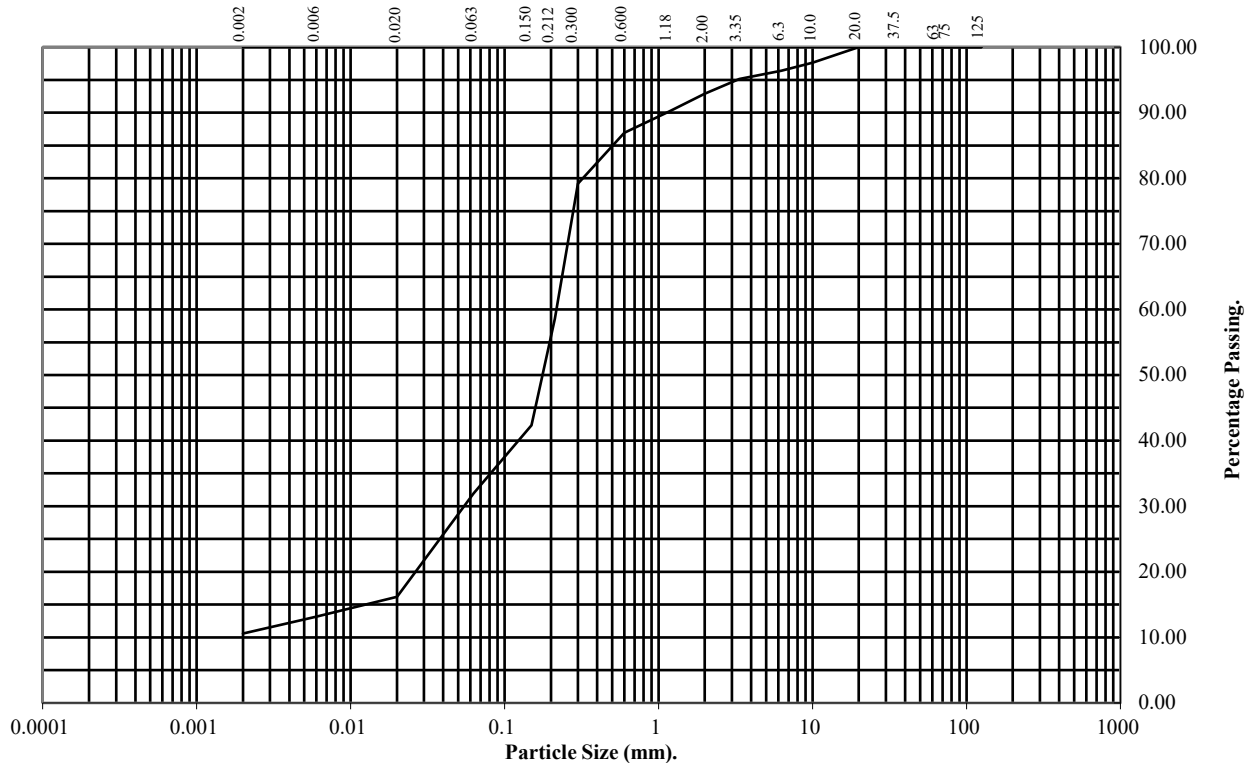
Sample Number: 7 Base Depth(m): 0.50

BS Test Sieve (mm)	Percentage Passing
125	100
75	100
63	100
37.5	100
20	100
10	98
6.3	96
3.35	95
2	93
1.18	90
0.6	87
0.3	79
0.212	59
0.15	42
0.063	32

Particle Diameter	Percentage Passing
0.02	16
0.006	13
0.002	11

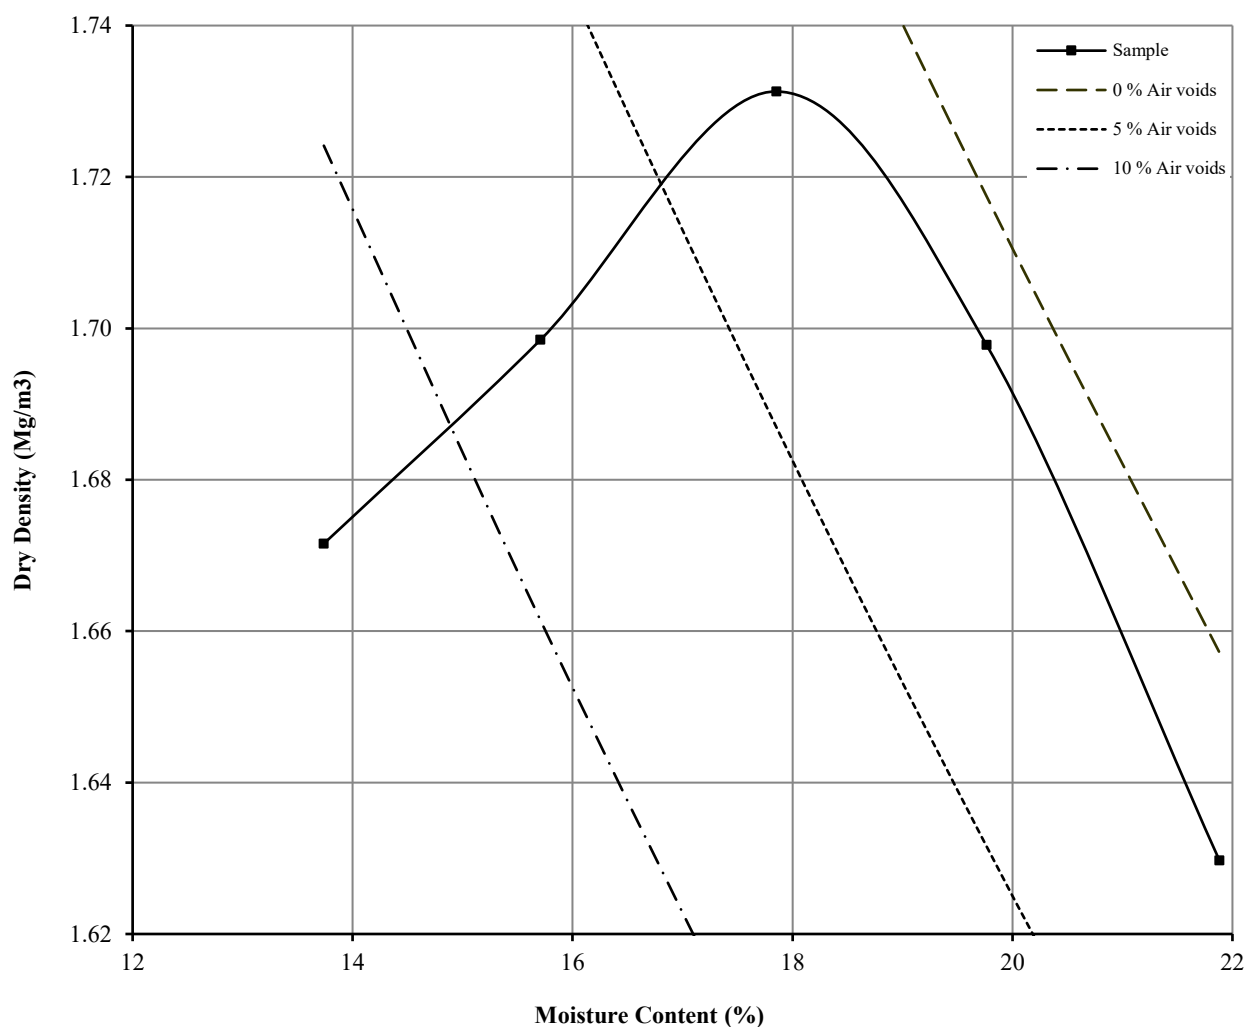
Initial Moisture Content:	26	Method of Compaction:	2.5kg	Separate Samples
Particle Density (Mg/m ³):	2.60	Measured	Material Retained on 37.5 mm Test Sieve (%):	0
Maximum Dry Density (Mg/m ³):	1.73		Material Retained on 20.0 mm Test Sieve (%):	0
Optimum Moisture Content (%):	18			
Remarks				
See summary of soil descriptions.

One sample of natural ground was submitted for dry density/moisture content relationship testing using both a 2.5kg and 4.5kg rammer to assess its suitability for re-use in earthworks. The results are summarised in Table 4.6.3.

Based on the results of the compaction test and the moisture contents of similar samples (22% to 25%), the granular drift deposits are considered too wet to achieve suitable compaction.

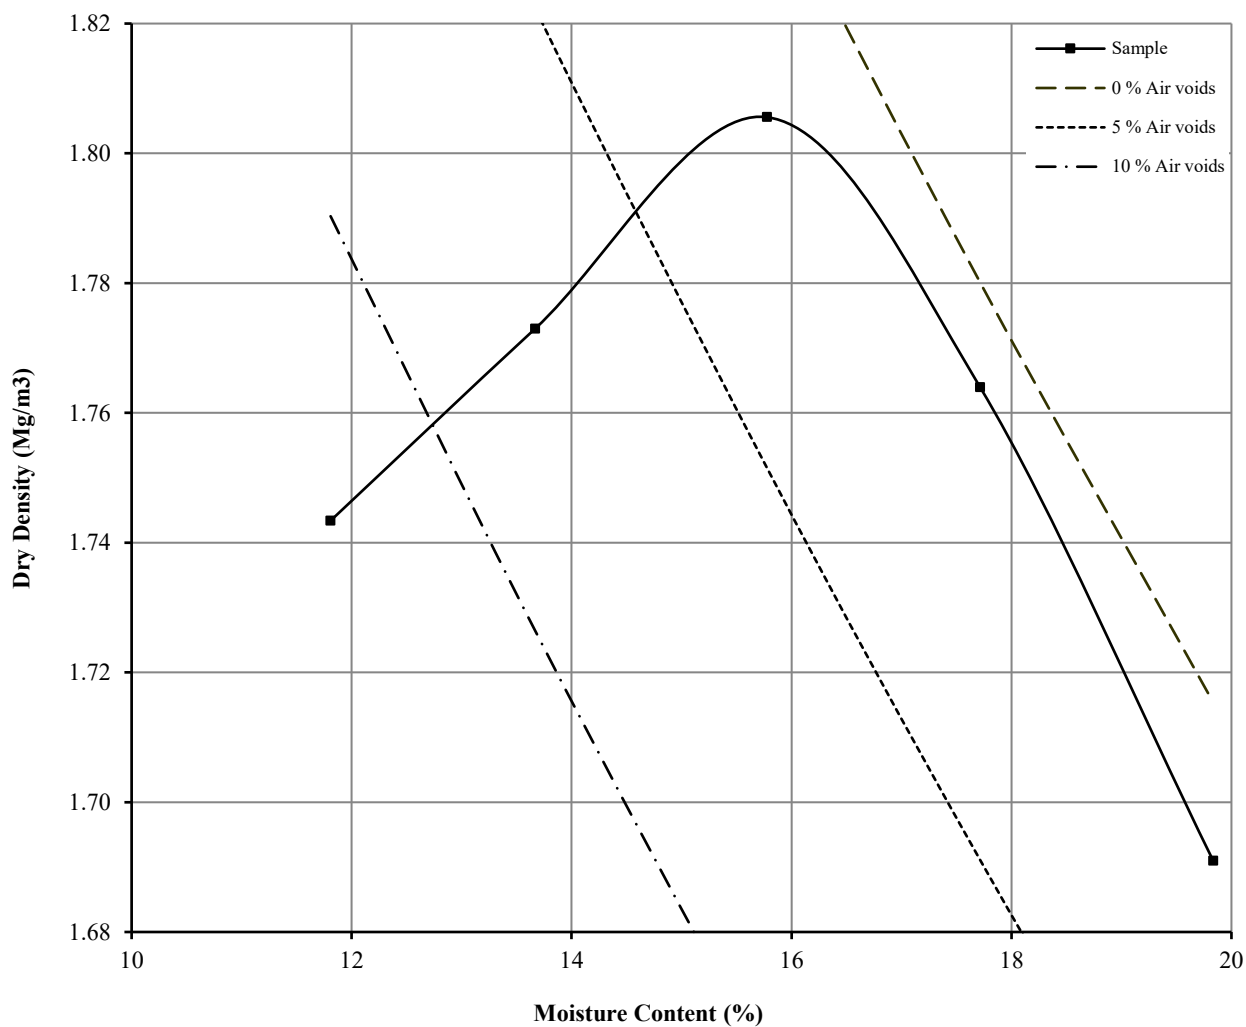
Initial Moisture Content:	26	Method of Compaction:	4.5kg	Separate Samples
Particle Density (Mg/m ³):	2.60	Measured	Material Retained on 37.5 mm Test Sieve (%):	0
Maximum Dry Density (Mg/m ³):	1.81		Material Retained on 20.0 mm Test Sieve (%):	0
Optimum Moisture Content (%):	16			
Remarks				
See summary of soil descriptions.

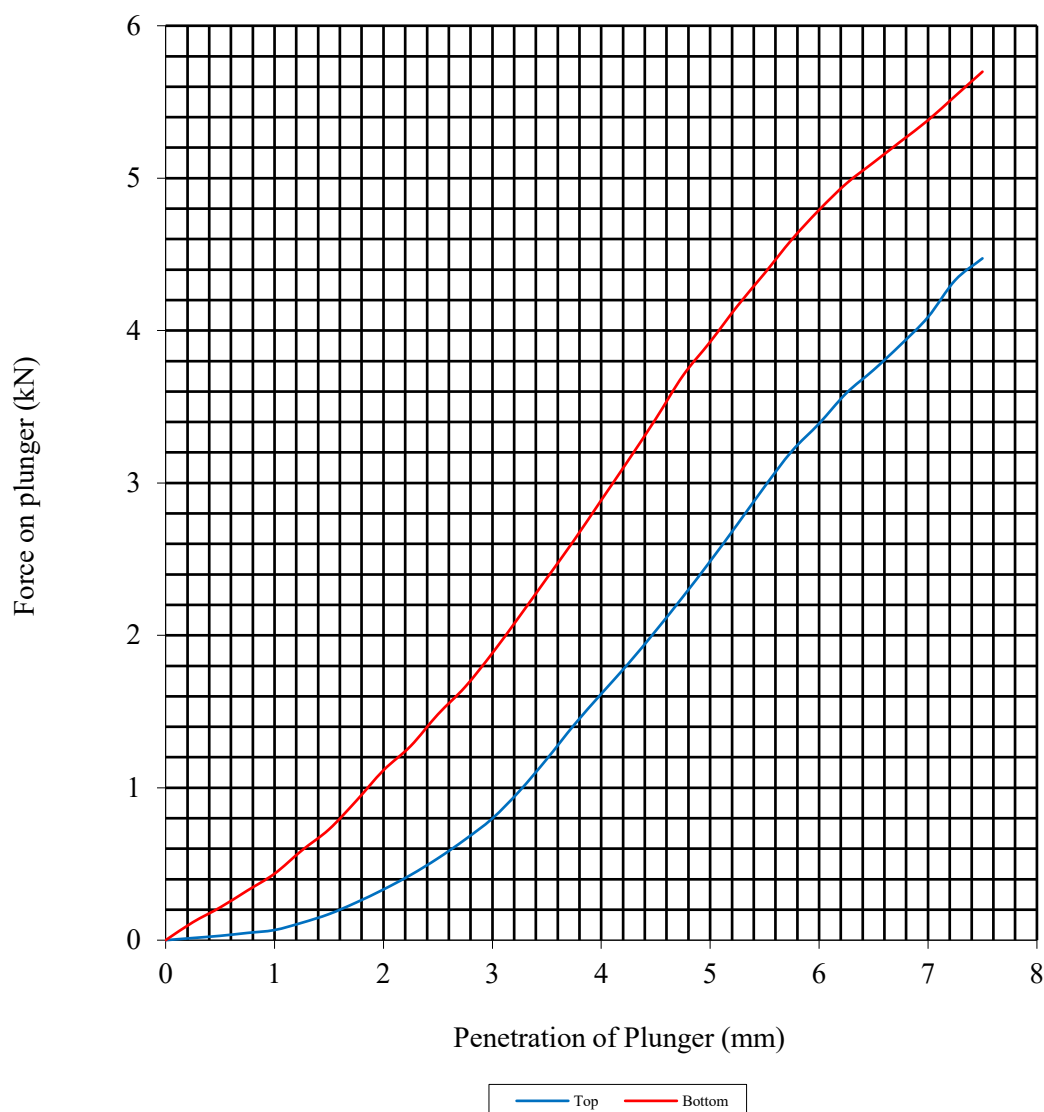
Initial Sample Conditions		Sample Preparation		Final Moisture Content %		C.B.R. Value %	
Moisture Content:	22	Surcharge Kg:	4.20	Sample Top	22	Sample Top	12.4
Bulk Density Mg/m3:	1.88	Soaking Time hrs	0	Sample Bottom	22	Sample Bottom	19.6
Dry Density Mg/m3:	1.54	Swelling mm:	0	Remarks : See Summary of Soil Descriptions.			
Percentage retained on 20mm BS test sieve:			0				
Compaction Conditions		2.5kg

Remoulded California Bearing Ratio (CBR) tests were carried out on two samples of natural ground and one sample of made ground at their as received moisture contents using the 2.5kg rammer. The results are summarised in Table 4.6.4 below.

Sample	Material	As Received Moisture Content (%)	CBR Value (%)		Average* (%)
			Sample Top	Sample Bottom	
TP108 1.25m	Light brown and brown slightly silty SAND with occasional gravel sized shells/shell fragments.	22	12.4	19.6	-
TP117 0.2-0.5m	Light brown silty SAND with abundant shells.	24	5.4	7.6	-
TP120 0.1-0.5m	MADE GROUND: Light brown slightly gravelly silty SAND with medium cobble and low boulders content	20	25.8	28	26.9

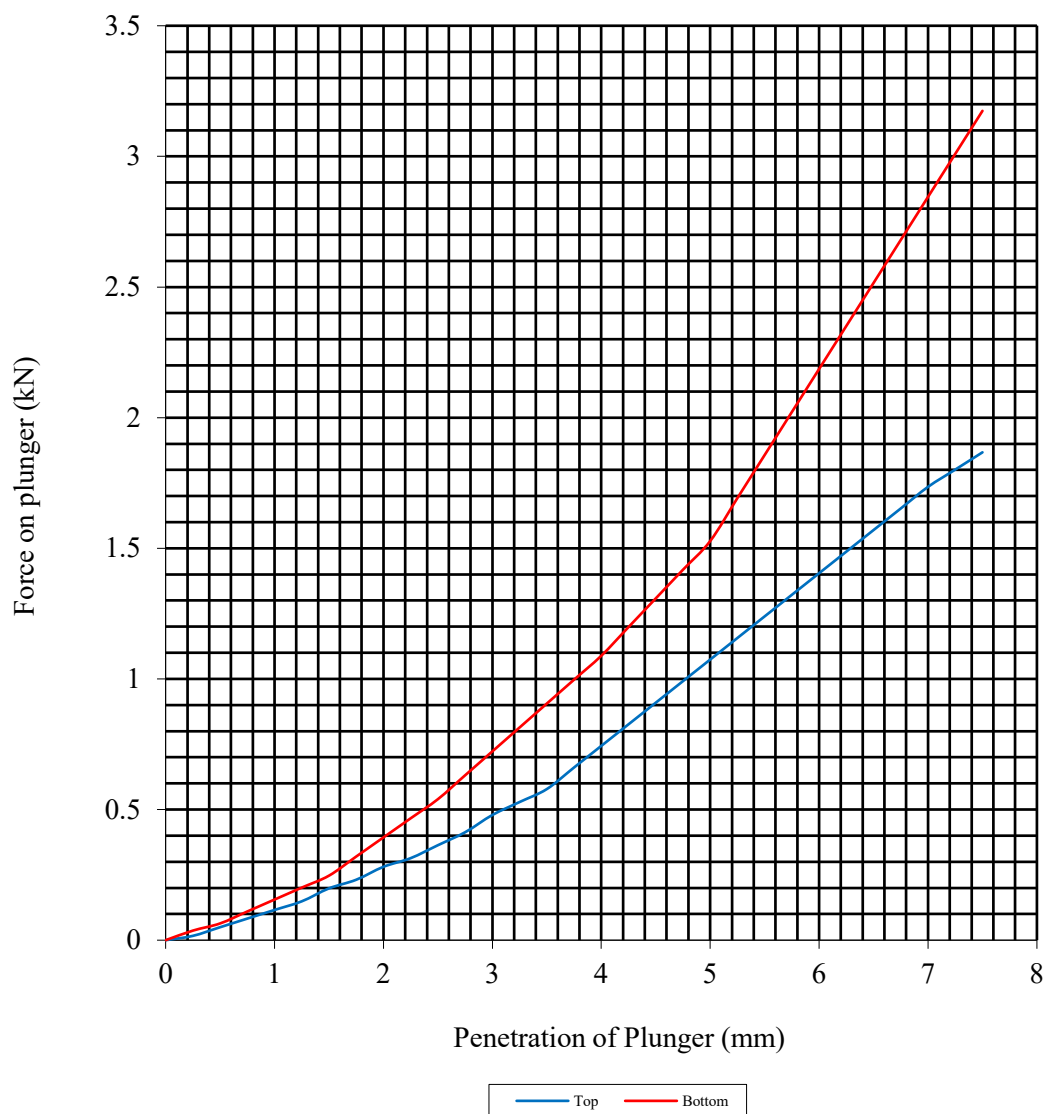
Initial Sample Conditions		Sample Preparation		Final Moisture Content %		C.B.R. Value %	
Moisture Content:	24	Surcharge Kg:	4.20	Sample Top	24	Sample Top	5.4
Bulk Density Mg/m3:	1.87	Soaking Time hrs	0	Sample Bottom	24	Sample Bottom	7.6
Dry Density Mg/m3:	1.51	Swelling mm:	0	Remarks : See Summary of Soil Descriptions.			
Percentage retained on 20mm BS test sieve:		0					
Compaction Conditions		2.5kg

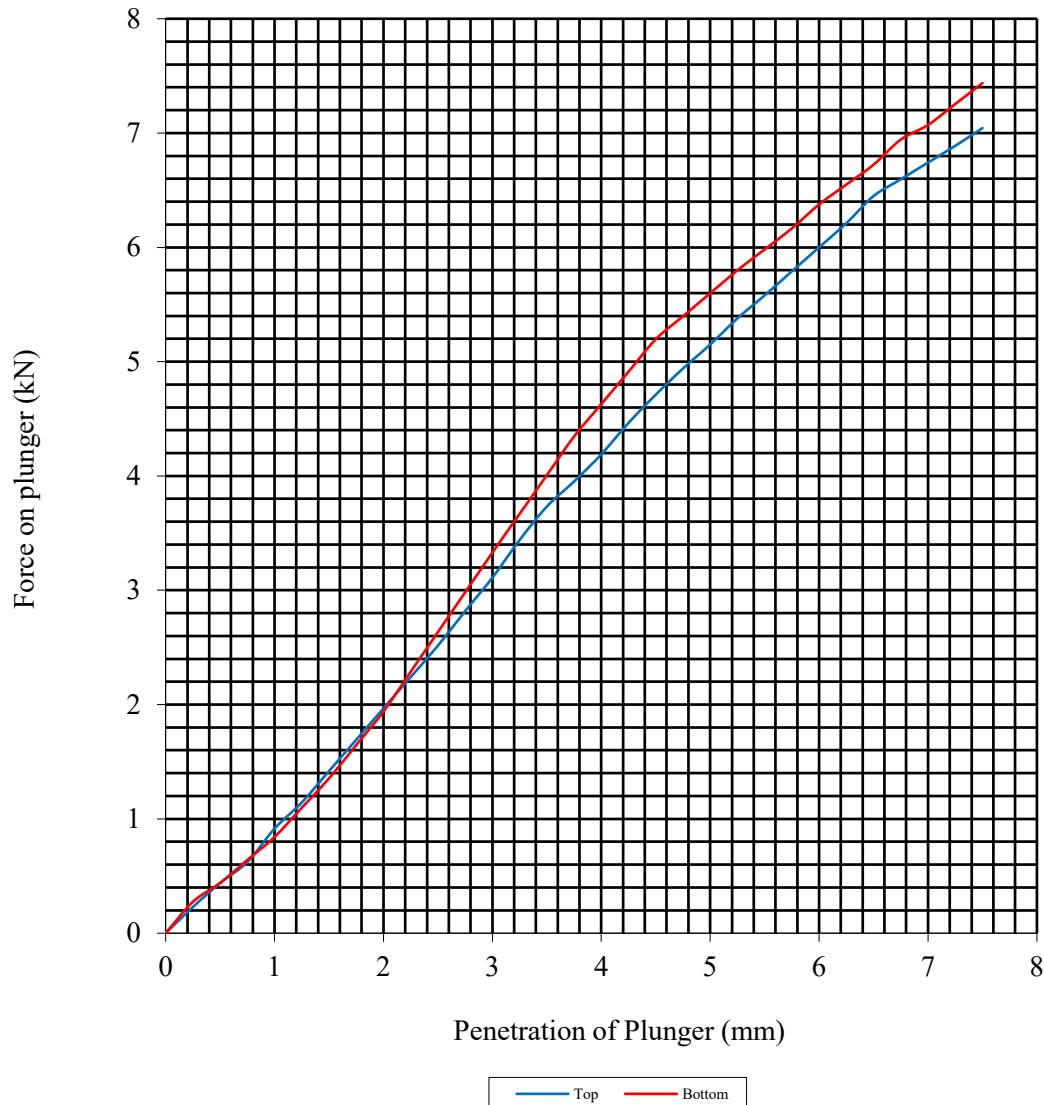
Initial Sample Conditions		Sample Preparation		Final Moisture Content %		C.B.R. Value %	
Moisture Content:	20	Surcharge Kg:	4.20	Sample Top	20	Sample Top	25.8
Bulk Density Mg/m ³ :	1.89	Soaking Time hrs	0	Sample Bottom	20	Sample Bottom	28.0
Dry Density Mg/m ³ :	1.57	Swelling mm:	0	Remarks : See Summary of Soil Descriptions.			
Percentage retained on 20mm BS test sieve:			0				
Compaction Conditions		2.5kg
