Compliance Assessment Report CAR_NRW0046445

Permit being assessed: JP3894FM.

For: The Windmill Site, **held by:** Thorncliffe Building Supplies Ltd

Type of assessment: Site Inspection,

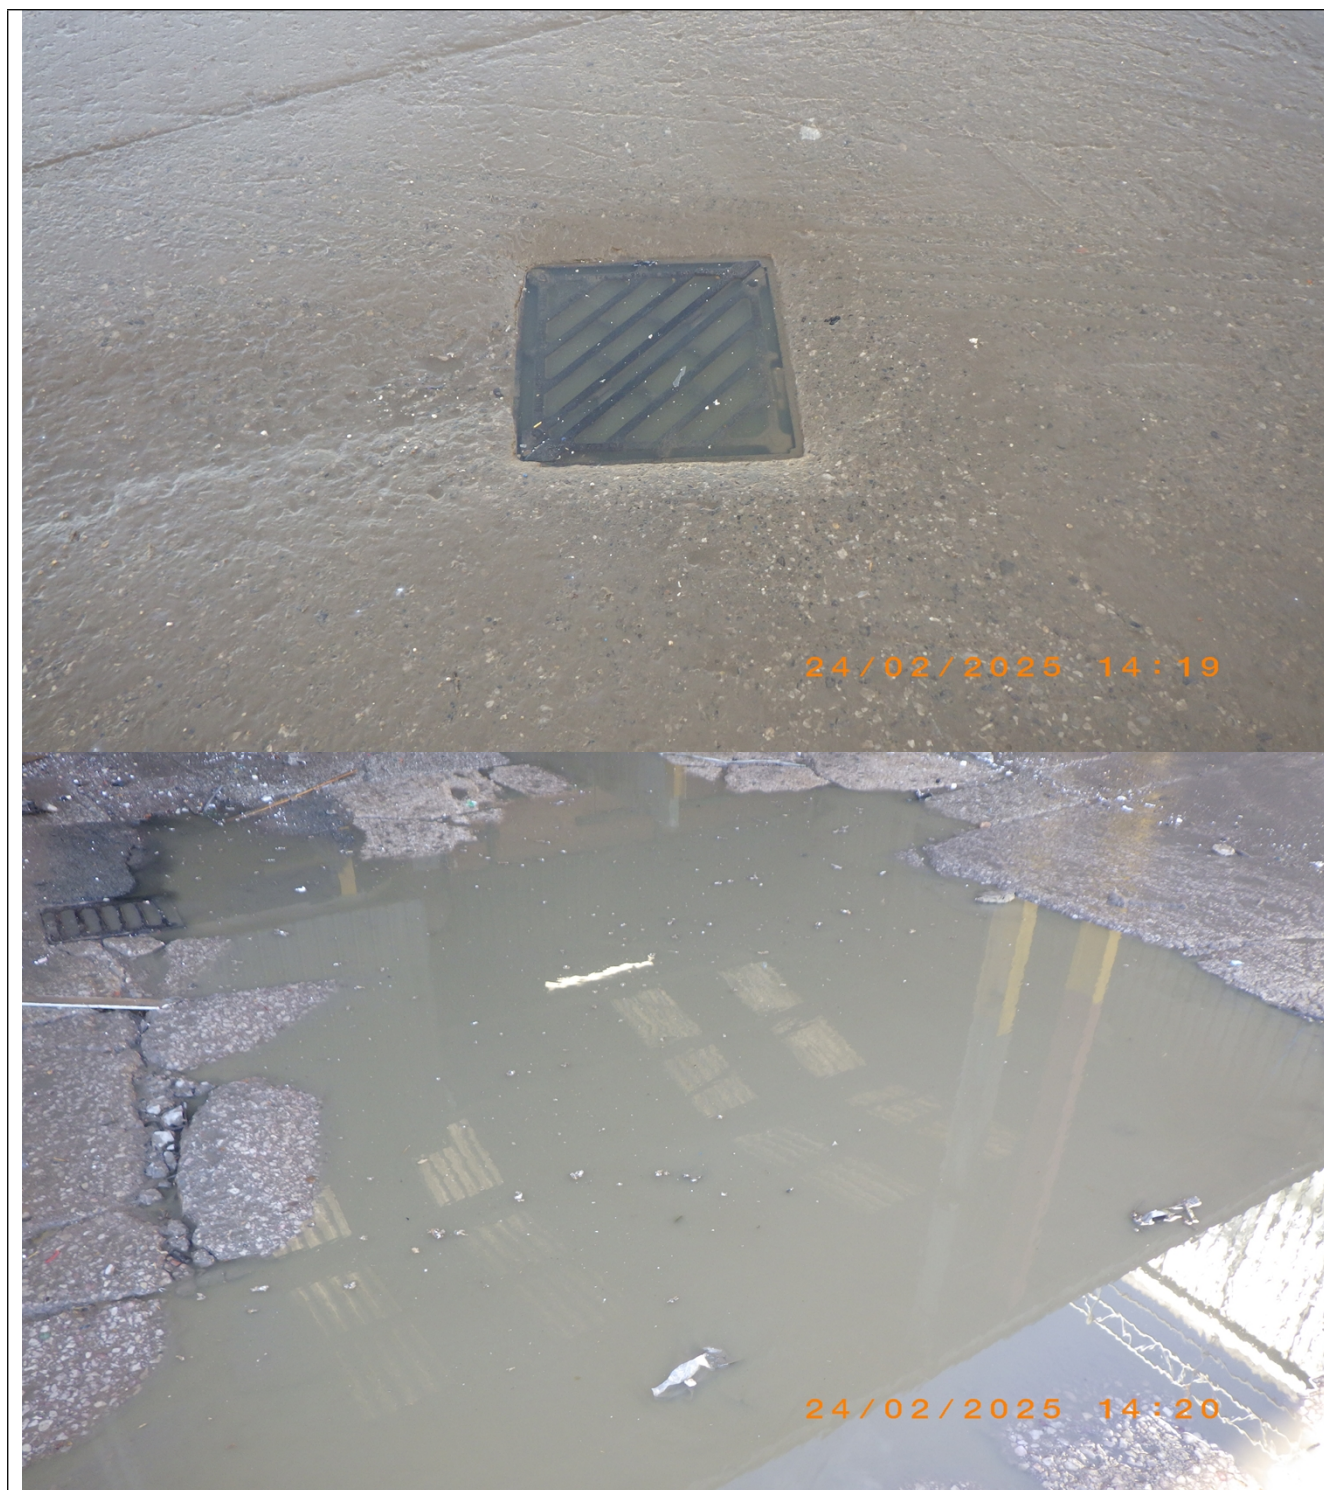
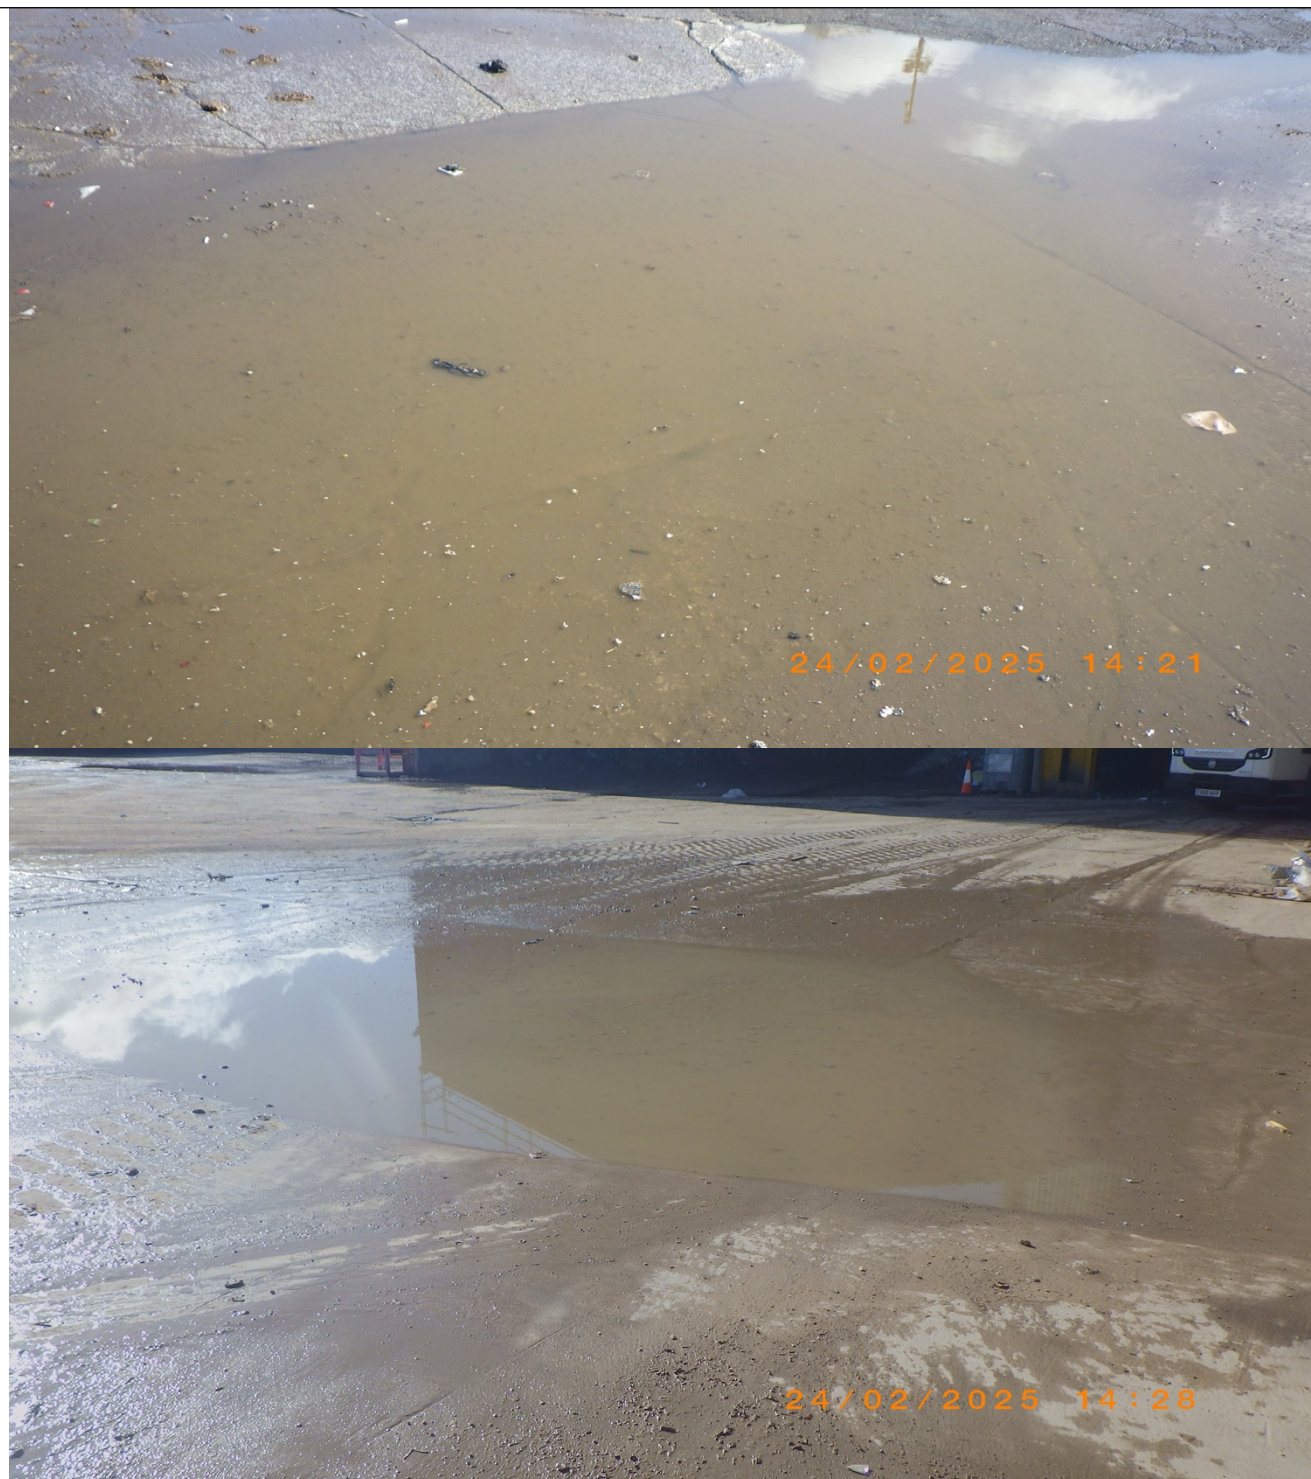
Walking across the yard, there was a lot of standing water across the site. There were also some drains that were visibly blocked. Cracks could also be seen in the concrete. Dan said the recent heavy rainfall had led to the standing water on site.

Photos showing standing water and blocked drains on site

The blocked drains, standing water and cracked concrete gives cause for concern that site drainage is not working as it should. The cracks in the concrete could mean surface waters can leak into the ground beneath. If the drains are blocked, run off cannot drain as it should and may find an alternative path off site.

A CCS C3 score has therefore been assigned against permit condition 2.1.1.

The standing water on site would suggest section 10.9.2 of the EMS is not being complied with. Waters should fall towards the sites drains and gullies.

The root cause of this issue is therefore deemed to be inadequate EMS procedures.

This is due to the risk of contaminated site waters leaking through cracked concrete to ground. Blocked drains may cause run off from site.

ACTION: Clear all drains and gullies to ensure site drainage is able to work effectively. Repair cracked and uneven concrete to ensure the surface is

impermeable and that surface water flows towards the gullies and drains.

ACTION: Review and update EMS procedures for the management of site surface infrastructure and drainage. For example, there should be processes in place for identifying drainage issues on site, processes for servicing of drainage and interceptors etc.

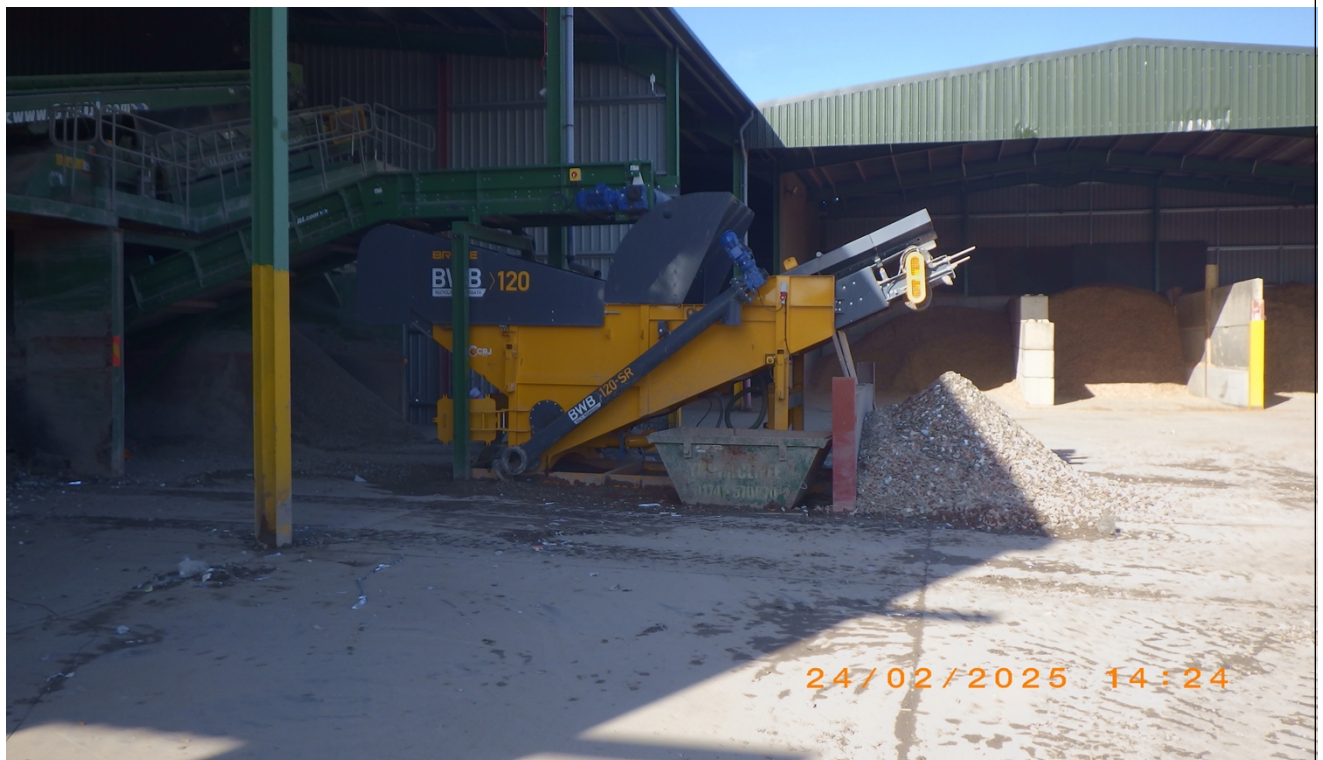
Photograph showing fines treatment area and water bath

Within the fines treatment area, the site has acquired a recycling water bath. This machine separates the waste through size and weight. Lighter wastes are skimmed off the surface. The water system washes waste at the same time.

Heavier waste was coming out the end of the water bath machine. Dan explained the machine had been bought to help separate rubble from the fines. However, he stated this machine was not working as expected, therefore it was unlikely they would continue to use it.

Table S1.1 of the site permit states "Treatment operations shall be limited to: screening, air separation, crushing, shredding, magnetic separation, eddy current separation, baling, wrapping. The washing of waste is not an authorised treatment activity on the site permit.

As the washing of waste is not an authorised treatment activity, the permit has been scored a CCS C3 for this permit breach.

ACTION: Stop the use of the water bath and washing of waste. Apply for a permit variation if this is a form of treatment the site wishes to use.

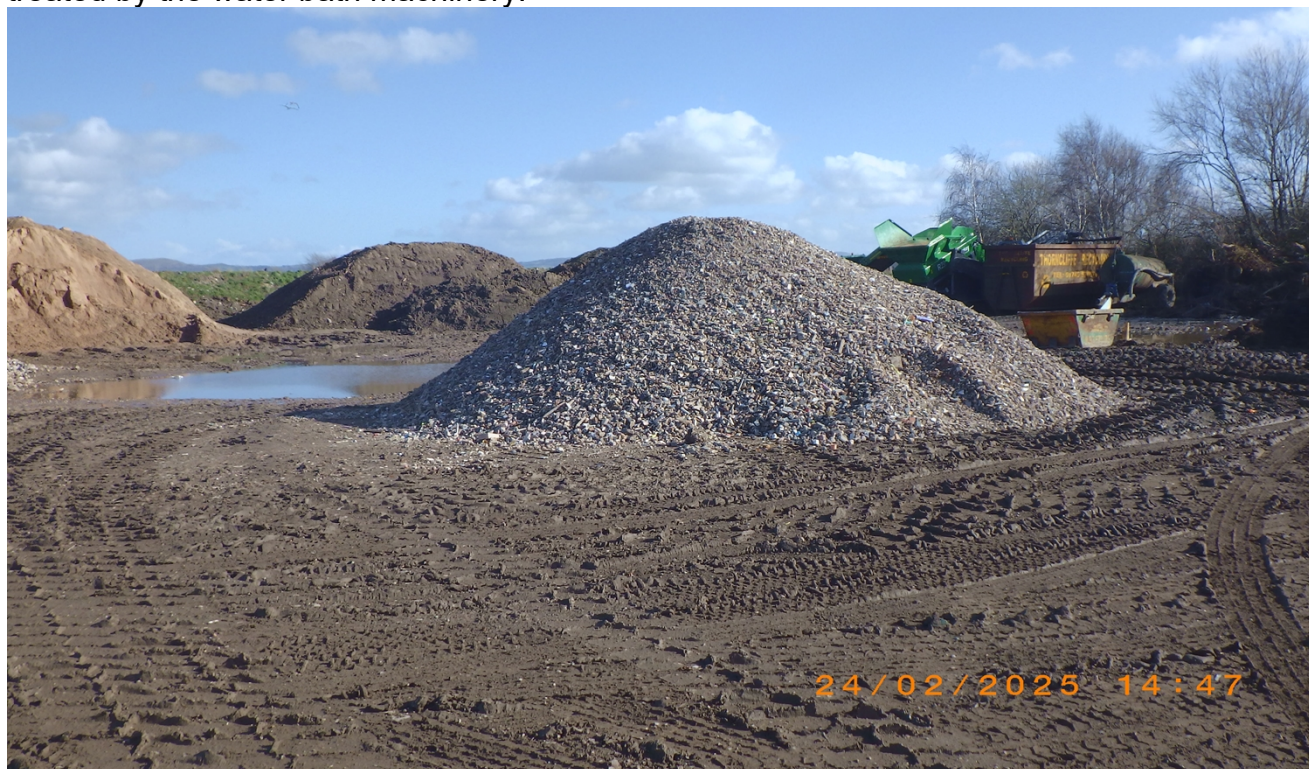
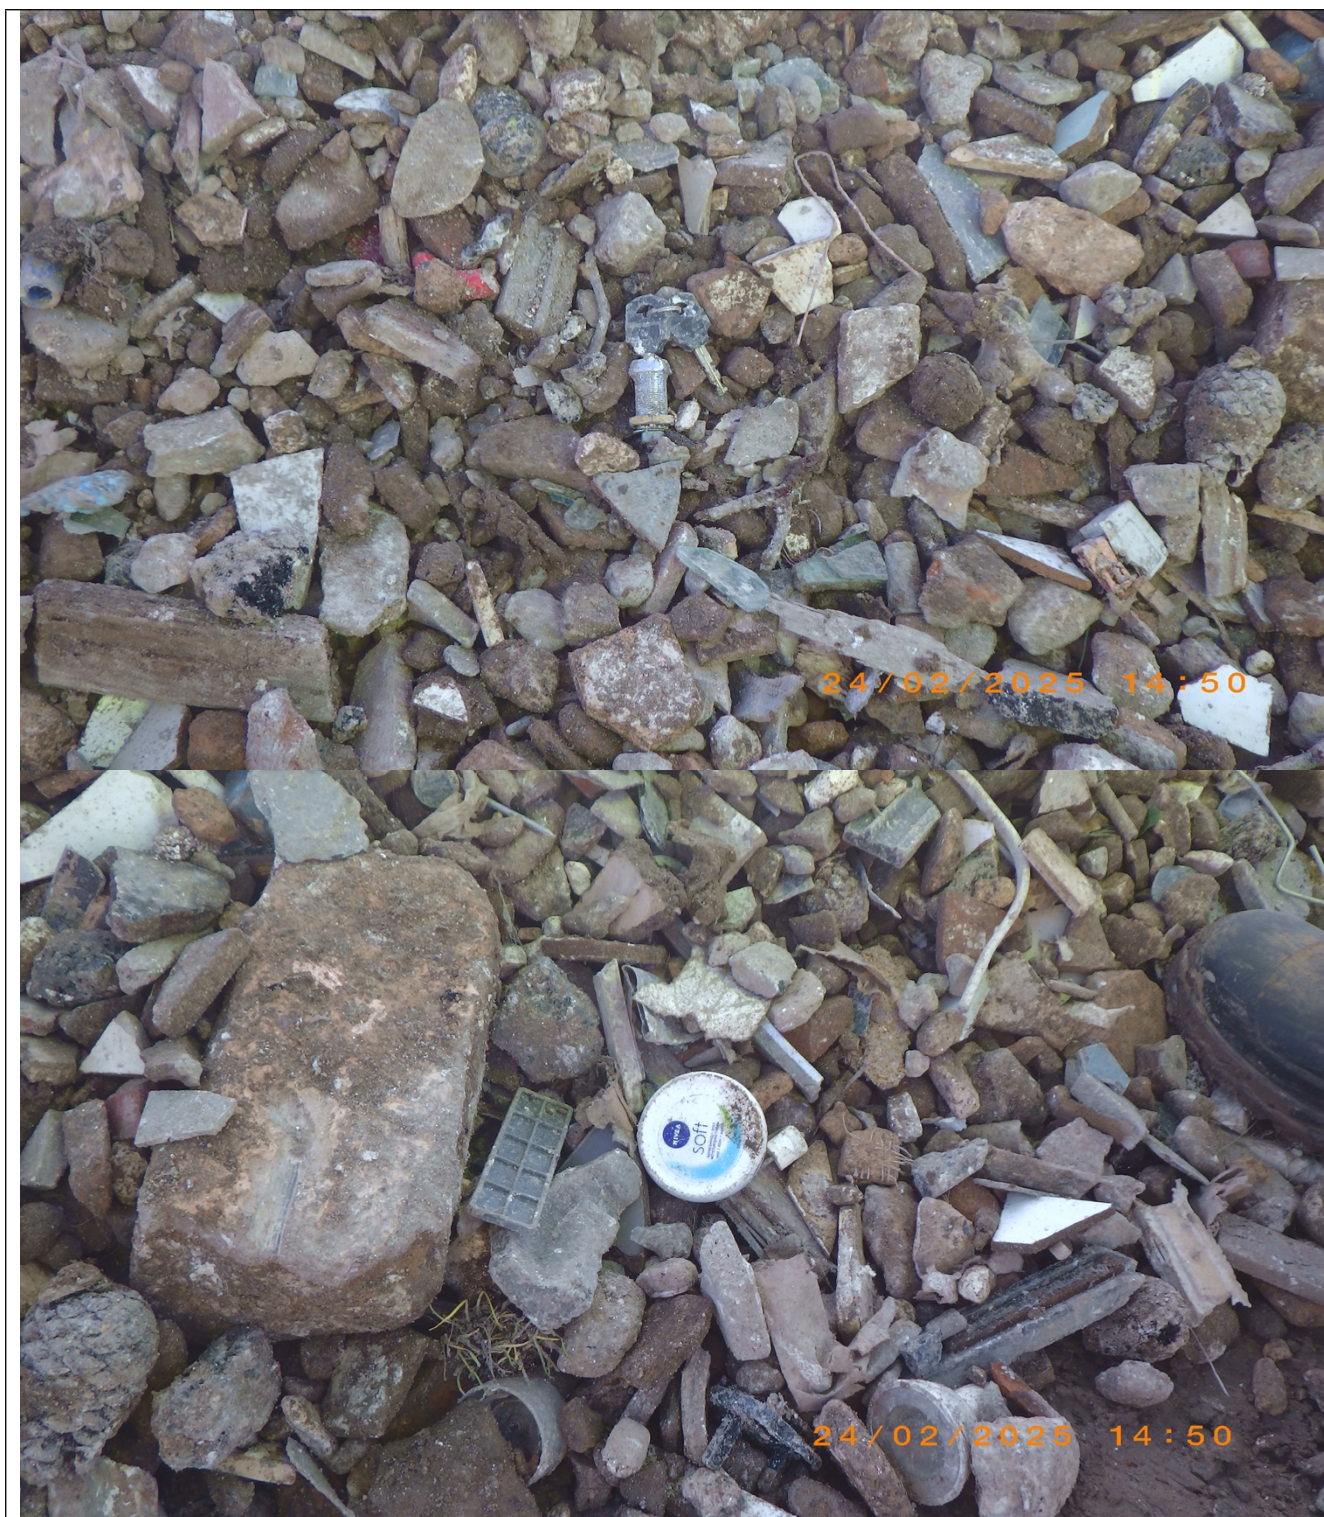
Within the inert waste treatment area, there was a stockpile of treated waste that had been treated by the water bath machinery.

Photograph showing treated waste from water bath, being stored in inert waste treatment area

The input of this waste treatment process, is still 19-12-12 wastes (other wastes (including mixtures of materials) from mechanical treatment of wastes other than those mentioned in 19 12 11), from residual skip waste. This waste code would still remain and the output of the water bath should not be entering the inert waste treatment area. Whilst Dan explained the waste had been moved to the inert waste treatment area temporarily, it was clear that 19-12-12 waste was being treated and washed to generate an aggregate material.

Residual skip waste should not be entering the inert waste treatment process, because this waste could contain a variety of contaminants such as gypsum (from plasterboard), asbestos, micro plastics, biodegradable wastes and hydrocarbons. Contaminated waste could then be leaving site as a 'product' with no regulatory controls on where this material ends up, which poses a significant risk to both people and the environment. The treated stockpile from the water bath contained visible contaminants such as plastics and metals. This was being stored on permeable ground, risking contaminated run off to surface water and groundwater.

The site is allowing 19-12-12 waste to enter the WRAP QP aggregate, which is not a specified waste in appendix C of WRAP. Therefore, this is a clear breach of procedures.

This lack of adherence with EMS procedures has been scored a CCS C2 score.

ACTION: Ensure EMS procedures are followed for the production of WRAP QP recycled aggregate on site. Only wastes listed in Appendix C of WRAP should be used as inputs.

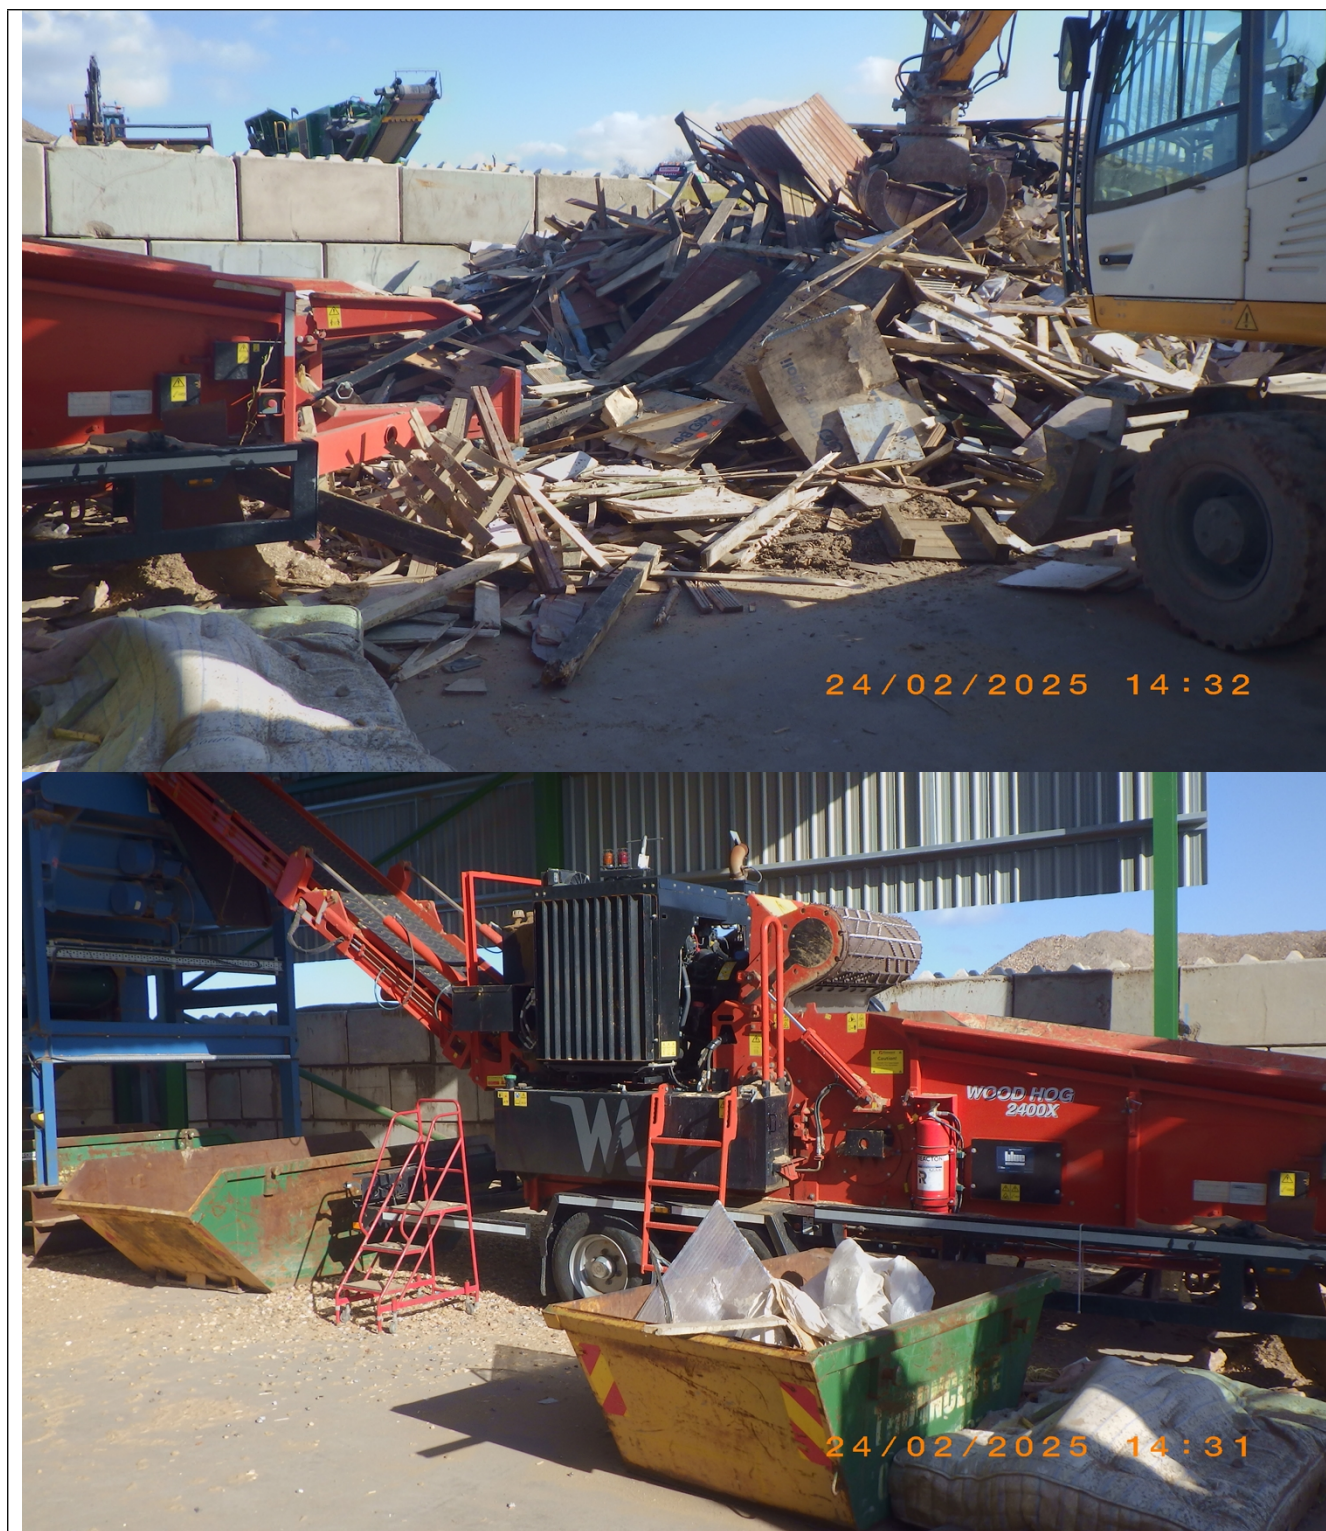
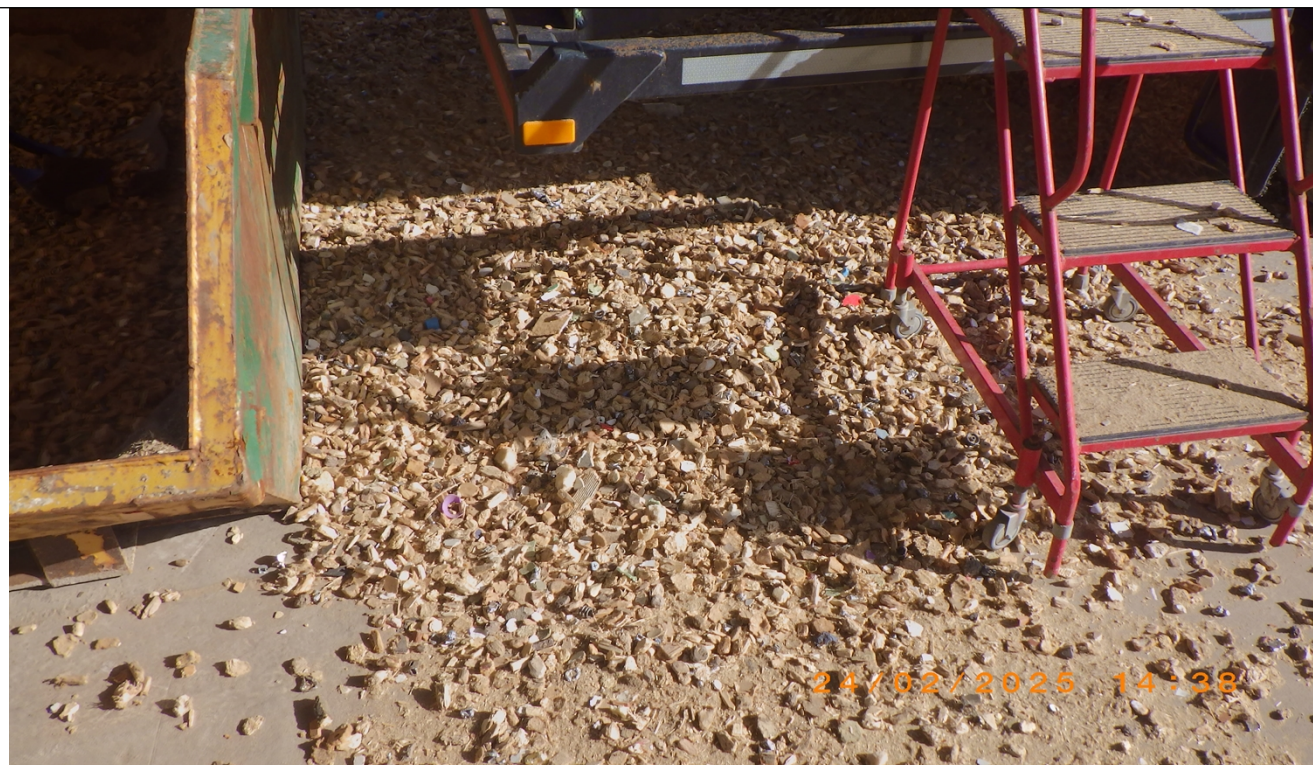
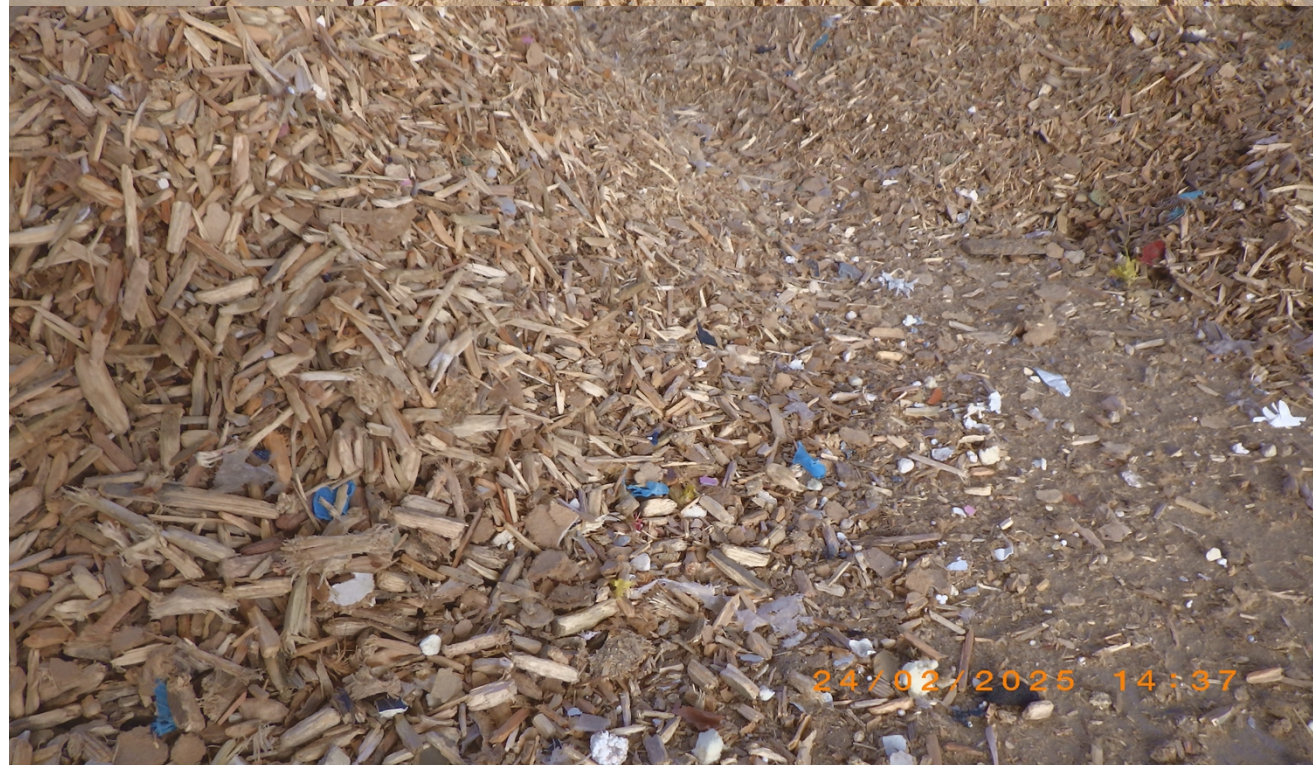
Photographs showing wood treatment area

The outside wood treatment area was observed. Dan explained that only virgin wood is accepted and treated on site. However, upon inspection of this area, it was evident that other wood sources were being treated. Pieces of metal and plastic were observed on the ground below the hogger and in the skip between the hogger and eddy current machine. Dan stated Grade A wood is also accepted and treated.

ACTION: Please provide detail of all wood inputs and outputs to and from the site.

Include virgin timber sources as well as waste wood sources. Provide waste transfer notes to evidence these movements.
