Maendy Quarry

Review of Monitoring Data and the Restoration Scheme

January 2025

Prepared by
Technical Operations - Landfill

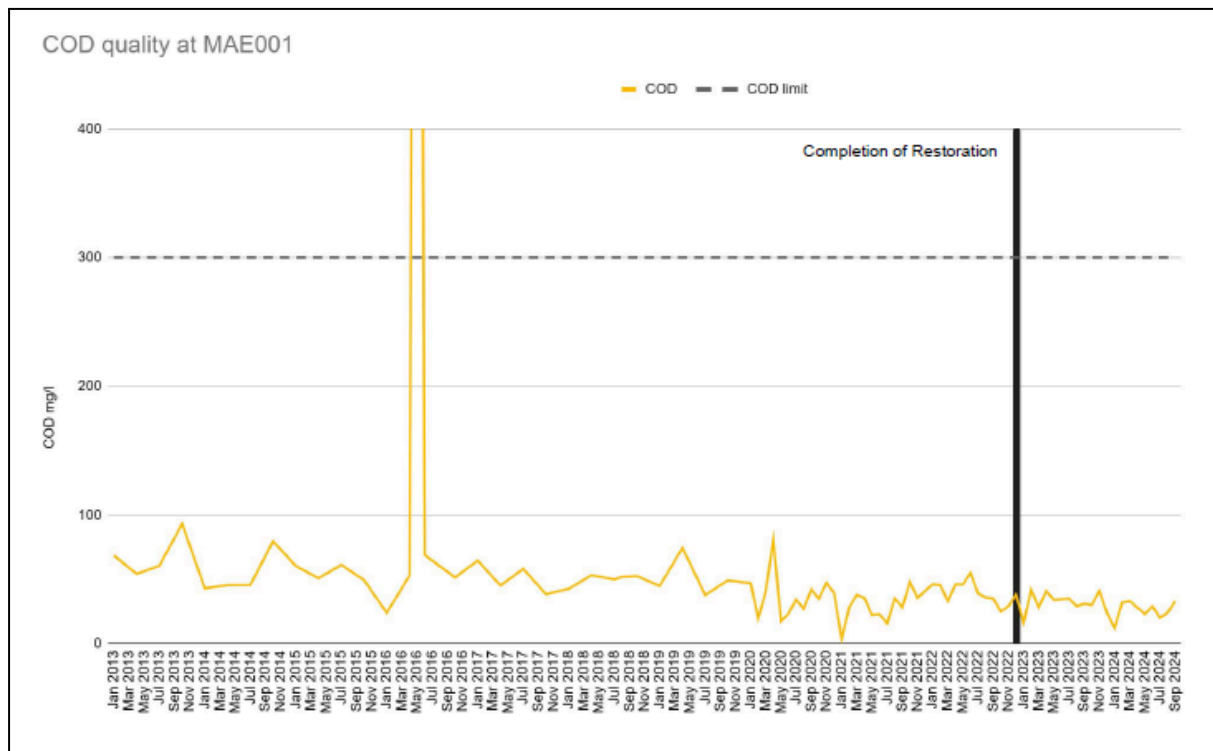
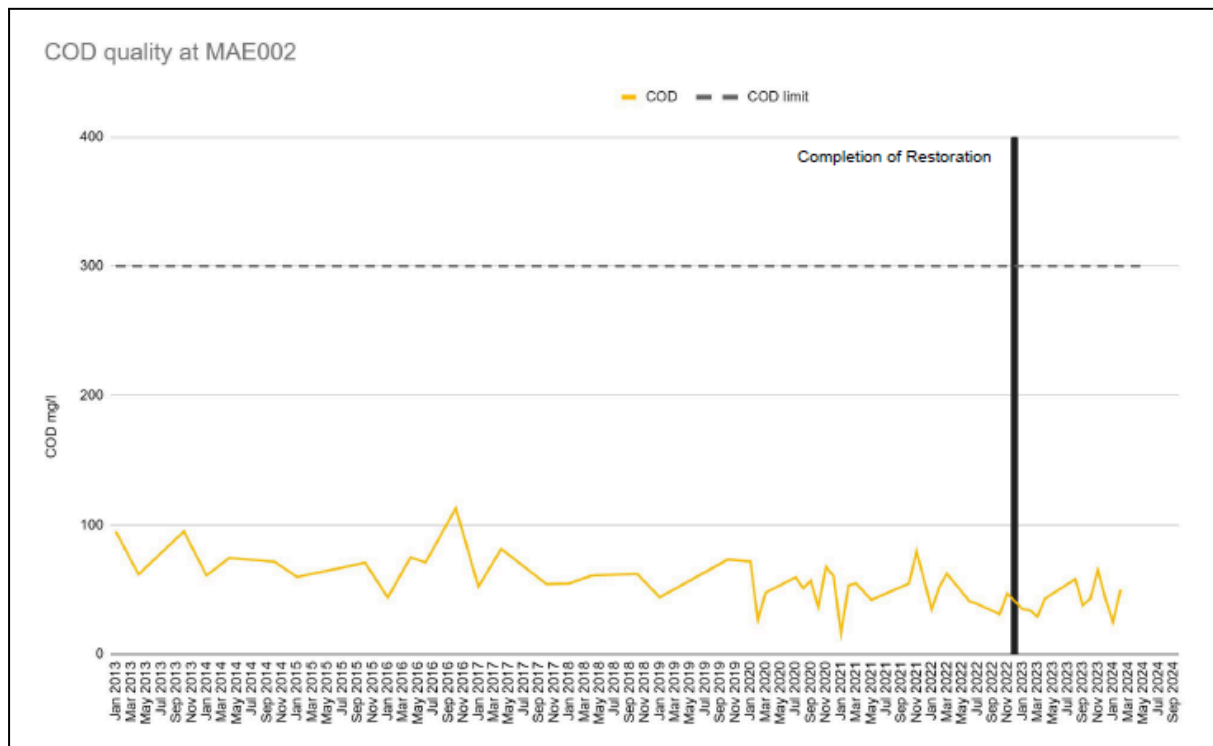
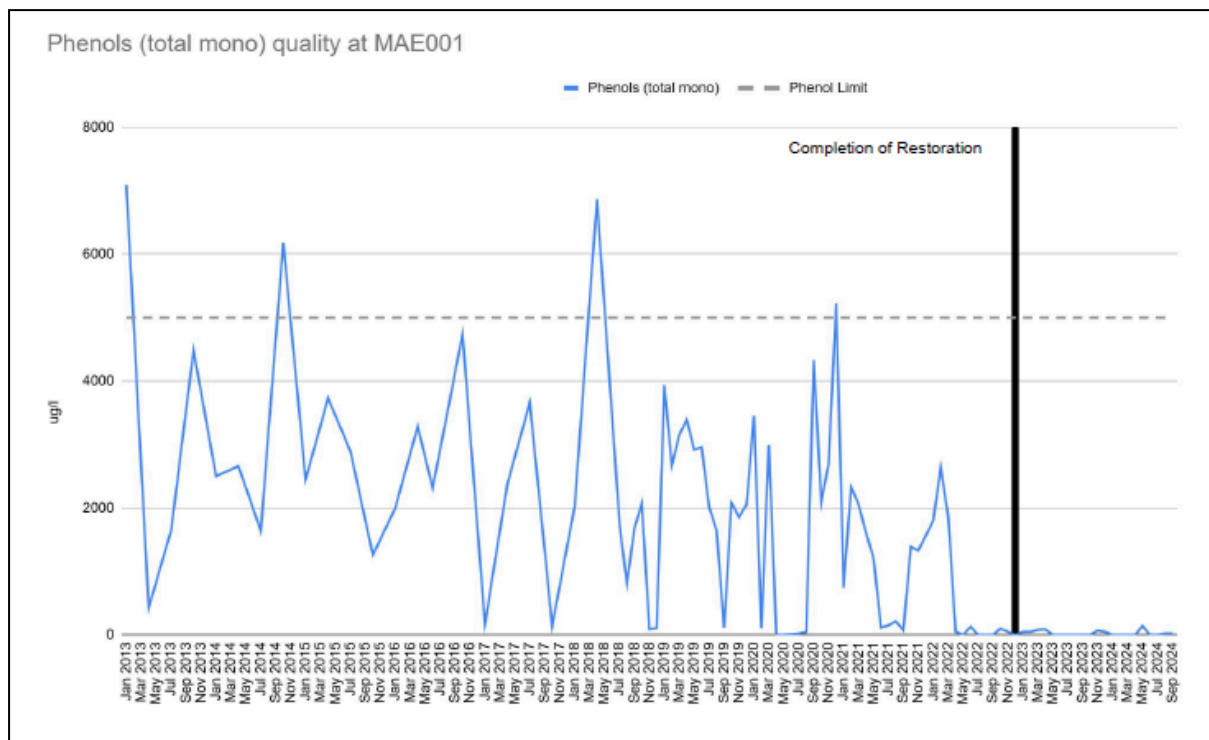
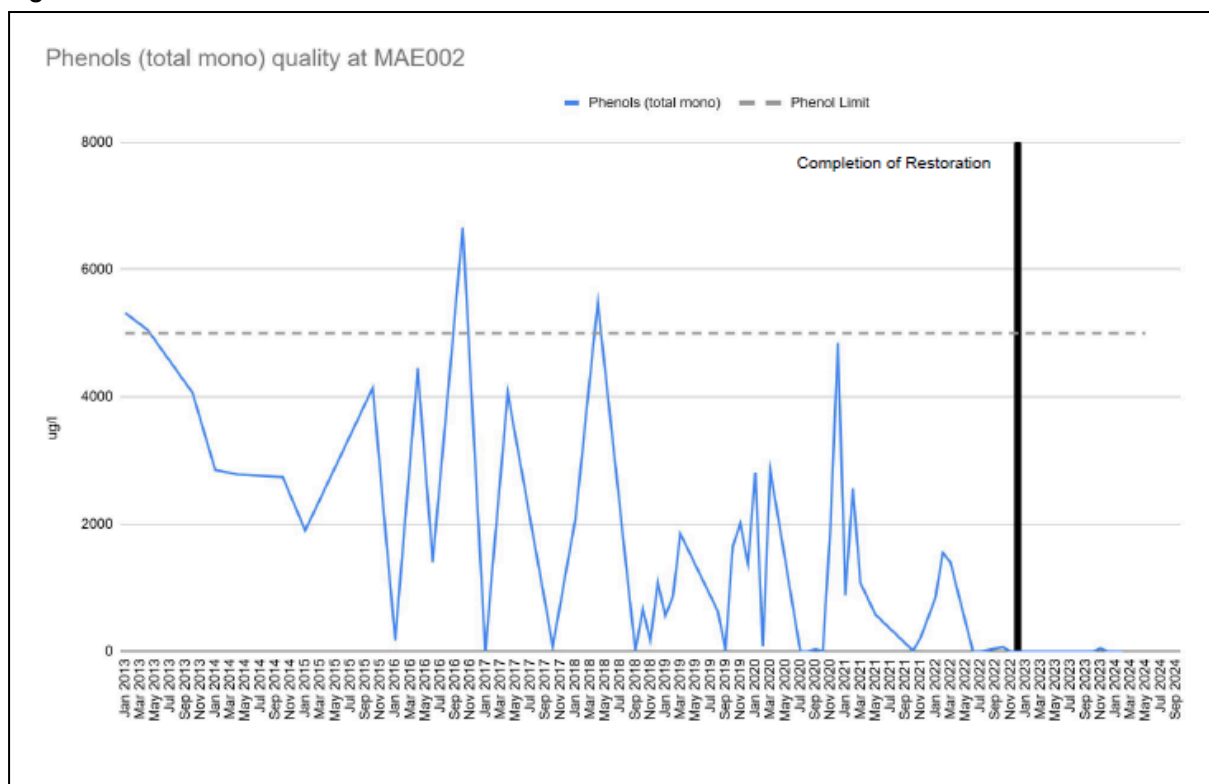
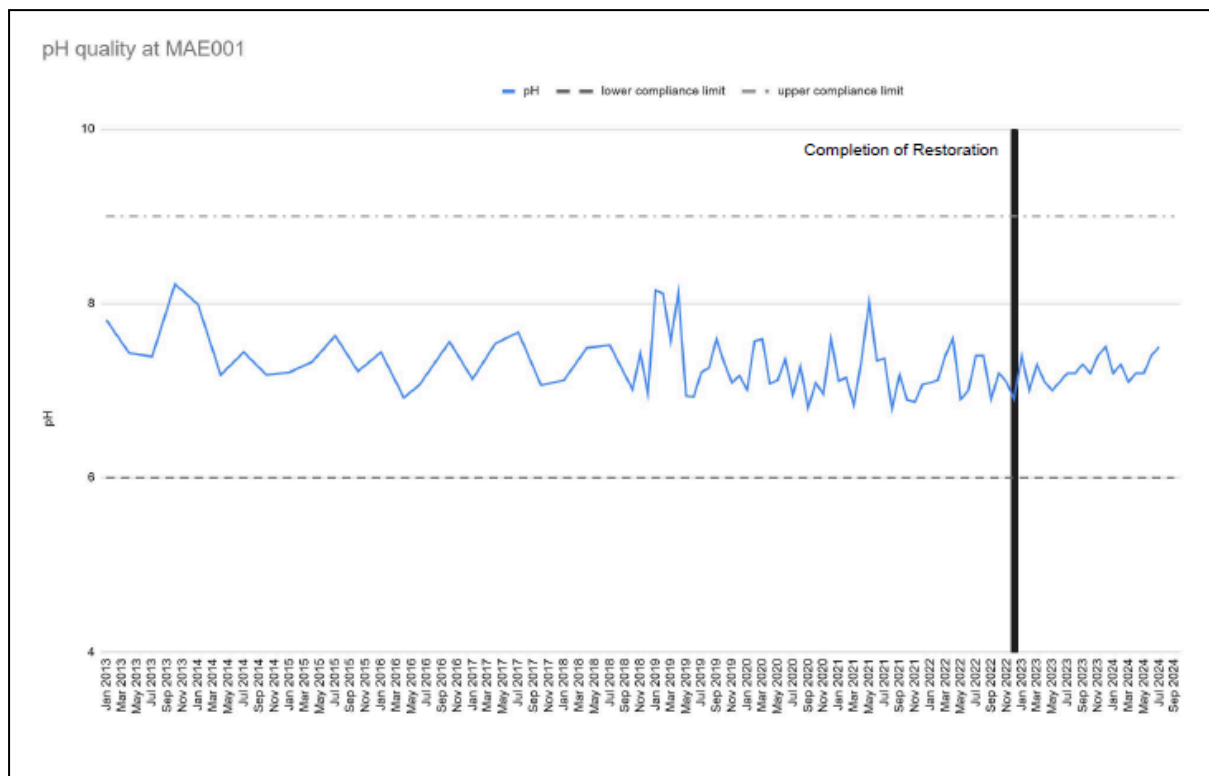
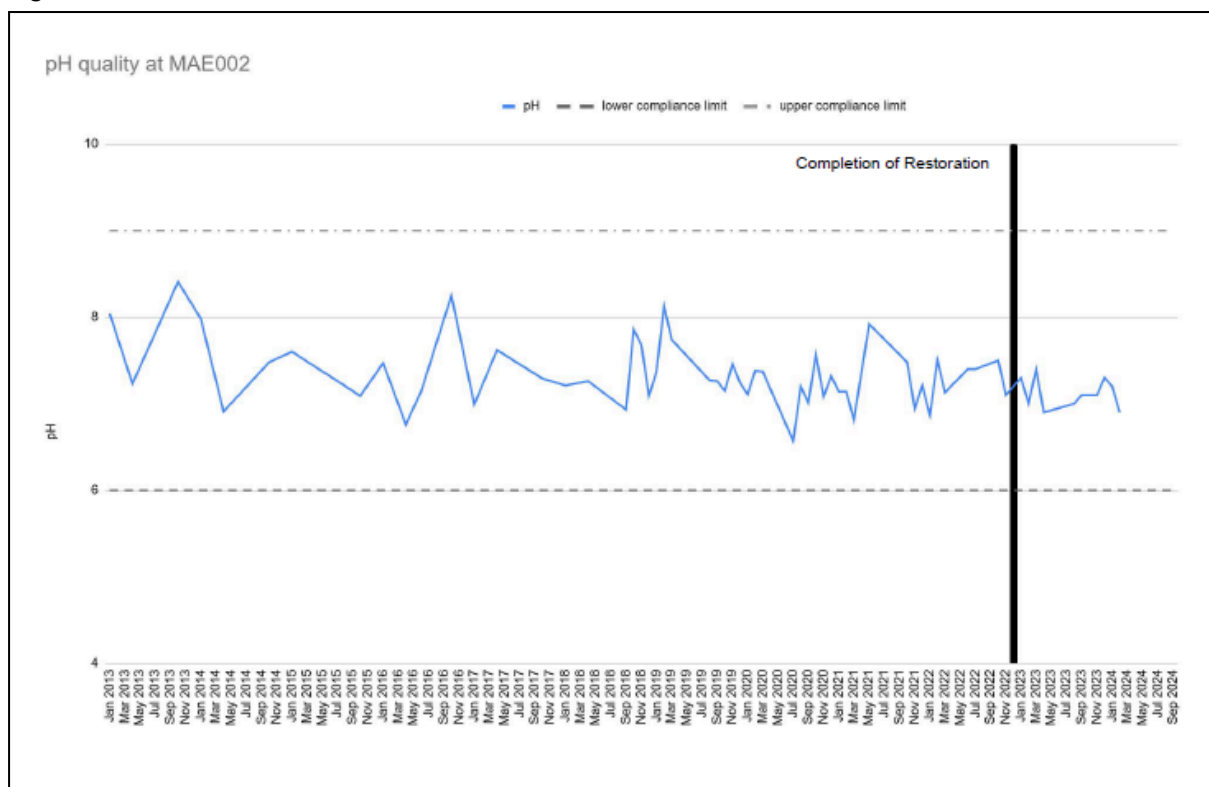
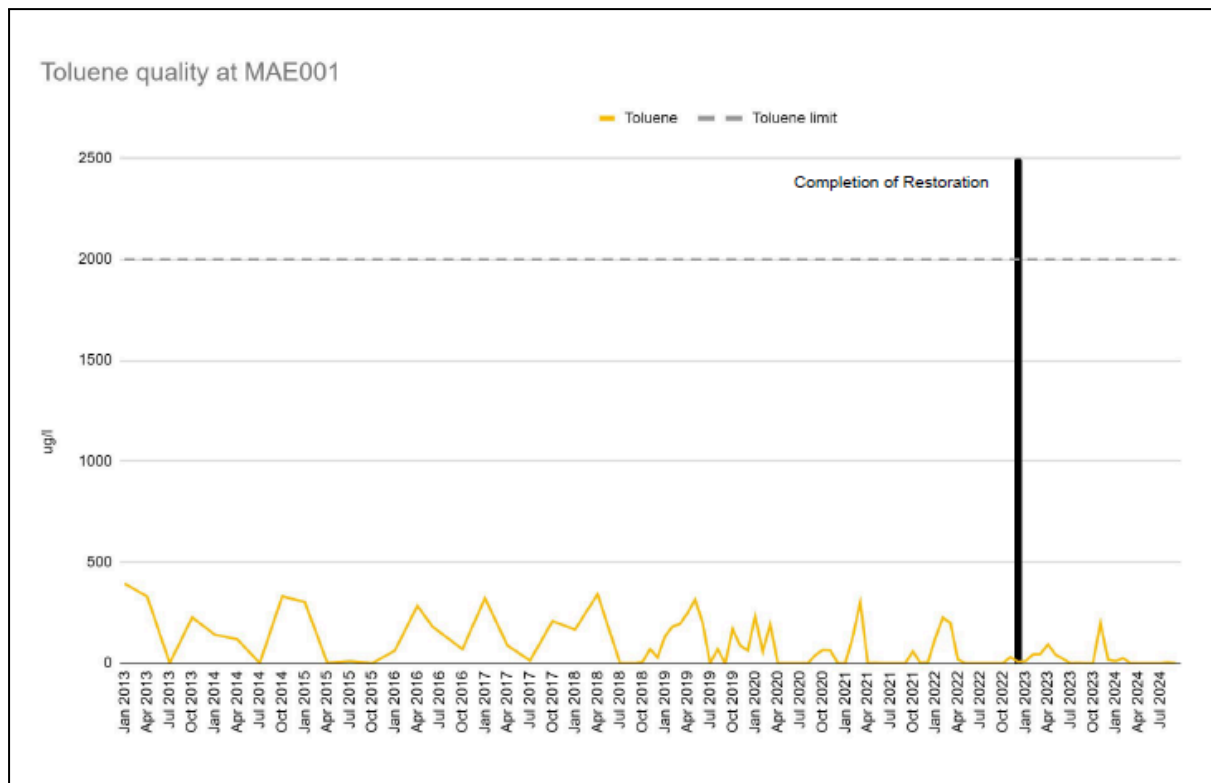
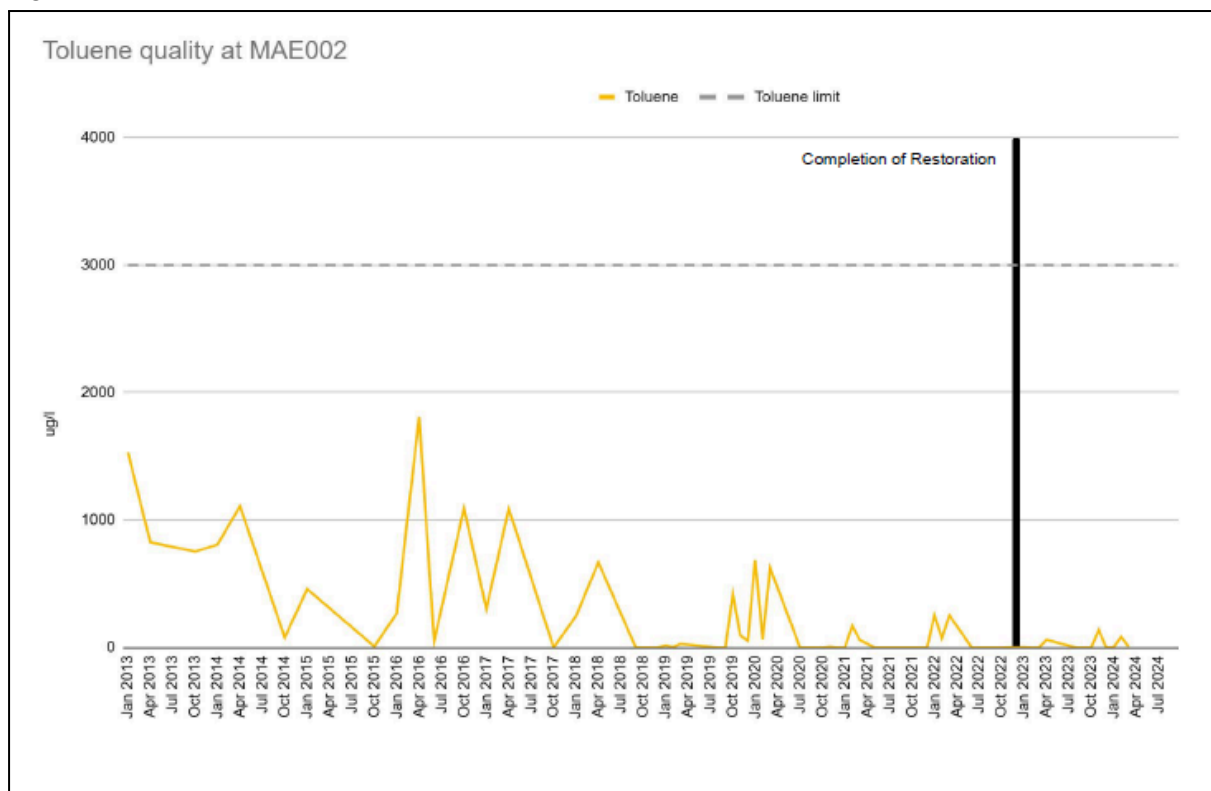
The results of the monitoring undertaken in accordance with Table S3.1 of the Permit at the site, show that since the variation of the Permit in 2018 toluene, phenol (total mono) and COD have been consistently measured below the respective permit limits at MAE001 and MAE002. This is shown in Figures 1 to 8 below.

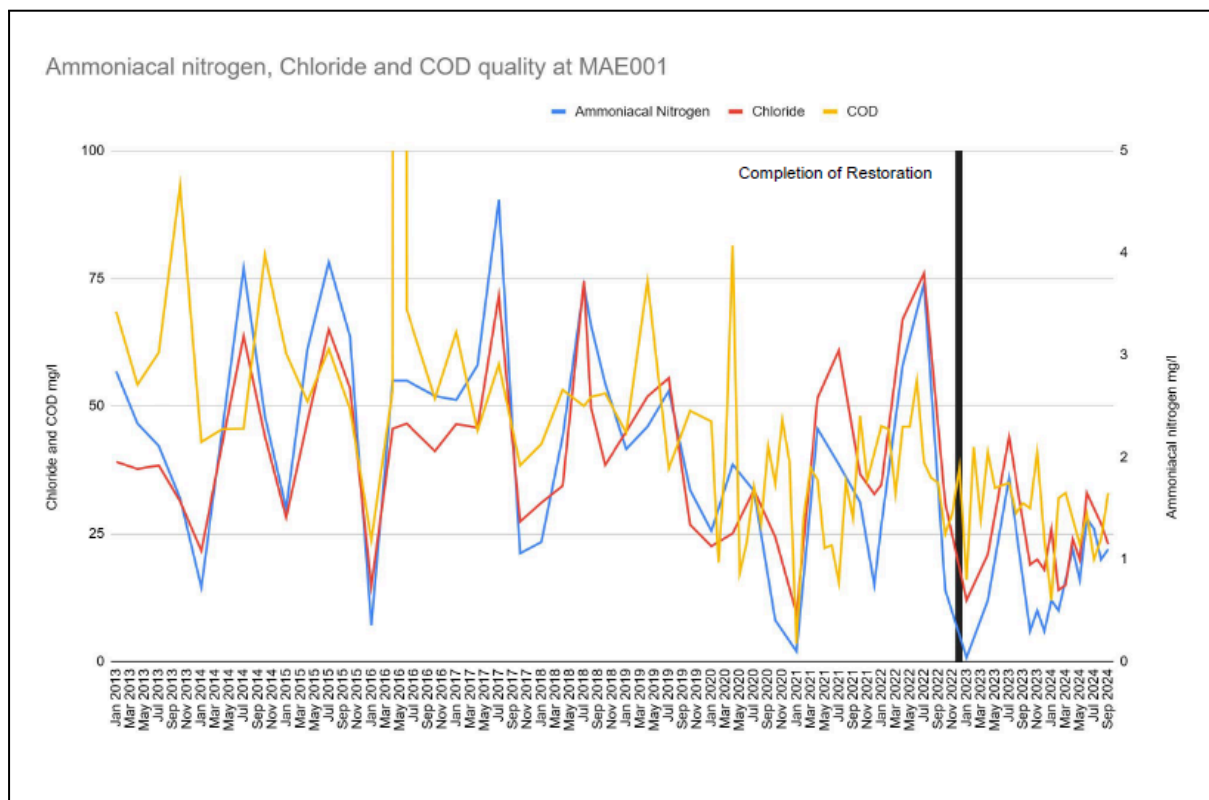
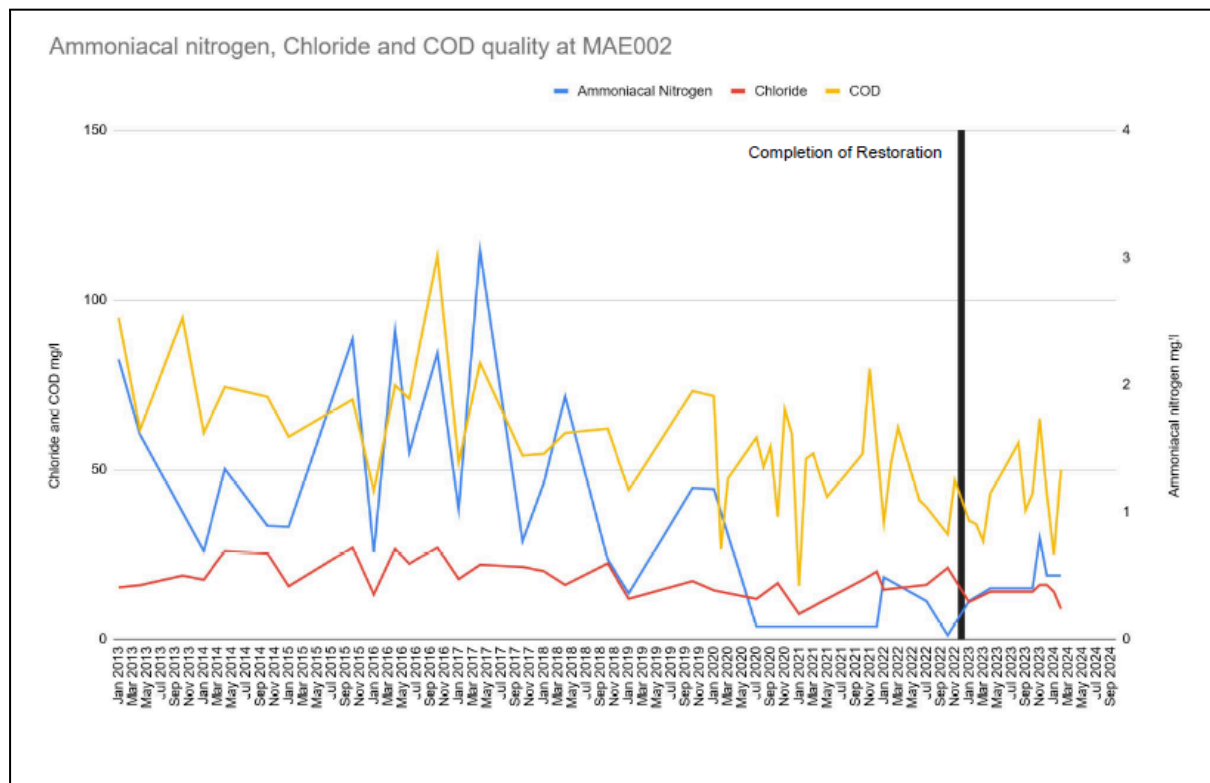
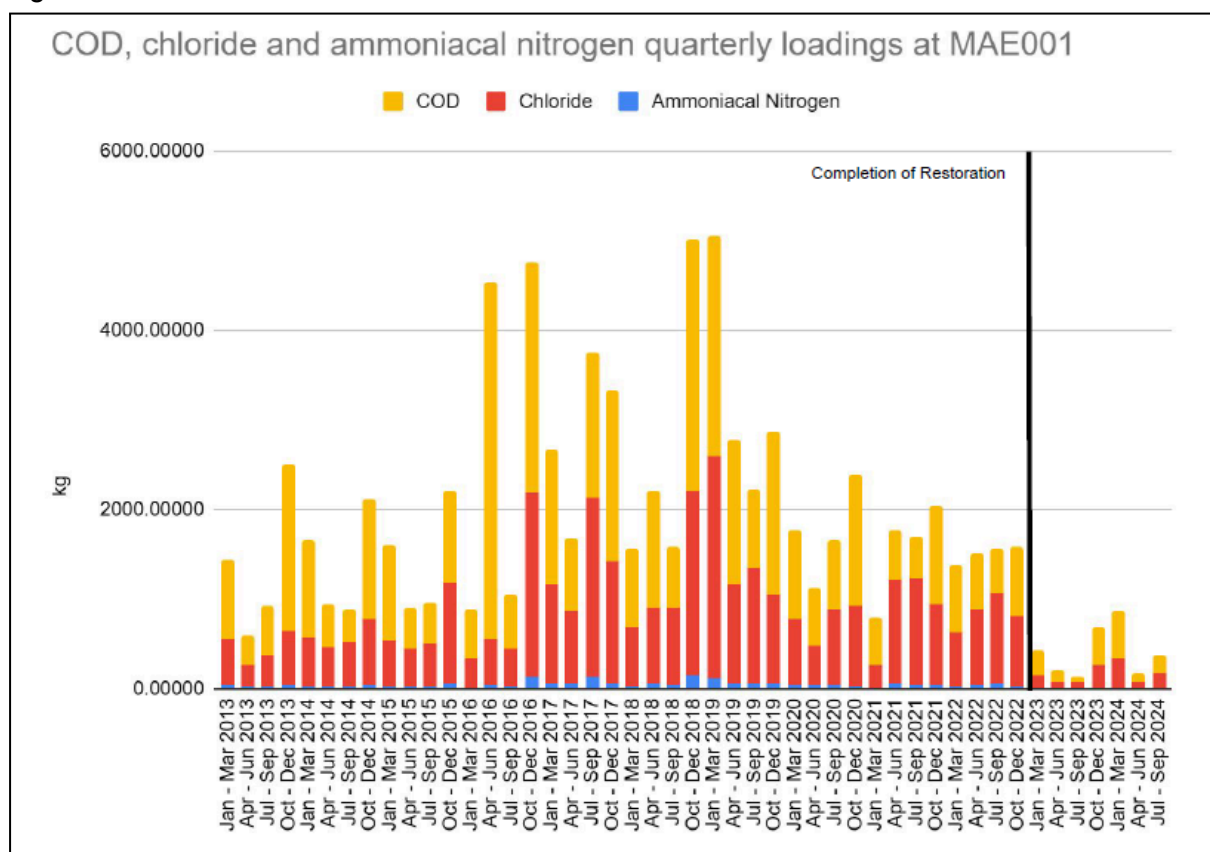
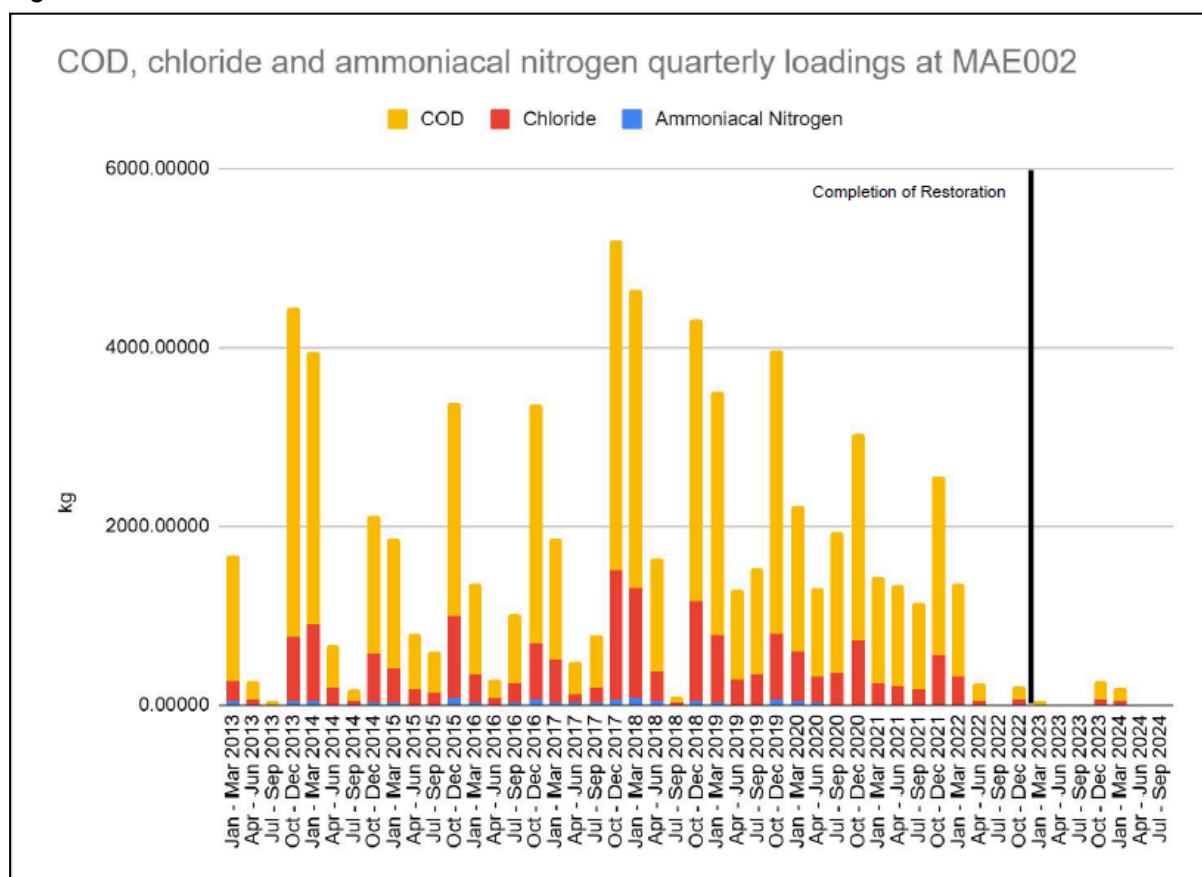
The graphical summaries of the quality and loading data are presented in appendices B and D respectively, however figures 9 to 12 below demonstrate the wider quality of the discharges.

Prior to the restoration scheme there appears to be a seasonal trend with higher concentrations and flows, leading to higher loadings in the discharges during months with higher rainfall. Following the restoration scheme it is evident that some seasonal effect can be seen, however there is a step change in loading at both discharges, which are likely to be due to both flow routing and retention/attenuation in the eastern quarry as a result of the capacity of the wetland.

- There has been no change in the fact that higher concentrations have been observed at MAE002 compared to MAE001, both prior and following the restoration works.

- Following completion of the restoration scheme there has been a continued notable reduction in ammoniacal nitrogen, chloride and COD.

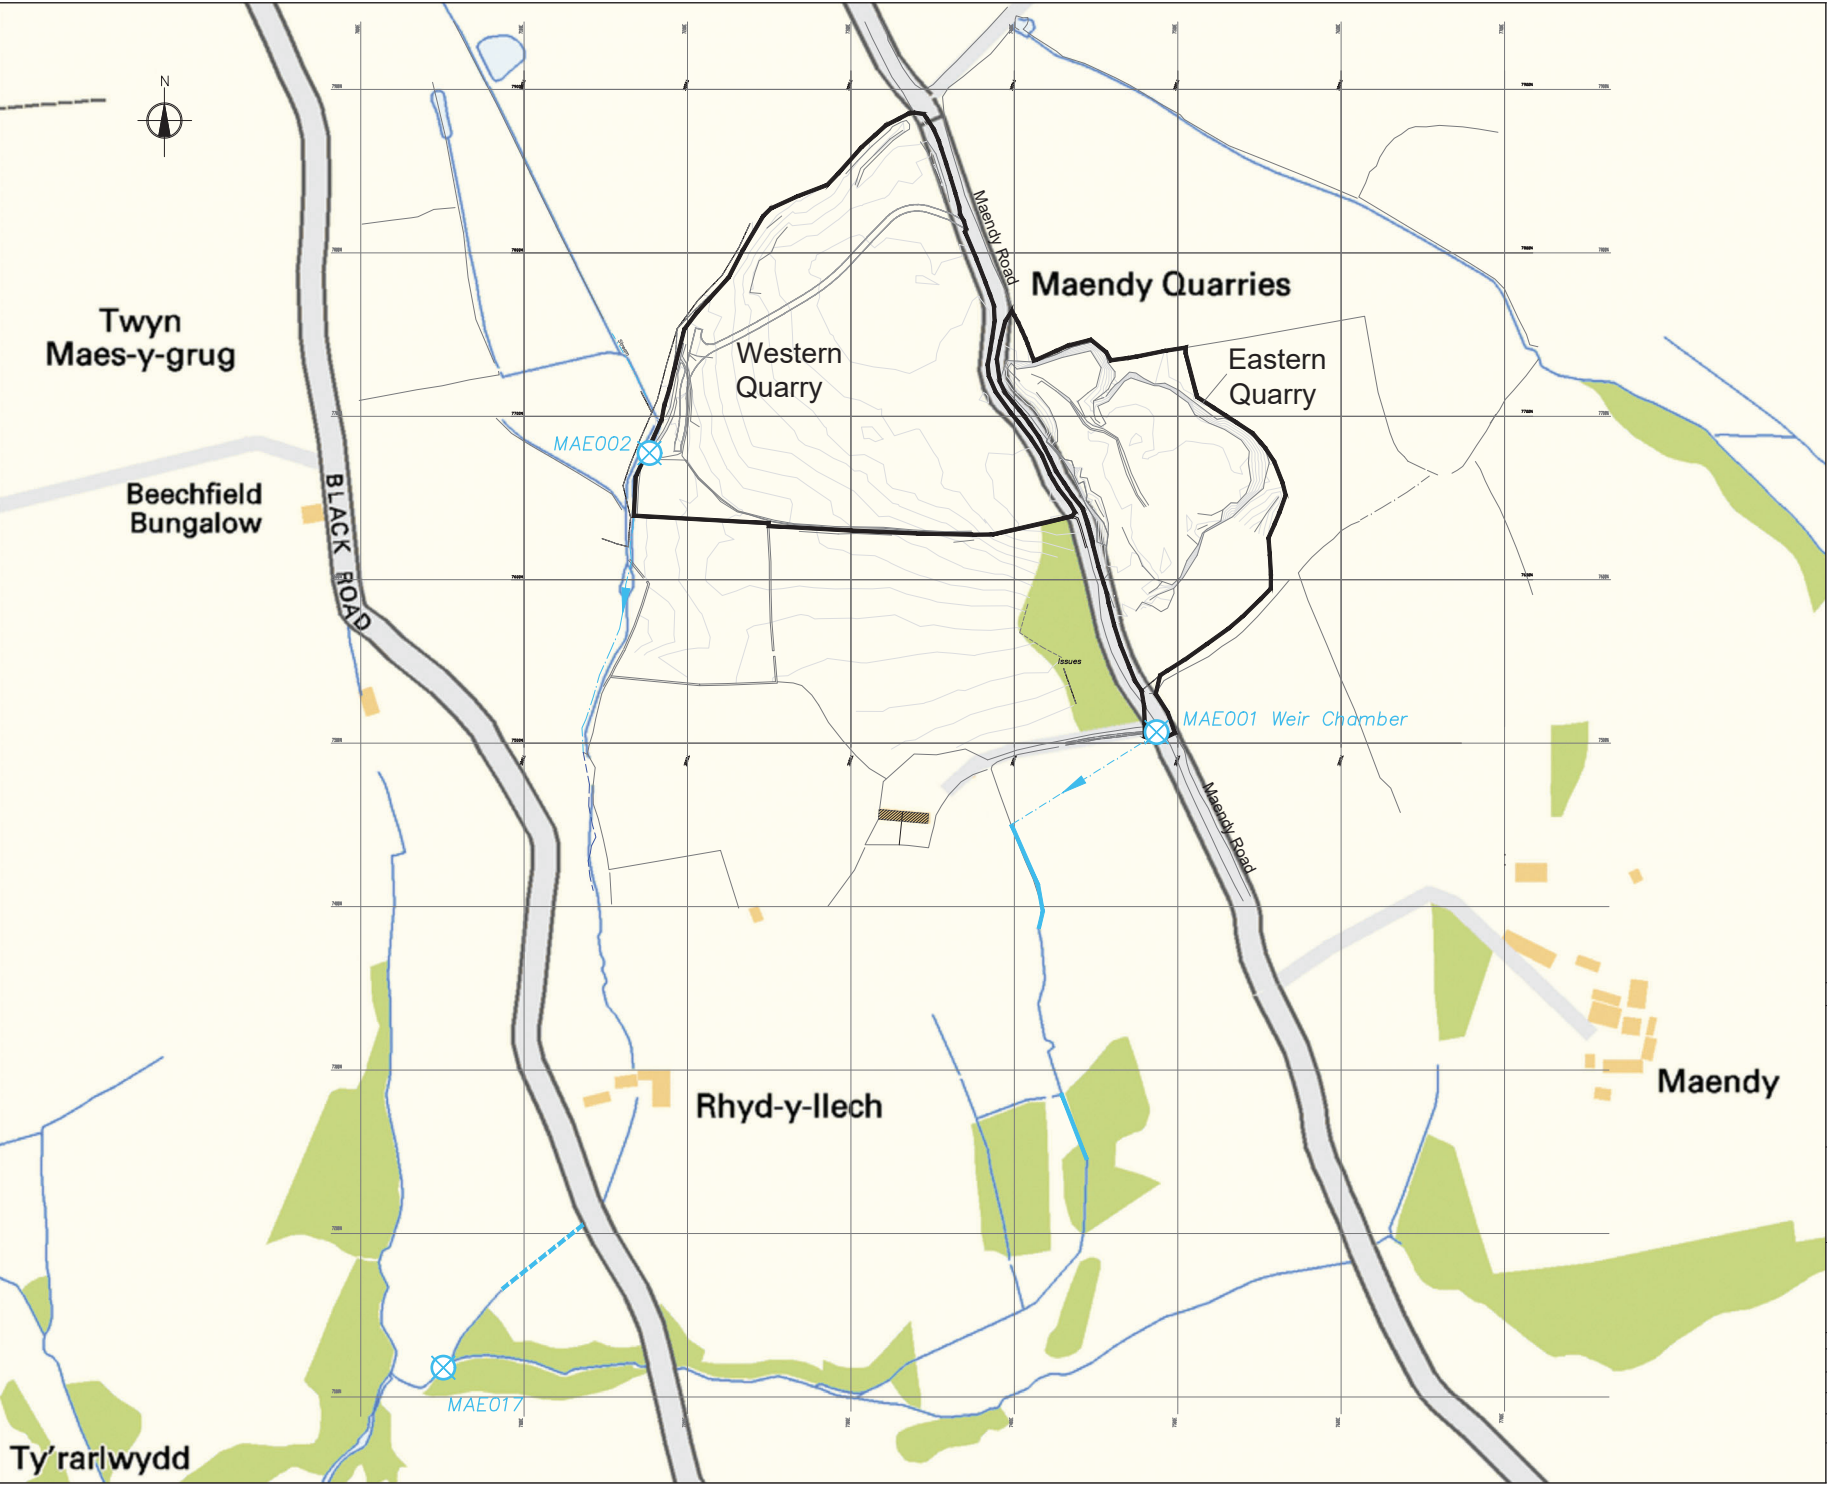
Drawing Maendy_1222-monitoring

- Site Boundary
- Surface Water
- Pipe or sub-surface flow
- Surface Water Location
MAE001

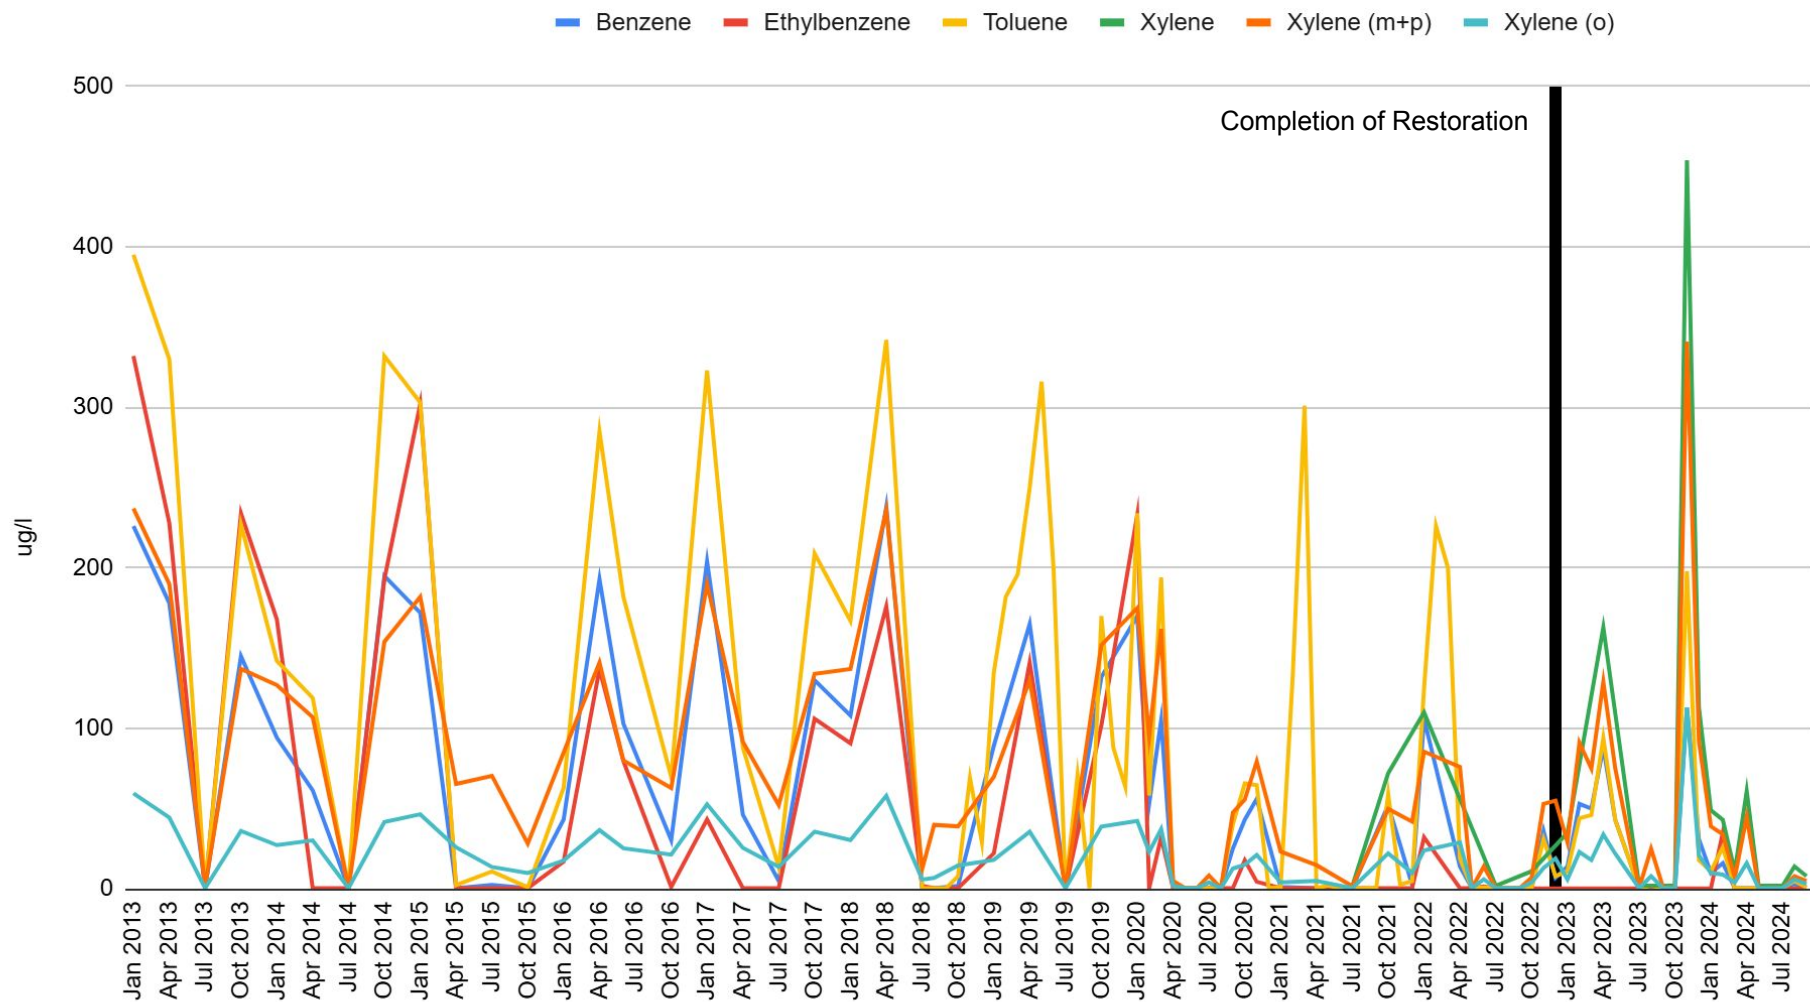
BTEX quality at MAE001

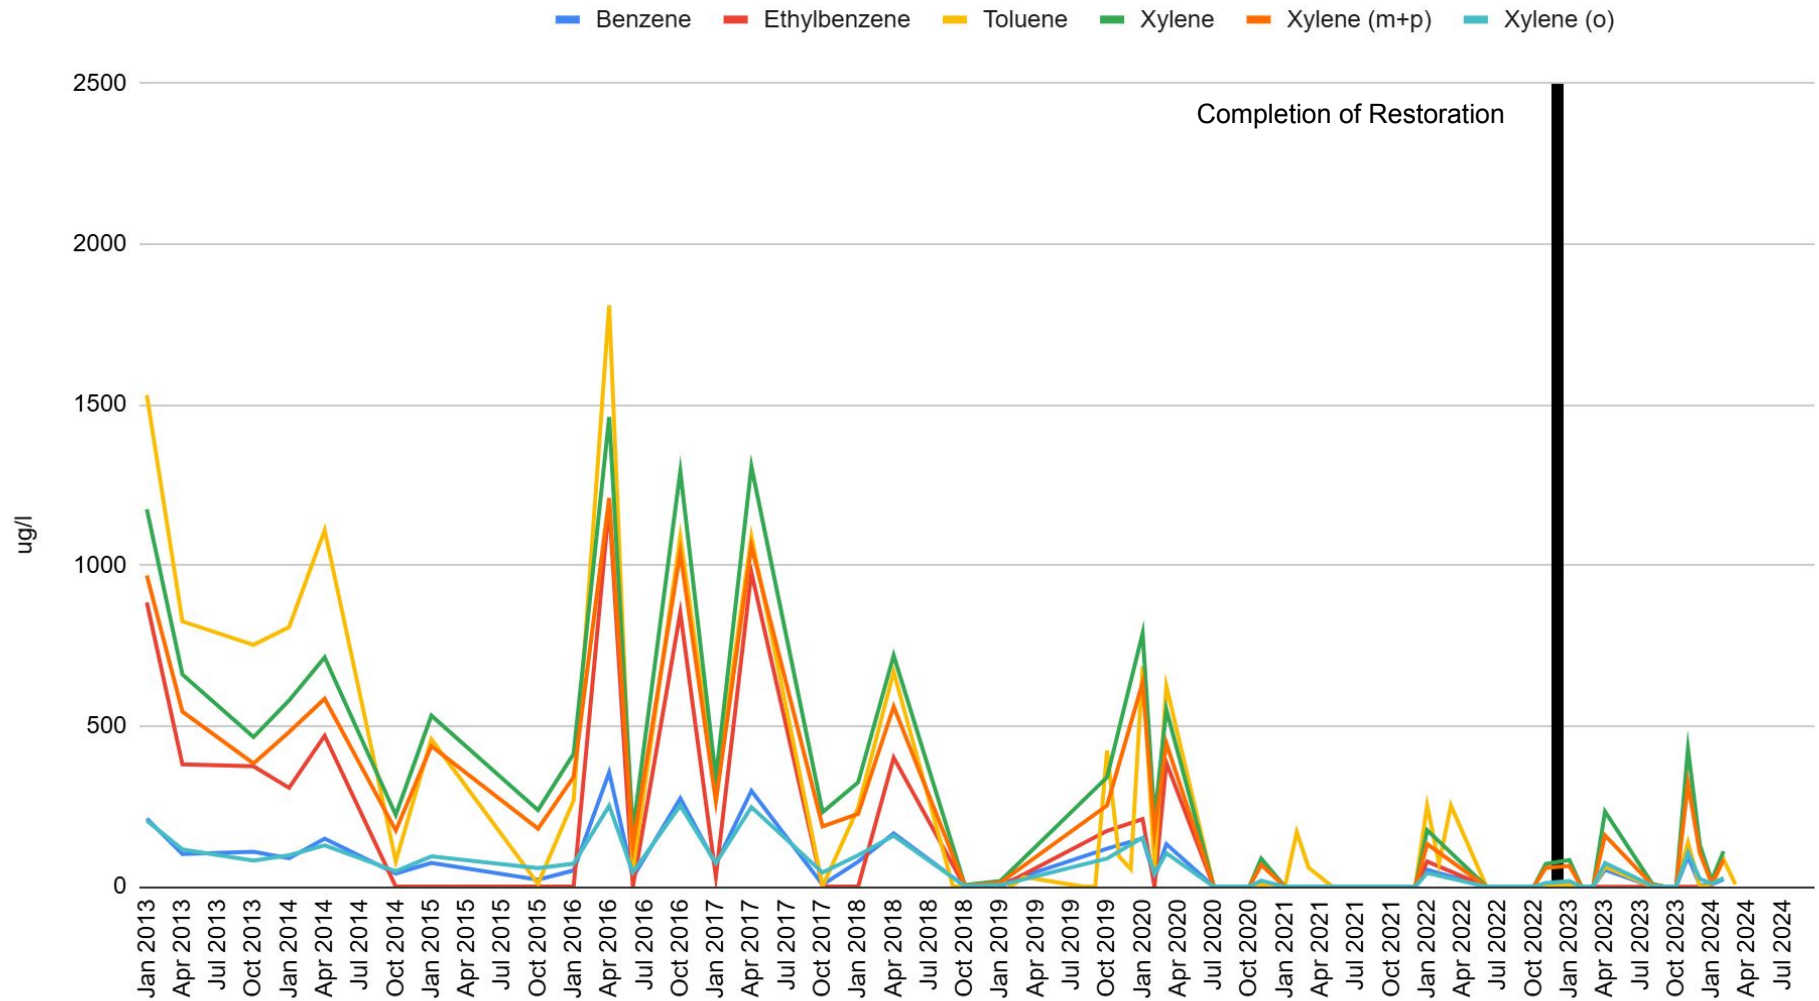
BTEX quality at MAE002

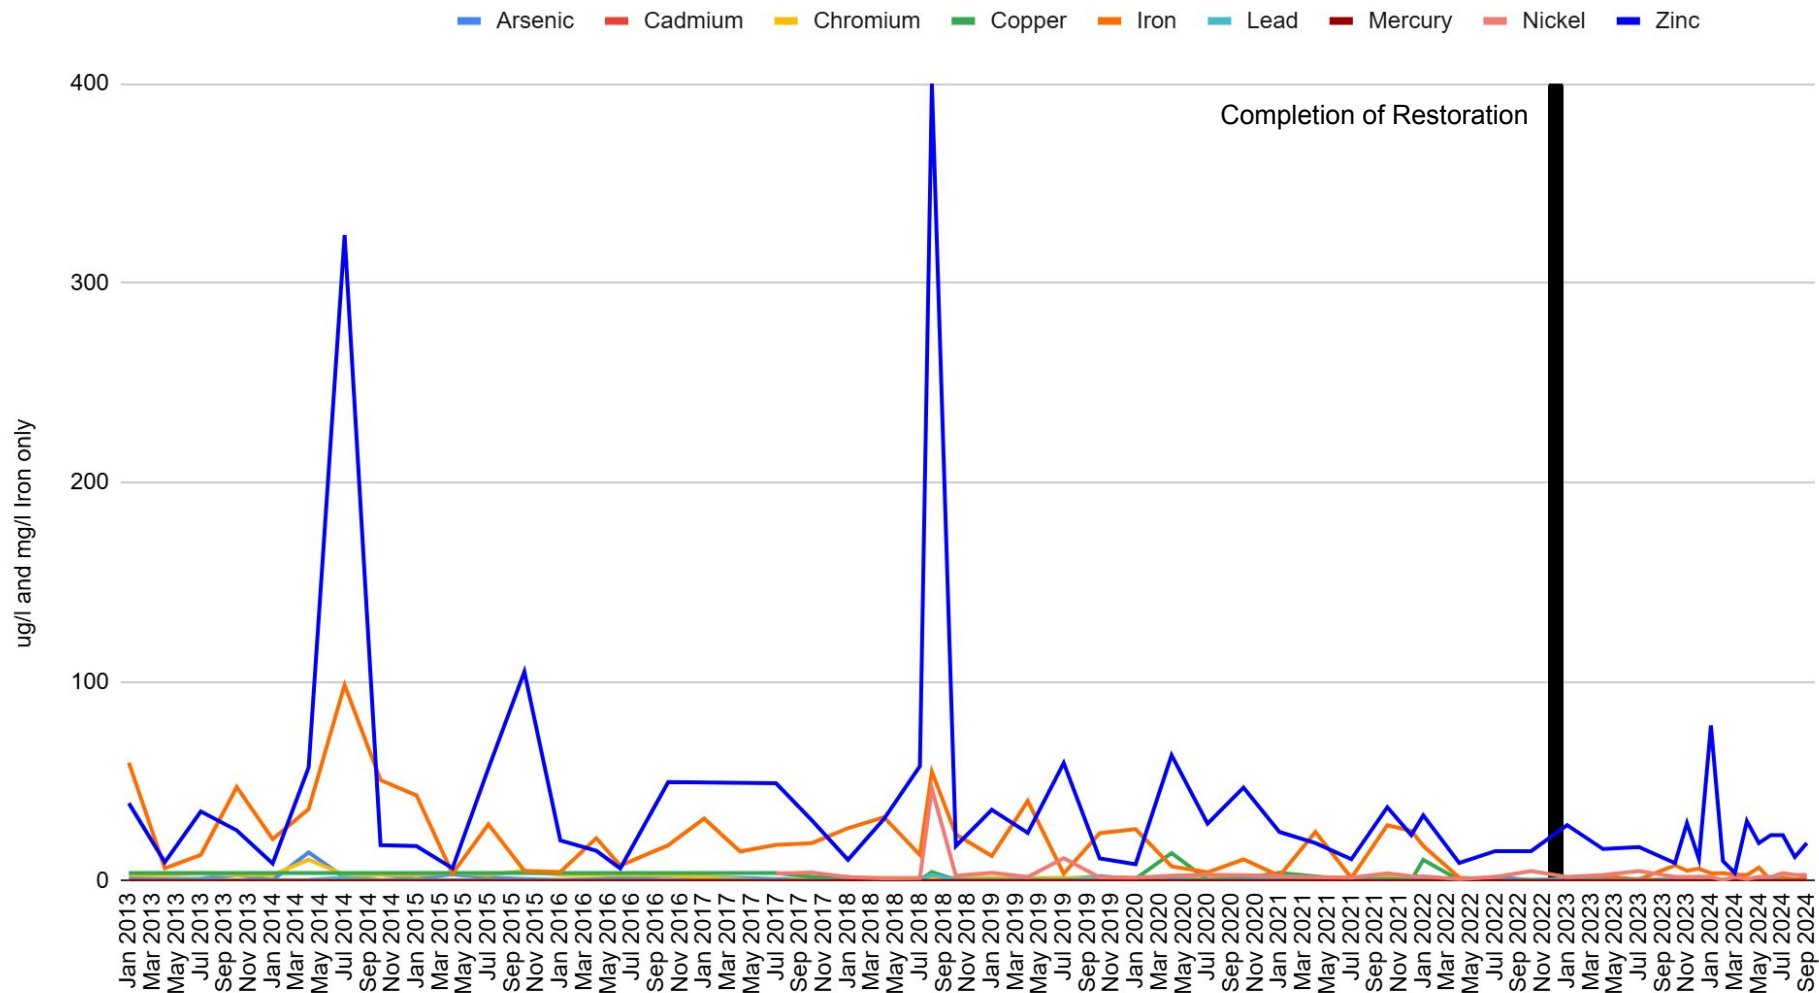
Metals quality at MAE001

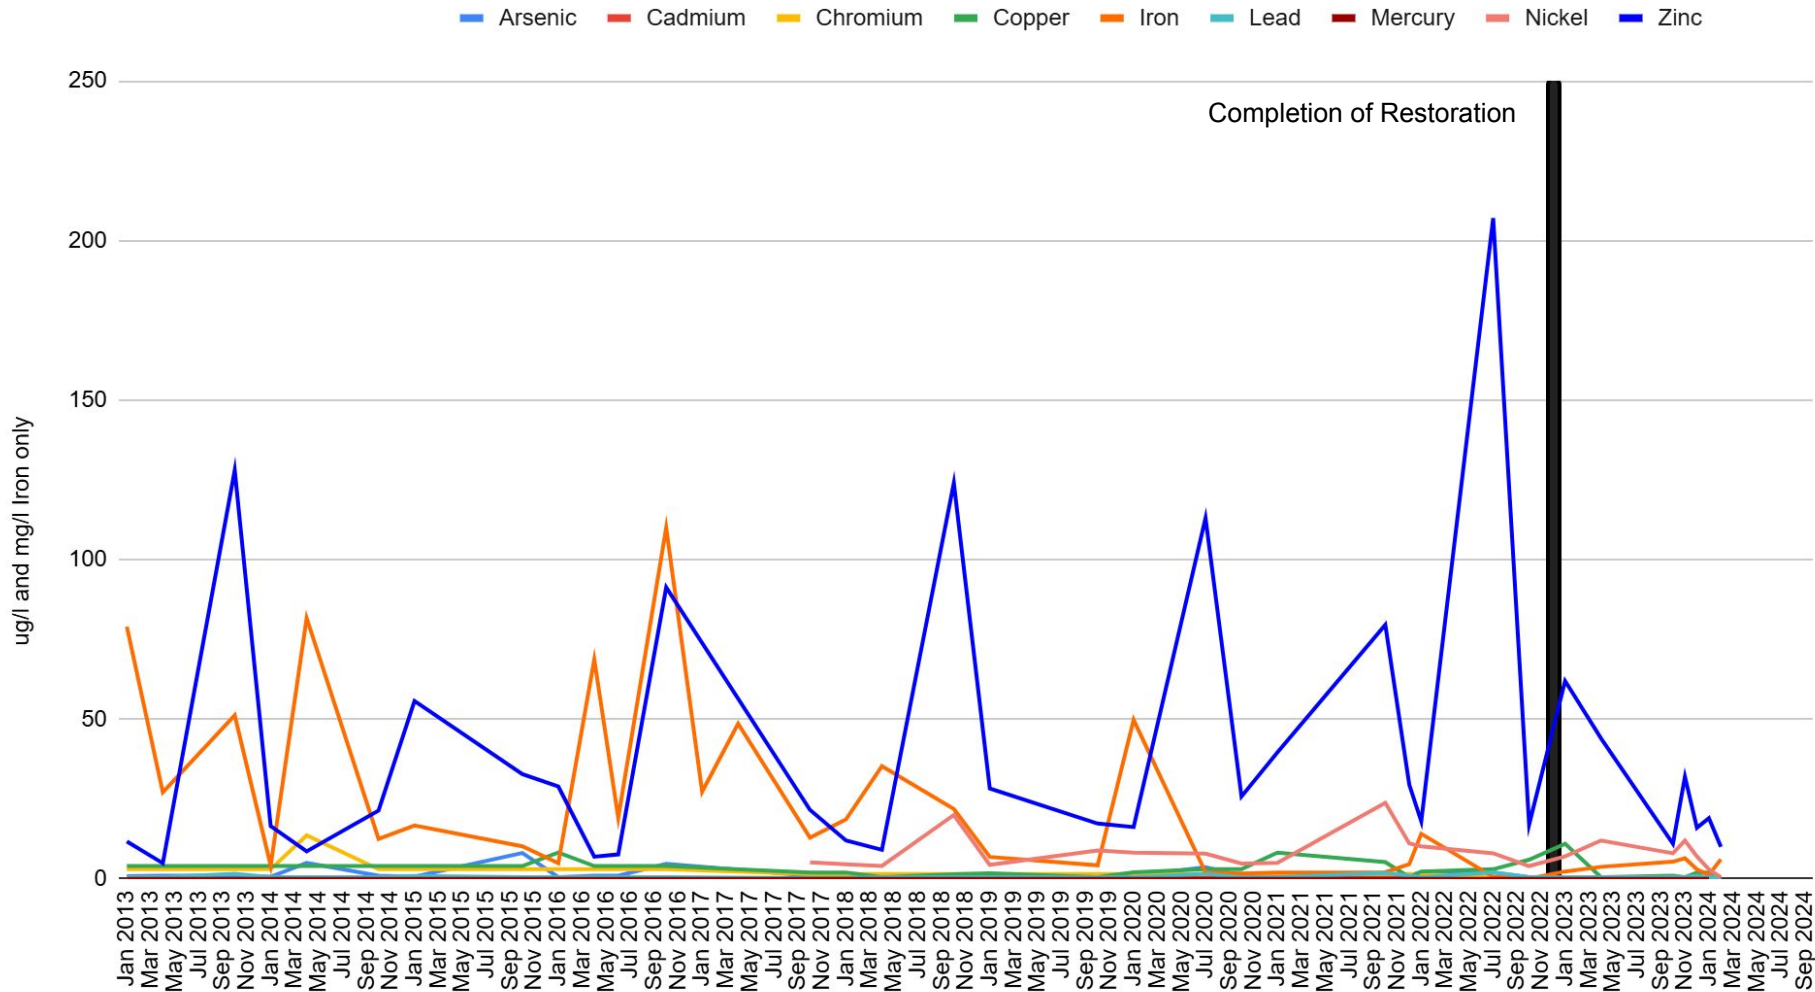
Metals quality at MAE002
