Maendy Quarry

Review of Monitoring Data and the Restoration Scheme

January 2025

Prepared by
Technical Operations - Landfill

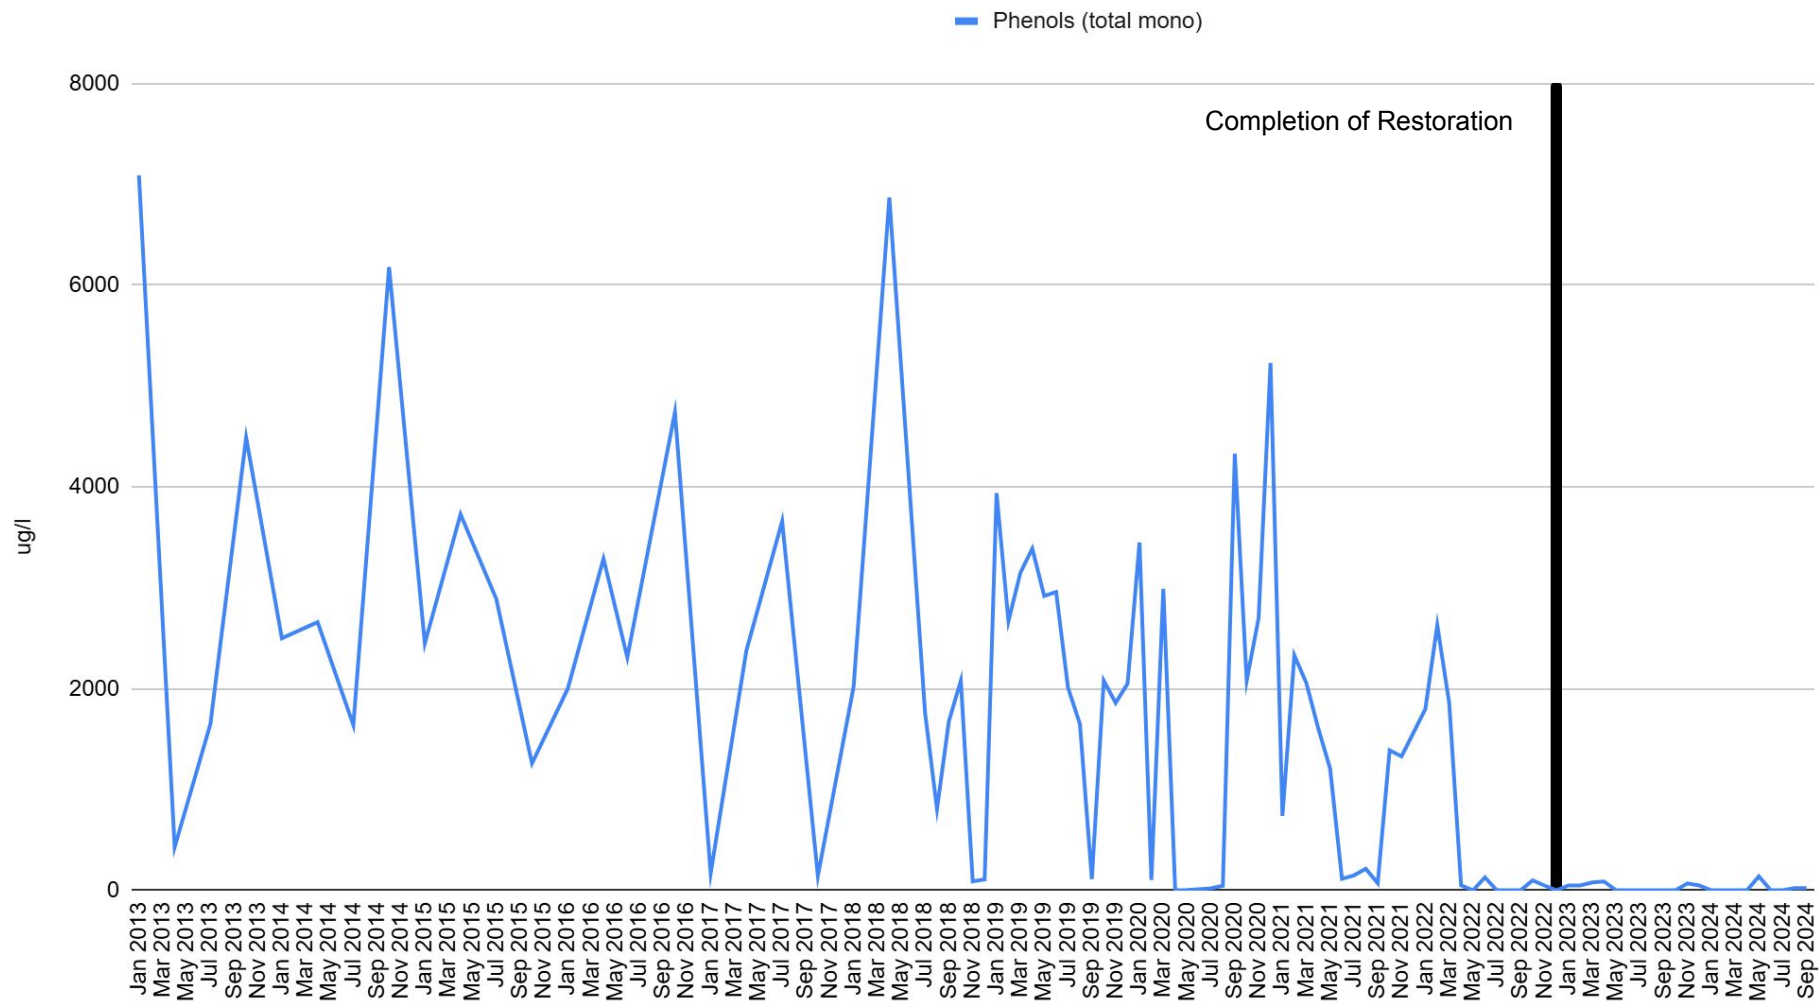
Phenols (total mono) quality at MAE001

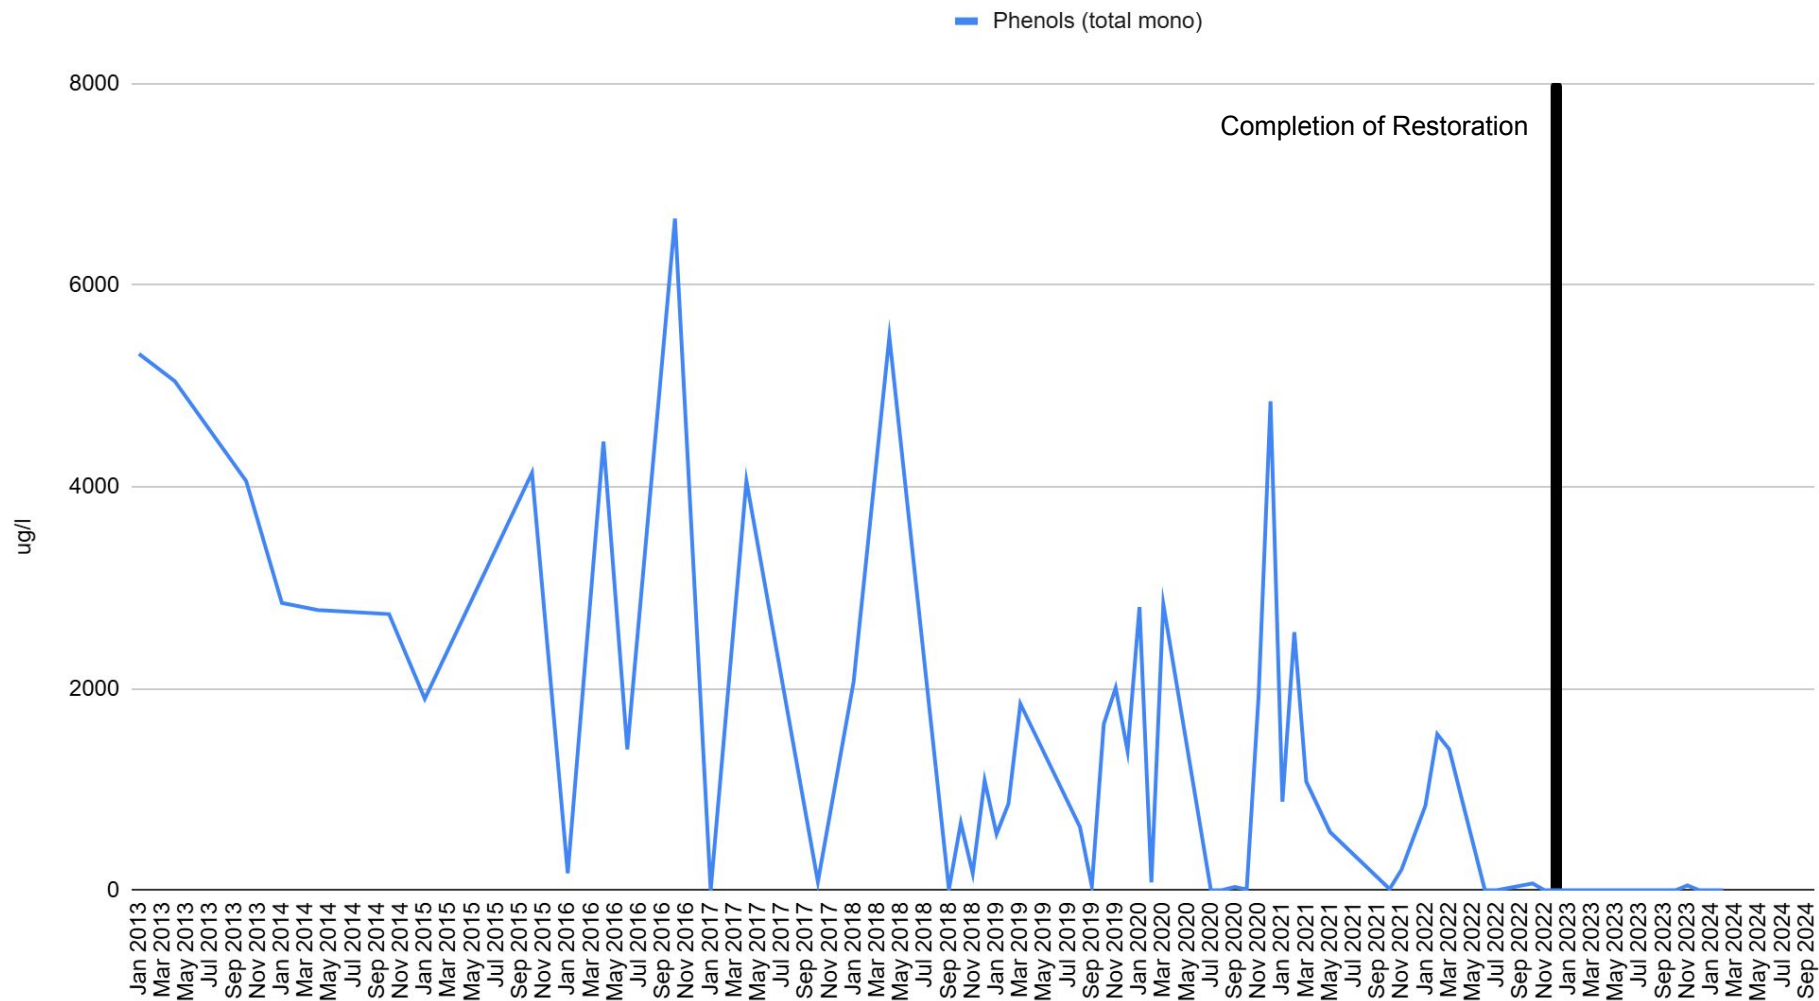
Phenols (total mono) quality at MAE002

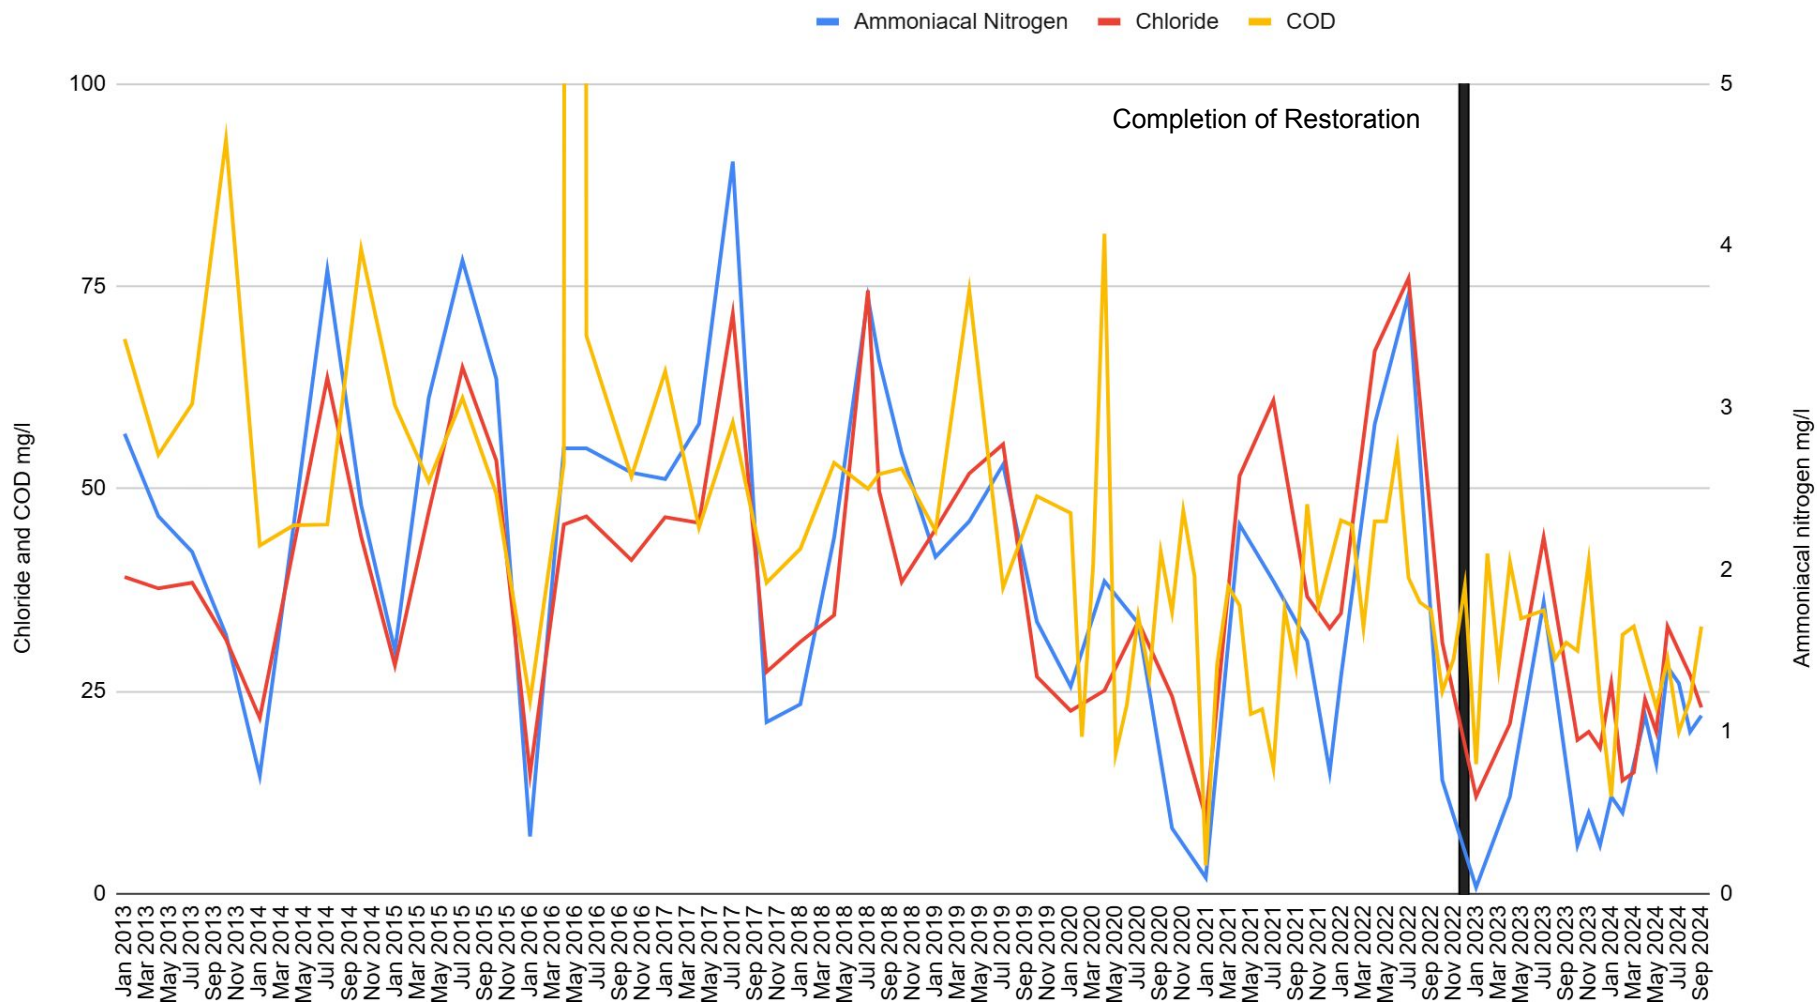
Ammoniacal nitrogen, Chloride and COD quality at MAE001

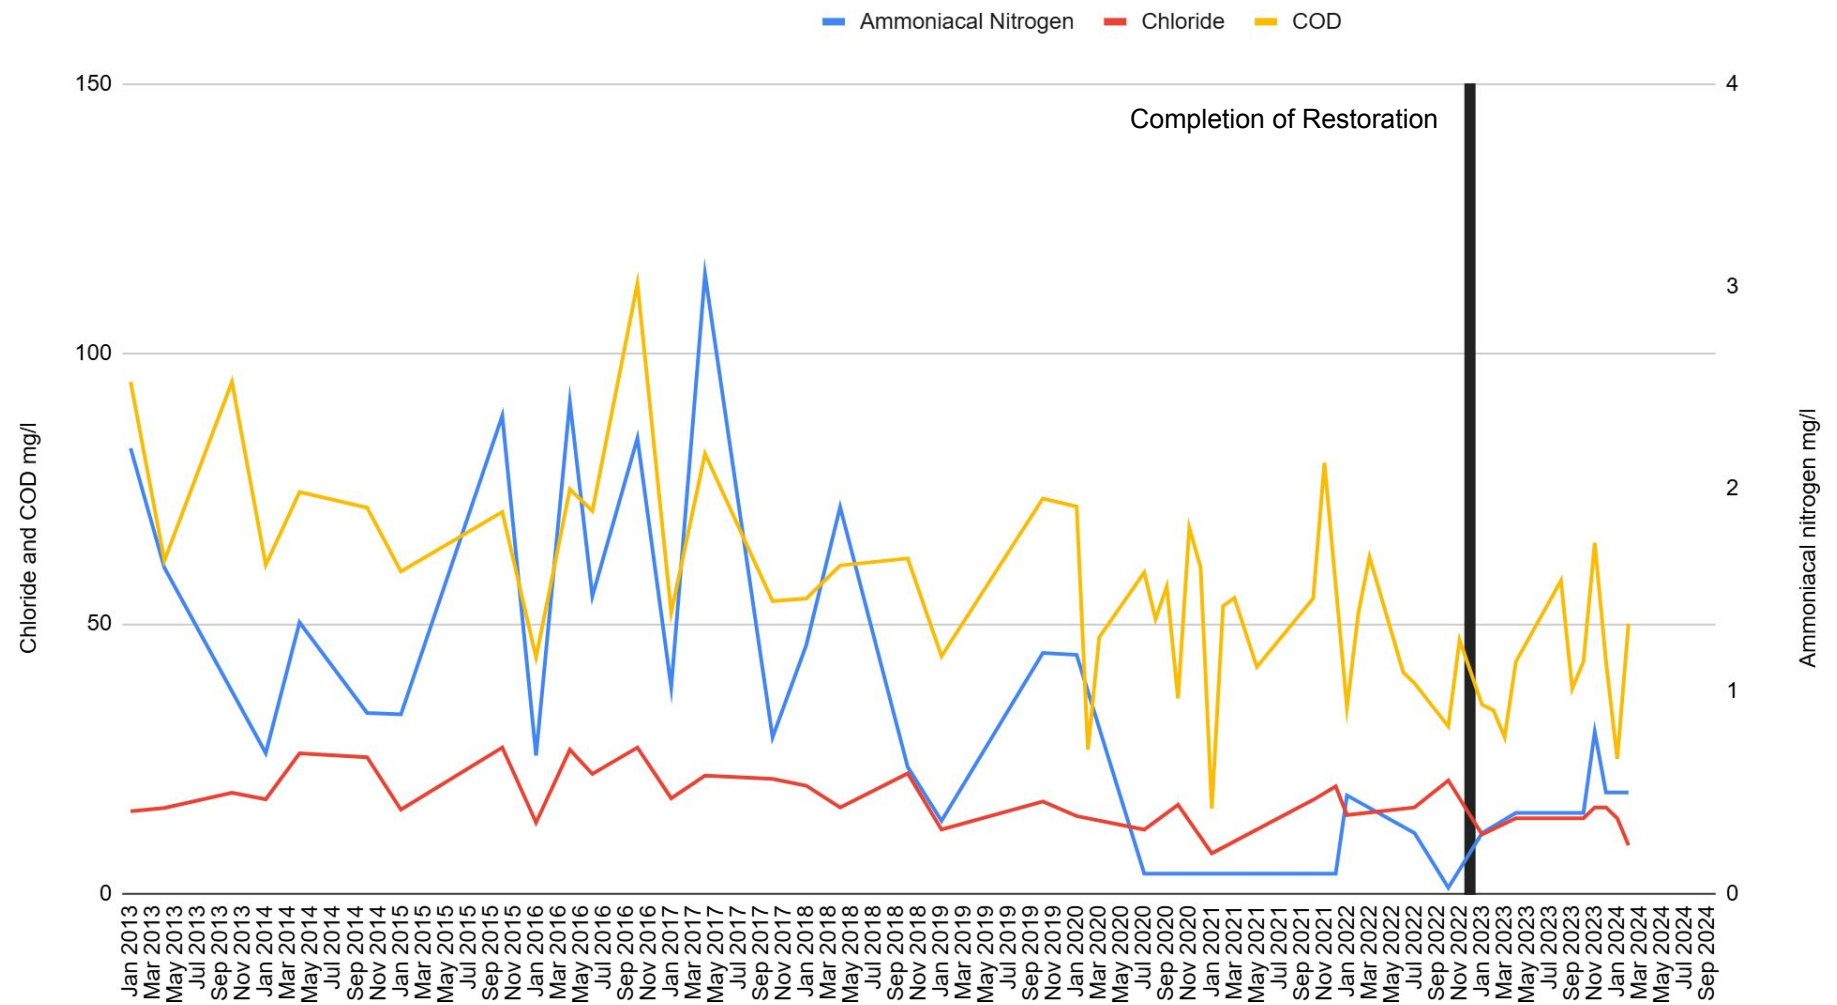
Ammoniacal nitrogen, Chloride and COD quality at MAE002

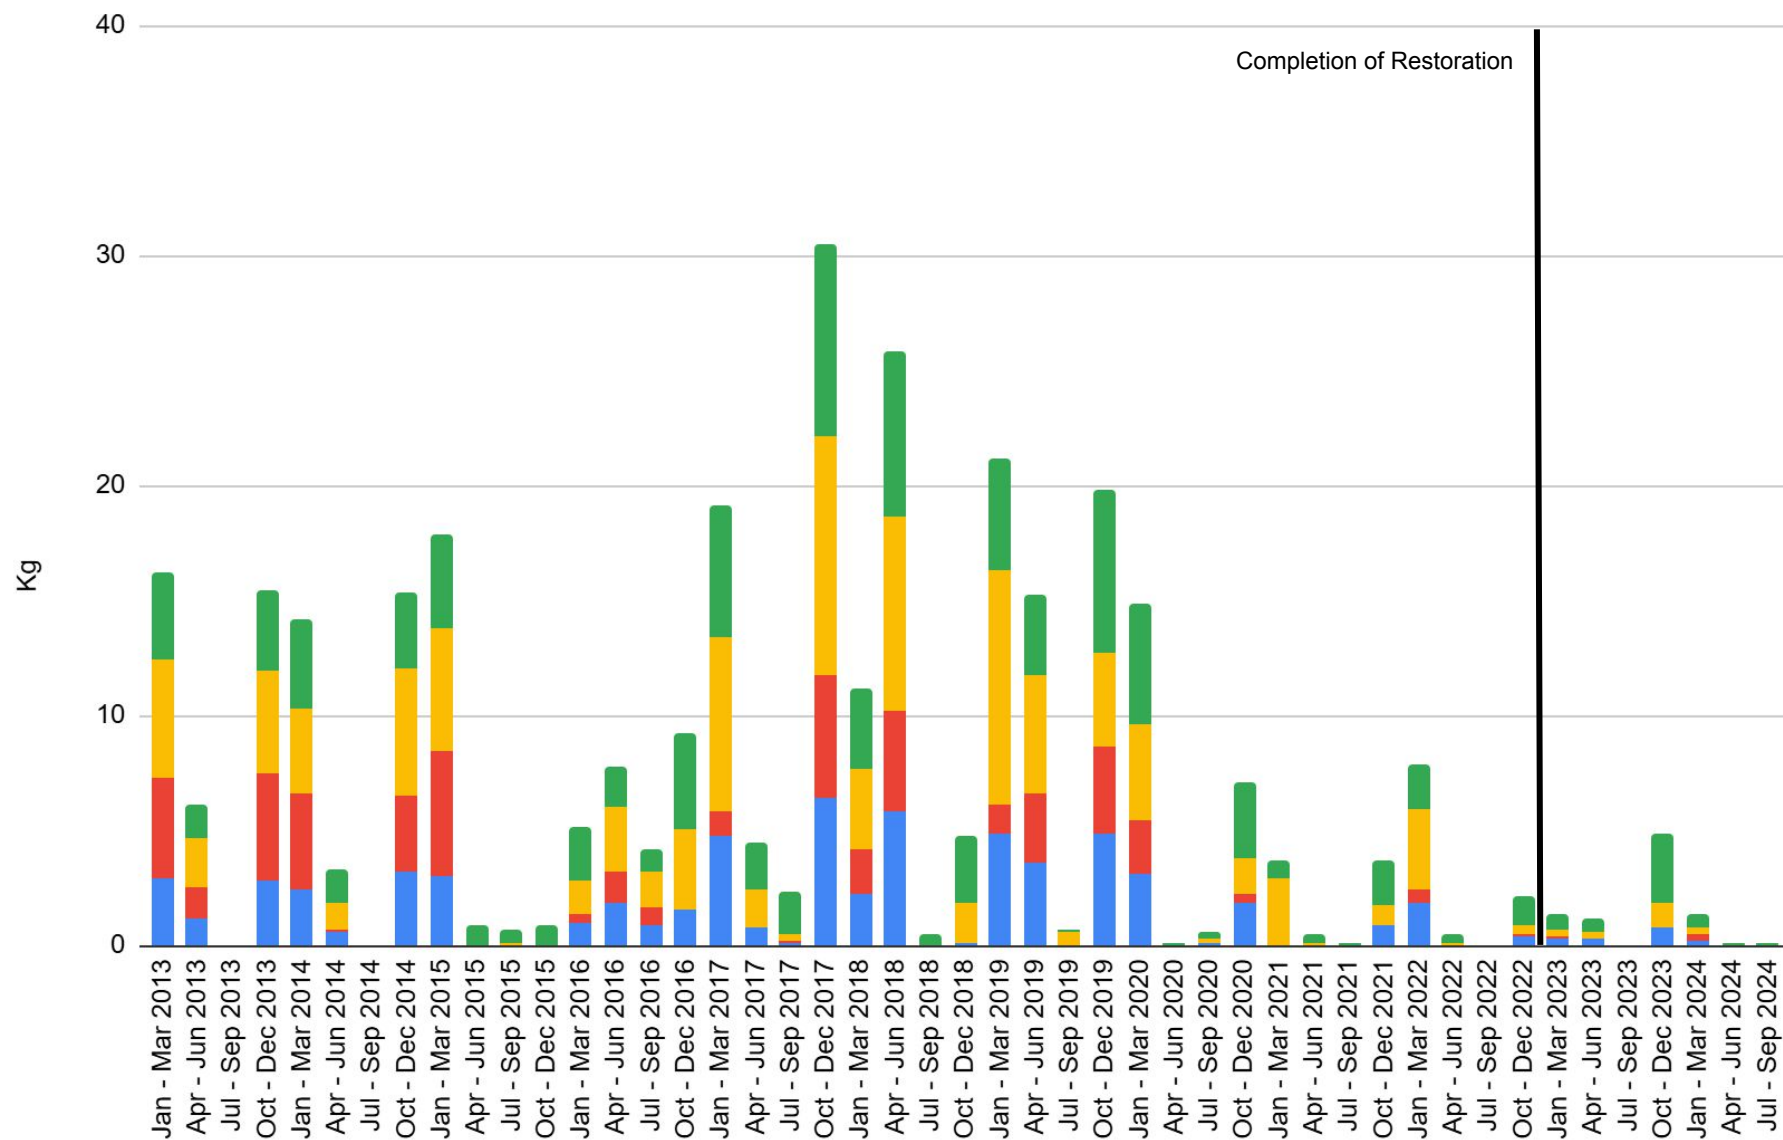
BTEX quarterly loadings at MAE001

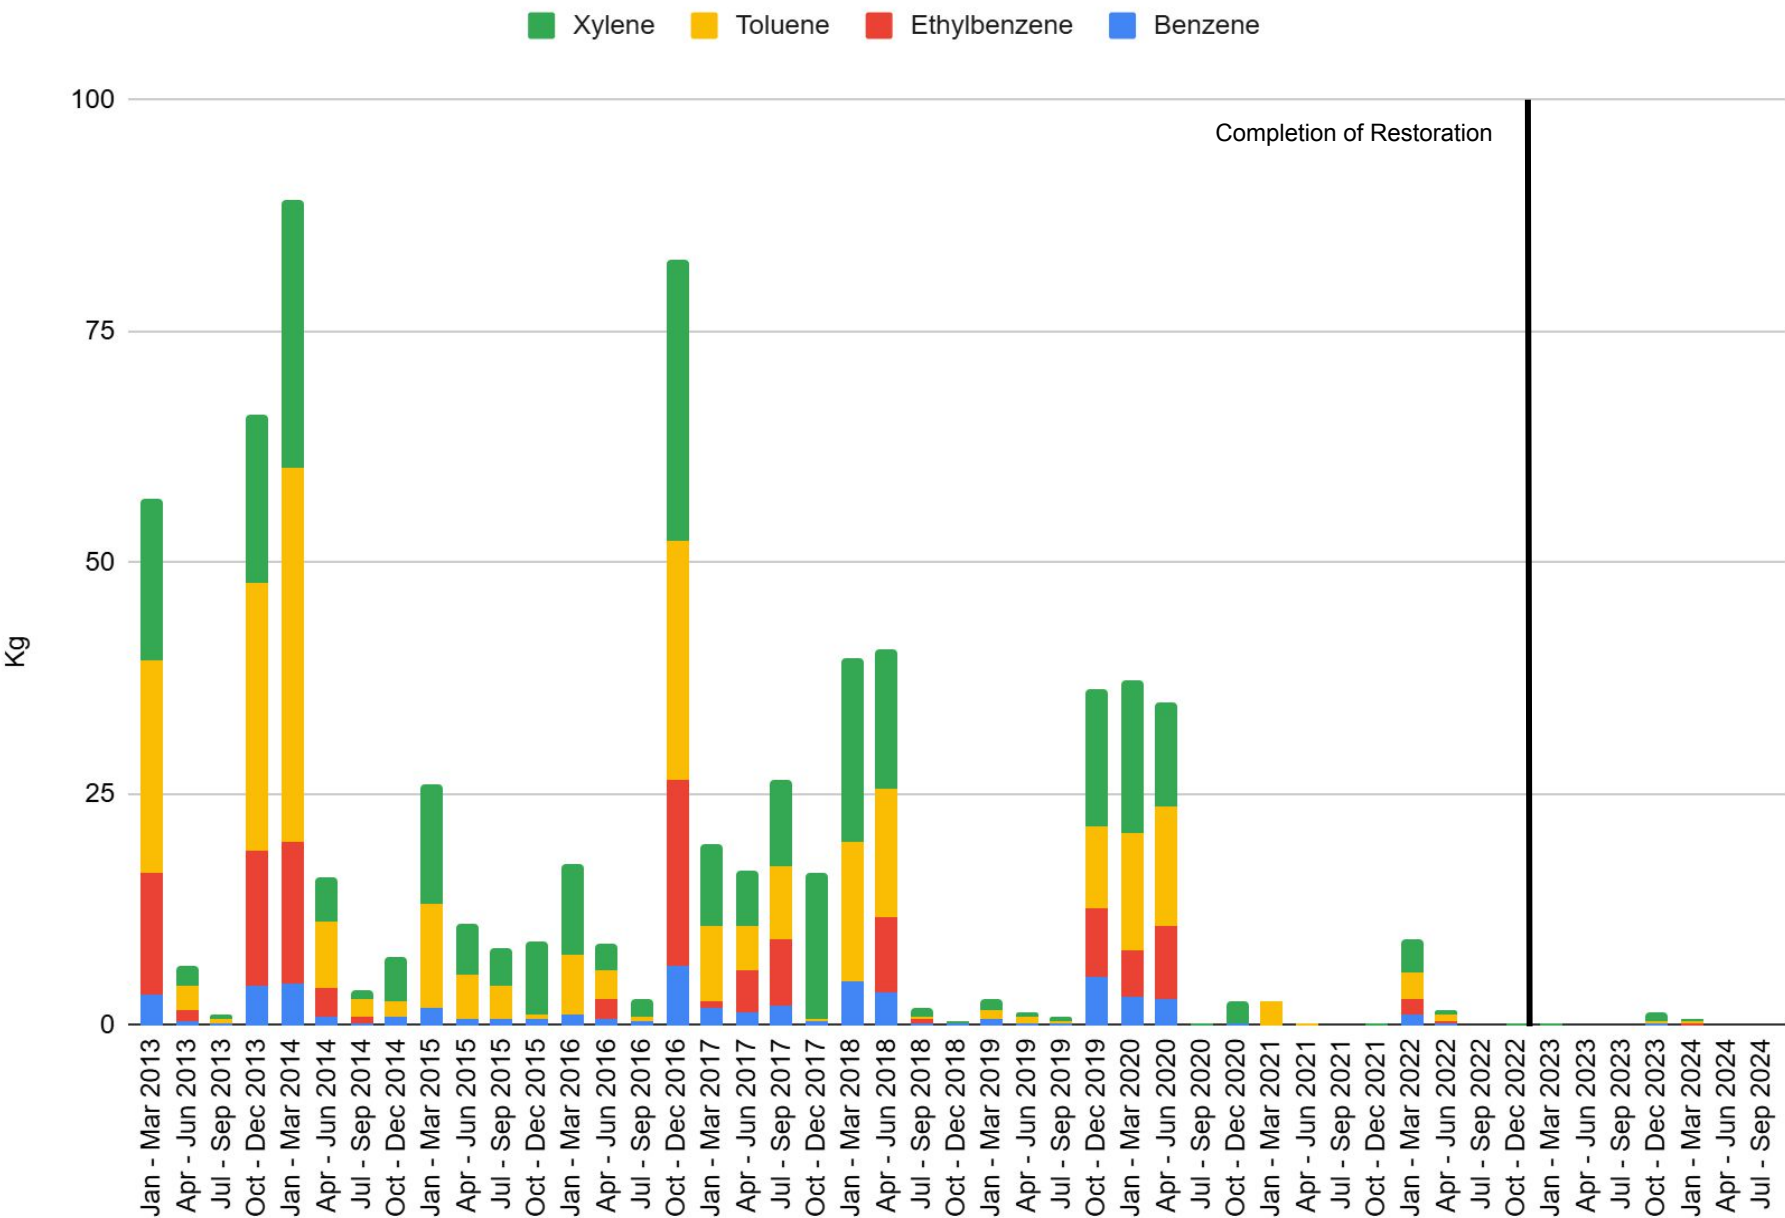
BTEX quarterly loadings at MAE002

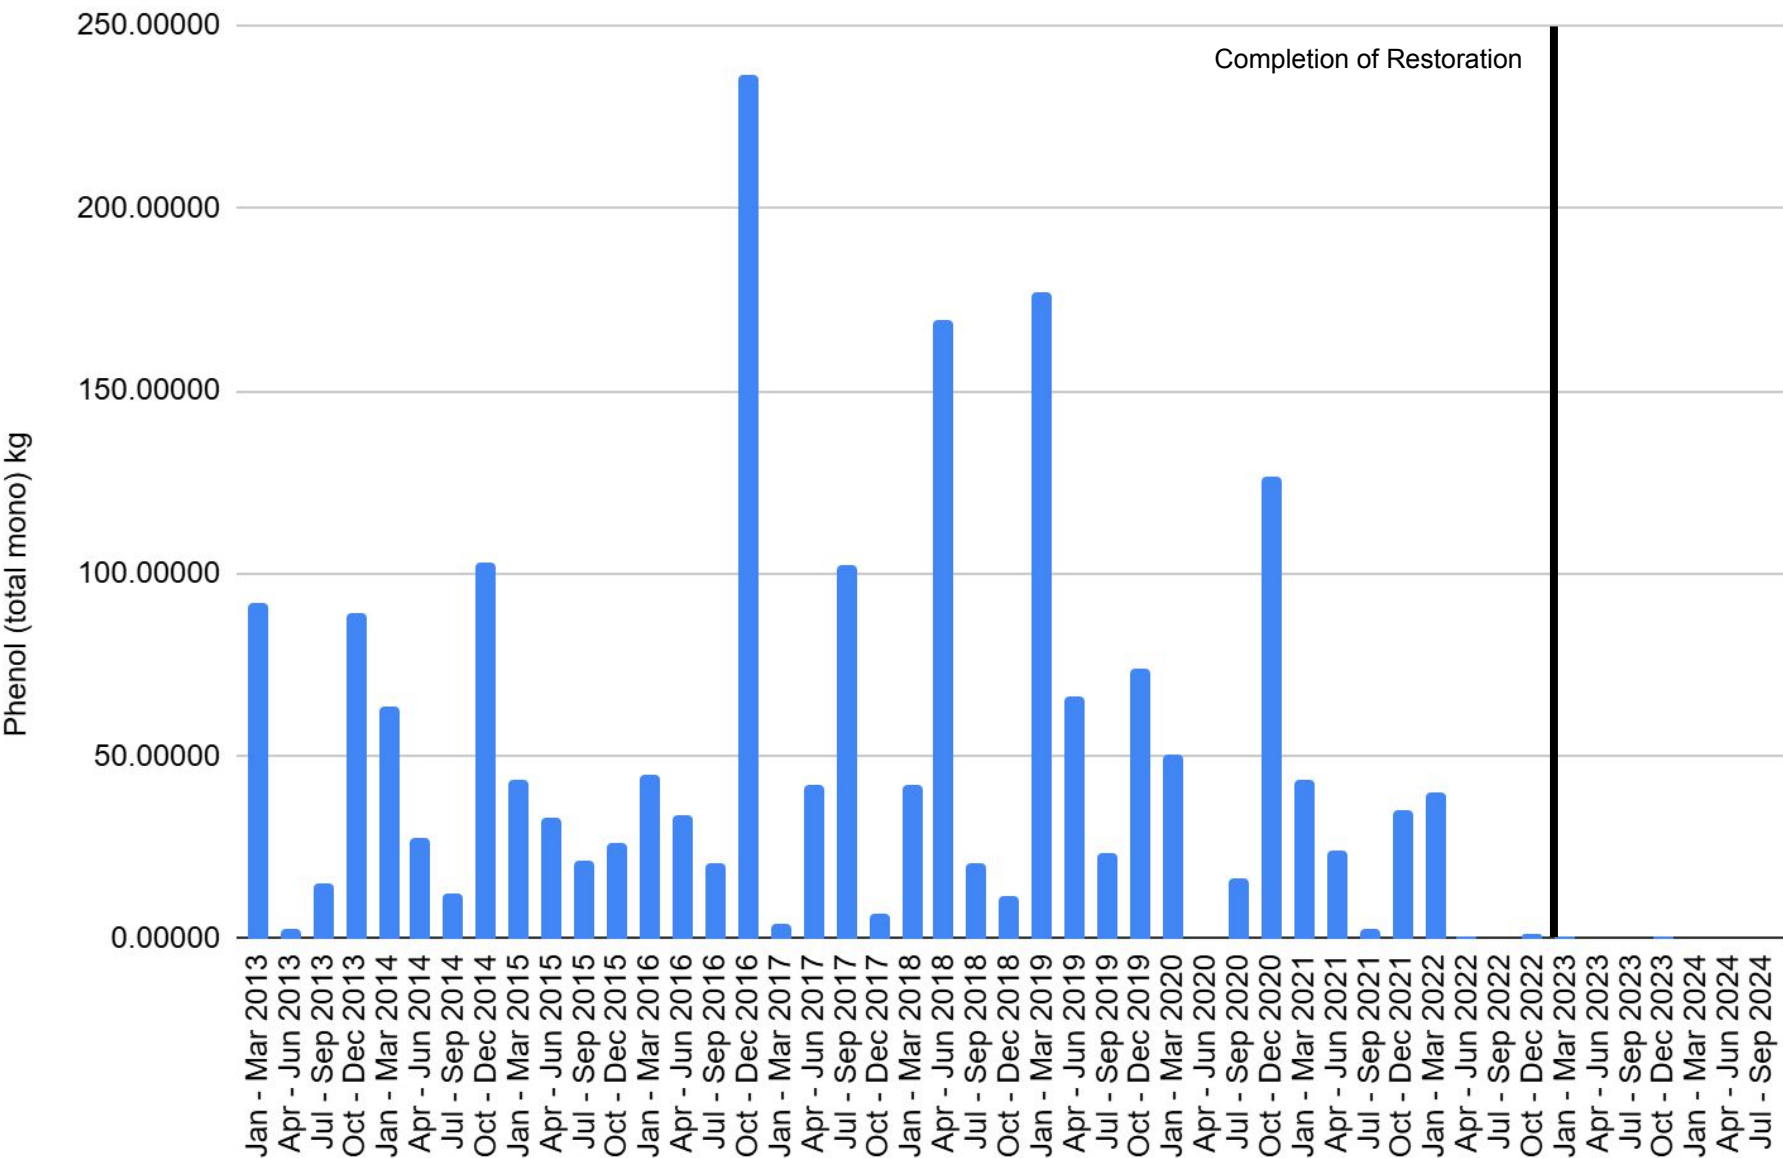
Phenol (total mono) quarterly loadings at MAE001

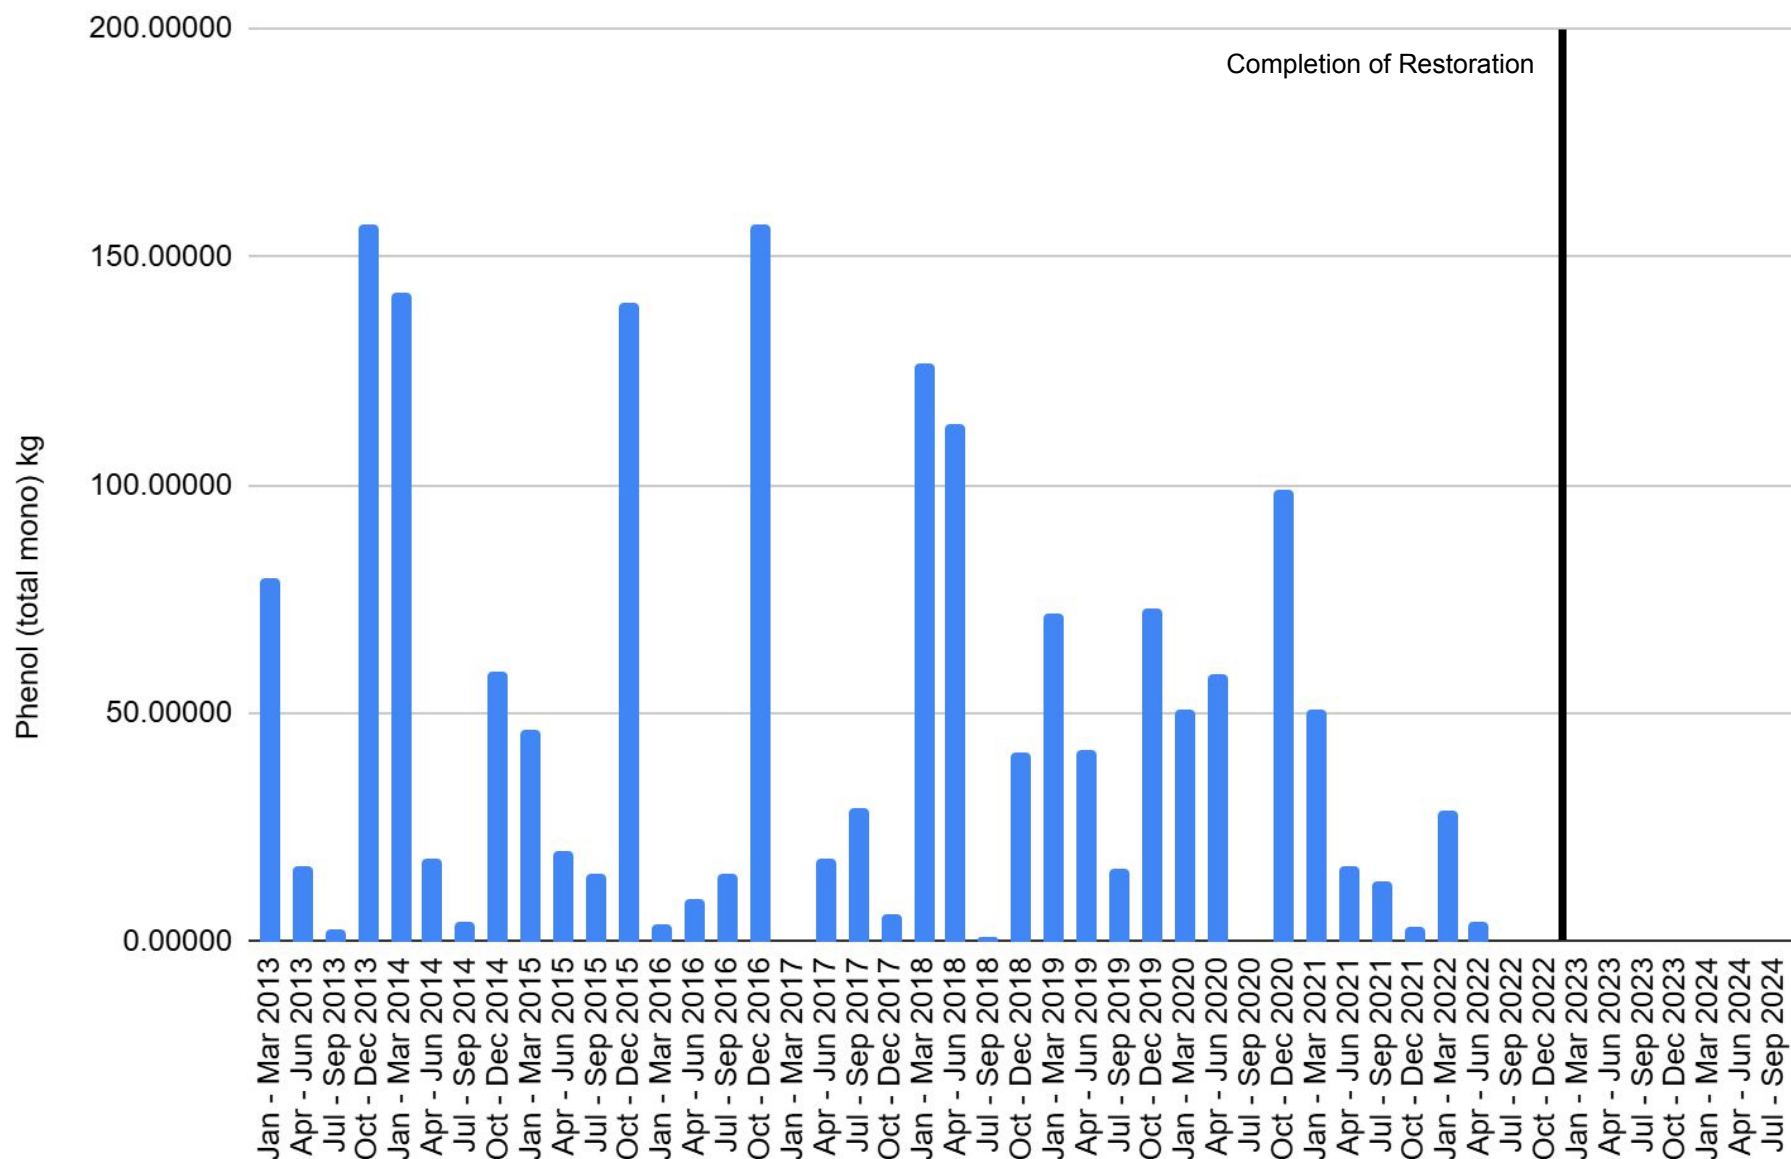
Phenol quarterly (total mono) loadings at MAE002

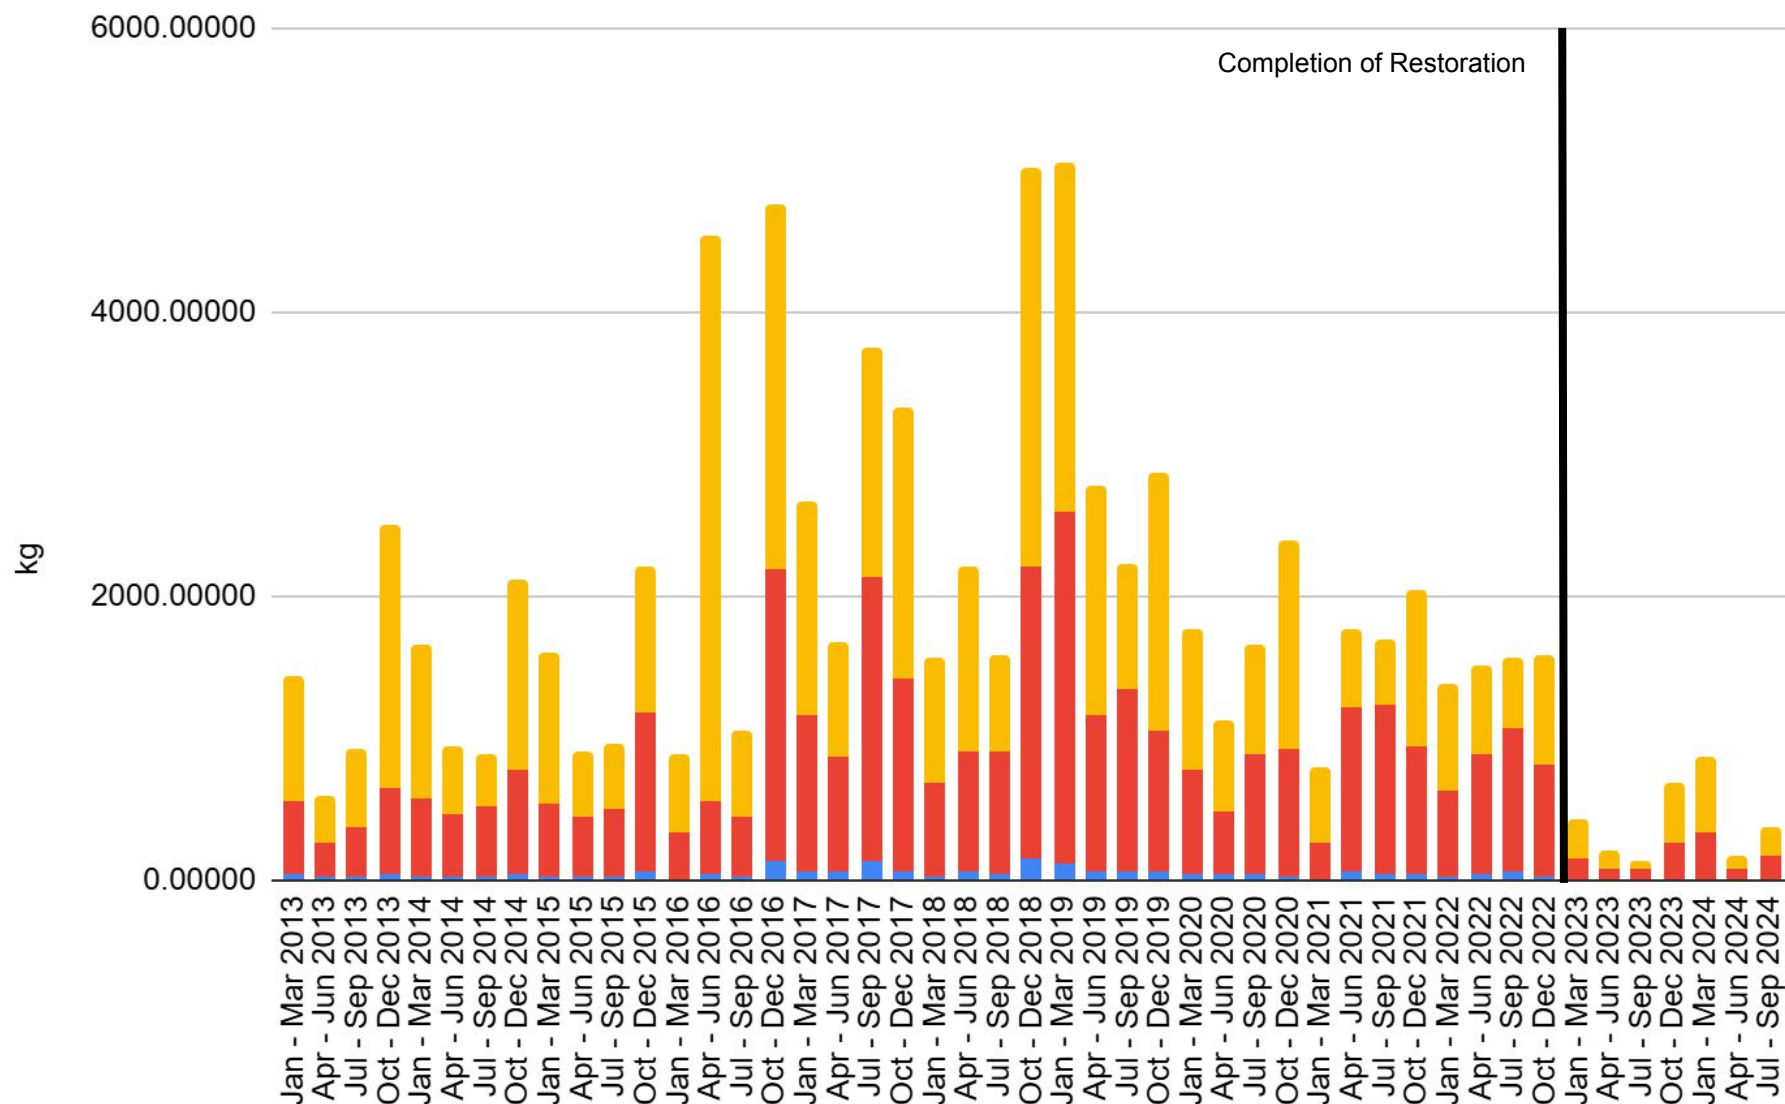
COD, chloride and ammoniacal nitrogen quarterly loadings at MAE001

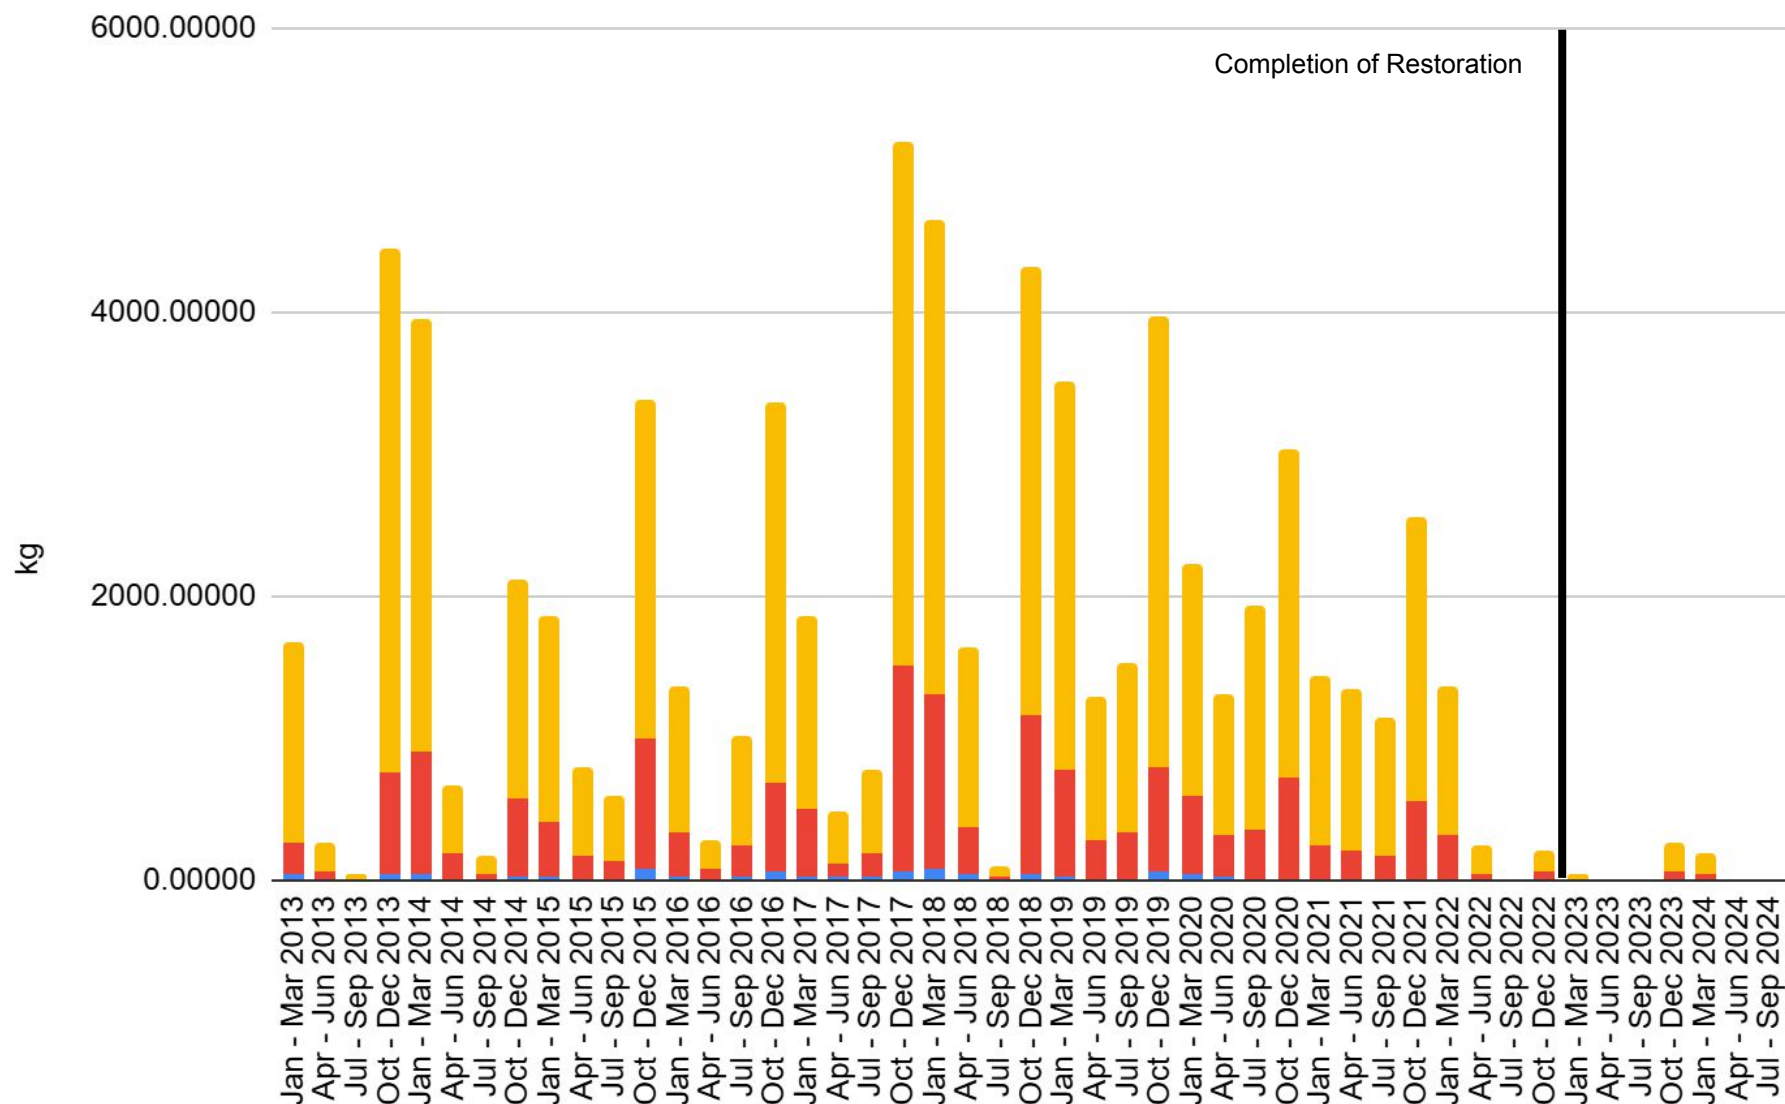
COD, chloride and ammoniacal nitrogen quarterly loadings at MAE002
