# Gwydir Mawr Preliminary Ecological Assessment

Project Number CPF 12814

| <b>Document Title:</b> | Gwydir Mawr, Trefor Preliminary Ecological Appraisal |

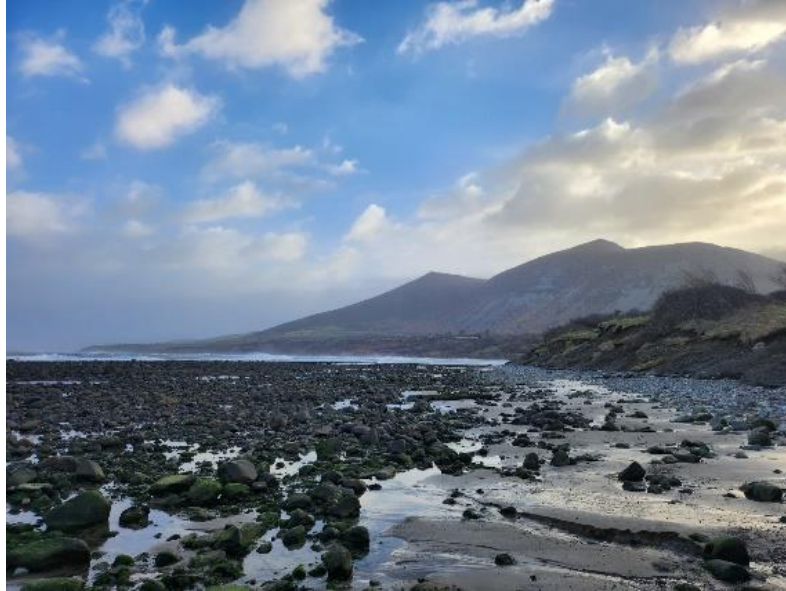
**Site Photograph No 1** – View of one of intertidal zone on site.

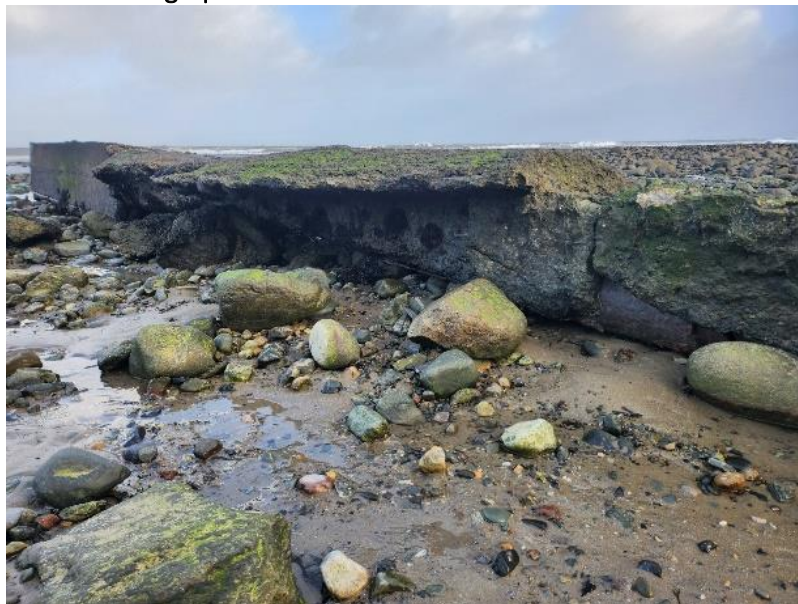
**Site Photograph No 2** – Damaged pipe.

The works of replacing the damaged drainage pipe has potential to disturb and cause a pollution incident therefore the contractor must adhere to the recommendations made in this report. They will make sure no siltation or contaminants enter the intertidal shingle and gravel stream area through good working practices such as creating a dry working area with sandbags, refuel 10m from the intertidal area and riverbank, no storage of materials within 10m of the intertidal area or riverbank and having an emergency response plan in place should there be a fuel leak on site. Following good working practices and adhering to the pollution prevention guidelines effects on the intertidal area and watercourse and water quality can be ruled out.

A narrow strip approximately 1m x 5m of intertidal shingle and gravel will need to be temporarily set aside in the area of the works to enable the new pipe to be put in place (details of the works will be included in the Client's drawings included in the appendix of this report when available). The shingle and gravel will then be replaced over the new pipe. Leaving the material on site will ensure any fauna will remain on site with minimal disturbance.

- Arising's from the works should be carefully moved to one side and then replaced over the pipe when the works are completed. Should any materials need to be removed off site, they must be collected and disposed of in accordance with the relevant waste regulations.

Works must start at least one hour after dawn and end one hour before dusk to avoid impacts on nocturnal animals including bats and otters that use the shoreline for foraging and commuting. All works to be carried out in the dry over low water. If intertidal stones are moved any fish will be rescued and replaced under nearby stones.

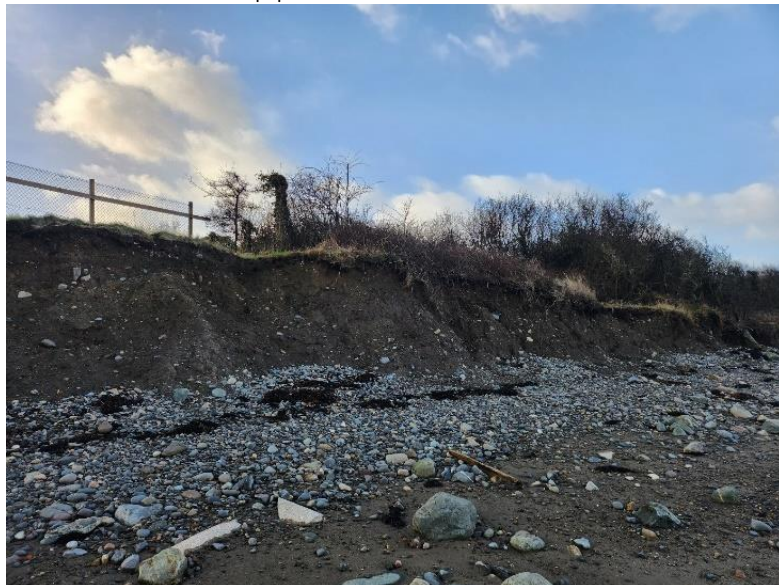
Site Photograph No 4 – Terrestrial area and till deposit.

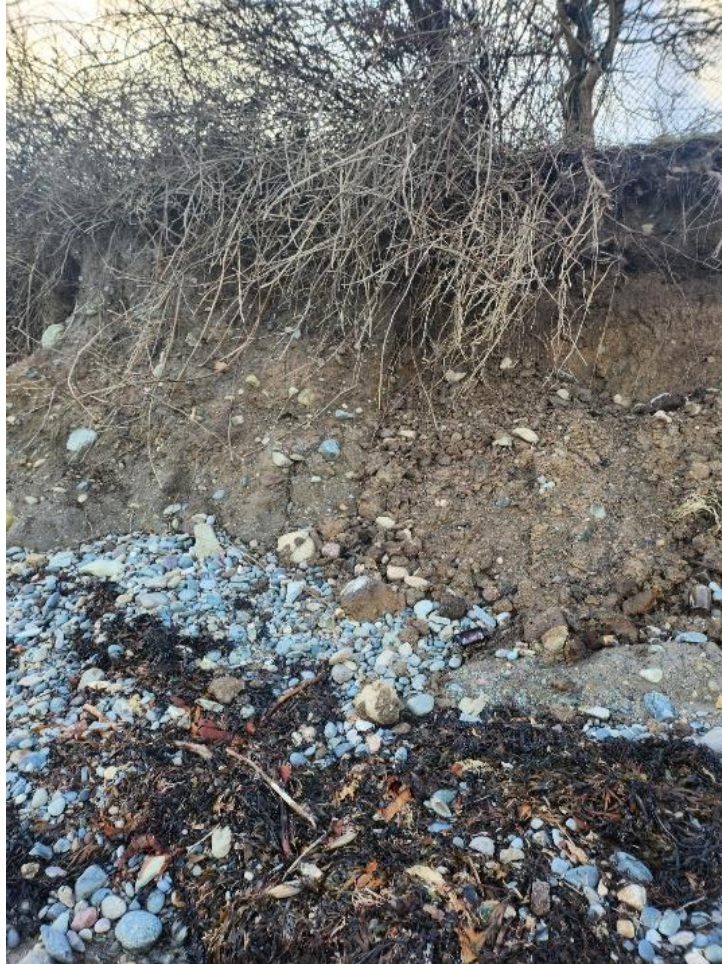
Site Photograph No 5 – Blackthorn on top of the cliff area.

There are no trees in the area of the damaged pipe. The blackthorn on top of the slope directly south will not be affected by the works of repairing the damaged pipe. However, the contractor must adhere to Trees in Relation to Design, Demolition and Construction British Standards 5837 (2012) therefore root protection must be included to ensure no damage to the tree roots on site.

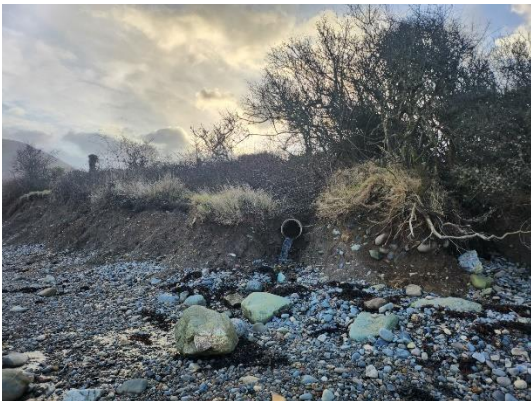
An unnamed stream runs out to sea approximately 10m west from the damaged drainage pipe and the water was clear at low level during the survey. Rivers and streams are extremely important LBAP habitats. Rivers and streams, including their bankside vegetation as well as providing a habitat for otters and water voles, rivers and their banks act as corridors for many species. Rivers are of great importance to both habitats and species, which are listed on Schedule 7 priority habitat.

Site Photograph No 6 – Culverted unnamed watercourse outlet.

There are no works in the ordinary watercourse therefore no permit is required. As the works are near the intertidal zone the works has potential to disturb and cause a pollution incident therefore the contractor must adhere to the recommendations made in this report and in the Marine Licence when it arrives. They will make sure no siltation or contaminants enter the intertidal zone through good working practices, refuel 10m from the intertidal zone, no storage of materials within 10m of the riverbank and having an emergency response plan in place should there be a fuel leak on site. Following good working practices and adhering to the pollution prevention guidelines effects on the intertidal zone and water quality can be ruled out.

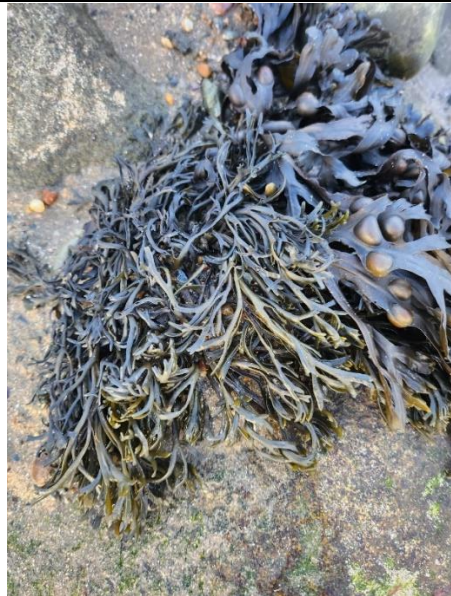
Algae recorded on site include spiral wrack *Fucus spiralis* and channelled wrack *Pelvetia canaliculate*.

Site Photograph No 7 - Channelled wrack on the left and spiral wrack on the right side.

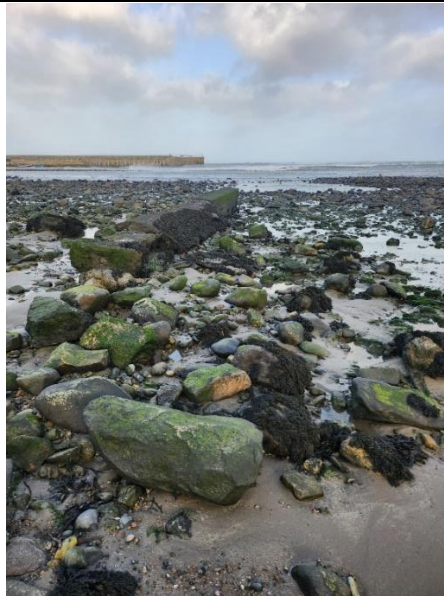
Channelled wrack was also attached to the broken drainage pipe.

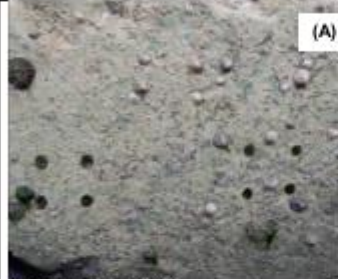
| <p><b>Description</b></p> <p>Retrofitting rock armour or concrete surfaces with habitat features by drilling small and varied diameter holes - pits (A), grooves (B) and/or recessed crevices.</p> <p>The aim is to provide water retaining features and/or refuge and/or secure anchor points which improve ecosystem heterogeneity.</p> | |
| <p>(A)</p> <p>[Source: Hall et al. (2018)]</p> | <p>(B)</p> <p>[Source: Hall et al. (2018)]</p> |

| <p><b>Effectiveness: benefits assessment</b></p> <ul style="list-style-type: none"> <li>• Increase in species diversity compared with business as usual in both holes and grooved treatments. 6 of 10 functional groups were unique to the drilled pits (Firth et al., 2014).</li> <li>• The increase in species diversity was greatest on the grooved treatments (Naylor et al. 2017).</li> <li>• Species of commercial importance were only found in the enhanced areas demonstrating that this technique provided supporting ecosystem services (Naylor et al. 2017).</li> <li>• Limestone had higher overall species richness and diversity than the granite rock armour (Naylor et al. 2017).</li> </ul> | <p><b>Challenges: limitations and risks</b></p> <ul style="list-style-type: none"> <li>• Need to be certain that structural integrity / durability will not be affected – may require a sacrificial layer of concrete.</li> <li>• Over time, effects lessened as the pits were filled with sessile species reaching a biodiversity maximum.</li> <li>• Due to local hydrodynamics the bed level of the foreshore rose unevenly resulting in some features being 'lost'.</li> <li>• Since many experiments are at the plot scale rather than at the full structure, it's unclear whether interventions actually enhance biodiversity or aggregate organisms already on the structure.</li> </ul> |
