**REMEDIATION VALIDATION  
REPORT  
Escrow Site 1  
(Rectifier Yard)**

**20/0626/01.3**

**Orthios Eco Park  
Former Penrhos Works  
Holyhead  
LL65 2UX**

**Geo<sup>2</sup> Remediation Ltd**

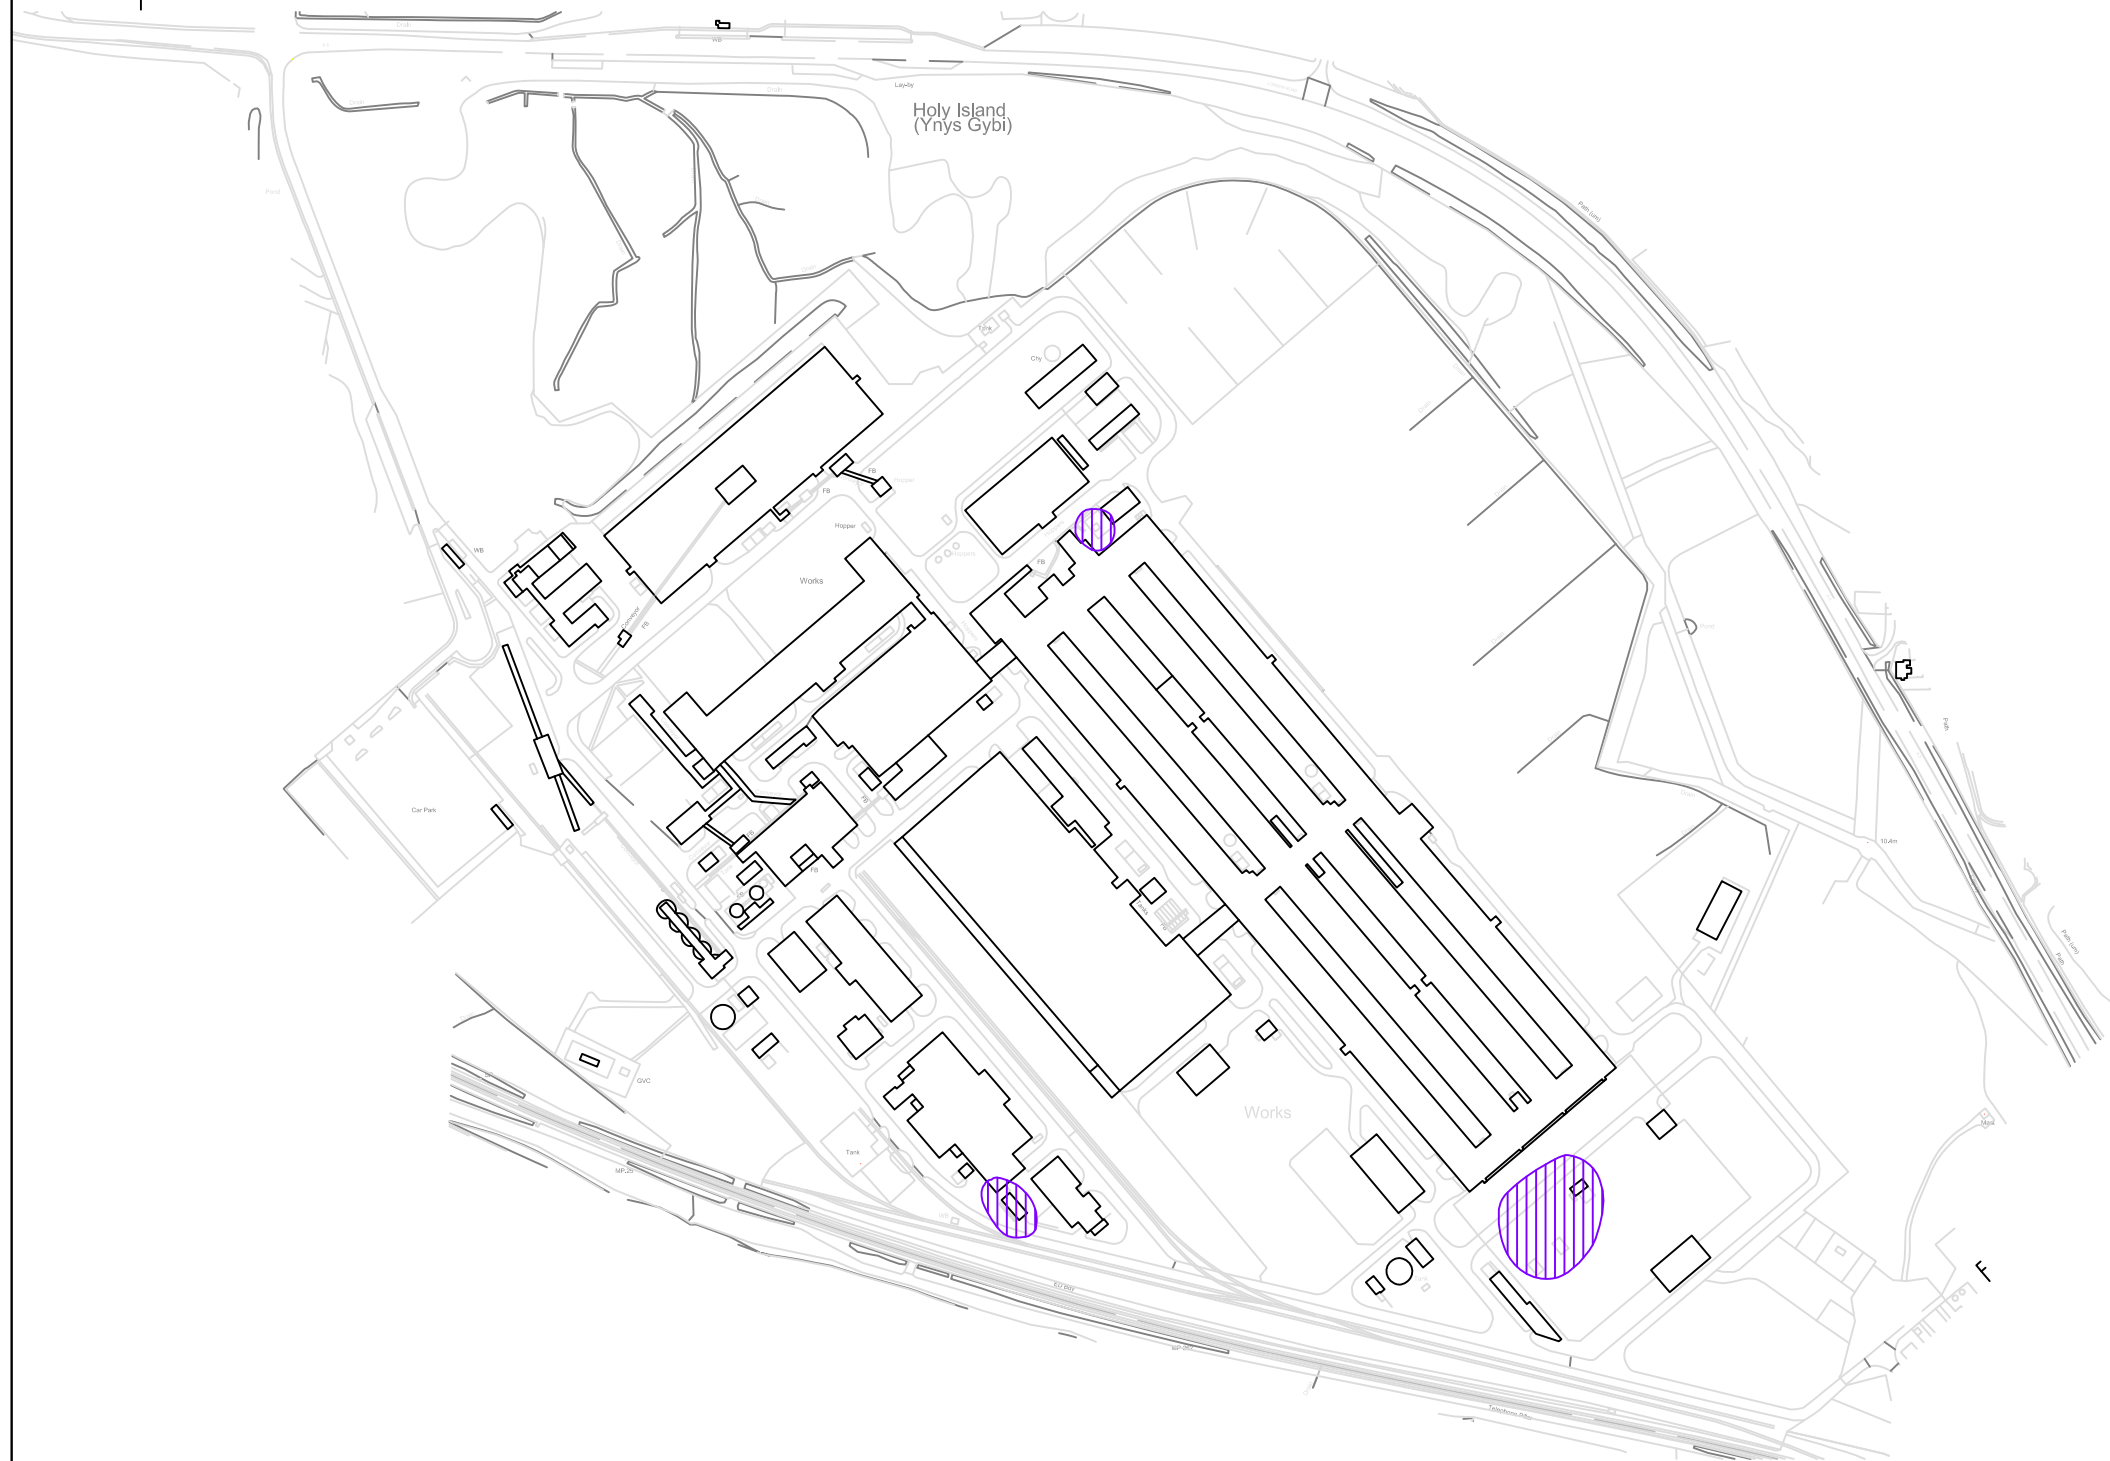
## Figure 2

### Plumes Across Anglesey Aluminium Site

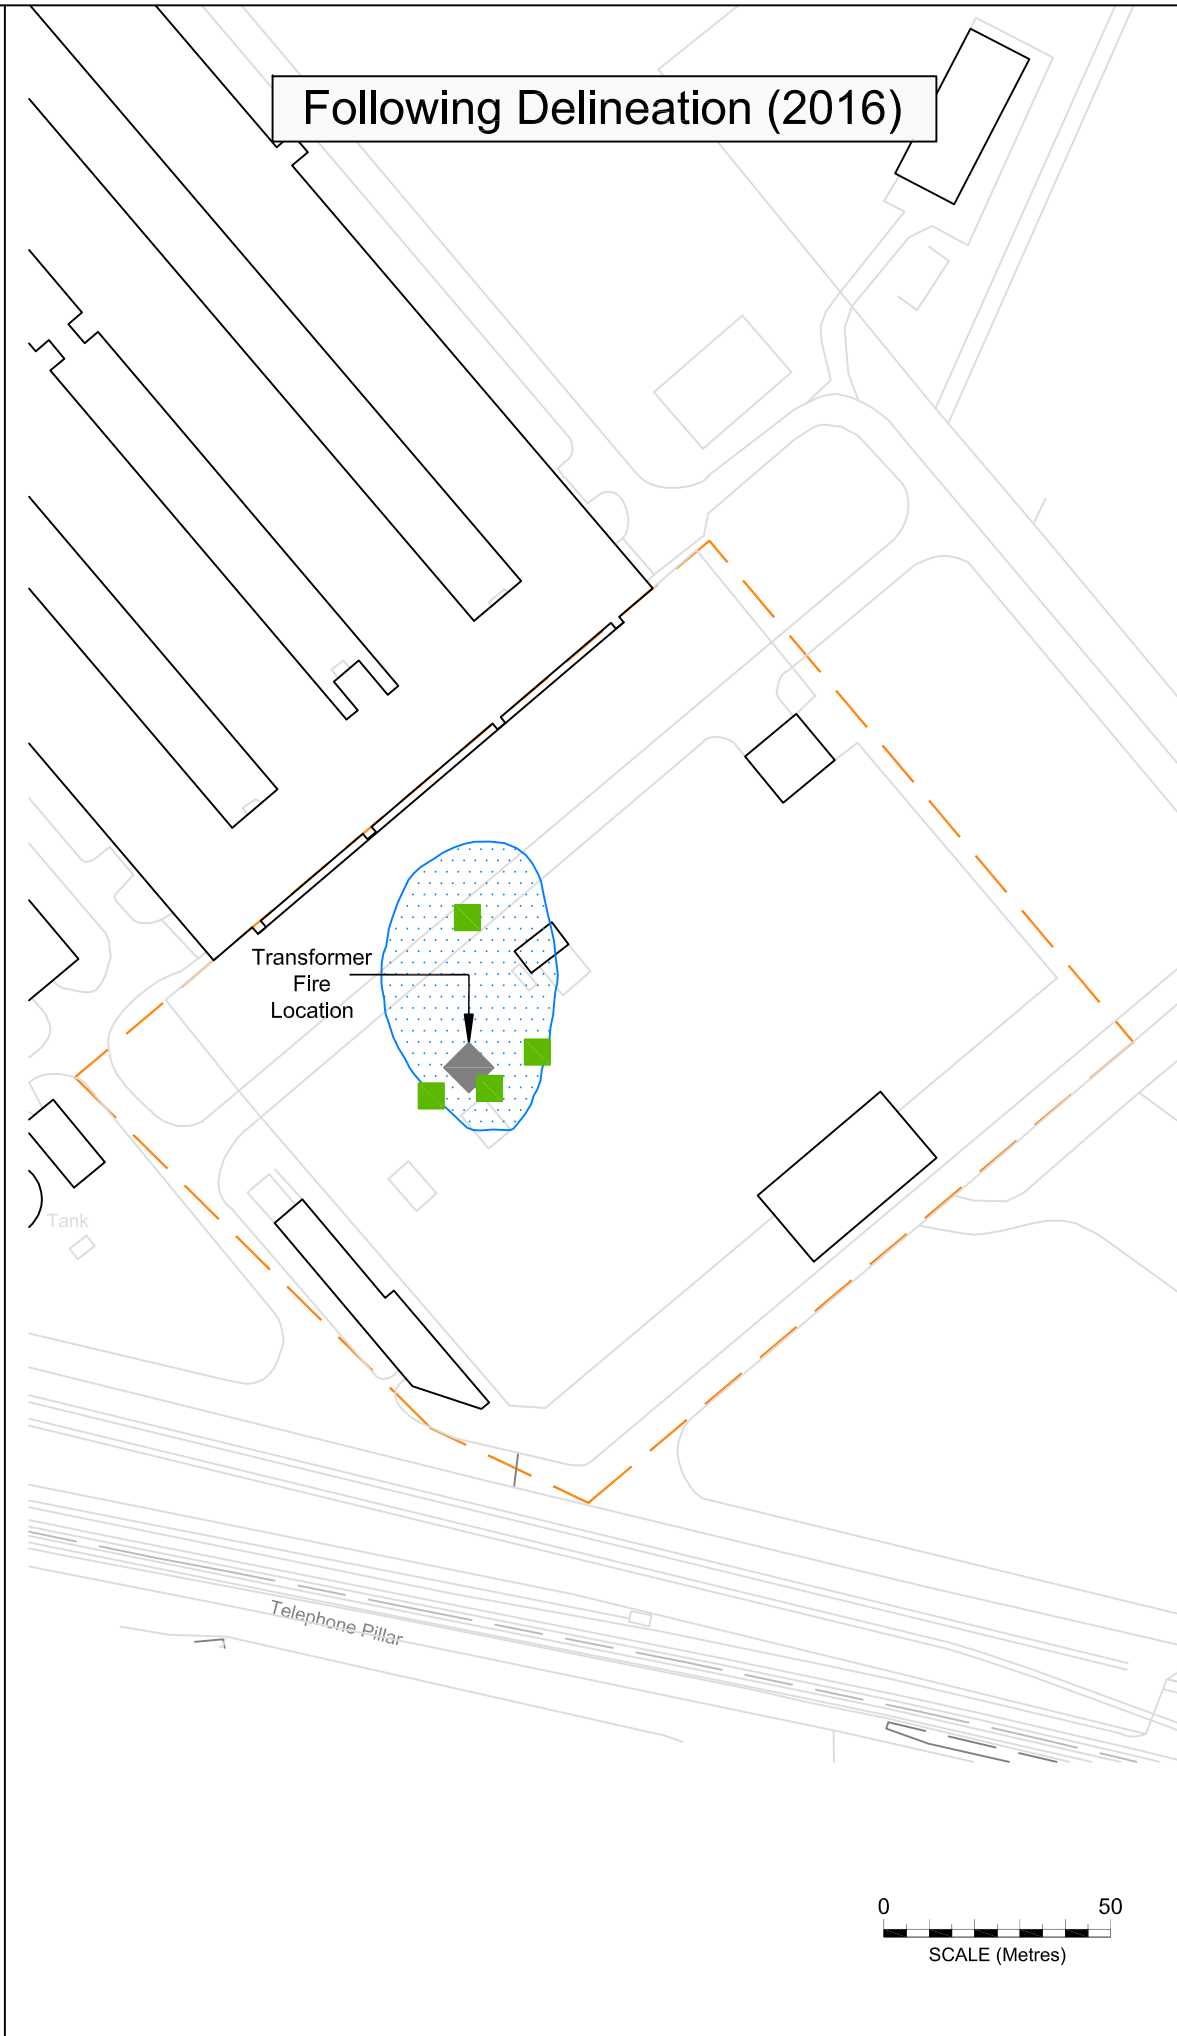
**Figure 4**

**Plume Delineation Superficial**

- Rectifier Yard Extents
- Estimated Plume Extent (Before Delineation)
- Plume Extent (After Delineation)
- Free Product (2009)
- Free Product (2013)
- Free Product (2016)
- Transformer Fire Location
