## Compliance Assessment Report CAR\_NRW0048174

**Permit being assessed:** AN0237001

For: CONCRETE BATCHING PLANT WAUN-Y-POUN, held by HANSON AGGREGATES  
At: CONCRETE BATCHING PLANT, WAUN-Y-POUND INDUSTRIAL ESTATE, EBBW  
VALE, BLAENAU GWENT, NP23 6PL.

**Type of assessment carried out:** Site Inspection, Reason: Routine.

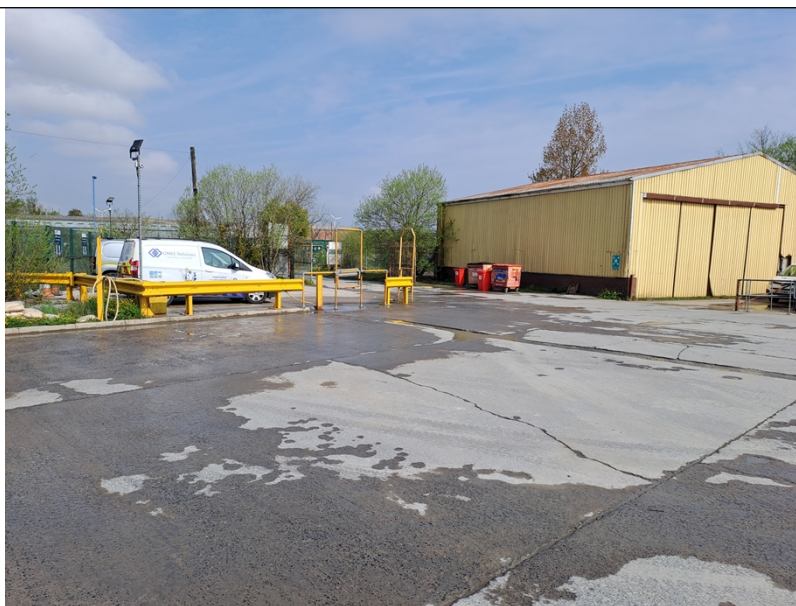
A general site walkover and condition assessment was undertaken to begin my visit. The yard was in a good condition, with no standing water or excessive silt/debris present, as seen in Figures 1 & 2. It was noted that the site no longer uses detergent to wash down plant/machines after the visit in 2020 highlighted this as an issue. As a result, no foam was observed anywhere on site.

Figure 1 – General site conditions at the time of the visit.

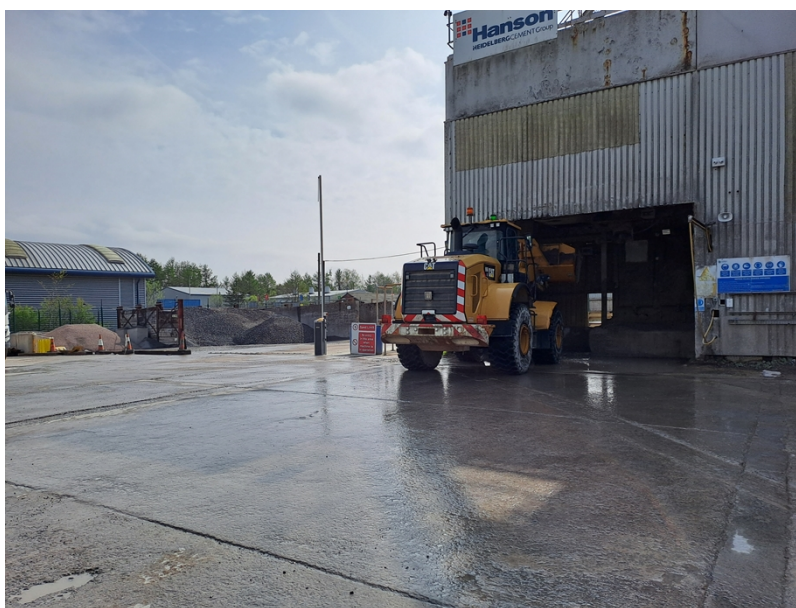
Figure 2 – General site conditions at the time of the visit.

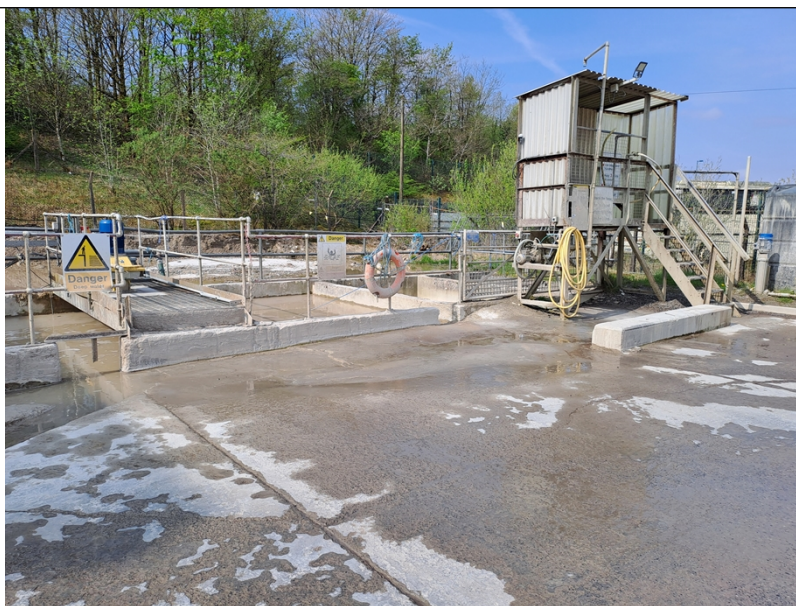
The operators endeavour to capture and re-use as much water on site as possible through channelling surface runoff back into the treatment system tanks. These channels can be seen in Figure 3 leading to the treatment tanks.

Figure 3 – Treatment tanks at the time of the visit with surface water drainage channels visible directing water into the treatment tanks.

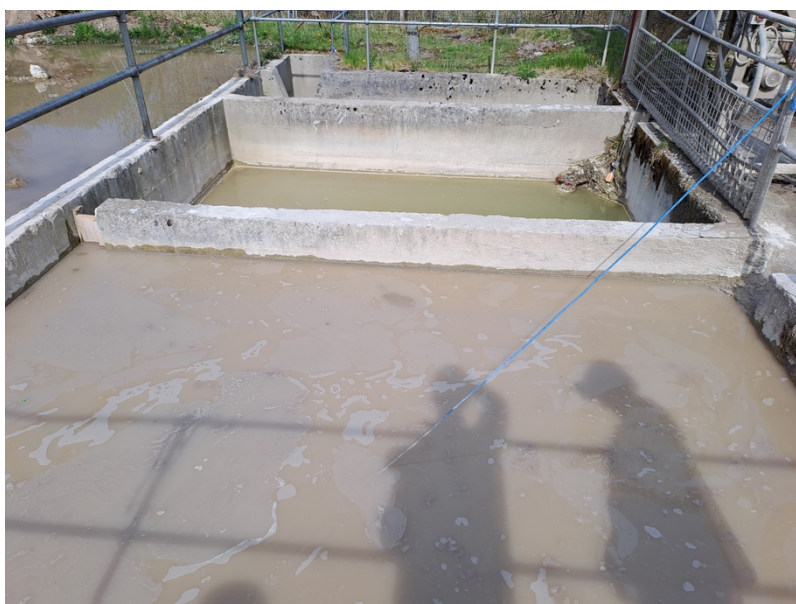
The treatment pits were inspected and a description of the process was given by the operational manager. A stirrer agitates suspended solids, bringing them to the surface before the water is recirculated and reused on site. These tanks appeared to be in good condition with no major defects observed, as seen in Figure 4. All tanks were observed, with the final tank showing no excessive build-up of suspended solids, as expected. This is seen in Figure 5.

Figure 4 – The treatment pits at the time of the visit. No defects or issues observed.

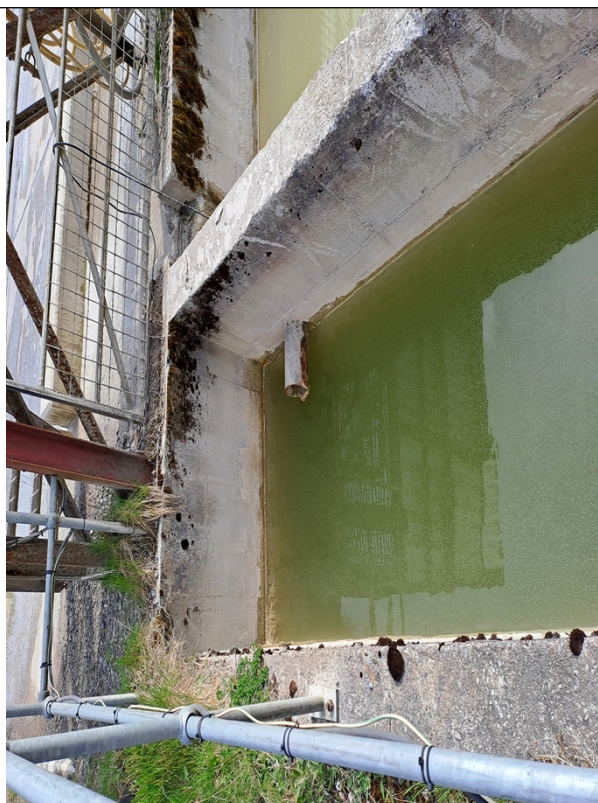
Figure 5 – The final settlement tank prior to discharge.

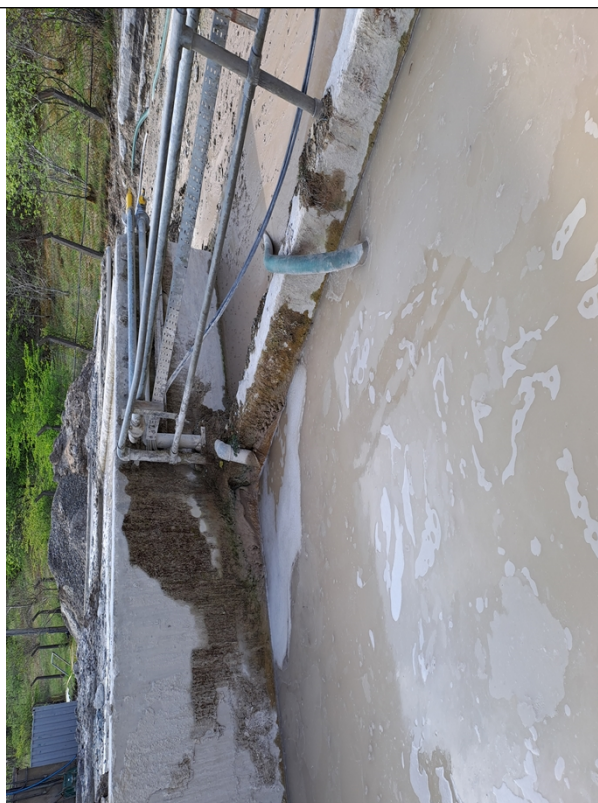
A green pipe was observed leading into the first settlement tank, as seen in Figure 6. When queried, the operations manager noted that this was a part of their surface water management for site. Surface water that run off the hill to the rear of the site tends to pool behind the production units, causing standing water. This pipe is used to pump that water off the site and into the treatment pits, which it would naturally do given time to enter the surface water channels on site. As this is rainfall dependant and is covered as part of the site's consented discharge volumes I do not see this as a non-compliant activity.

Figure 6 – A pipe used to channel excess surface water into the treatment tanks.

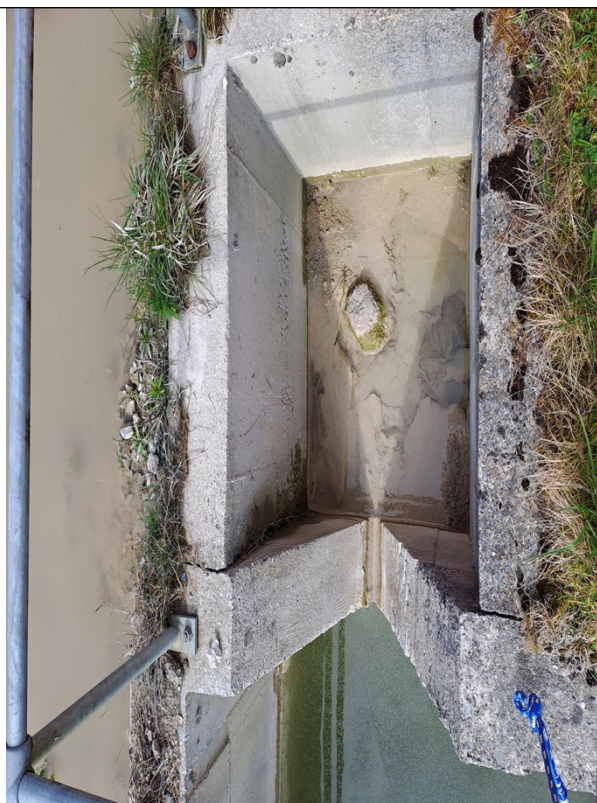
Due to the period of dry weather at the time of the visit, the outlet of these tanks was blocked to retain as much water on site as possible for re-use in the production process. As a result there was no discharge from the tanks at the time of the visit, as seen in Figure 7.

Figure 7 – The discharge point of the treatment tanks to the wider site drainage. No flow at the time of the visit.

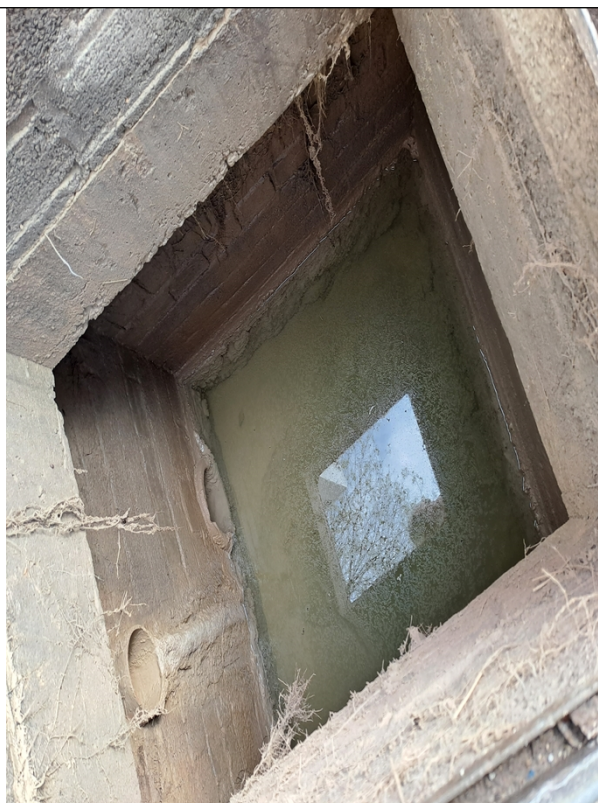
The site's oil interceptor was checked with no issues observed. There was no flow through the system due to the tanks being isolated, as seen in Figure 8. Similarly, the consented sample point also displayed no flow due to the retention of water on site, as seen in Figure 9.

Figure 8 – Oil interceptor at the time of the visit.

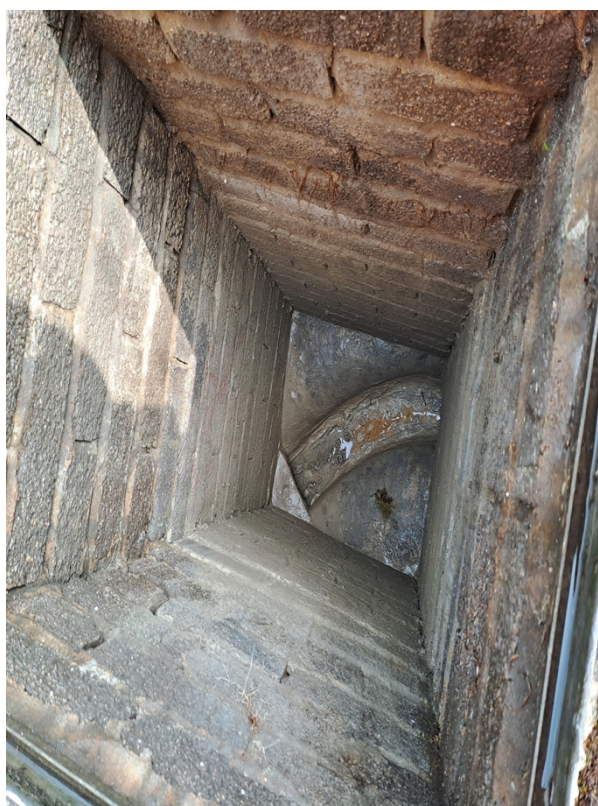
Figure 9 – The sample point with no flow as observed during the visit.

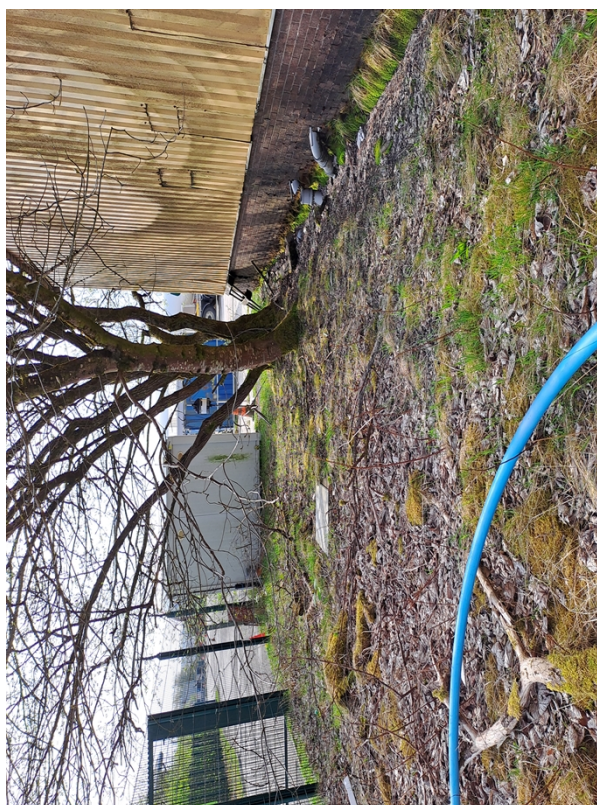
The sample point itself is in the correct location as confirmed by an onsite grid reference check (SO1557710607). Access to the sample point is adequate with no major obstructions causing hinderance, but there was some debris on the access route which could pose a trip hazard for those wishing to access it. This is seen in Figure 10. A clean up of this debris is advised and reflected in the actions below.

Figure 10 – The access route to the sampling point with the aforementioned debris present e.g. branches, disused pipework, general waste etc.

| Criteria | Action needed | Complete by |
|---|---|---|
| WQ-A1 | Clear the debris from the path leading towards the sample point to ensure safe access for all who require it. Evidence of this work should be provided using the contact details below. | 01/06/2025 |

1. Clear the debris from the path leading towards the sample point to ensure safe access for all who require it. Evidence of this work should be provided using the contact details below.
