Port Talbot Steelworks: Decommissioning Process and Environmental Oversight.

Assets decommissioning activities.

The following section provides decommissioning details with selected photographs to demonstrate that the assets have been rendered inoperable with confirming its current status.

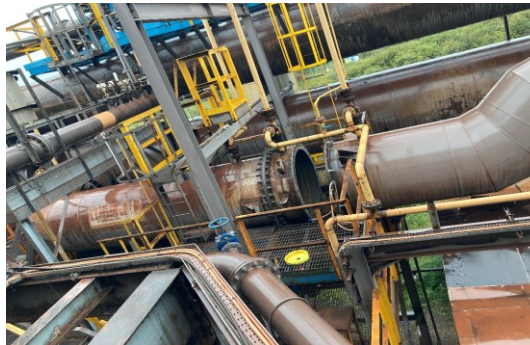
Photo: Blast Furnace Gas supply to Boiler 3 decommissioned

All Margam Boilers 3, 5, 6 & 7 & Service House Boilers 4&5 : Boilers drained. Feed water, steam pipes and fuels supplies decommissioned and positively disconnected. Dosing systems removed. Ancillary electrical equipment decommissioned.

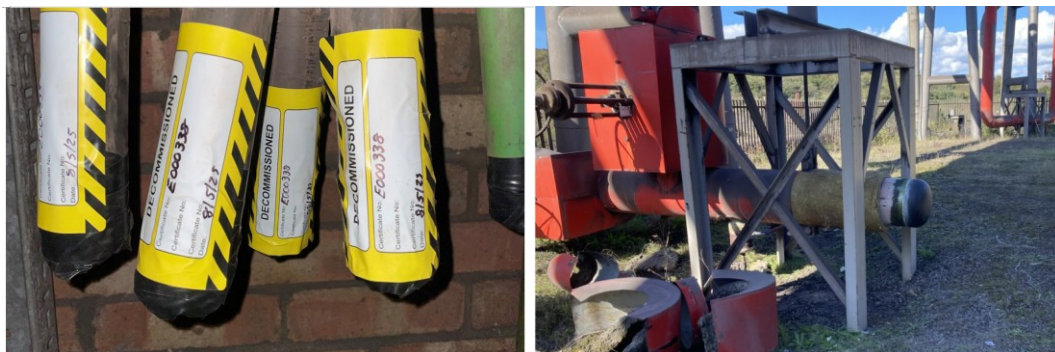
Photo: no 6 TA electrical cables cut and capped and 11 bar steam superheater capped

- Margam A and C Turbo Alternators : All steam supplies decommissioned. All electrical power cables decommissioned.

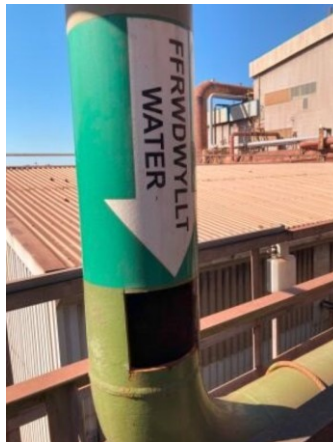
Photo : Water supply pipe cut to Demineralisation Plant decommissioned

- Margam C Demineralisation Plant : All inlet water feeds, including Afan Ffrwyd, Dock and Recovered Demineralised Water supplies, isolated and disconnected. Hydro Tanks drained. Chemical Dosing Tanks have all been drained and flushed.

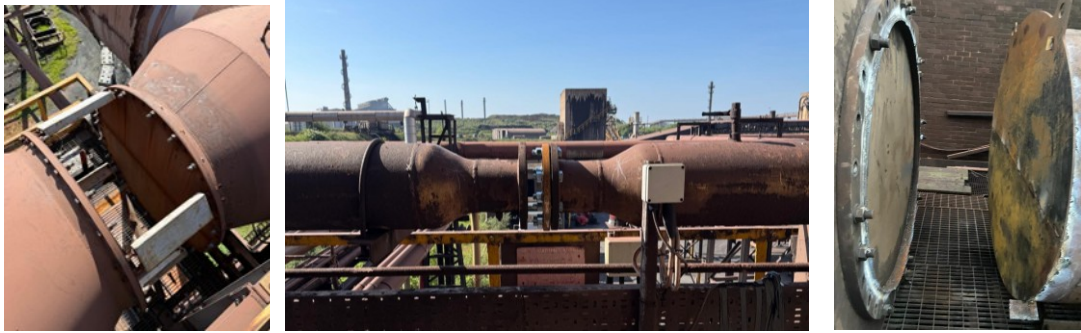
Photo : process gas pipelines cut and blanked with line of sight

- Furnace structure and water cooling systems; all water systems drained, pumps and motors decommissioned and furnace open to atmosphere.
- Process gas containing assets such as stoves, gas plant and transport pipe lines; all purged, blanked to create system separation and where possible open to atmosphere.

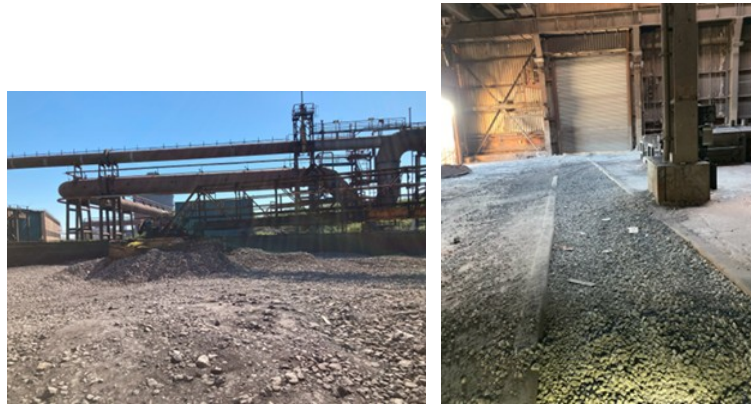
Photo : water separation pond and slag runner filled up with stone

- Cast houses and ancillary assets; all assets immobilised and troughs and ponds filled up with stones.

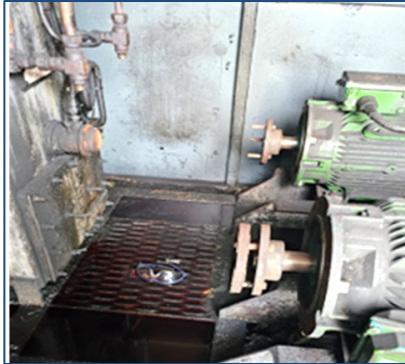
Photo: hydraulic pump removed from battery machine

- The entire coke making plant— doors, machines, heating systems, gas and water networks—have been fully drained, immobilised and secured as part of decommissioning. Coke cars and locomotives have already been scrapped via internal Regeneration team.

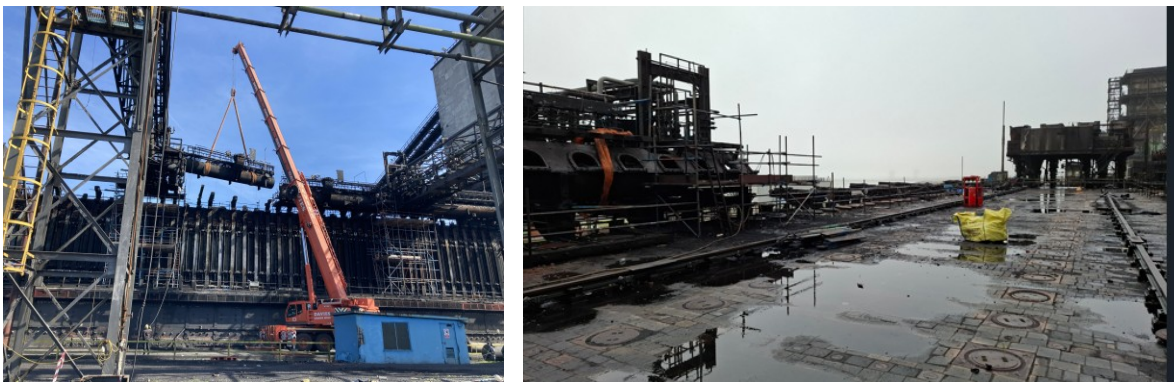
Coke ovens are not designed to be cooled down for long periods of time and the resulting temperature drop in the battery caused cracking in the refractory linings and movement of gas pipes connected to the battery due to thermal stress. This caused a potential hazardous situation and as such many of these assets were dismantled to prevent structural collapse (see photos below).

Photo: removal of unstable gas pipes from the battery top

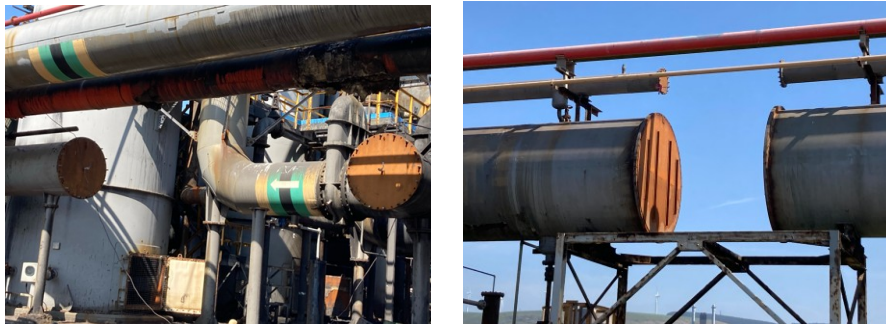
Photo: section of process gas transport removed

- All process gas pipework has been purged with nitrogen with positive line breaks in place. Where required (for safety reasons) pipe sections were kept under nitrogen blanket and plans are in place for pipe internals cleaning and/or sections to be removed.

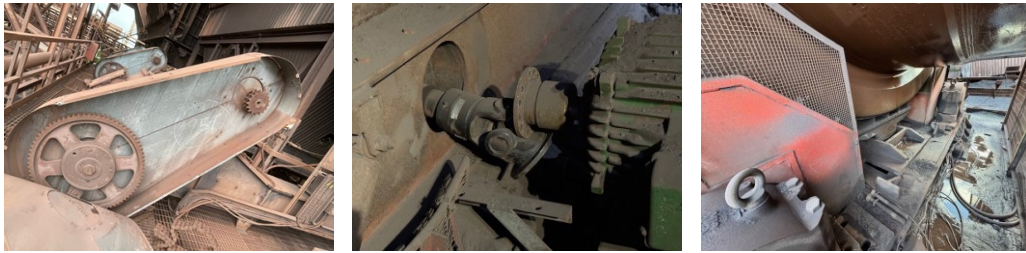
Photo: drive chain removed, screen drives disconnected, mixer immobilized

The Sinterplant assets with the iron ore blending assets and all ancillary supporting equipment have been decommissioned. The sinterstrand (rotating unit for baking sinter) with ignition hood, product cooler and product conveyors have been immobilized and large numbers of coolings trays and conveyor belts have been removed.

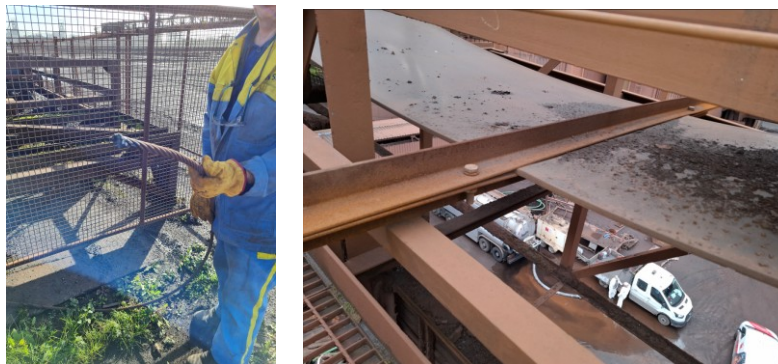
Photo: dead weights cable cut, conveyor belt secured

- Conveyors: Head chutes have been cleaned down. The belts have been removed or cut and clamped in some places. All conveyors have been electrically decommissioned.

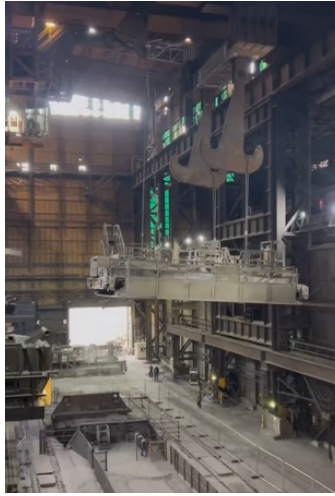
Photo: Desulphurisation Asset Fume Hood being removed

- Hot Metal Preparation : all services have been disconnected and decommissioned. The fume hoods have been removed from the asset. Hydraulic system has been drained and hydraulic hoses have been disconnected and removed.

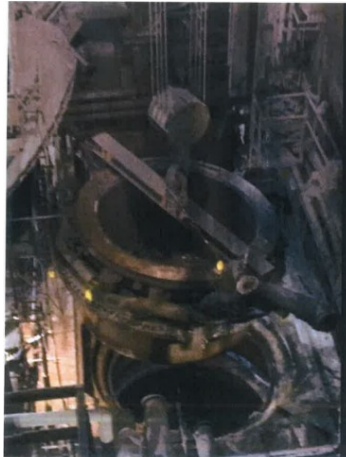
Photo: lower hood being removed from vessel

- Convertors / vessels; disconnected from services and lower hood above vessel removed

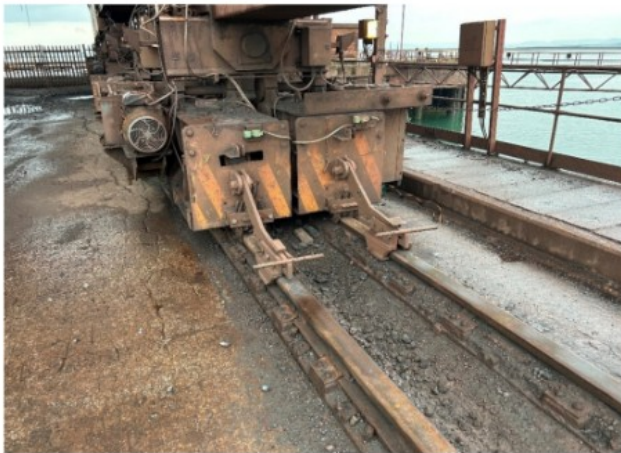
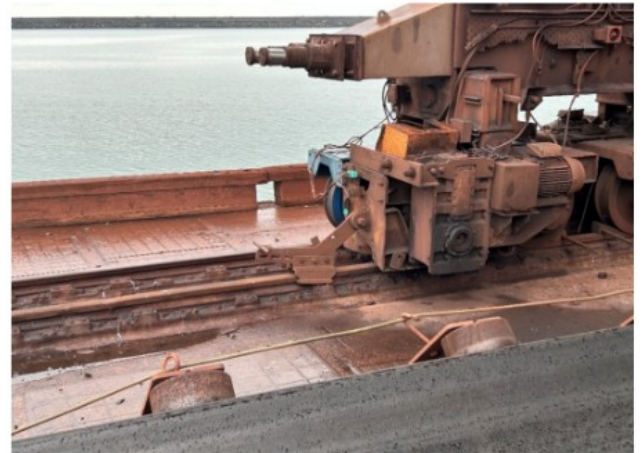
Photo: Unloader 4 clamped to rails

- Unloaders 3, 4 and 5; assets secured in place by rail clamps and chocks with the grabs been removed. The unloaders motors have been electrically decommissioned. The unloader hydraulic system and accumulators has been drained of oil with hoses removed. Orders have been placed to dismantle and remove all 3 Unloaders and will be completed by November 2025.

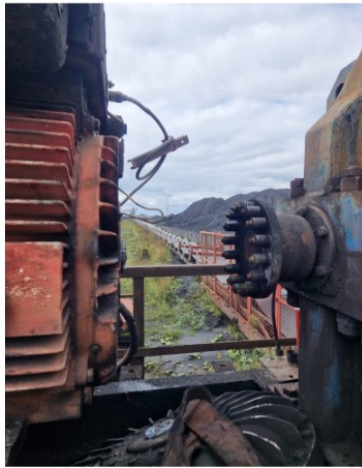
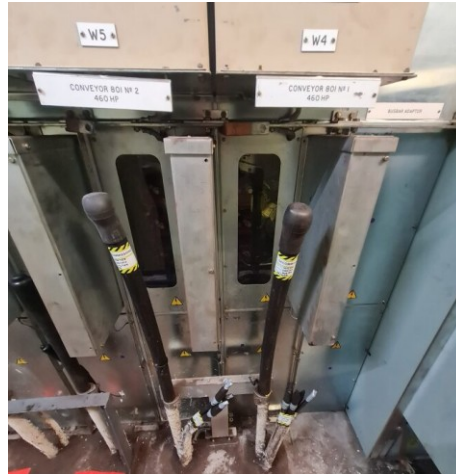
Photo: Conveyor 804, coupling in drive removed and Conveyor 801 electrical supply cut and capped

- Conveyors : Any deadweights have been lowered to the ground and for the majority of the conveyors the belts have been removed. Conveyors have been electrically decommissioned.

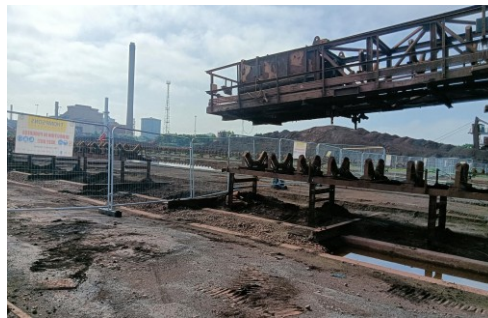
Photo : section of conveyor structure removed in stockyard area for CDM perimeter fencing.

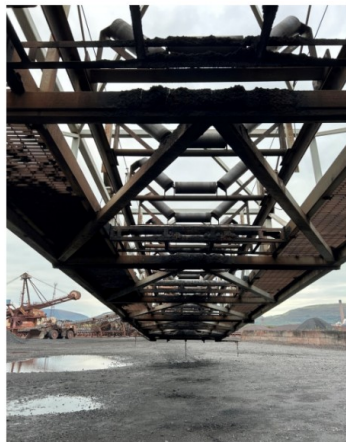
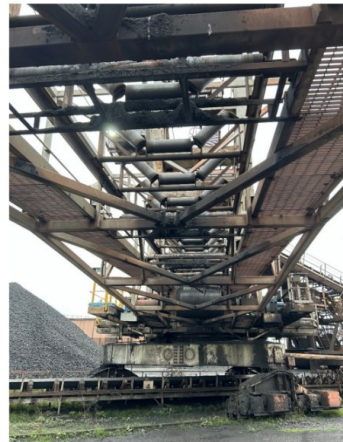
Photos: Conveyor Belt removed from Ore Stacker

- Stackers: The stackers are positioned at the safest position at end of the stockyards and physically isolated. The stackers have been electrically decommissioned.
