Client: **Wyn Griffiths & Sons**  
Site: **Ty Mawr Landfill Site**  
Project Title: **Schedule 4 Response**  
Document: **A2058/ Schedule 4**  
Project Director: **A.Stocks**  
Project Manager: **S.Venning**  
Address: **Egniol Ltd  
Amber Mill  
Oakerthorpe  
Alfreton  
Derbyshire  
DE55 7LL**

## TY MAWR FARM LANDFILL

### PPC LANDFILL PERMIT APPLICATION

#### SCHEDULE 4 RESPONSE

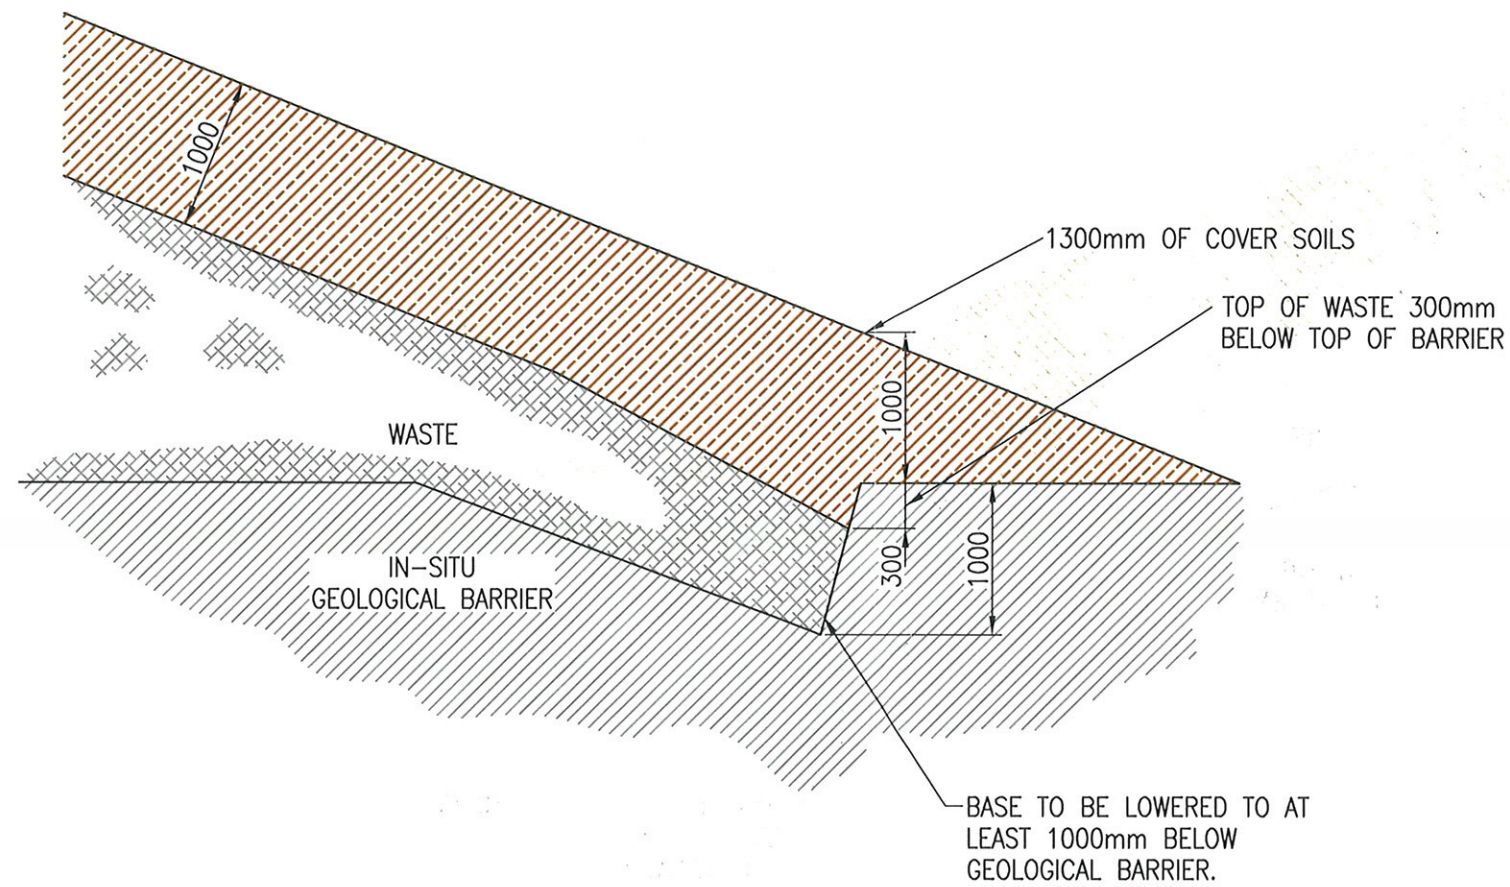
| DRAWING NUMBER<br>2058.SRA.02 | ISSUE<br>Fn | REVISION<br>- |

ENGINEERING &  
INSTALLATION DETAILS

- 3.5 Stability calculations of the completed slope have been carried out using SLOPE/W for the existing design as shown on drawing 2058.SRA.02 in both normal and saturated groundwater conditions. The calculated factors of safety, Fs, from the analyses are summarised in Table 2 and the SLOPE/W output files are enclosed in Appendix 1.

- 4.1 The Fs that have been presented in this report have been calculated using conservative inputs into the SLOPE/W model to present 'worst case' scenarios.
- 4.2 The existing engineering design of the site as presented in drawings 2058.SRA.01 and 2058.SRA.02 result in acceptable Fs under both normal and saturated groundwater conditions and therefore it is not considered necessary to change the design of the site in lieu of these results.

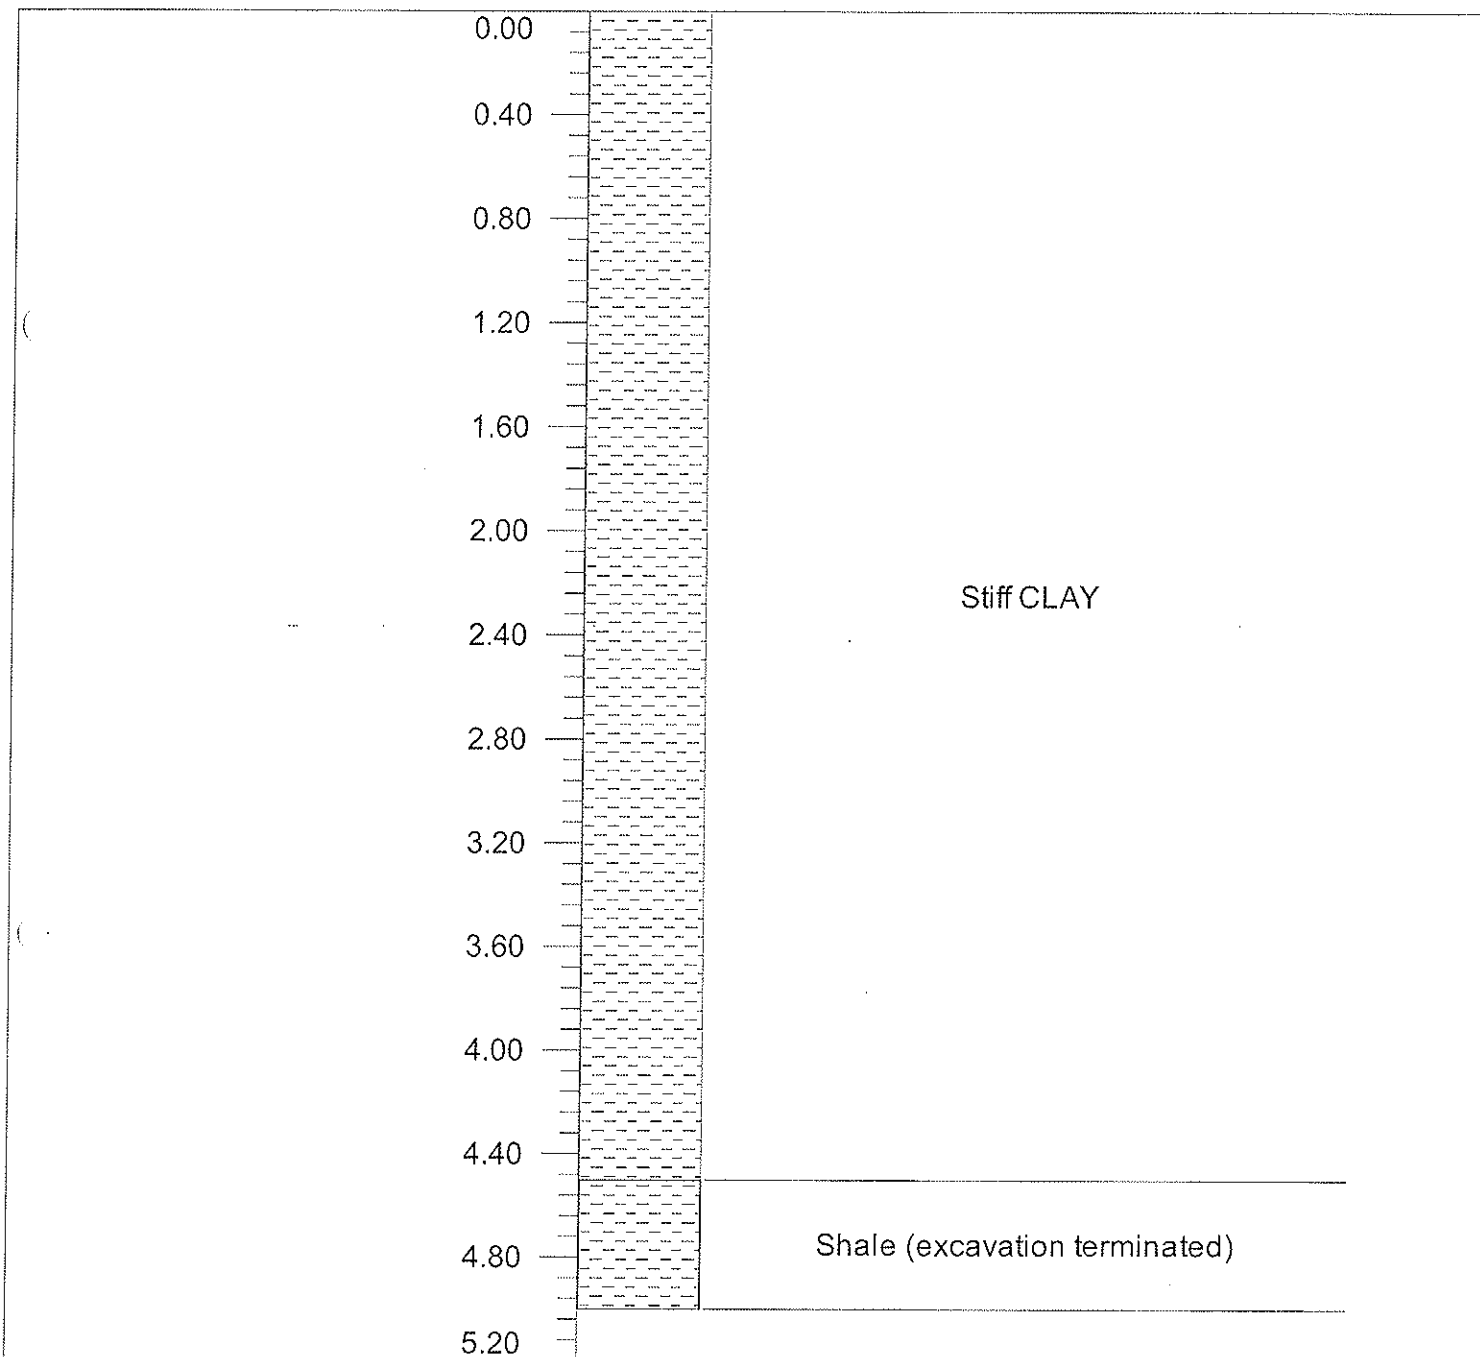
| Client: Wyn Griffiths | Northing: | Sheet: 1 of 1 | Borehole ID: GW1 |

Borehole GW1 was the original water well, which was drilled at the site. As such, only limited information about the layers encountered is available from the site owners. This has been used to construct a borehole log, which is contained within Appendix 3.

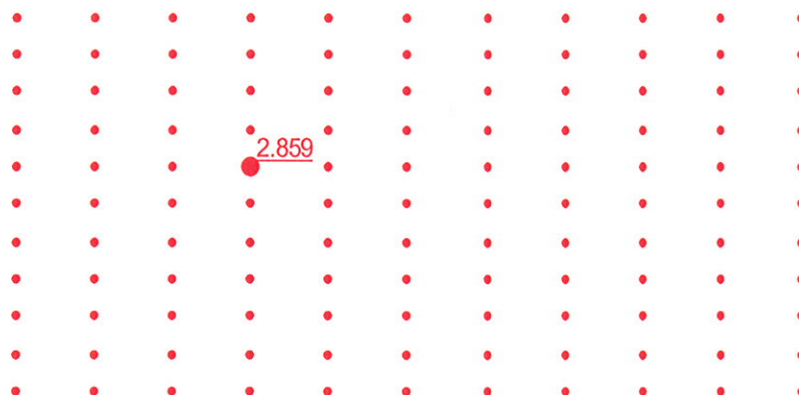
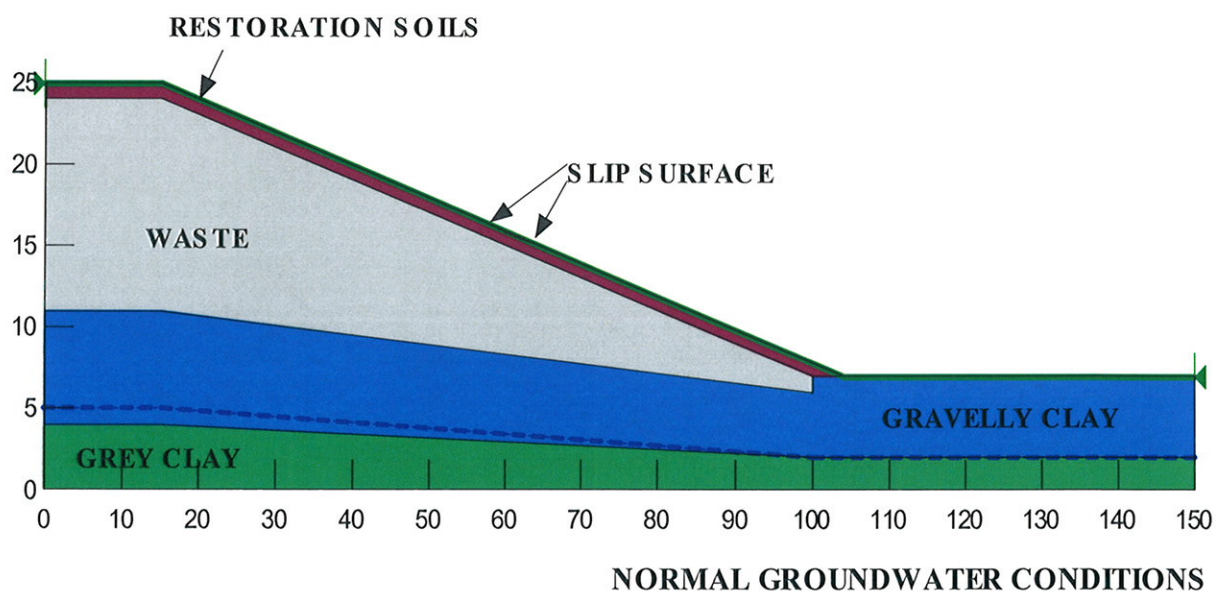
Output from SLOPE/W

**STABILITY ASSESSMENT**

| Situation | Factor of Safety<br>(Fs) |
|---|---|
| Normal Conditions | 2.859 |

- 3.6 In both cases the calculated Fs values are considered acceptable. The critical slip surface under normal conditions is confined to the restoration soil layer above the waste mass with the slip surface being approximately 6m in length approximately half way down the slope, whereas the critical slip surface under saturated conditions extends through the waste mass and into the gravely clay below, the slip surface extends over approximately two thirds of the length of the slope with the toe of the slip surface daylighting past the toe of the restoration soils.

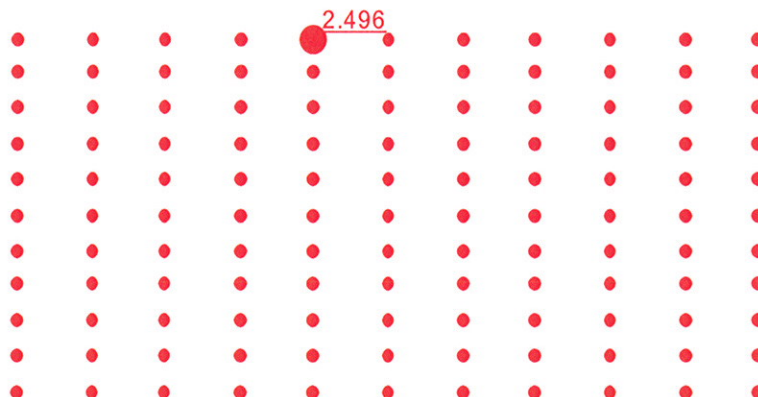
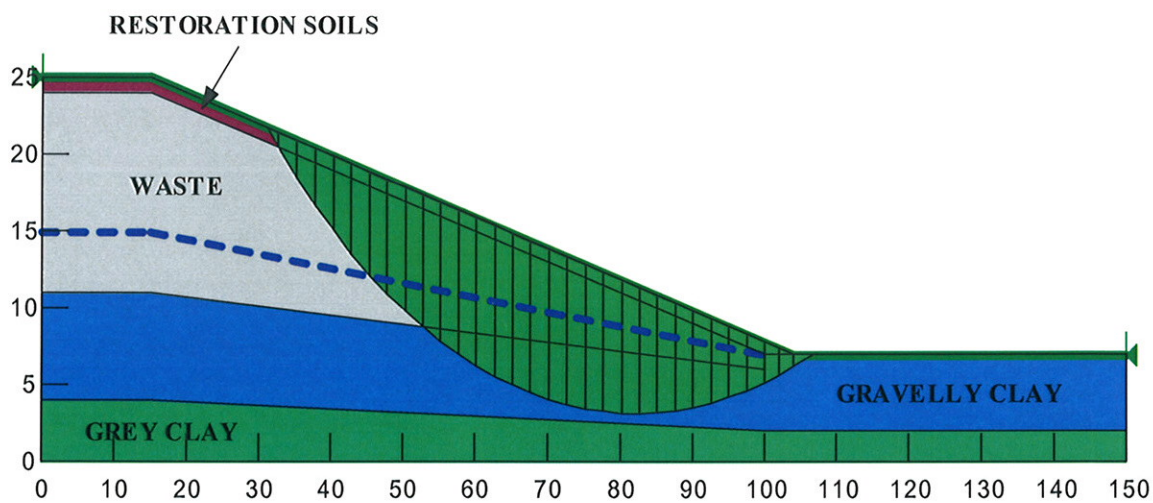
**STABILITY ASSESSMENT**

**SATURATED GROUNDWATER CONDITIONS**

| Situation | Factor of Safety<br>(Fs) |
|---|---|
| Saturated Conditions | 2.496 |
