# Bioaerosol Sampling Report

Bryn Lane IVC (Phase 1)

FCC Environment

29<sup>th</sup> April 2025

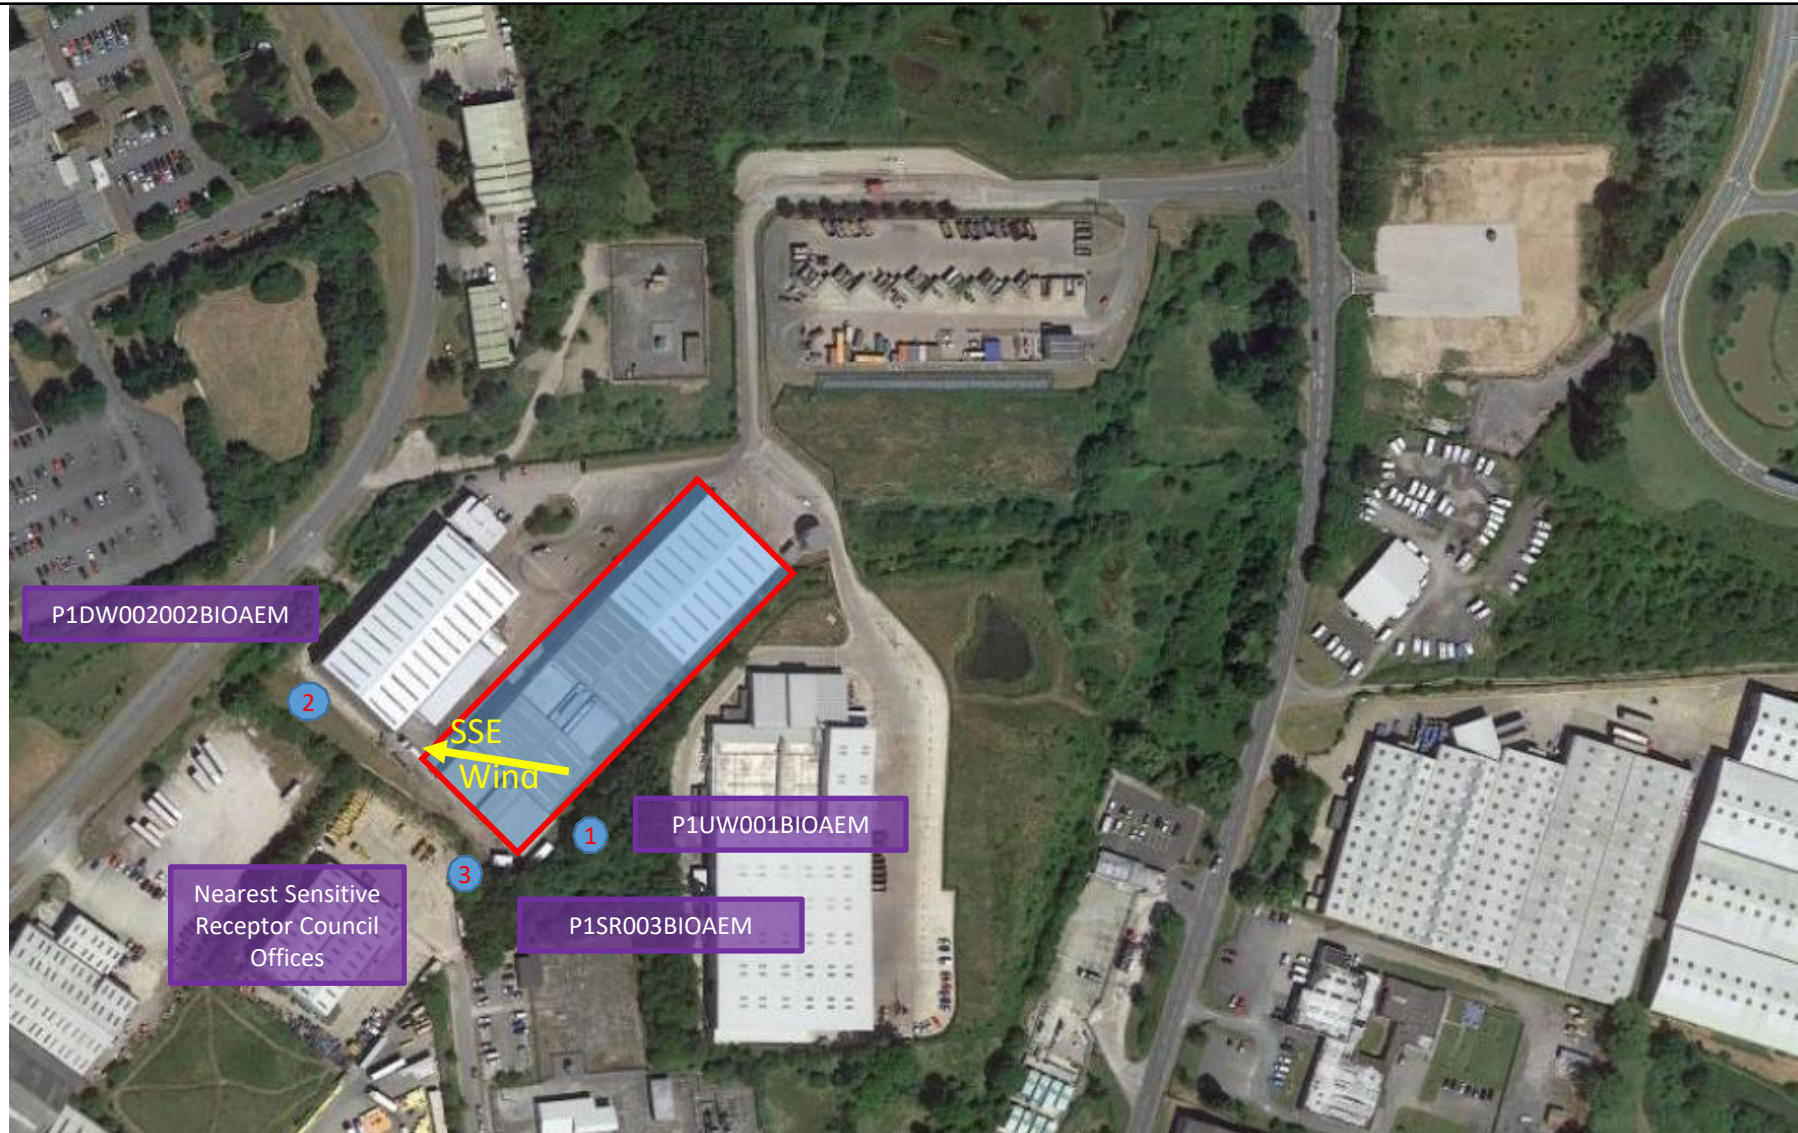
FCC – Bryn Lane Phase 1 IVC 29/04/2025  
Aerial Plan Showing Bioaerosol Sample Locations

1 – Upwind

2 – Downwind

3 – Sensitive Receptor

Blue area – Emission source

Red Box – Site area

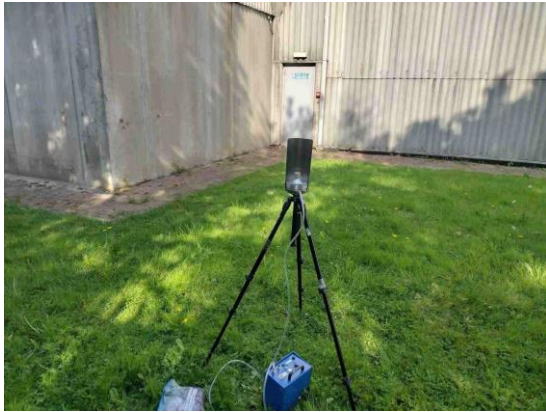
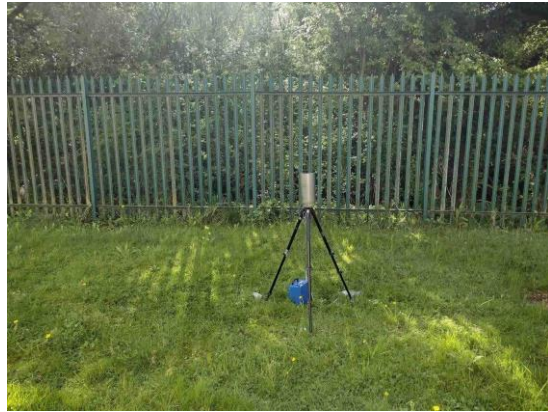
Location	Description	Comments
Upwind location 001	Grassy path behind the IVC	Distinct waste odour
Downwind location 002	Northern edge of site	No odour
Sensitive Receptor location 003	Grass Verge close top fence line	No odour
