## Compliance Assessment Report CAR\_NRW0048583

**Permit being assessed:** AW1003301

For: Llangammarch Wells Wastewater Treatment Works, held by DWR CYMRU CYFYNGEDIG

**Type of assessment carried out:** Site Inspection, Reason: Routine.

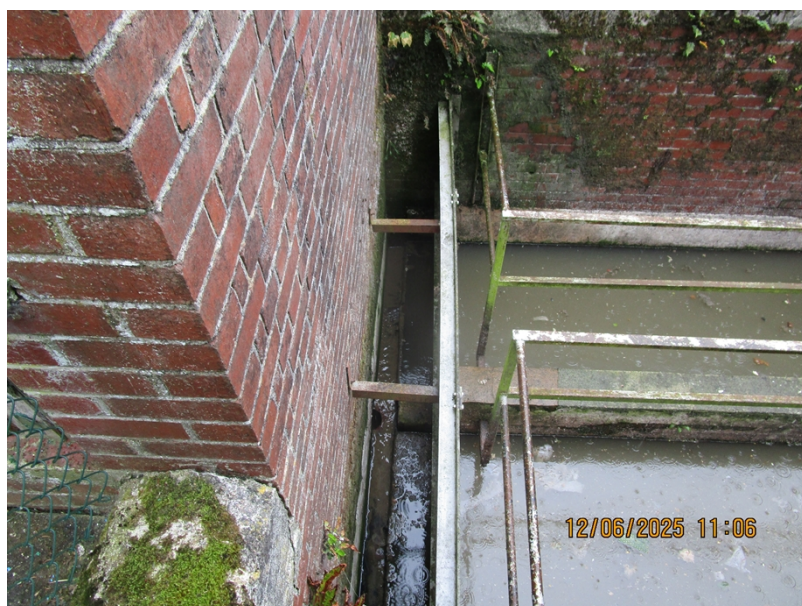
The primary settlement system consists of two small rectangular tanks in a below ground level housing, with retention boards at both ends to hold back solids within the centre of tanks. The retention boards appeared to be effectively preventing significant solids from passing through to the next stage of treatment. There were some small signs of sewage fungus present within the outfall channel; however, this was not excessive. The effluent from the primary settlement tank is then pumped up to a syphon chamber servicing the filter bed, where it passes through a COPA sack to catch large solids. The syphon chamber is used to ensure that sufficient hydrological power is built up to power the rotation of the distribution arms.

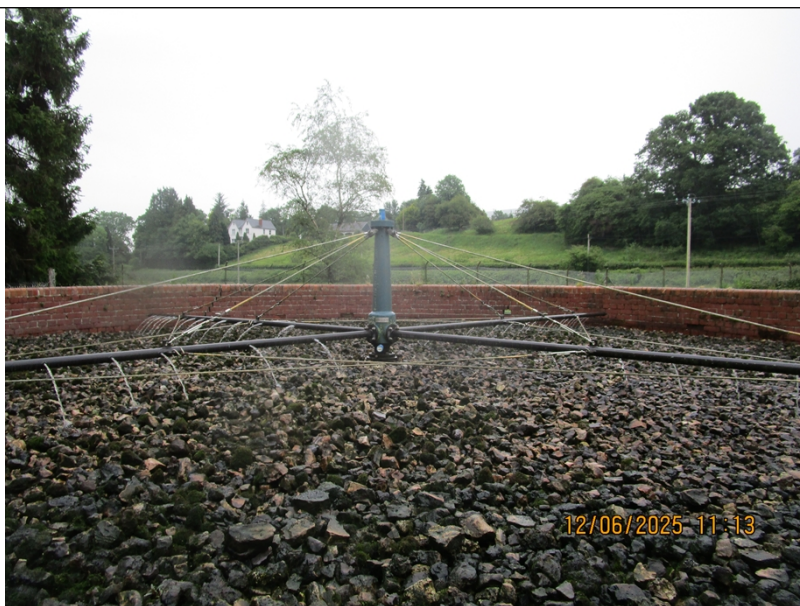
The works contains a single raised filter bed coating stone media. Once the syphon discharged there were no signs of blocked outlets, and the rotating arm appeared to be distributing flows across the media effectively. The filter bed at the works appeared to be operating effectively. The outfall of the filter bed is directly into the humus tank of the works.

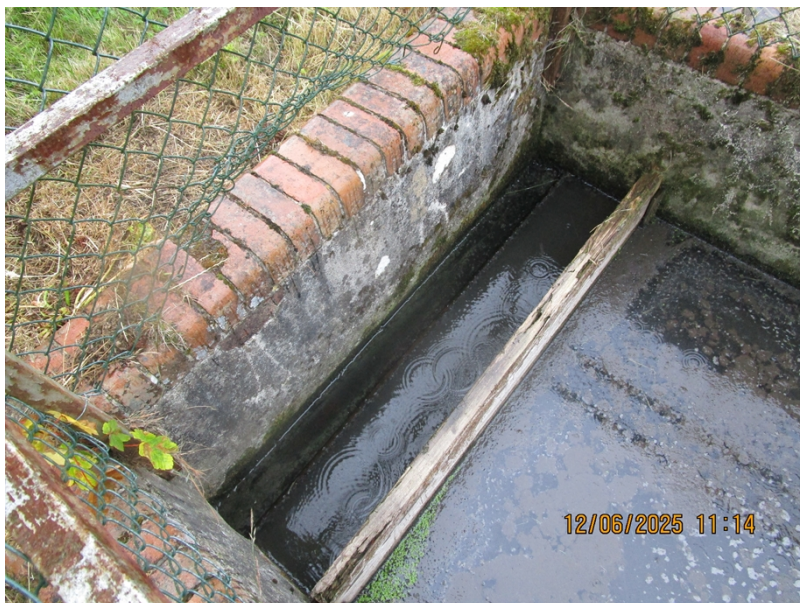
The final settlement tank on the works is a small rectangular tank with a retention board on the outfall end to slow down flows and prevent solids passing over. The final settlement system appeared to be operating effectively and there were no signs of significant solids or sewage fungus present within the outfall channel.

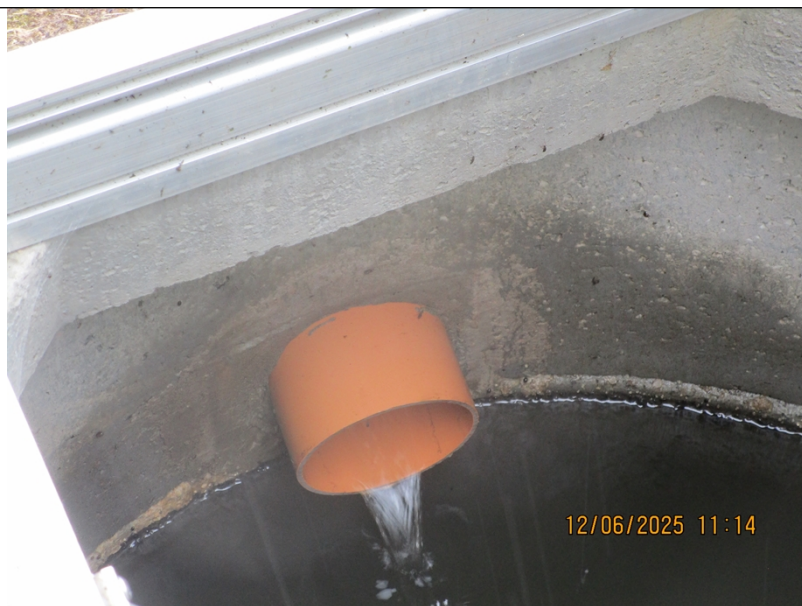
The final effluent sample point is located within a newly installed covered chamber. The sample point was clearly labelled with appropriate signage and allowed for a representative sample of the effluent to be taken. At the time of inspection, the effluent was flowing freely and showed no signs of discolouration or sewage fungus within the pipe. The water level within the chamber was close to the pipe, however there was still enough room to collect a sample directly from the effluent pipe.

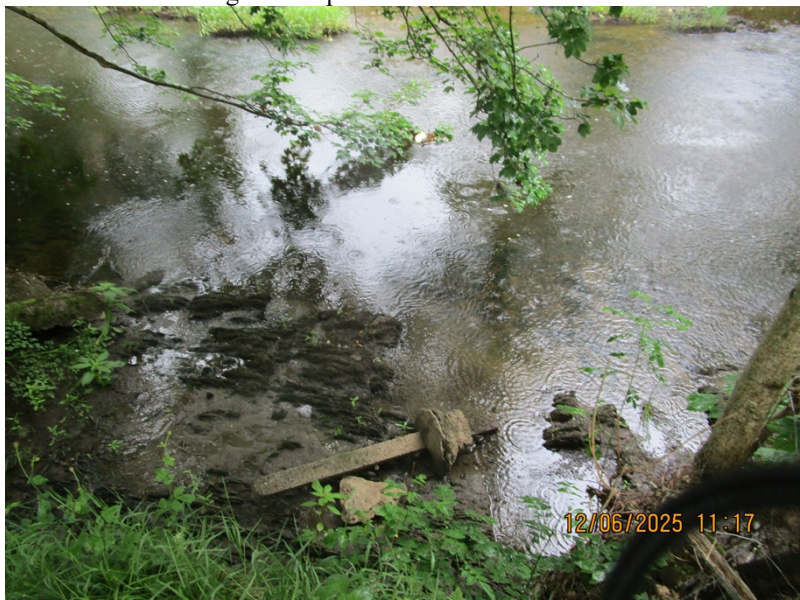
It appears the original outfall has at some point collapsed into the watercourse, and now the discharge is slightly set back from the main channel of the watercourse, discharging behind the collapsed part of the original outfall. This does result in the discharging slightly outside of the main flow of the river; however, this did not appear to be causing any issues with effluent mixing within the watercourse. I do not believe this constitutes a noncompliance against the permit as the approximate location is the same.

There were no signs of contamination or discolouration to the receiving watercourse and no signs of sewage fungus around the outfall. The watercourse at the time of inspection was slightly lower than usual due to prolonged dry weather, but still showed no signs of impact from the work effluent.
