Land Quality Assessment

Former aluminium slag reprocessing plant

Fenn's Bank, Whitchurch, SY13 3PA

Reference: 30756R1

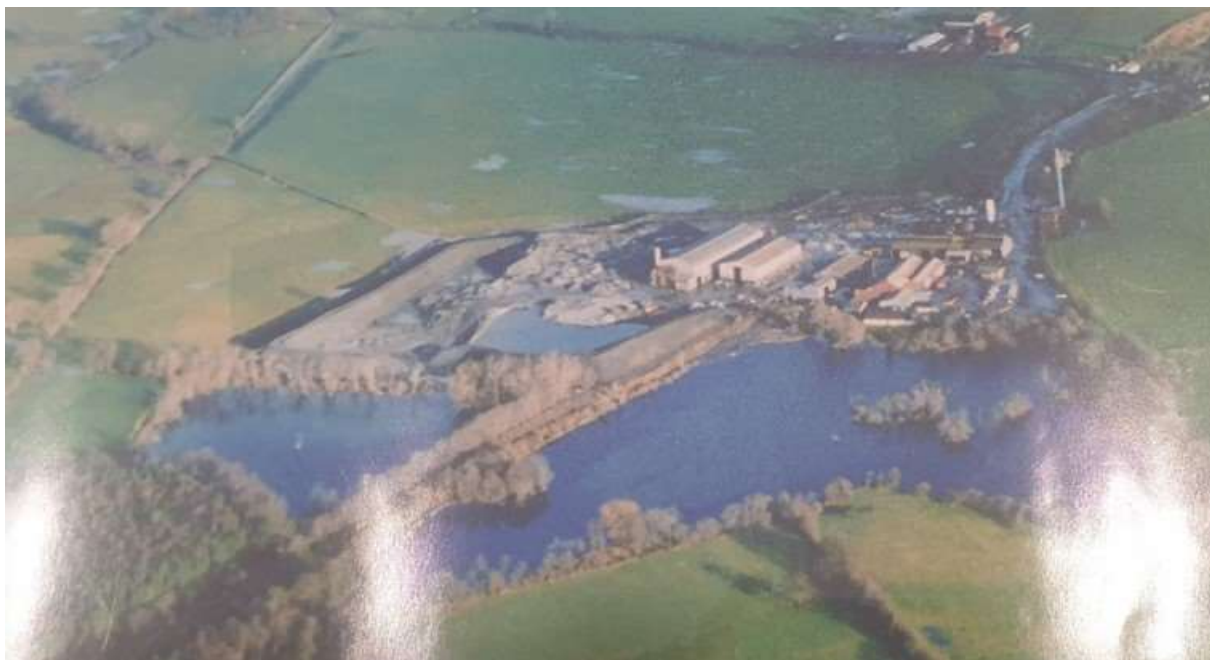
Figure 2.4 Conditions prior to development of the current site

Figure 2.4 shows Wardle's aluminium foundry buildings prior to the development of the TRP site, and during the landfilling operation. It can be seen that there is an area to the north of the foundry that was clearly being worked, but is not part of the current landfill footprint. This area was not capped as part of the remedial works undertaken at the landfill in 2002. Figure 2.5 shows an estimate by Befesa of the area of uncapped deposits. This indicates that there are local deposits of waste that may be generating ammonia which is freely discharging into the environment.

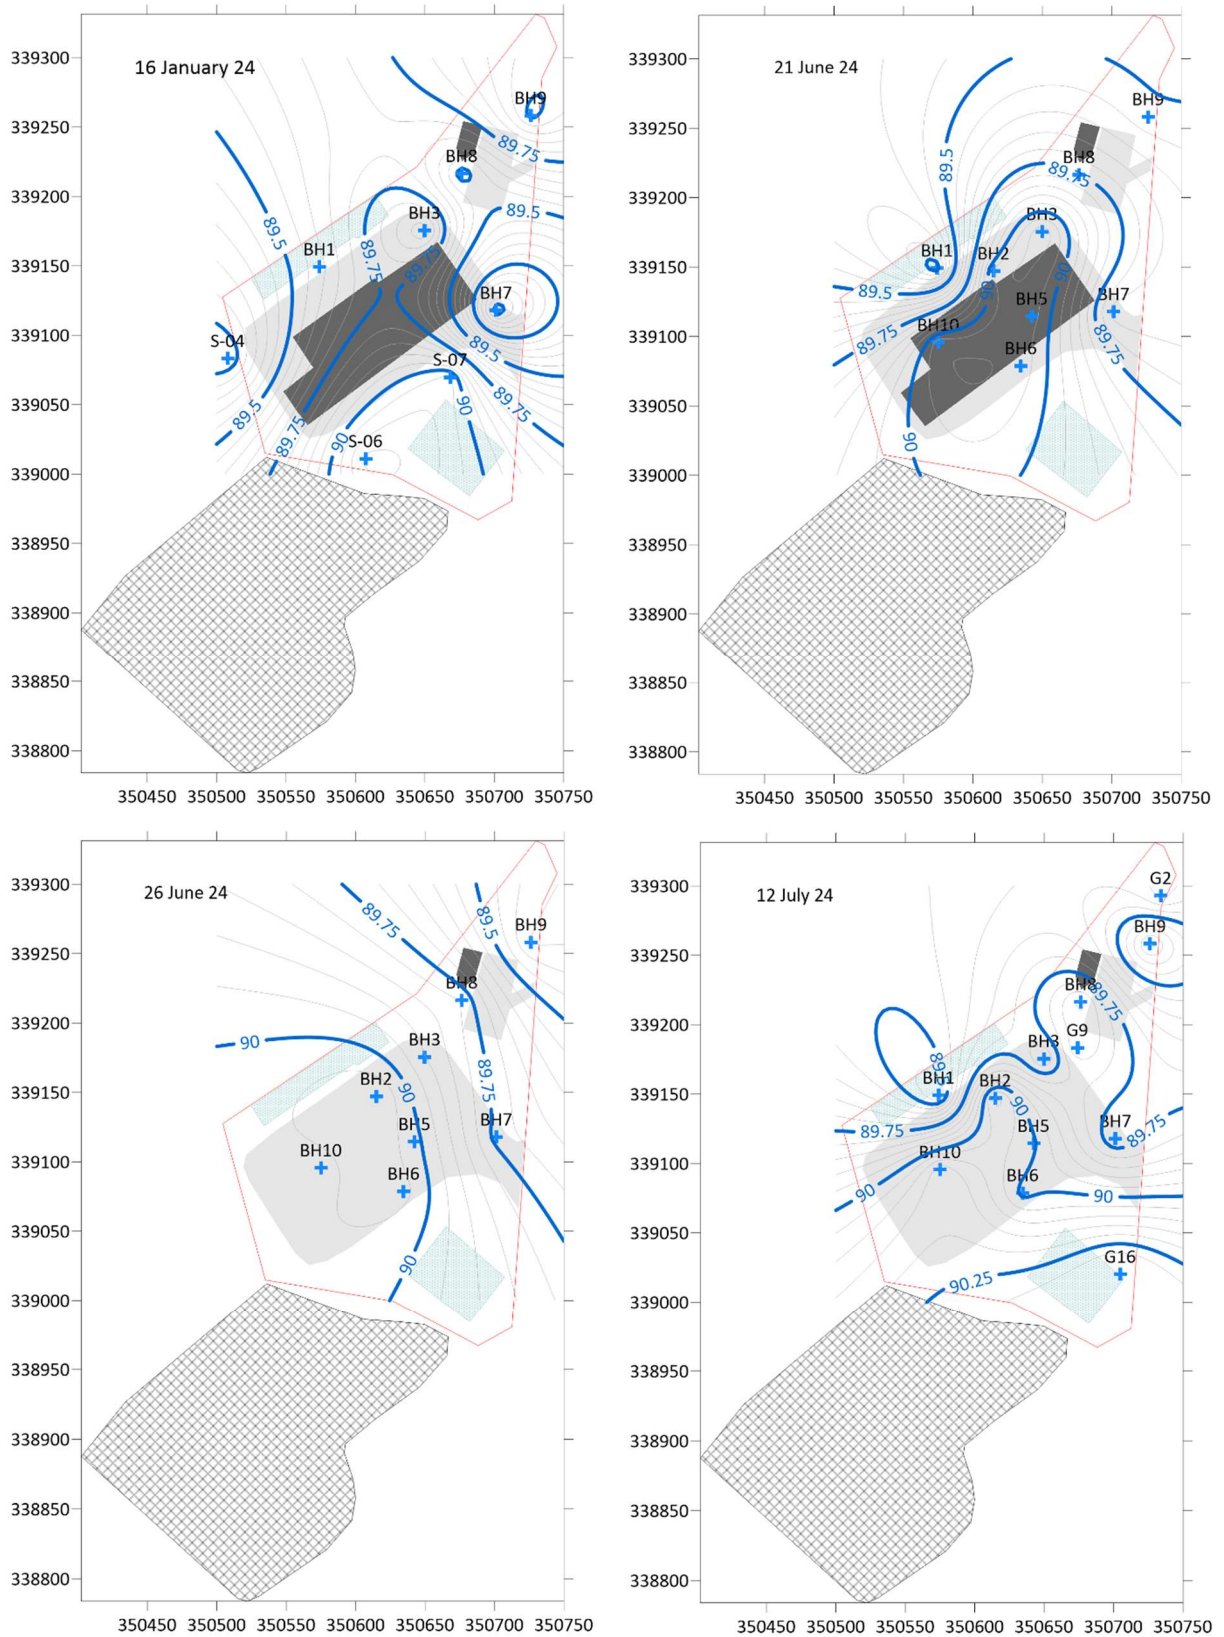
Figure 3.6 Groundwater contours (dates)

Borehole	Groundwater level							
	16 January 2024		21 June 2024		26 June 2024		12 July 2024	
	(m bgl)	(m aOD)	(m bgl)	(m aOD)	(m bgl)	(m aOD)	(m bgl)	(m aOD)
S-04	0.45	89.20						
S-06	0.415	90.17						
S-07	0.54	90.07						
BH1	0.9	89.58	1.27	89.21			1.09	89.39
BH2			0.405	90.07	0.37	90.10	0.34	90.13
BH3	0.57	89.95	0.38	90.14	0.62	89.90	0.88	89.64
BH5			0.1	90.07	0.15	90.02	0.16	90.01
BH6			0.305	90.08	0.315	90.07	0.4	89.98
BH7	1.27	88.95	0.6	89.62	0.49	89.73	0.52	89.70
BH8	1.19	89.47	0.91	89.75	0.86	89.80	0.74	89.92
BH9	0.52	90.02	1.02	89.52	1.195	89.34	1.26	89.28
BH10			0.56	90.08	0.61	90.03	0.455	90.19

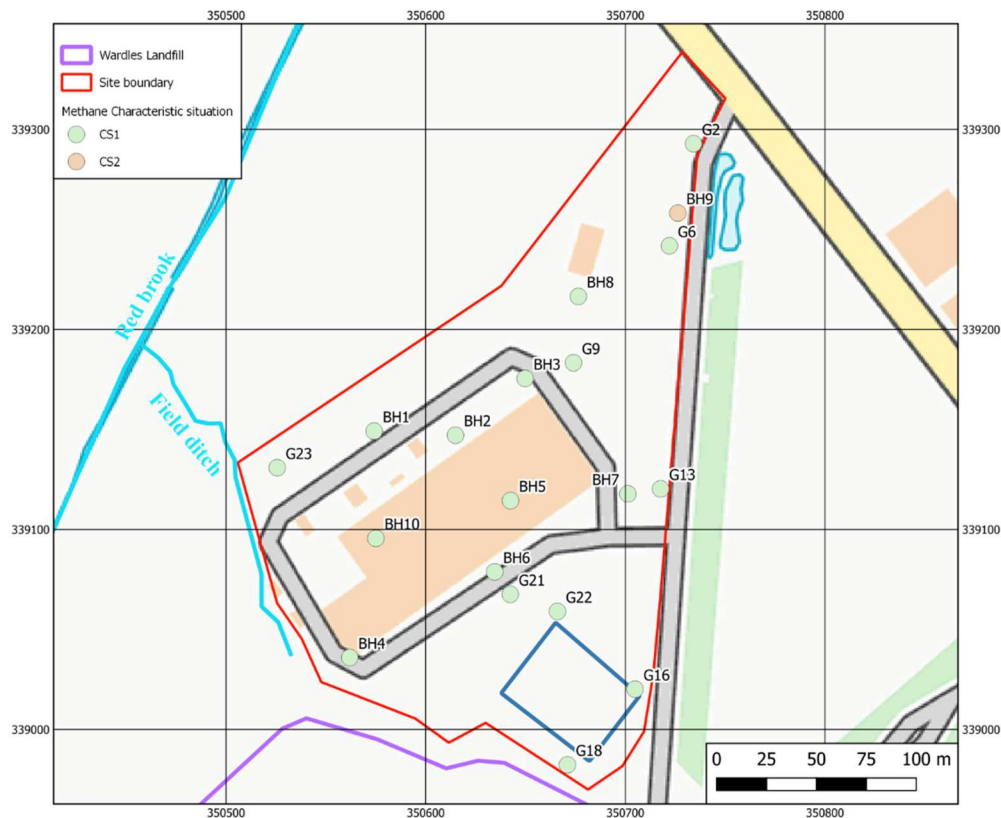
Figure 8.1: Worst case characteristic situation results for methane

The initial results show all locations to be CS1 (very low risk) for methane with the exception of BH9 during the June monitoring round, which was calculated as CS2 (low risk). Groundwater levels were above the borehole screen at each of the borehole locations; water data was not available for the gas spikes.

Maximum steady state flow rates and maximum concentrations for the two monitoring rounds for methane are presented in Table 8.2 below, with the worst-case resulting CS presented in Figure 8.1.

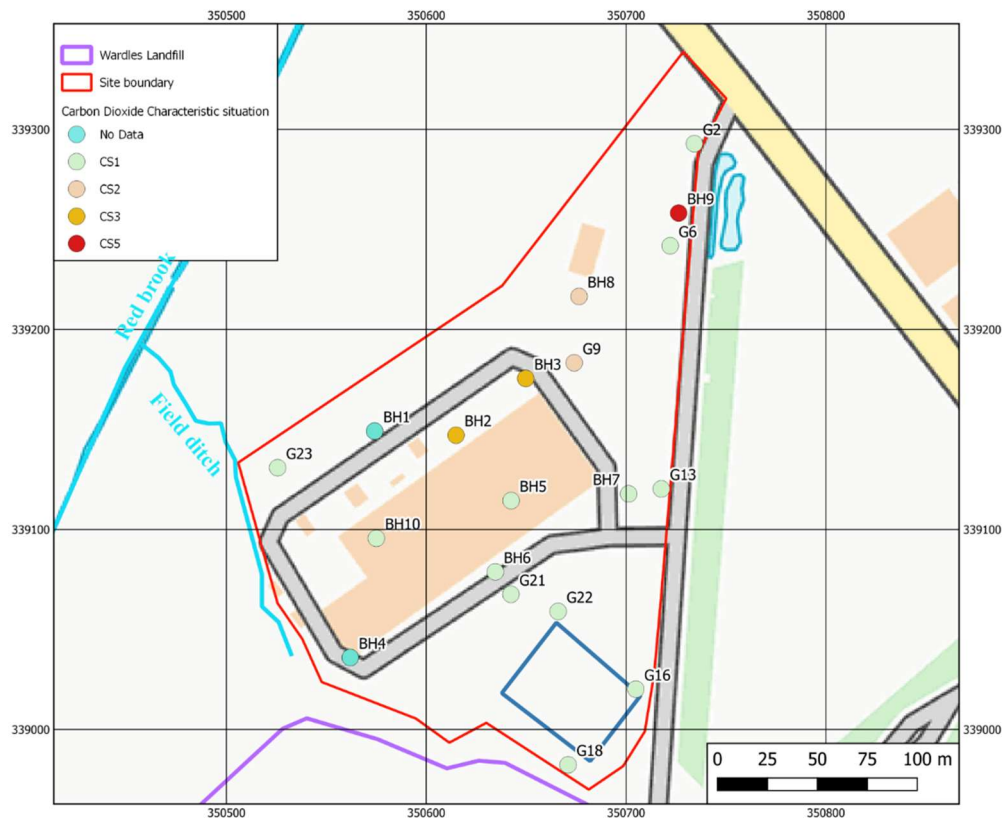
Figure 8.2: Worst case characteristic situation for carbon dioxide

A summary of the results is as follows:

Maximum steady state flow rates and maximum concentrations for the two monitoring rounds for carbon dioxide are presented in Table 8.3 below, with the worst-case resulting CS presented in Figure 8.2.

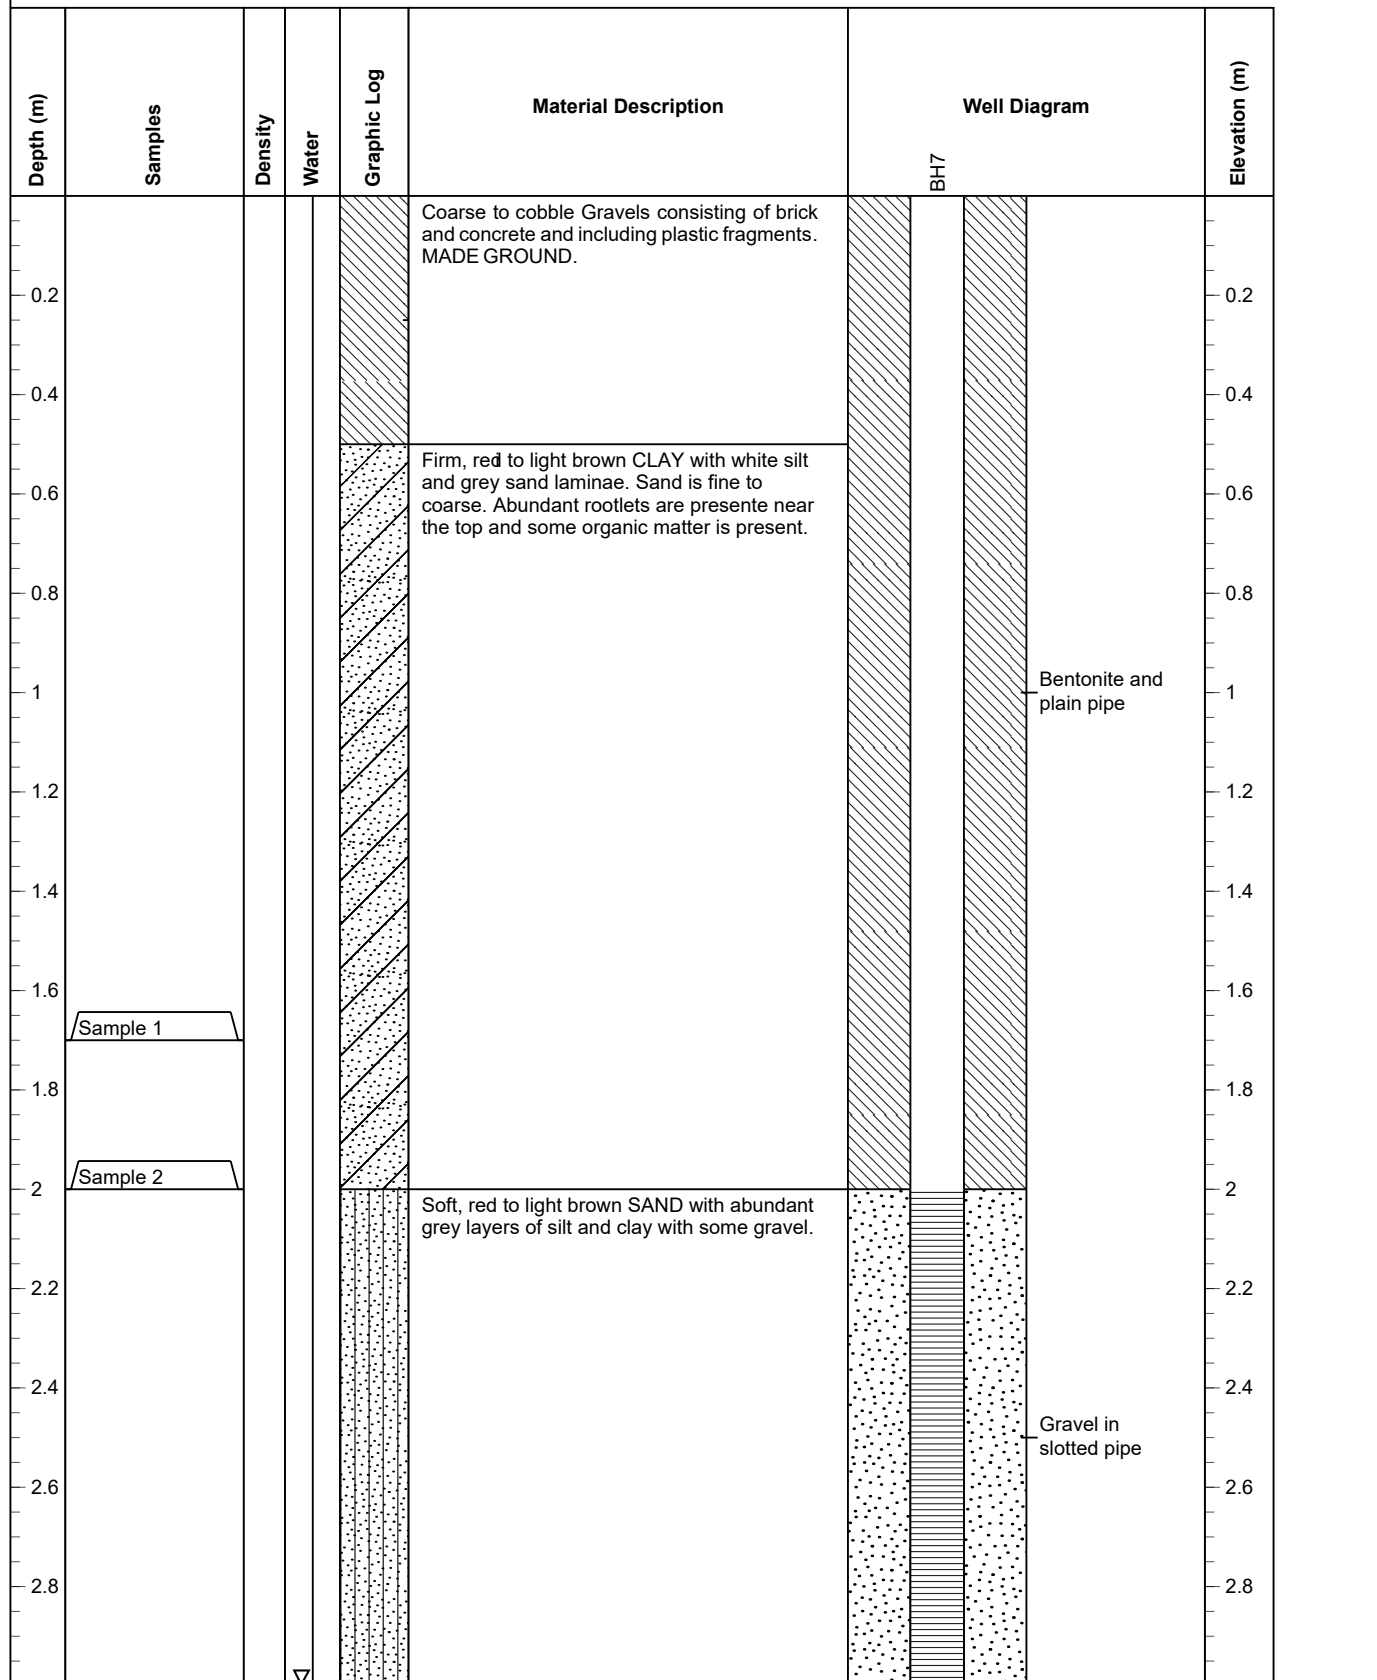
Comments Borehole drilled underwater. The Made Ground flooded the borehole. Ammonia smell in the air, oil sheen in superficial water in surrounding area of the borehole coming from vehicles in car park.

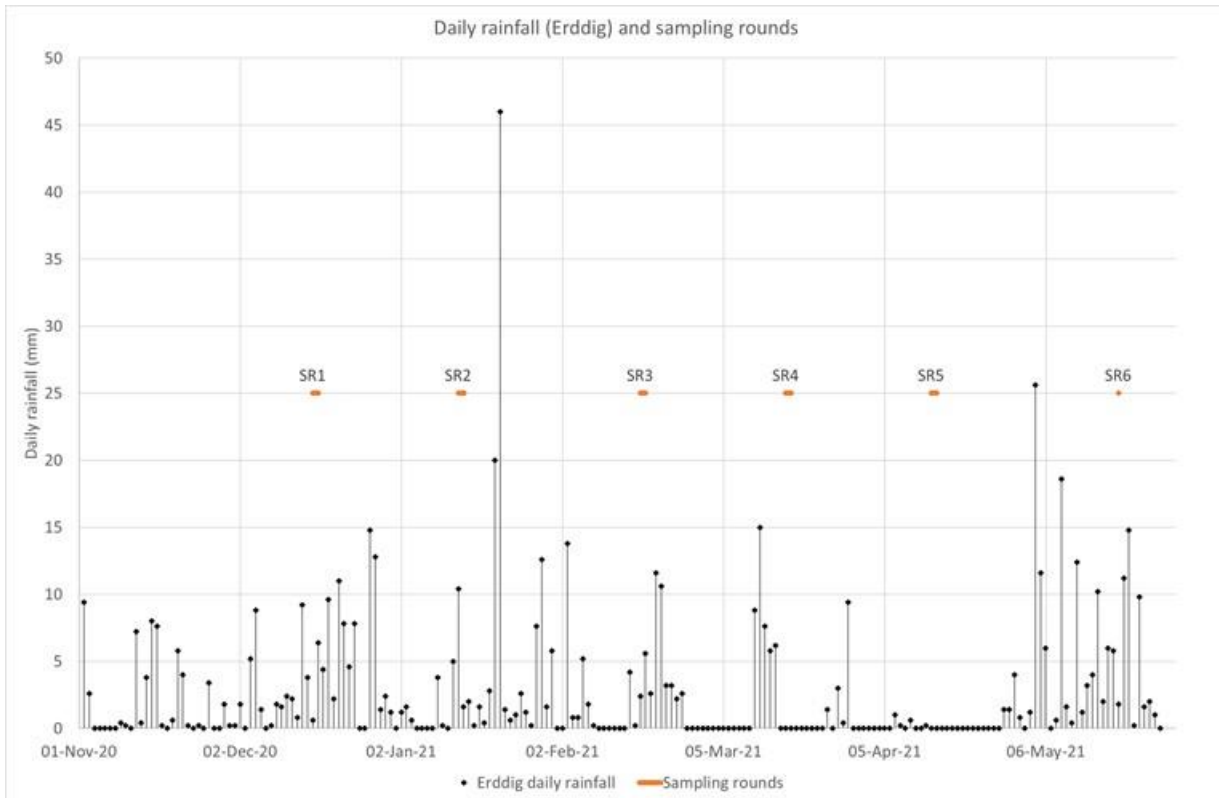
Figure 2-2 Daily rainfall (Erddig) during sampling period

Onsite weather station data for Befesa is available from 1 February 2016 to 29 November 2020. This is augmented by weather station data for Erddig National Trust site, located c.19 km northwest of Befesa. Monthly rainfall is presented in Figure 2-1 and daily rainfall at Erddig since the start of the sampling period (December 2020 to May 2021) is shown in Figure 2-2. Sampling rounds are marked on Figure 2-2 as SR1 – SR6.

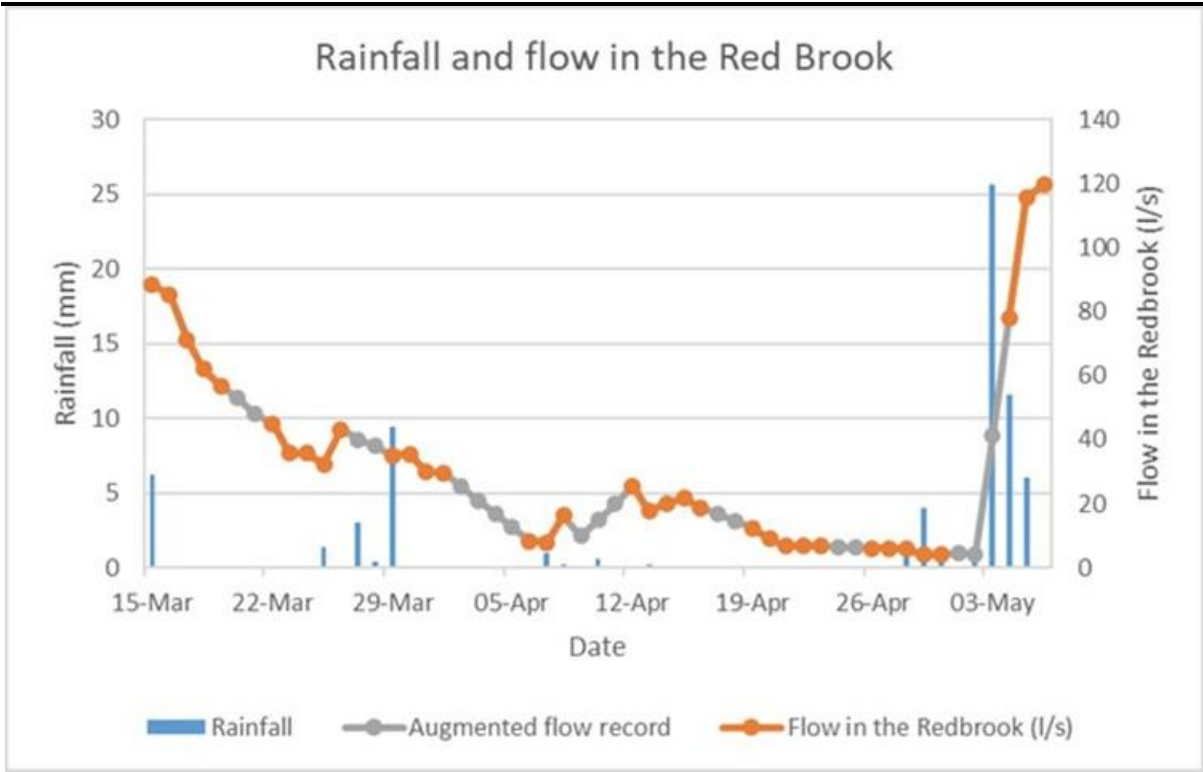
Figure 3-1 Flow measurement in the Redbrook

Technical note 30496TN3.3 reports on methods of measuring and calculating stream flow in the Redbrook. Since March, Befesa have undertaken daily measurements of stream velocity, and flow rates have been calculated using those data, as shown in Figure 3-1. Measured flows are shown in orange; the grey data points are estimated for days when data were not available, usually coinciding with a weekend.

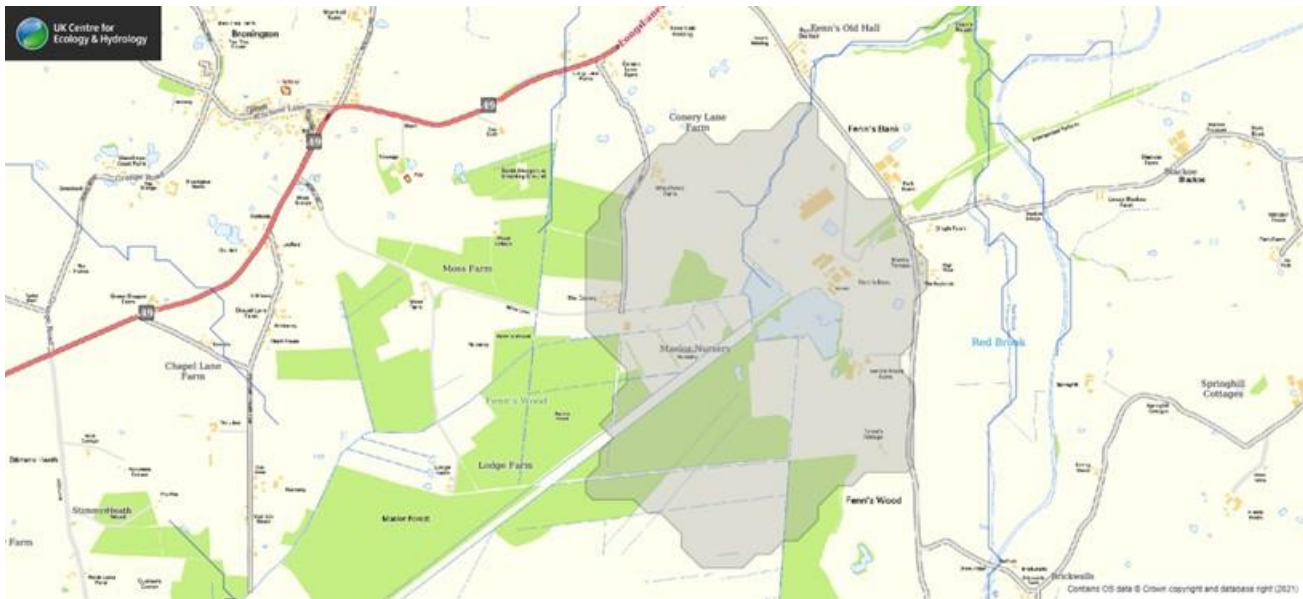
Figure 3-2 Catchment of the Redbrook

The catchment area of the Redbrook is estimated as 1.54 km², based on the FEH Web Service (Figure 3-2).

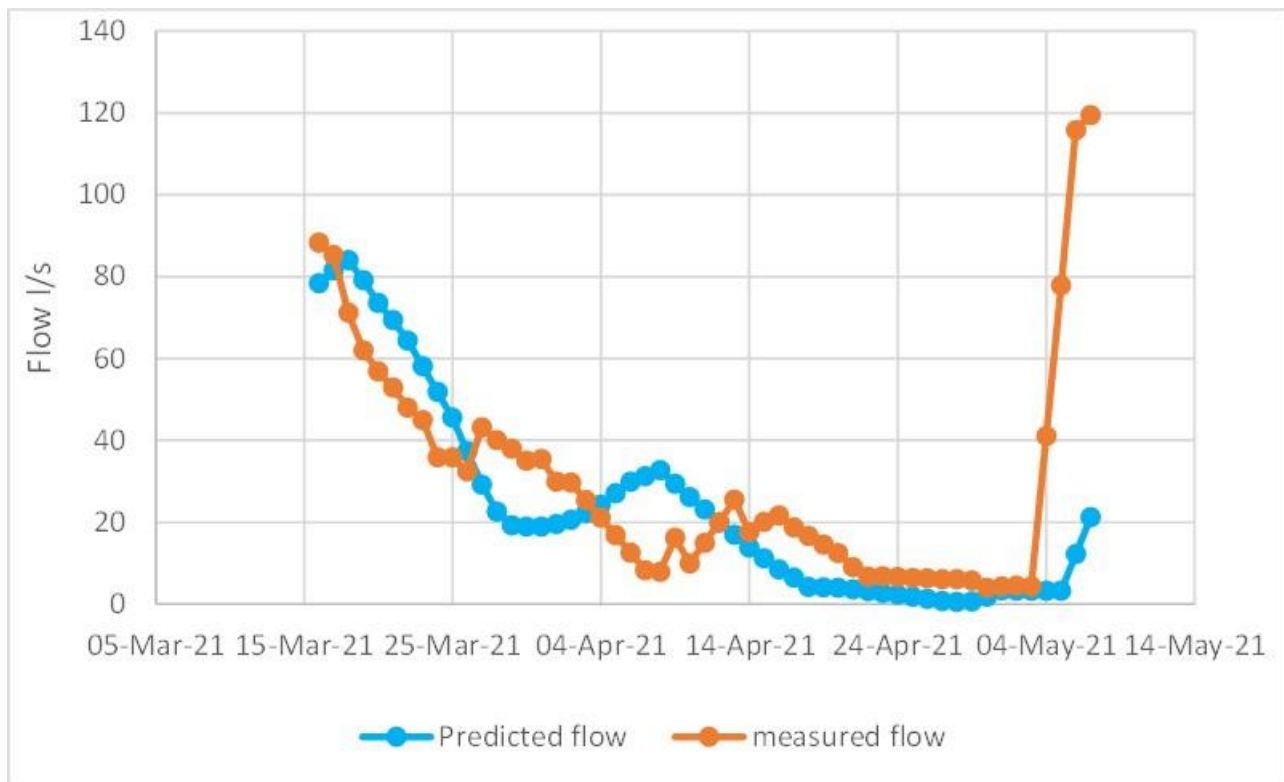
Figure 3-3 Measured and derived flow record

The flow record was calibrated against the measured flow record to set the adjustment factor, F. The resulting calculated daily flows are shown in Figure 3-3. The adjustment factor F was set to the value 2 to achieve the calibration shown.

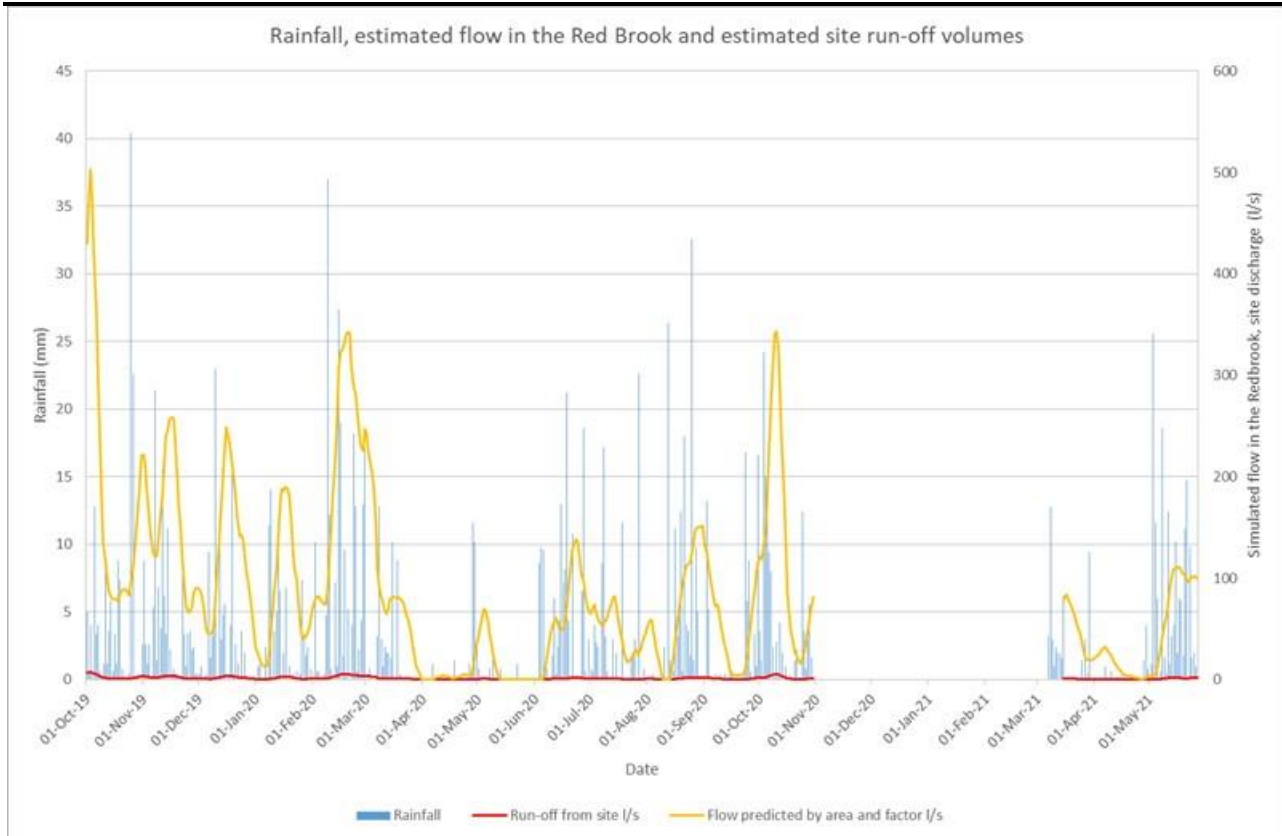
Figure 3-4 Generated flow record for the site and Redbrook.

Having calibrated the flow equation to measured data, the same relationship was used to generate a flow record for the period of the rainfall data record, as shown on Figure 3-4. Also shown on Figure 3-4 is an estimate of the site discharge, calculated as the effective rainfall over the site multiplied by the site area of 47264 m².
