**NANT-Y-GWYDDON  
LANDFILL SITE  
RHONDDA CYNON TAF**

**2019 Inert Bund Stability  
Assessment**

*Report Number 1983r1v1d0320*

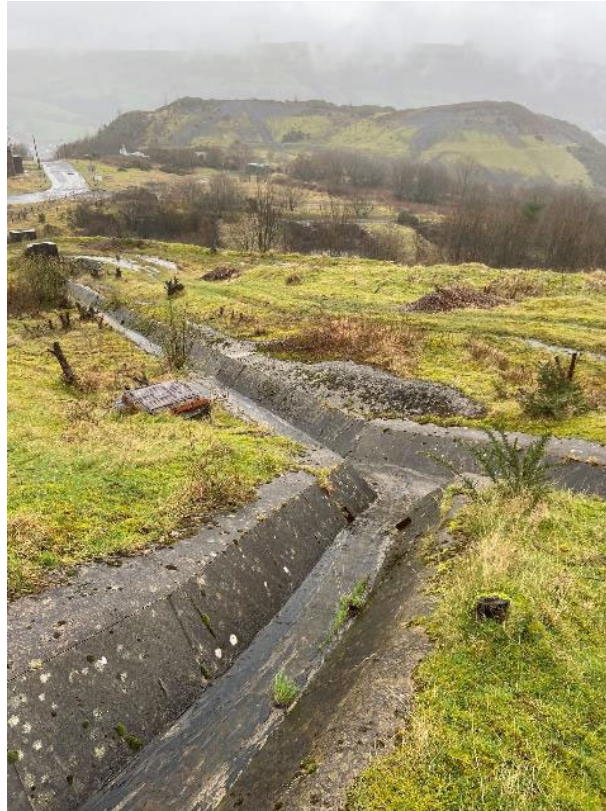
As can be seen in the photographs, the primary drains carrying surface water away from the landfill are in good working condition. Removal of overhanging vegetation from the surrounding area has reduced the risk of the culverts becoming blocked.

**Primary drainage culvert**

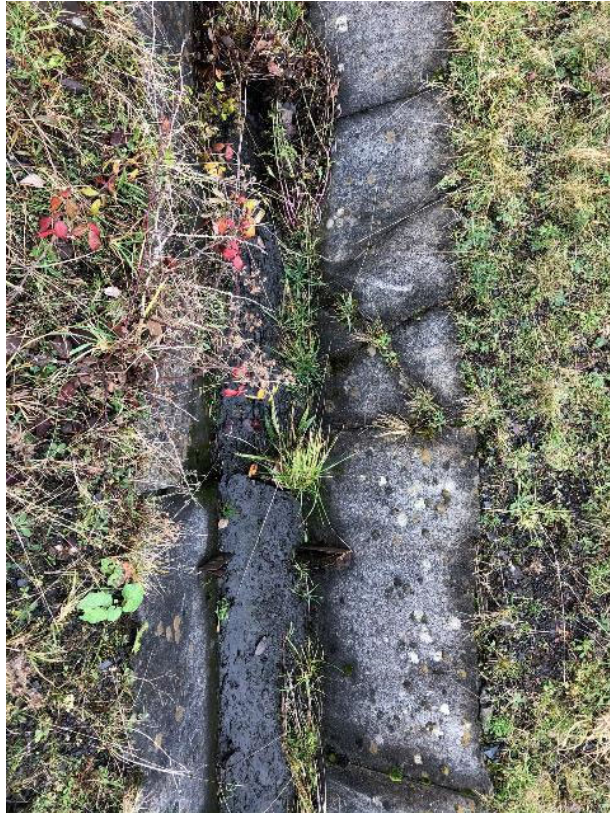
**Cracks in concrete drainage channel**

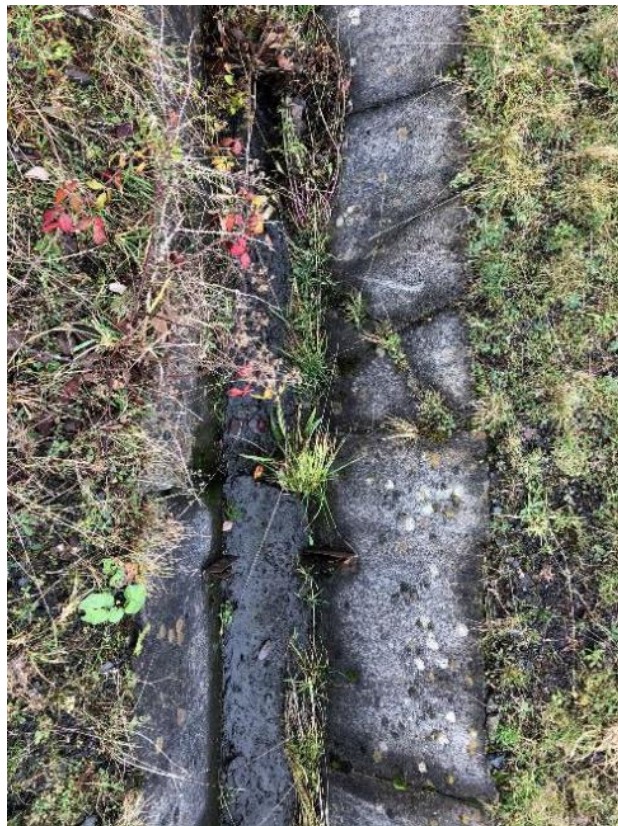
**Cracks in concrete drainage channel**

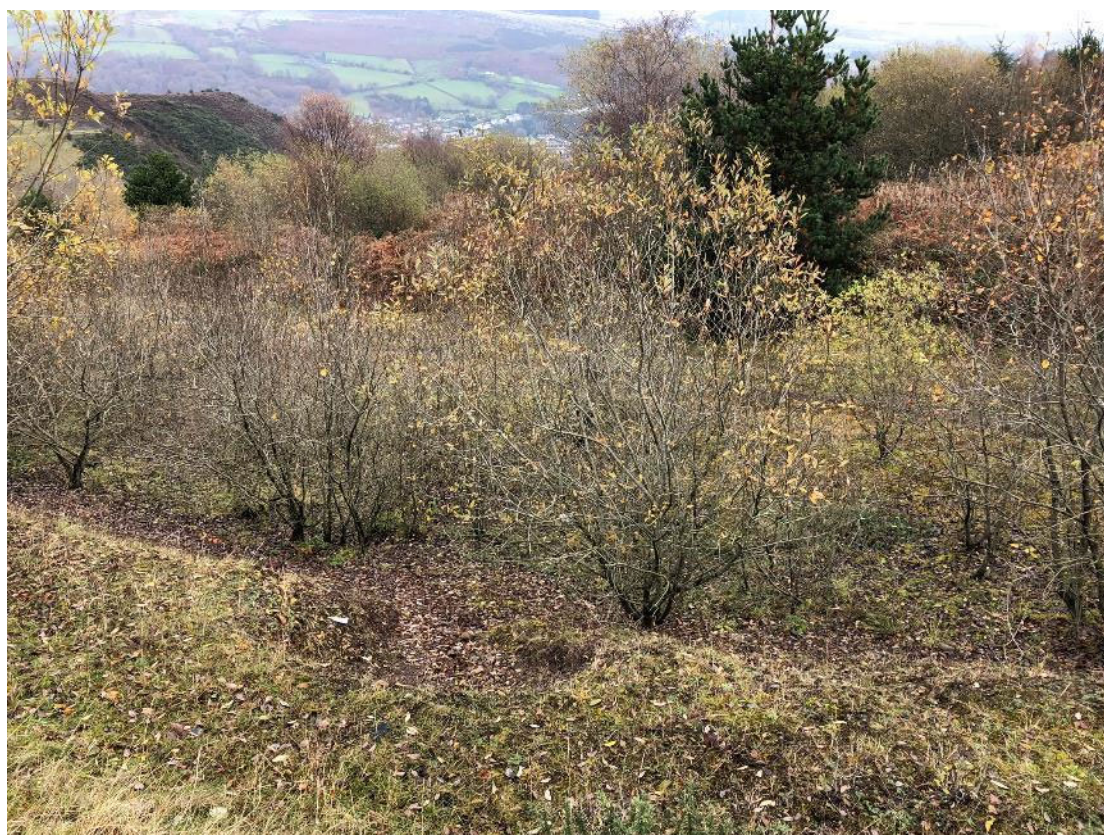
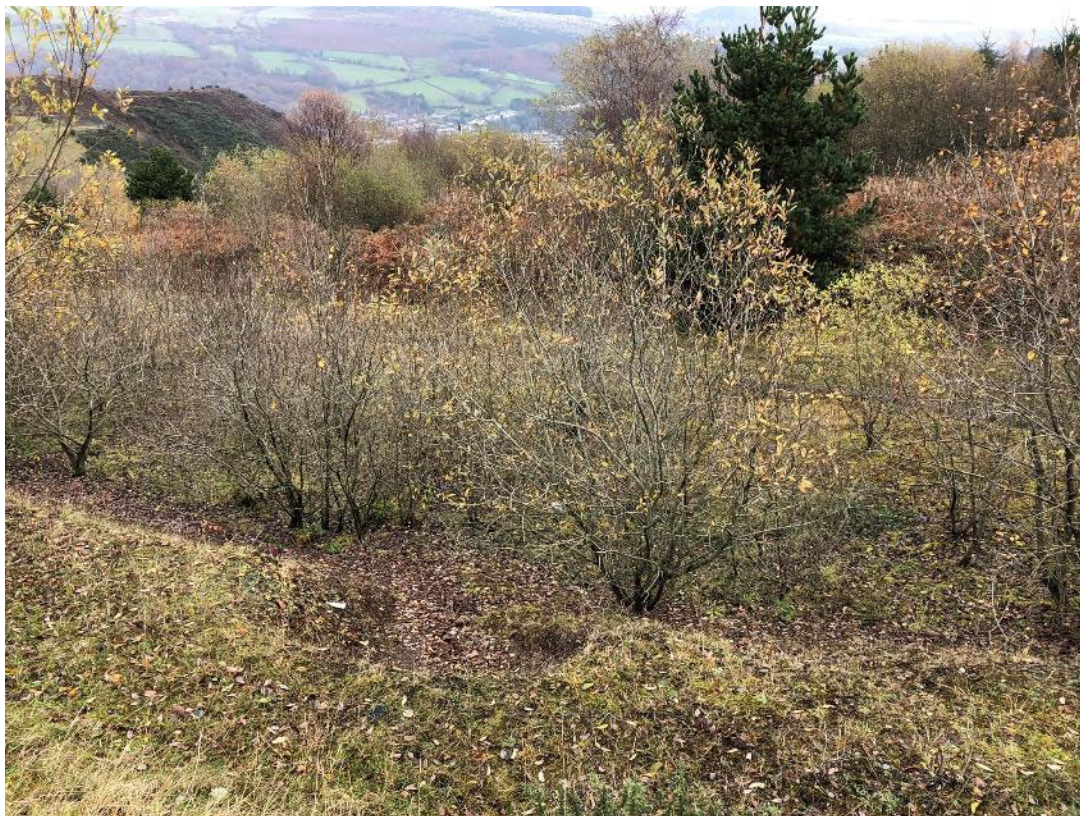
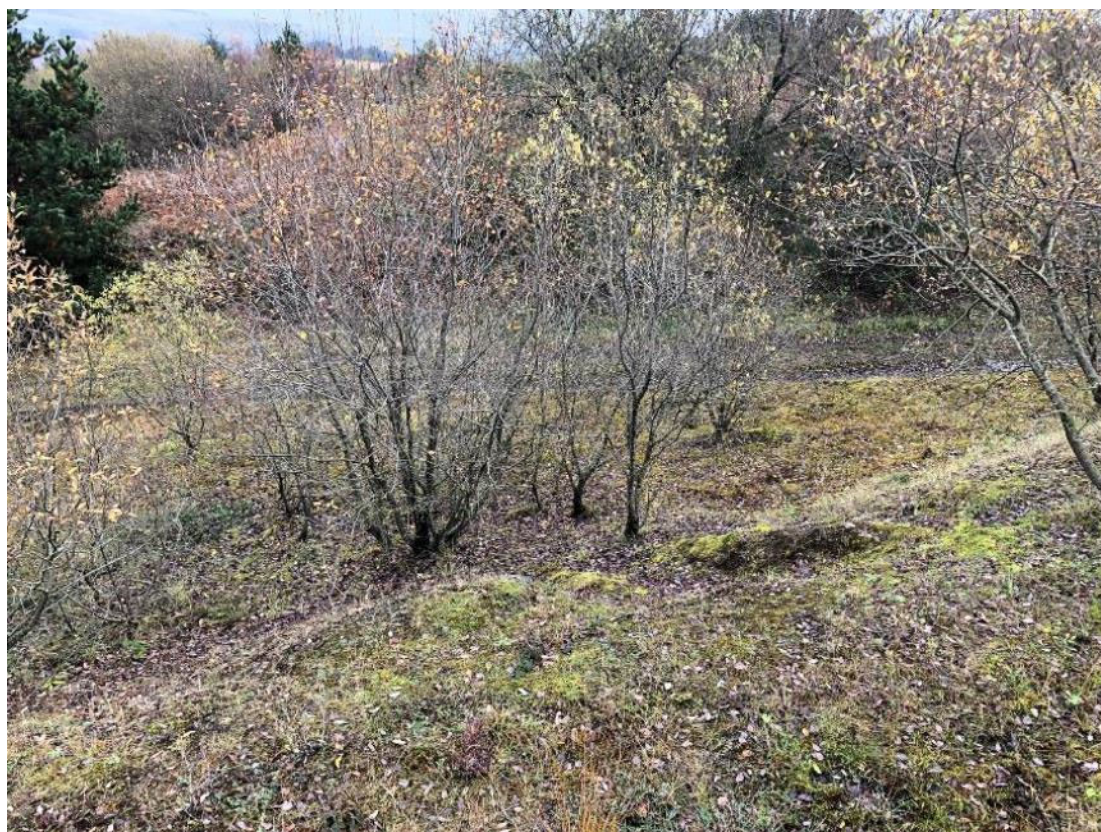
The inert bund was found to be well covered in grass, with gorse bushes, bramble and numerous small trees on the lower sections. It should be noted that some clearance work has been undertaken since the last review to remove many of the larger shrubs and trees. This has improved access to the bund and associated infrastructure. As stated previously, the bund has been constructed following a stepped profile, with slopes and berms forming the front face. The rear face cannot be seen, as it underlies the restored waste mass.

**Vegetation on Bund**
