**From:** Navigation <navigation.directorate@trinityhouse.co.uk>  
**Sent:** 15 August 2025 15:16  
**To:** Gareth Prebble; navigationsafety@mcga.gov.uk  
**Cc:** Josh Smart; Catherine Bransby  
**Subject:** RE: Q25072: Victoria Dock, Caernarfon

## Victoria Dock Sea Wall

### **Apply Marine Grade Pointing Mortar To The Voids Within The Masonry Stones**

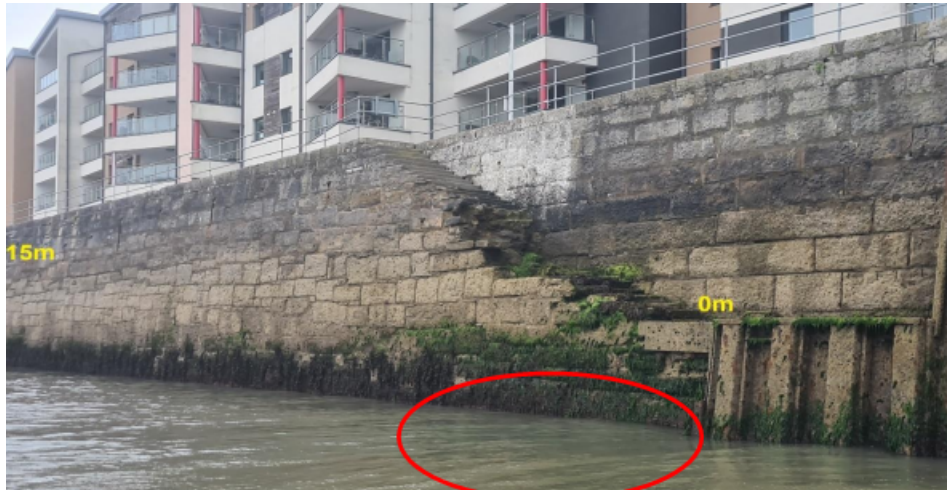
The client/owners are looking to implement the urgent repair works to this corner of the dock as soon as possible, the priority works are the pointing of large voids (joints) between the stone units under the existing steps (see below). The works will be carried out by either vessel or rope access (or combination of both). Please see brief description of the proposed works below, and we have also requested RAMS off the Contractor.

Apply high performance mortar to the deep voids which exist within several courses the mortar joints. These are located at the masonry stones just above seabed on the NE wall adjacent the half sheet piles. The voids are 0.8-0.9m deep and the mortar needs to be fully compacted starting each run from the back of each mortar joint and working forward.

Finally, several small mortar voids exist adjacent the piles on the NW wall and will be included as per above.

Remove weed from the damaged stepped area, the lower landing area and any areas where mortar application is required.

Again further investigate any missing mortar void depths and record any new findings and utilise a small pipe camera to look into the back of the mortar joints to see if they open to larger voids and if the back of the masonry stones are visible or not.

As required apply mortar repairs to any areas around the damaged section of stairs.
