## Event Duration Monitoring

### Trigger Exceedance Notification

Report type: Stage 2: Full Investigation Proposal

Location: CSO 11, Adjacent to Junction of Mumbles Rd Outside No. 48 Norton Road

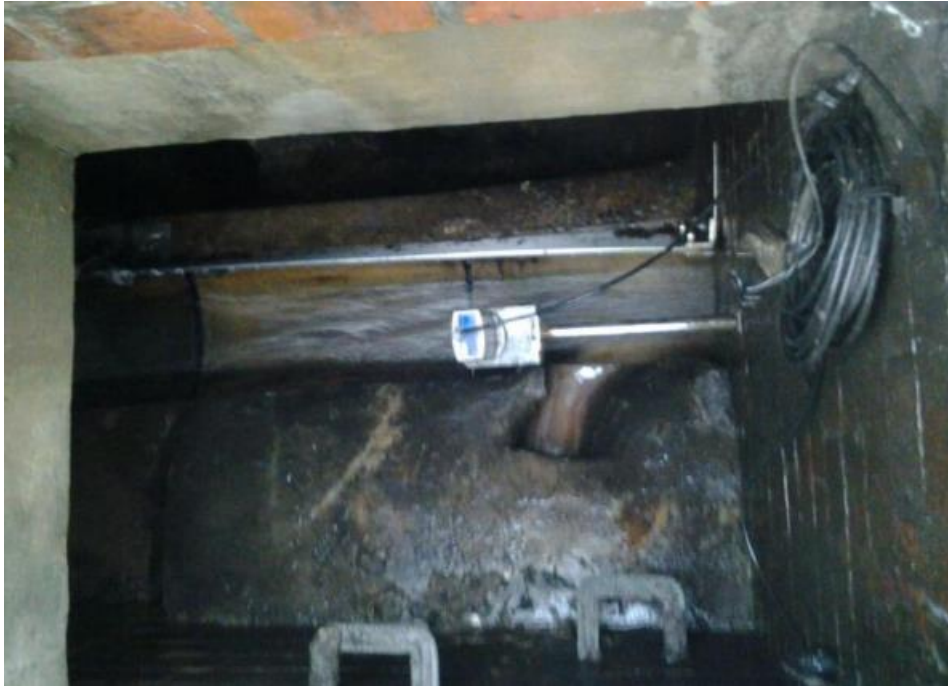
Figure 5: Internal View of CSO chamber and CELLO

Discharges are monitored with a 'CELLO' ultrasonic sensor, used for EDM purposes. PFF is controlled by the diameter of the outgoing pipe and capacity of the downstream network, and a spill occurs when flow exceeds 210l/s. Excess flows are screened via a 10mm bar screen and an overflow pipe runs from the CSO into a surface water sewer approximately 20m away on Norton Avenue where flows are then conveyed to the permitted discharge point.
