## Compliance Assessment Report CAR\_NRW0048812

| <b>Site name</b> | Withyhedge Landfill |
| <b>Type of assessment</b> | Site Inspection |

| <b>Date of assessment</b> | 9 <sup>th</sup> July 2025 | <b>Time in</b> | 09:45 | <b>Time out</b> | 14:00 |

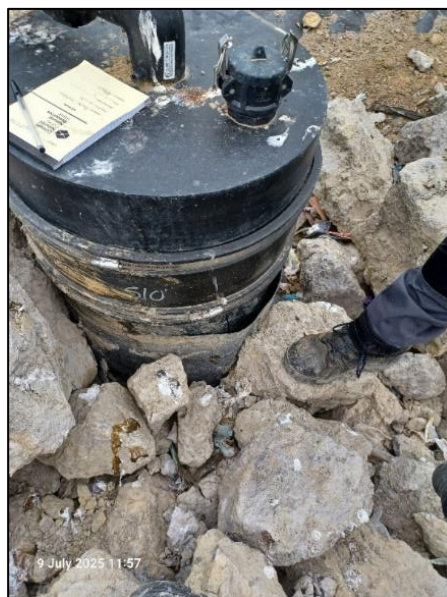
Image 1 - C9ALM1

During the construction of the access ramp, large pieces of the construction material have been allowed to strike the leachate monitoring well (C9ALM1) within Sub-Cell A; damaging the pipe boot seal (Image 1).

The damage to the pipe boot seal has provided a pathway for landfill gas to escape from the waste mass. Strong landfill gas odours were detected in the area surrounding the monitoring well and methane readings of >50% were recovered by the GAZOMAT from the failure point in the seal.

**The damage to the well and cap sealing detail at C9ALM1 is contrary to permit condition 2.10.1 and 2.10.2, as the operator has failed to take appropriate measures to collect, control and treat landfill gas. As a result of this, a non-compliance score of C3 has been allocated against compliance sub-criteria IR2K (Landfill gas management).**

**The damage to the well and cap sealing detail has resulted in an unauthorised point source emission which is contrary to permit condition 3.1.1. A non-compliance score of C3 has been allocated against compliance sub-criteria IR3A – Emissions to Air.**

It does not appear that any protective measures were put in place to protect C9ALM1 or the temporary cap from damage during the construction of the access ramp.

**This is in contrary to permit condition 1.1.1. A non-compliance score of C3 has been allocated against compliance sub-criteria IR1A – General Management.**

| Compliance Criteria | Action needed | Complete by |
|---|---|---|
| IR2K, IR3A | Operator to repair the seal around leachate monitoring well (C9ALM1). | Immediately |

**Action: Operator to repair seal to leachate monitoring well (C9ALM1).**
