## Compliance Assessment Report CAR\_NRW0049065

**Permit being assessed:** AN0295601

For: CEFN CARNAU UCHAF THORNHILL, held by Elysium Healthcare No.3 Limited

**Type of assessment carried out:** Site Inspection, Reason: Routine.

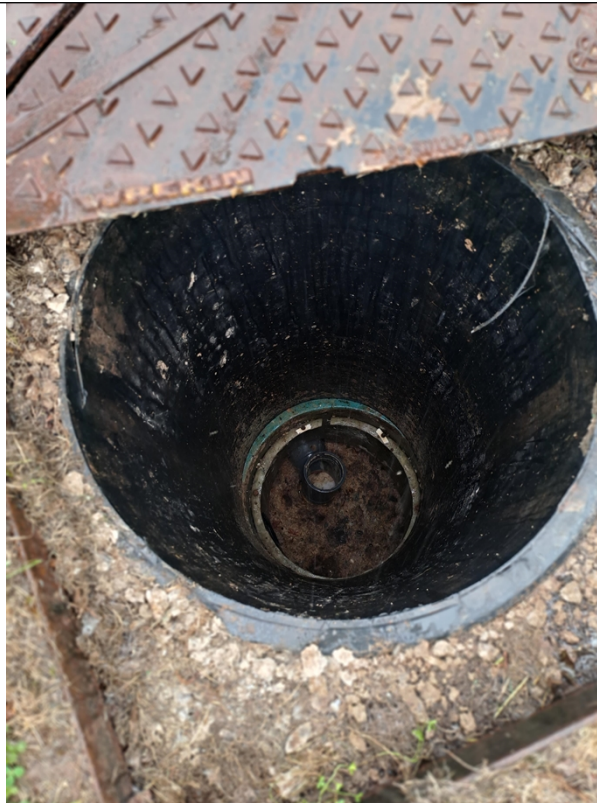
Chamber 1 is the primary solids settlement chamber. This was observed and appeared as expected with adequate capacity. As stated this is emptied every 2 months based on visual checks. The condition of the chamber is evidenced in Figure 1.

Figure 1 – Primary solids separation chamber as observed during the visit.

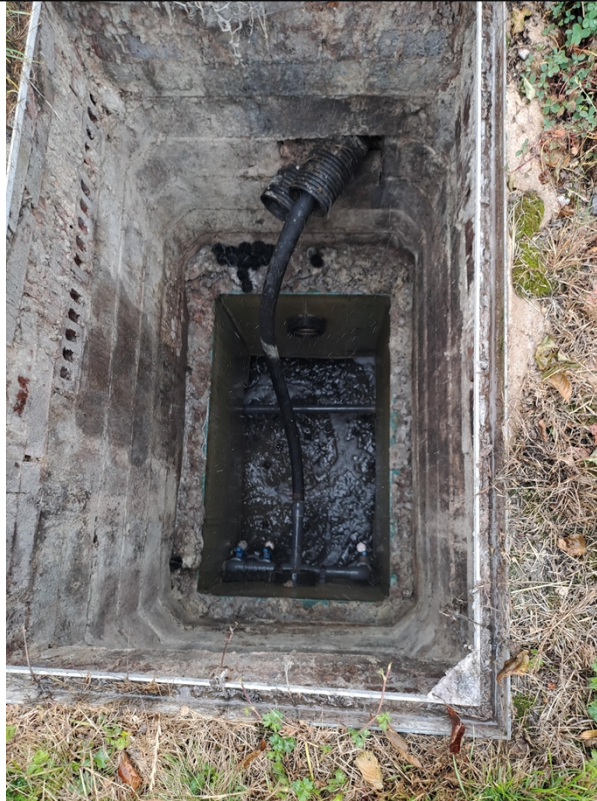
Chamber 2 is the aeration and bio media chamber. As observed in Figure 2, the aeration system was in good working order at the time of the visit with no visible solids carry over.

Figure 2 - Aeration and bio media chamber as observed during the visit.

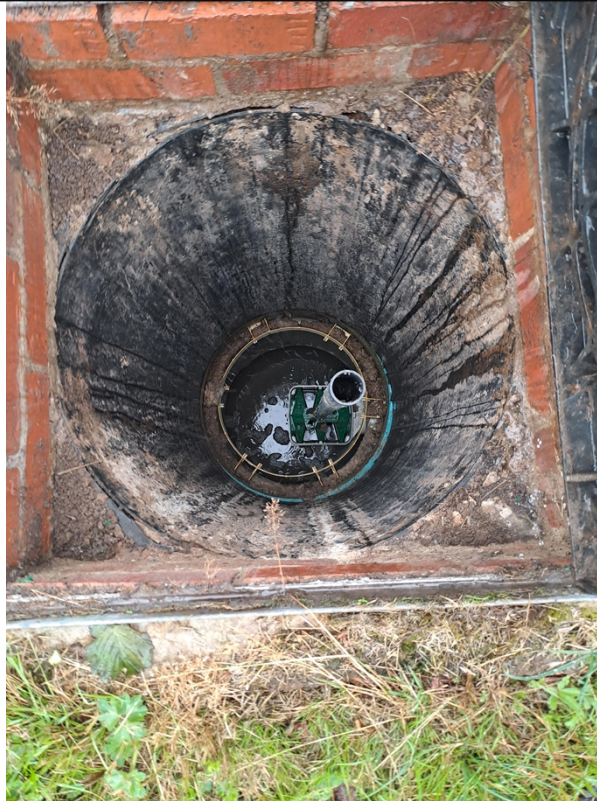
Chamber 3 is the final treated effluent chamber. There were no solids present, and the effluent appeared clear with no strong odour. This can be seen in Figure 3.

Figure 3 – Final treated effluent chamber as observed during the visit.

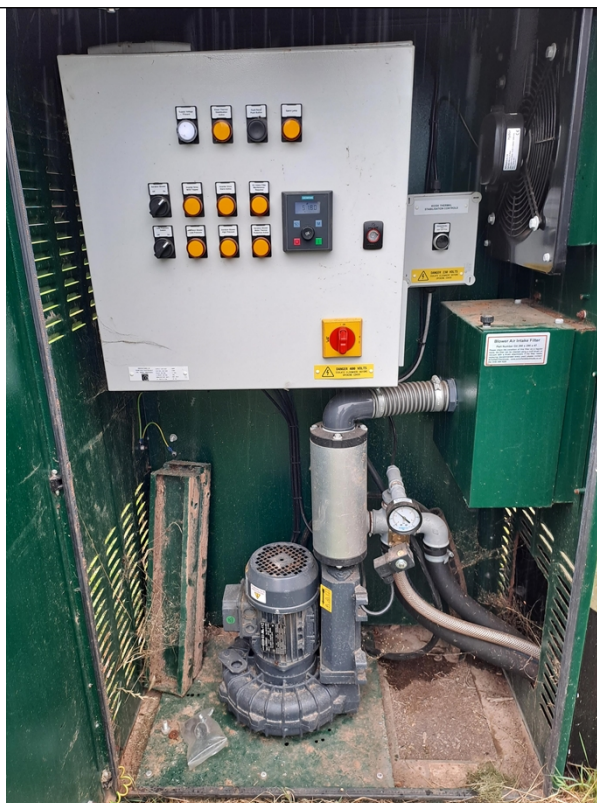
The control box for the system (Figure 4) was inspected. No apparent faults or issues were noted and it was working as designed.

Figure 4 – The treatment system control box as observed during the visit.

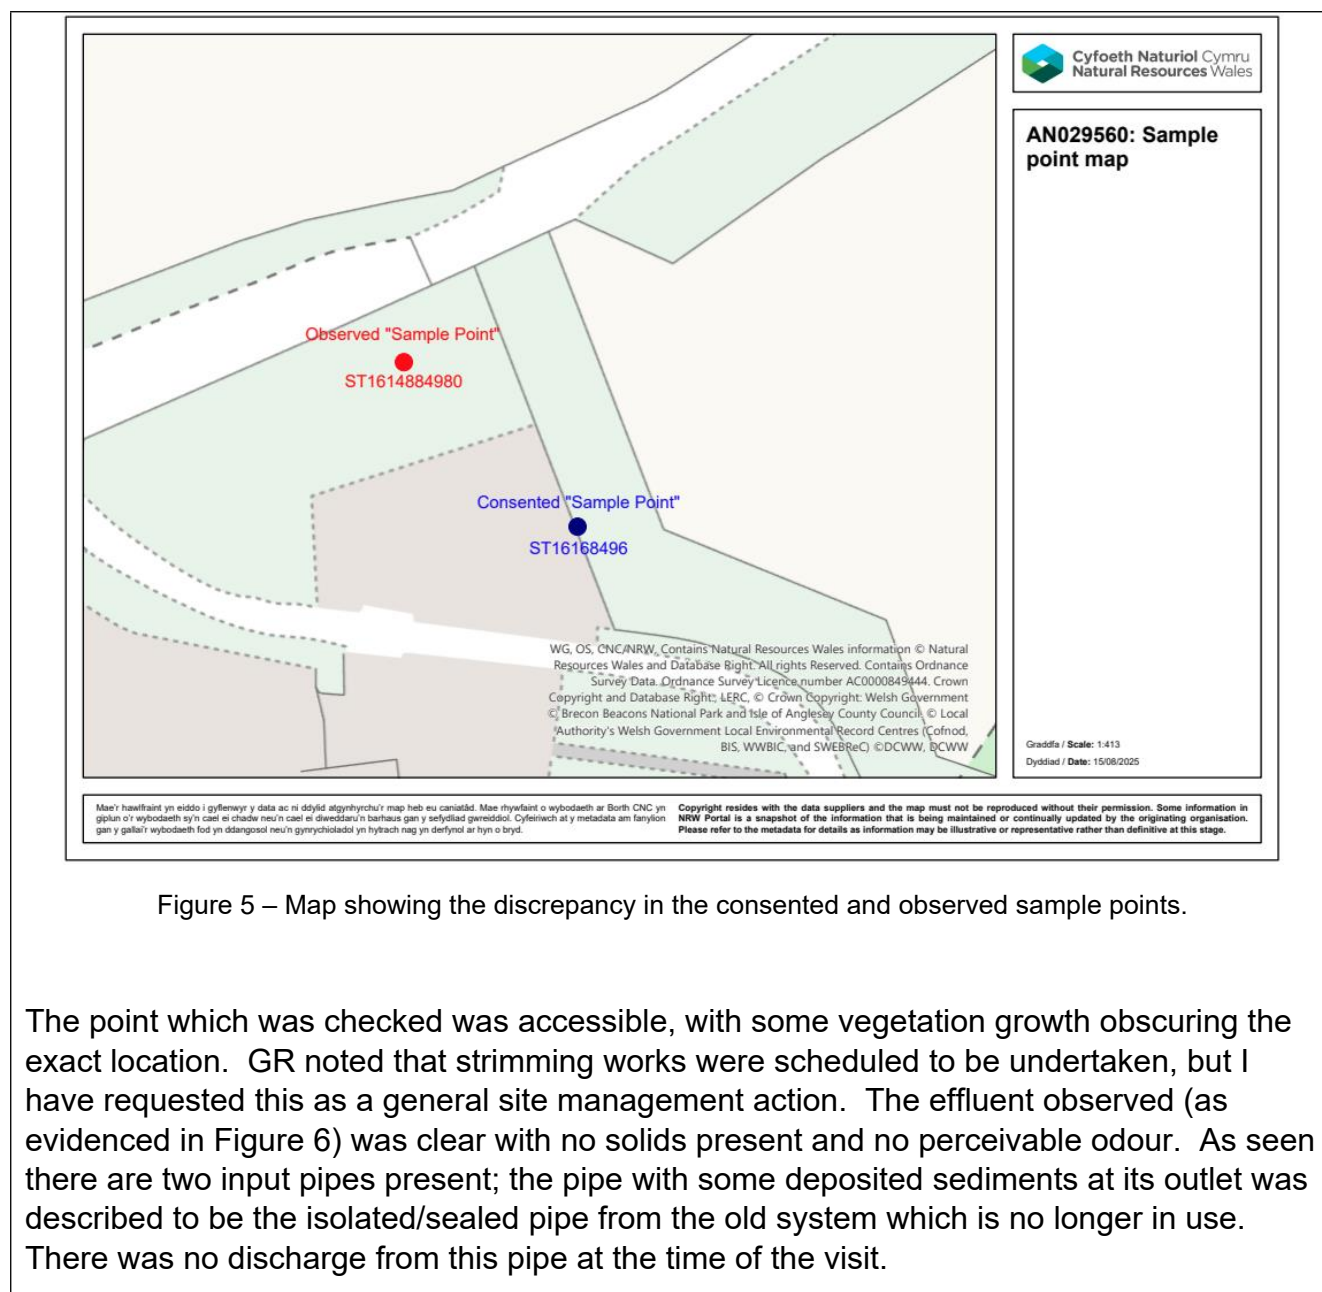
We then proceeded to inspect the stated sample point (as outlined by GR) which was located at ~ST1614884980. This is around 23m away from the consented sample point outlined in Condition 4 of the permit. I request that GR check the listed location (as seen in Figure 5) and confirm if there is a second access point where sampling can be undertaken. If not, a variation of the permit may be required to accurately indicate the point where samples can/should be taken.

Figure 5 – Map showing the discrepancy in the consented and observed sample points.

5. Confirm if the location of sample point observed is the only official one on site.

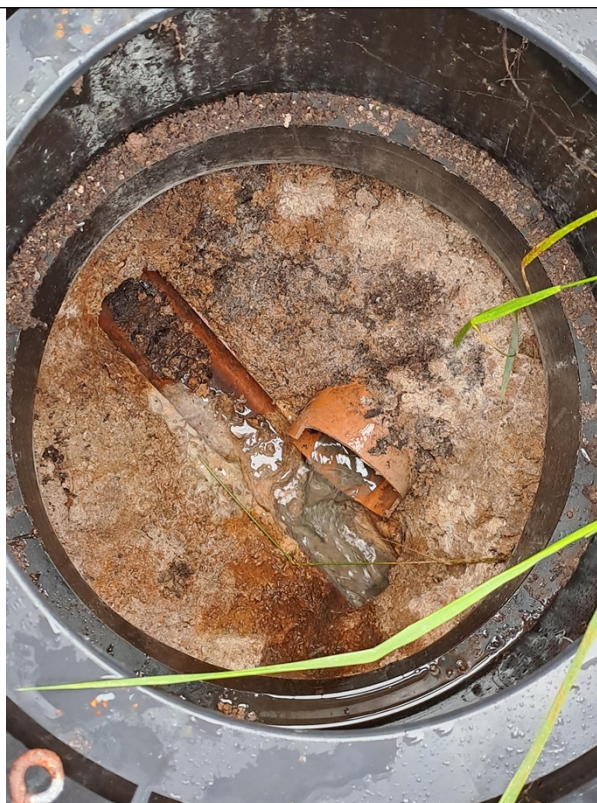
The point which was checked was accessible, with some vegetation growth obscuring the exact location. GR noted that strimming works were scheduled to be undertaken, but I have requested this as a general site management action. The effluent observed (as evidenced in Figure 6) was clear with no solids present and no perceivable odour. As seen there are two input pipes present; the pipe with some deposited sediments at its outlet was described to be the isolated/sealed pipe from the old system which is no longer in use. There was no discharge from this pipe at the time of the visit.

Figure 6 – The observed sample point at the time of the visit. Consistent clear flow can be see discharging. Note the defunct and isolated input from the old system in the top left of the chamber.

4. Strim area around sample point to improve access/visibility and provide evidence of its completion.

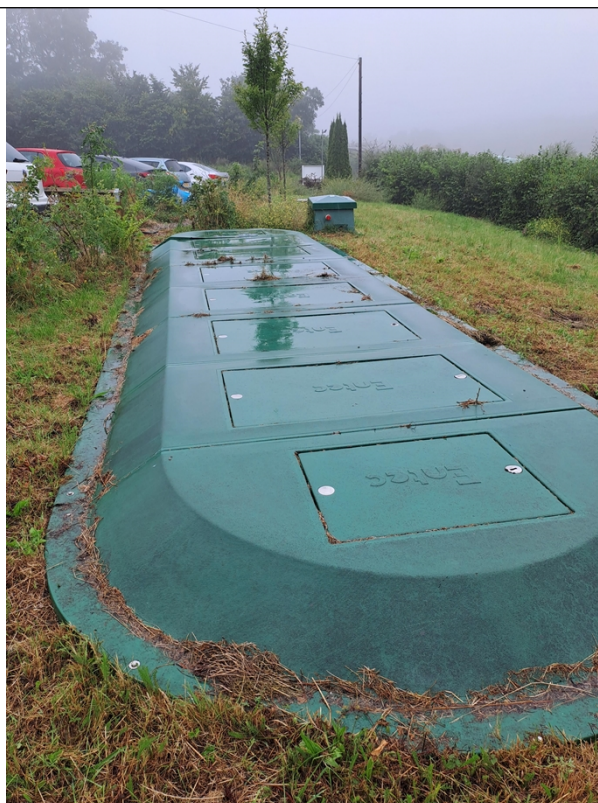
The old treatment system tank is still in place (Figure 7), however as stated there is no input into it and all pumps have been removed and power supply cut. Each chamber was stated to have been emptied, leaving no residual effluent within them. However, it is advised that the site explore the option to remove this infrastructure to avoid any unforeseen issues.

Figure 7 – The old treatment system as observed during the visit.

1. Explore the options for the removal of the old treatment system infrastructure.

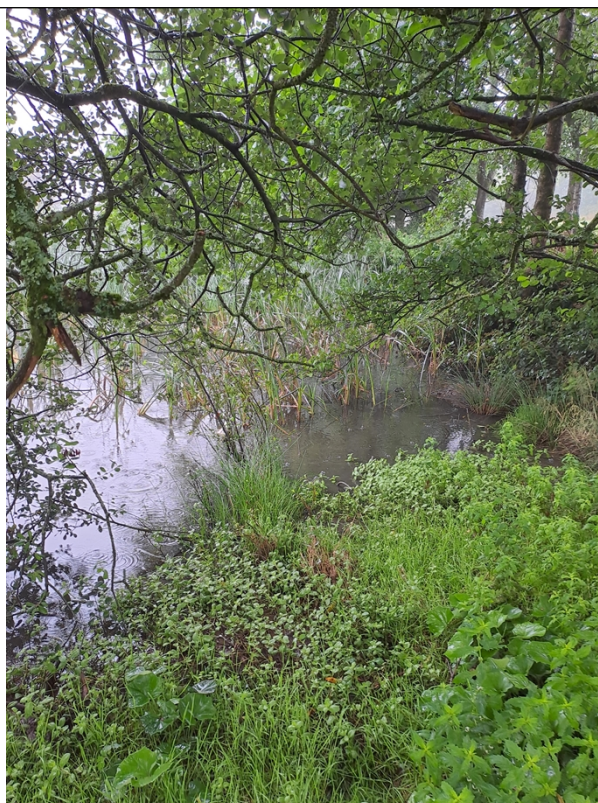
The discharge to the pond was inspected. While the exact point could not be accessed due to heavy vegetation growth, the pond was observed to be clear of any distinct impacts and displayed no discolouration. No odour or fungus was observed. This is evidenced in Figure 8. No further observations were made.

Figure 8 – The pond which the discharge enters as observed during the visit.
