# ZTN201121C - As-left Report Gwynt Y Mor Met Mast

RWE

On behalf of RWE, our team successfully executed the full decommissioning and removal of the Meteorological Mast at Gwynt y Môr.

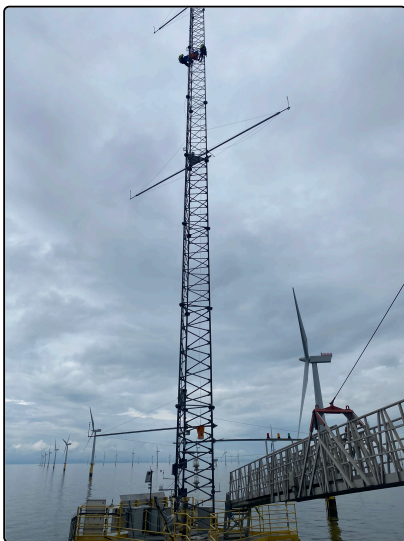
**1 Lattice mast prior to removal.**

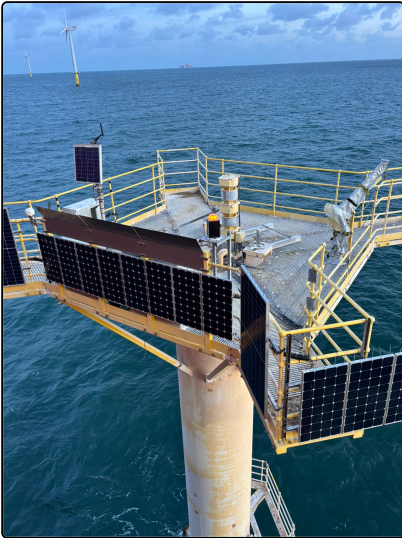
**4 Gwynt Y Mor Meteorological Mast - platform as seen upon arrival.**

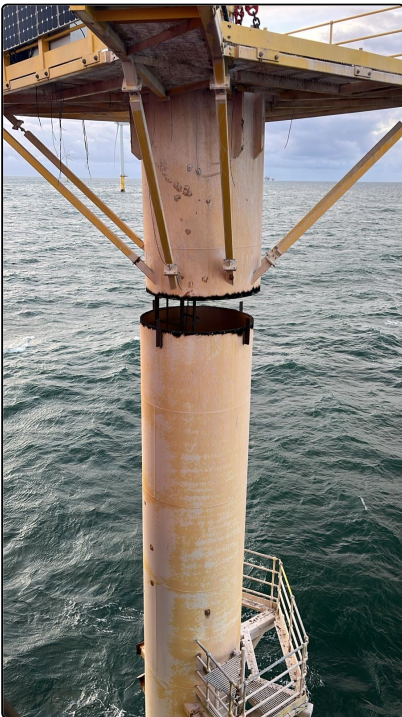
**5 Upper platform cut and being lifted.**

Immediately upon completion of jacking operations, work commenced on the removal of the upper platform of the meteorological mast. At 19:20 on 13 September 2025, the platform was landed on the deck of WIND SERVER. Subsequent work focused on separating the platform struts and the cut monopile section. By approximately 23:40, both the platform and monopile section were fully disconnected and properly seafastened on deck.

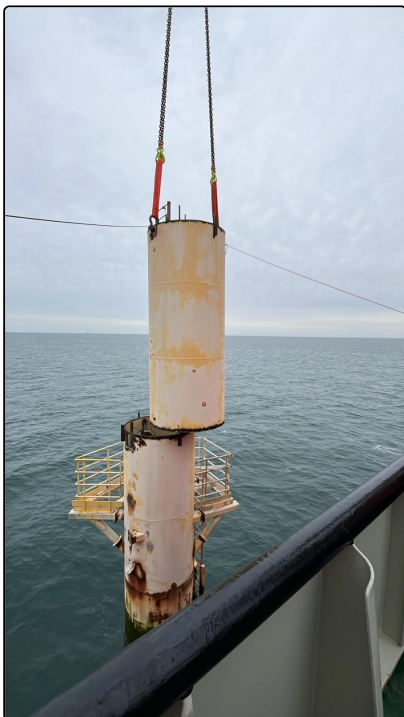
**7 Upper monopile section cut from lower monopile section.**

At 10:48 on the 14 September 2025 the upper monopile section had been cut from the remaining monopile and it was lifted to the deck of the WIND SERVER. At 12:30 the same day the section had been properly seafastened onto deck.

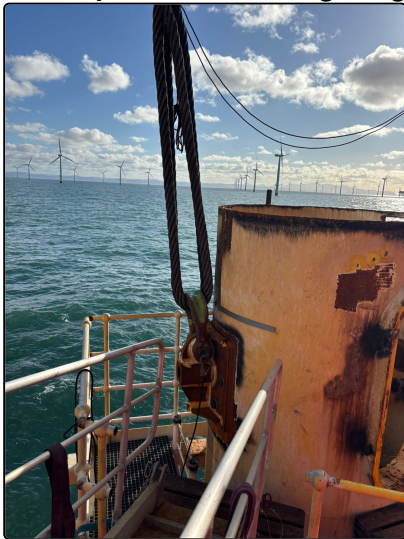
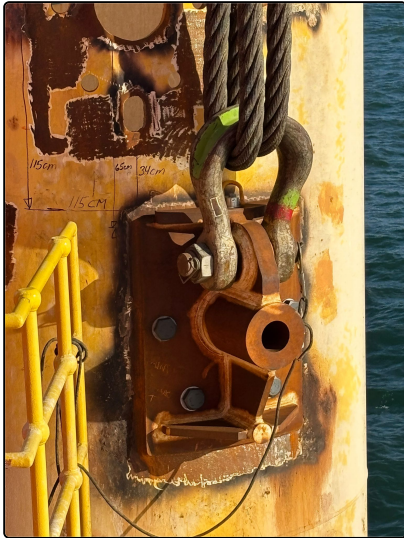
**9 Lifting brackets installed.**

**10 Lifting brackets installed.**

Over the following days, adverse weather conditions limited progress, and work was carried out whenever conditions permitted. During this period, the external platform was refurbished to serve as a working area and the WIND SERVER had been repositioned to enable these tasks and to prepare for the final scope of operations. By 01:00 on 22 September, the upper internal platform had been removed, along with the internal ladder and lower internal platform. Finally, lifting brackets were installed on the monopile.

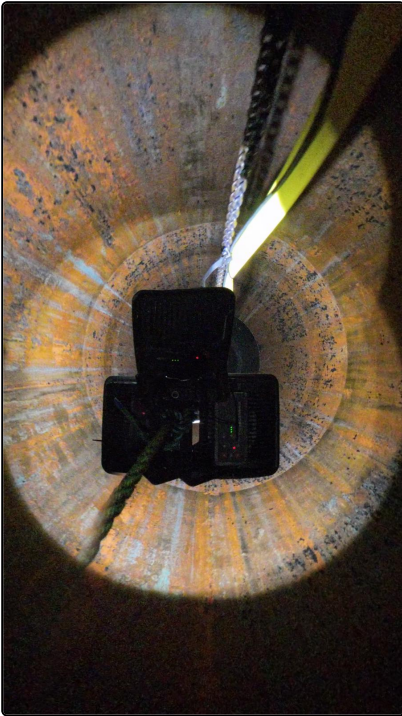
**12 Camera and Lights being lowered into the monopile.**

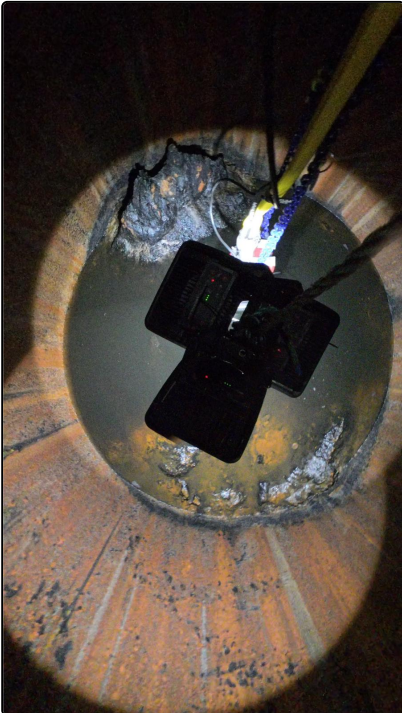
Subsequent inspections confirmed that no cleaning was required, as the entire almost 10 meters was completely clean and free from objects, marine growth, pebbles, or stones—contrary to what had been observed at most other locations.

**13 Camera and Lights at the bottom of the monopile.**

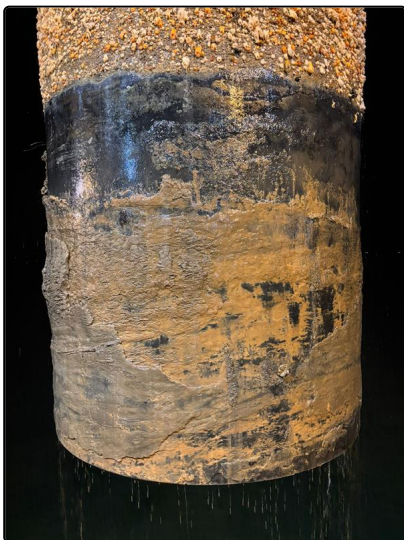
Subsequently, the monopile was lifted from the seabed, weighing 153.0 tonne.

15 MP being lifted out of the water

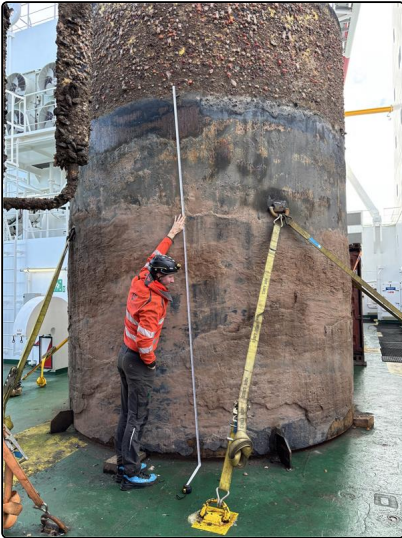
**16 Level of barnacles indicated the external seabed level**

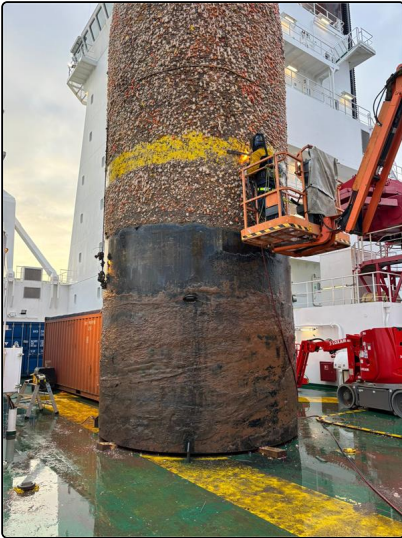
### **18 Cutting into 5m sections**

The monopile was landed and cut into 10 pieces and made ready for sea transport by properly seafastening them all.
