## Compliance Assessment Report CAR\_NRW0049209

**Permit being assessed:** AF4020601

For: ST MELLONS RHYMNEY VALLEY NURSERIES, held by HAYGROVE LIMITED

**Type of assessment carried out:** Site Inspection, Reason: Routine.

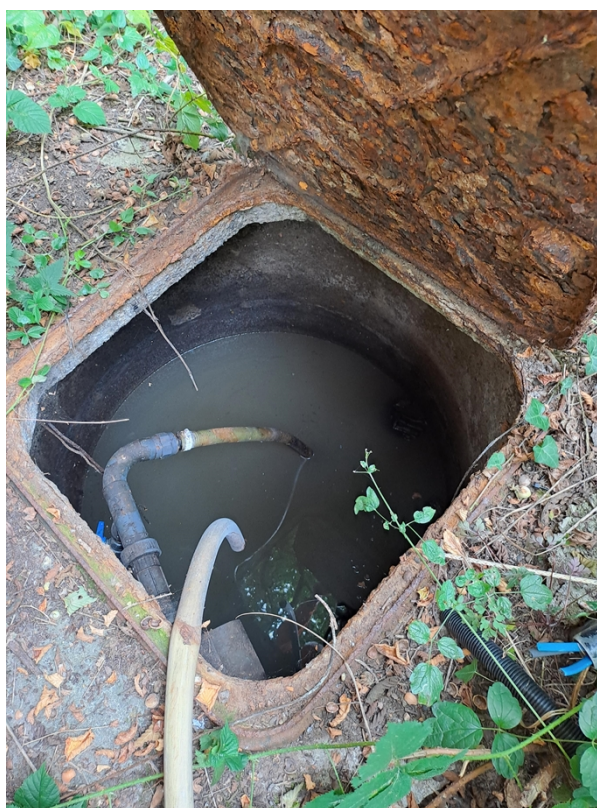
The primary/solids settlement tank was observed and inspected (located at ST2275183505). The pump was in place and appeared to be in good working order. There was no excessive build-up of solid waste and no other points of concern. This is evidenced in Figure 1.

Figure 1 – The primary settlement tank as observed during the visit.

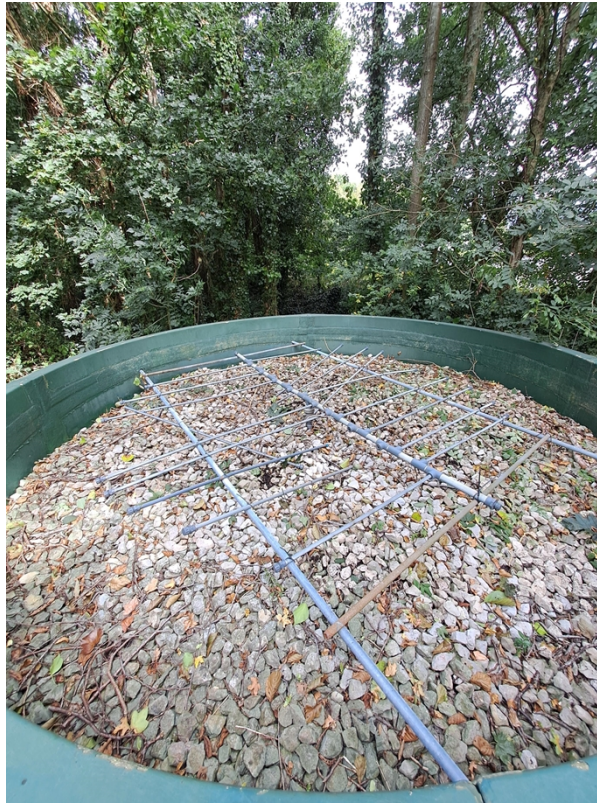
The filter system is located at ST2258683482 and was easily accessible due to recent groundworks to clear the area. On inspection it was clear that the system was quite dry due to a prolonged period of dry weather. Regarding the condition of the infrastructure, it was observed that several of the spray bars have been dislodged/broken which could lead to an uneven distribution of effluent throughout the bed. Additionally, there was a significant amount of vegetation material on the surface of the filter bed. These observations are evidenced in Figures 2, 3 and 4. I noted that these points would constitute breaches of infrastructure maintenance, but due to the age of the permit there are no conditions to regulate these breaches against. As such, I have actioned them below as a

Figure 2 – The filter system as observed during the visit.

1. Repair or replace the dislodged spray bars on the filter system to ensure even

distribution of effluent.

2. Remove excess vegetation from the filter bed to ensure efficient filtration of effluent can occur.

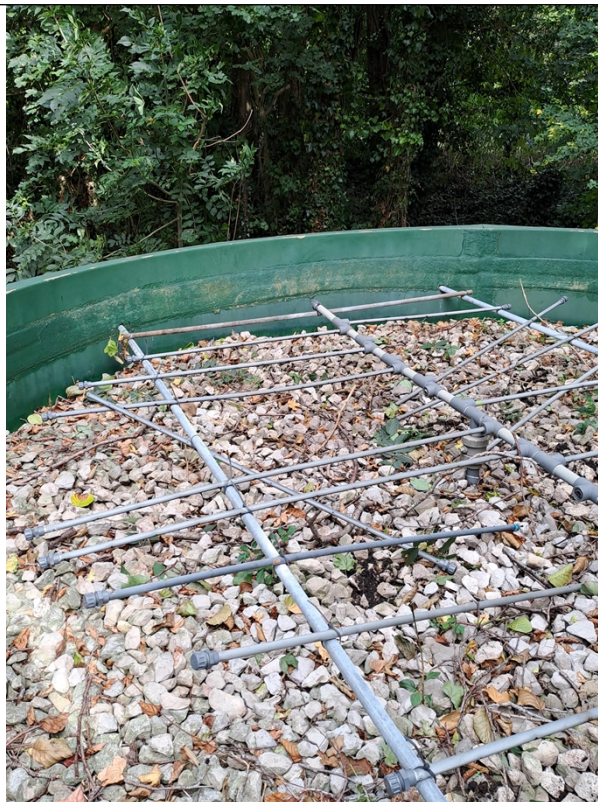
Figure 3 – The filter system as observed during the visit. Damaged spray bars and vegetation build up clearly present.

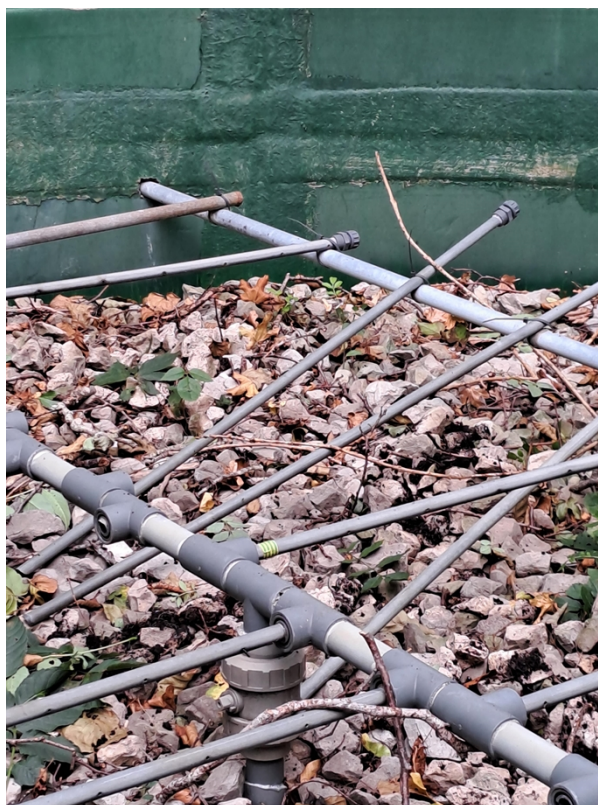
Figure 4 – The filter system as observed during the visit. Damaged spray bars as described above.

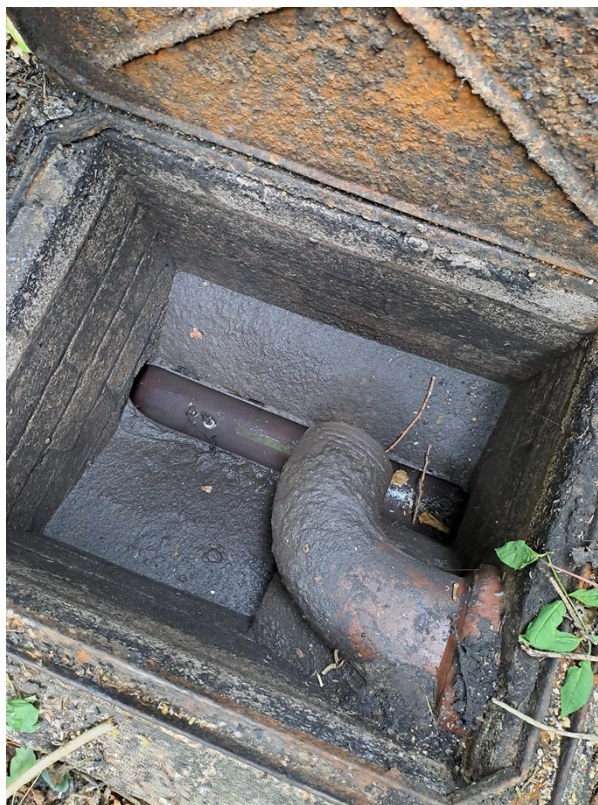
The final effluent sample point was confirmed to be located at ST2257783483. There was some discharge present at the time of the visit (as seen in Figure 5), but this discharge was clear and displayed no sign of solids carry over. No deposits of waste or fungus were observed in the chamber or pipework and there was no odour.

Figure 5 – The final effluent sample point as observed during the visit.

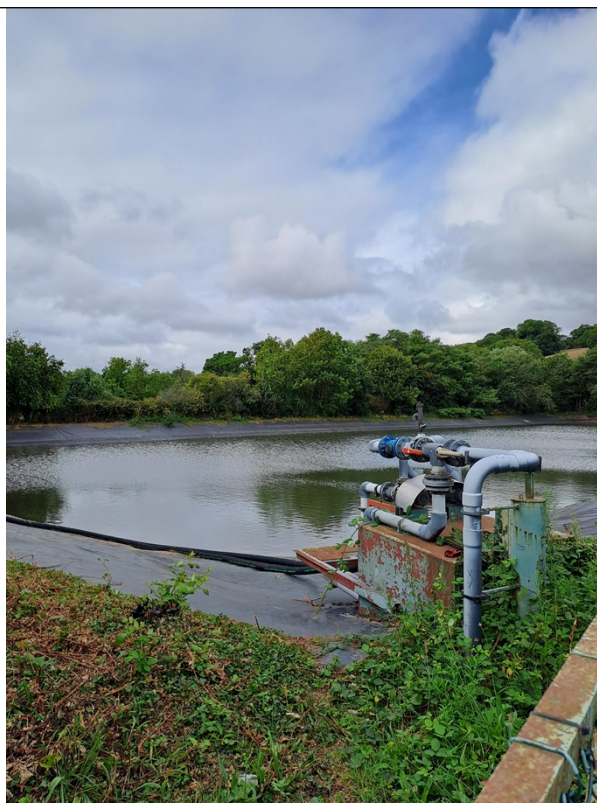
As stated in the initial meeting, the discharge point was not accessible during the visit due to it being a discharge to ground located underneath the reservoir. It was stated that this has always been the case as long as Haygrove Limited have operated the site. The only maintenance noted for the reservoir was that it was re-lined ~25 years ago. At the time of the visit the reservoir was holding water (Figure 6) and no issues were noted.

Figure 6 – The reservoir as observed during the visit.
