## Compliance Assessment Report CAR\_NRW0043194

**Permit being assessed:** GB3593HE

For: TRADE EFFLUENT TREATMENT @ BBH LTD, held by BURT BOULTON AND HAYWOOD LIMITED

**Type of assessment carried out:** Site Inspection, Reason: Routine.

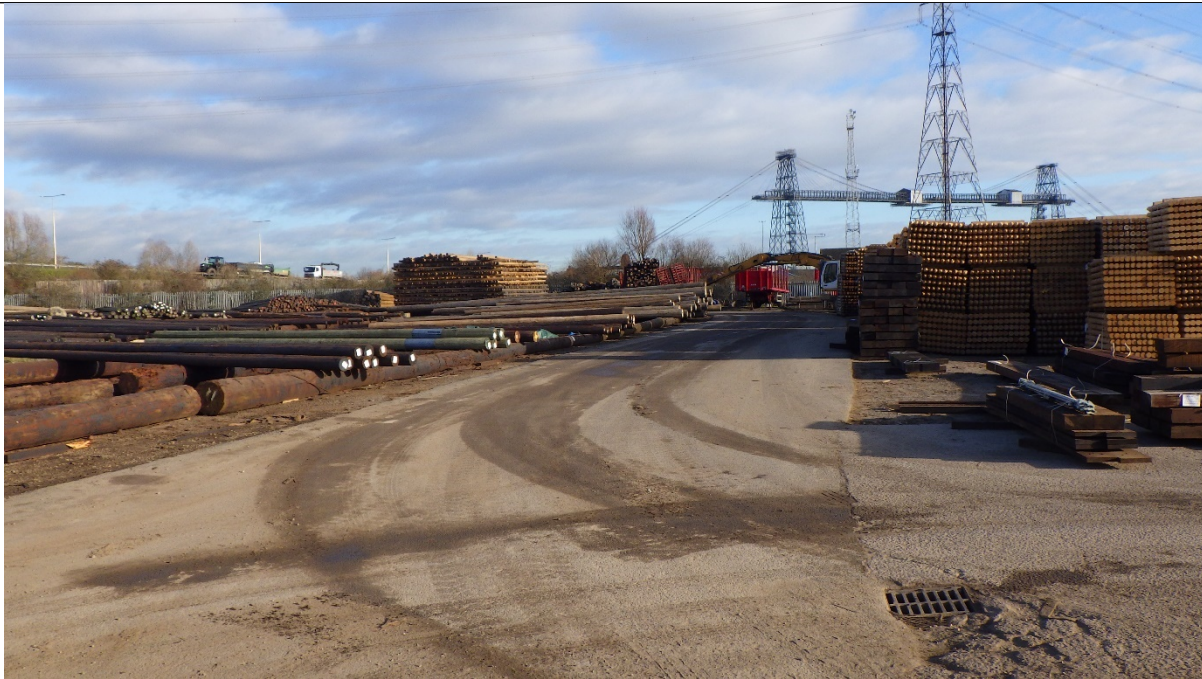
General site conditions were observed on the production yard. The site was generally clean with no excess debris or mud present on haulage roads as seen in Figure 1. I was noted that road sweepers are deployed periodically when needed to ensure roads are kept clear of excessive mud.

Figure 1 – Site visit photo: A representative view of site conditions at the time of the visit.

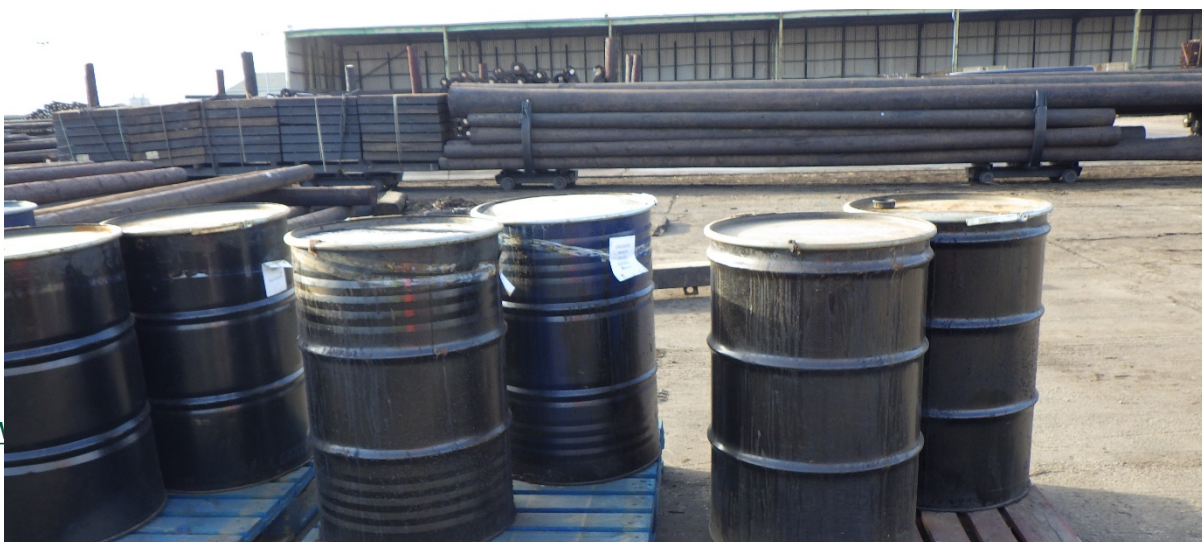
During the site walkover, approximately oil drums and one IBC were observed stored in the open on a wooden pallet as seen in Figures 2 and 3. On inspection, it was found that the drums contained solid waste only that was contaminated with creosote e.g. rubber gloves, paper towels, plastic packaging. This is seen in Figure 4. The IBC contained liquid waste contaminated with creosote. There was no containment in place to mitigate against any accidental spills or to prevent any wastes entering the site drainage network. I advised that all wastes should be stored on impermeable bases with containment measures (e.g. bunding with 110% capacity) to ensure no accidental spills lead to an environmental pollution incident. The Technical & Regulatory Manager agreed with this statement and ensured that they would relocate the wastes to a more appropriate location as soon as practicable.

Figure 2 (above) and Figure 3 (below) – Site visit photo: Drums and IBC observed on site.

1. Ensure that waste drums and IBC containing solid and liquid wastes are stored within a bunded area with 110% capacity. Provide evidence that this has been actioned/undertaken.

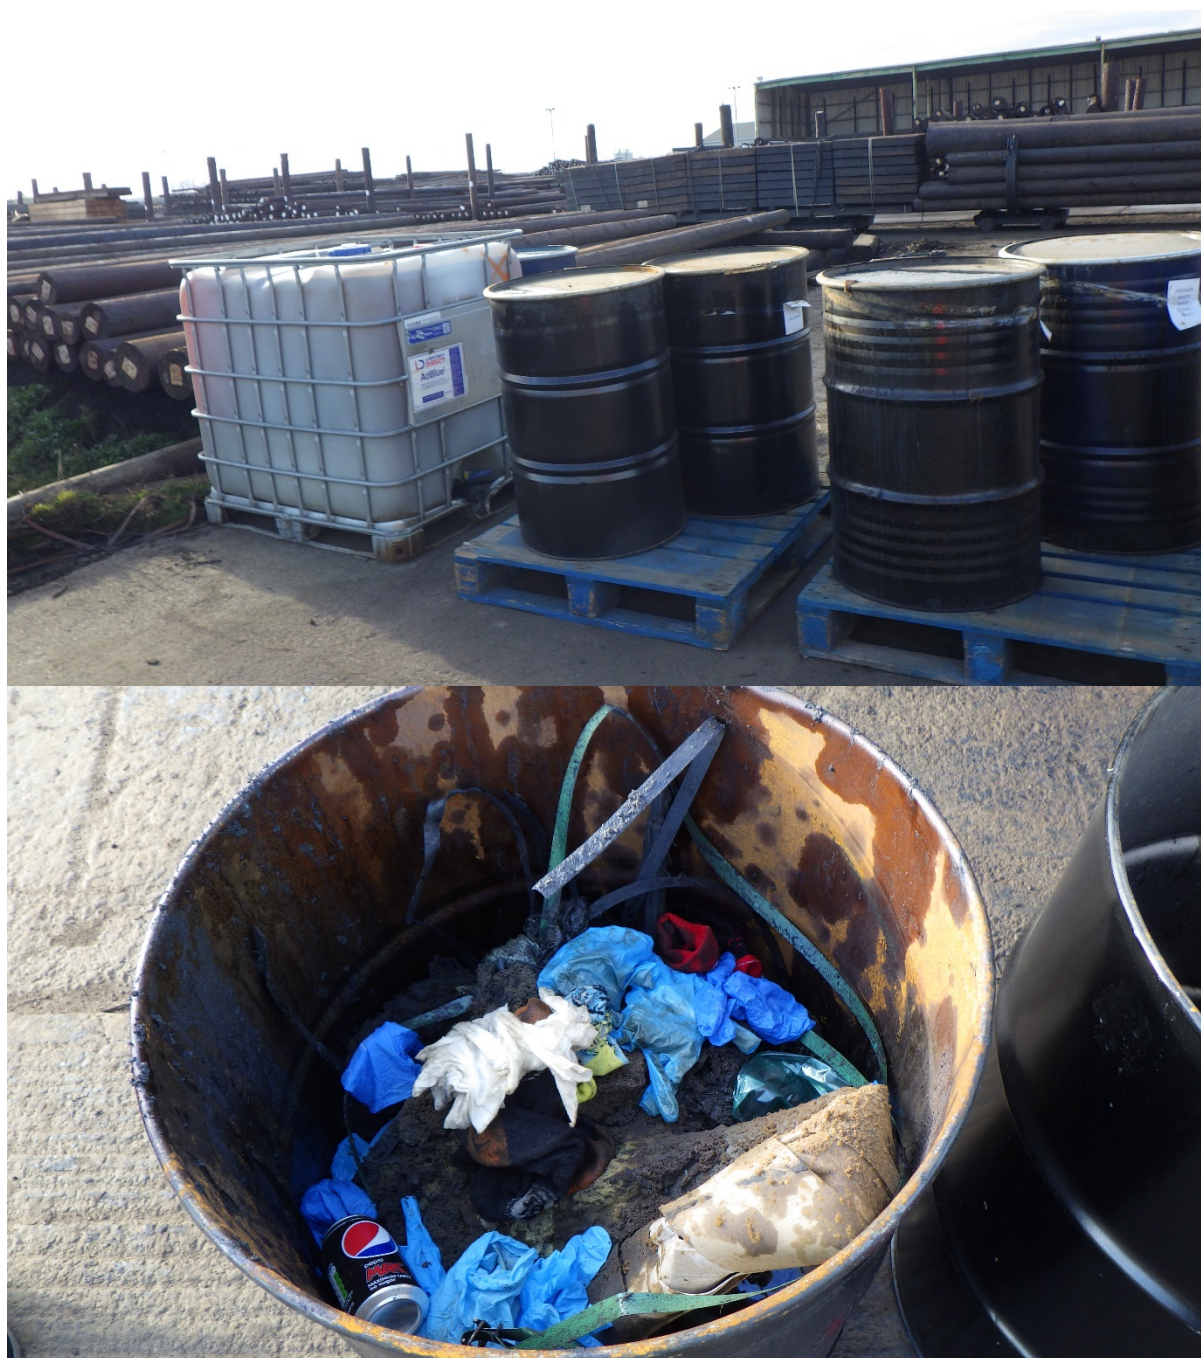
Figure 4 – Site visit photo: The contents of the oil drums being used to store contaminated solid wastes prior to disposal offsite.

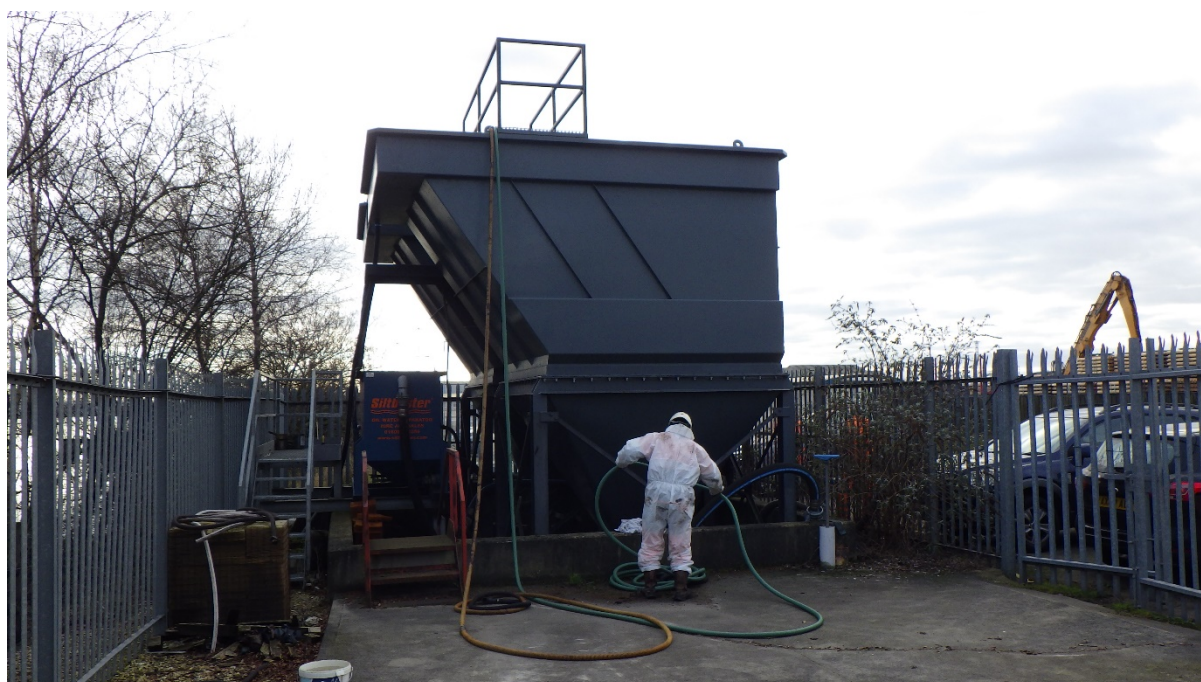
Figure 5 – Site visit photo: The onsite silt buster which was operational at the time of the visit.

The site drainage infrastructure was inspected, with the silt buster in operation at the time of the visit, as seen in Figure 5. The pre-treated effluent storage tank was holding water but there was little input at the time of the visit, as seen in Figure 6. No issues were noted regarding operations or maintenance since the system was reinstated to full usage in December 2023. It was noted that the system is serviced and jetted/cleaned as needed by GD Environmental, with the last routine maintenance visit being in “Summer 2023”. I have requested a copy of maintenance and servicing records for the system.

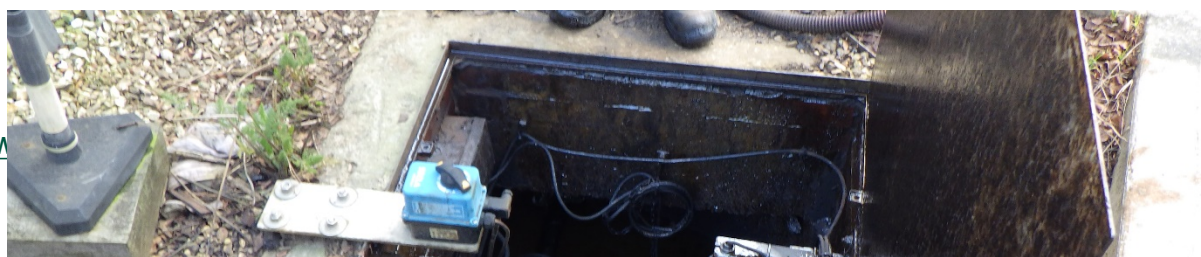
Figure 6 – Site visit photo: Pre-treated effluent tank holding water at the time of the visit.

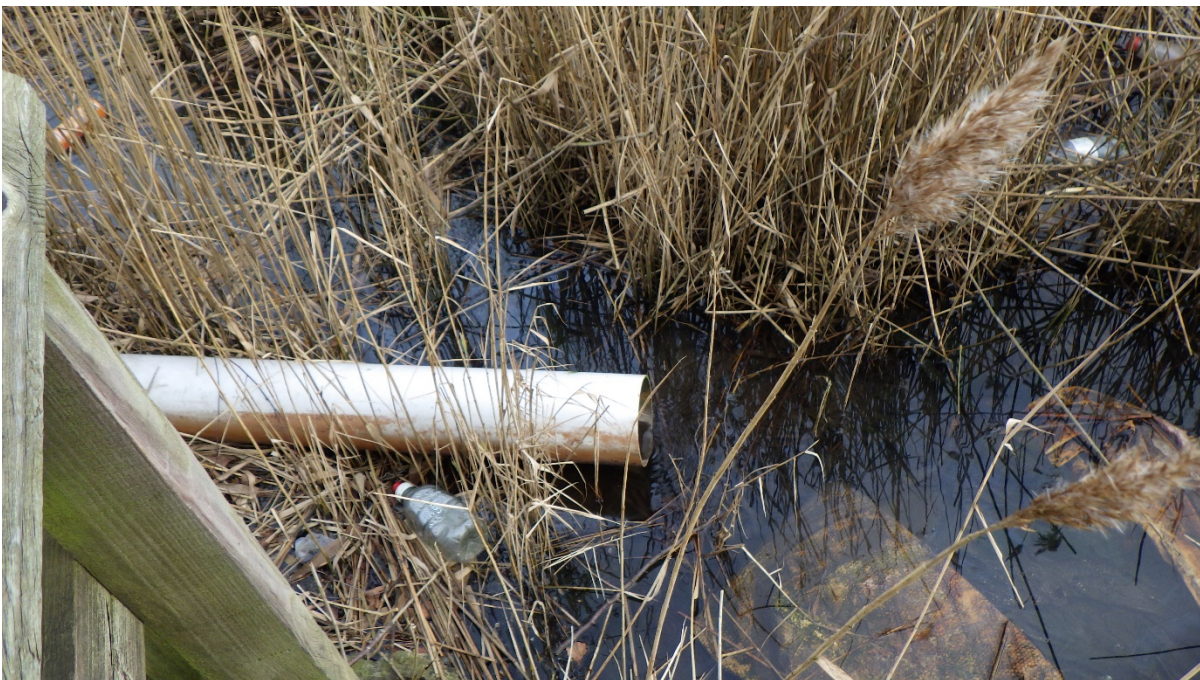
Figure 7 – Site visit photo: The discharge point at the time of the visit.

The discharge point was checked, with access being ok but the route was via a wooden jetty that was rotten and missing planks in sections. It was noted as a H&S concern and

advised that improvements could be made. Additionally, there was overgrown vegetation restricting a clear route to the discharge point. The discharge was active at the time of the visit but was very minimal with the visual composition appearing clear as seen in Figures 7 and 8.

**Justification:** The access was slightly limited at the time of the visit due to the aging condition of the jetty (that was rotten and missing planks in sections) needed to access the sampling/monitoring point. Additionally, there was overgrown vegetation restricting a clear route to the discharge point.

6. Undertake an assessment of the condition of the jetty used to access the discharge point as it is degrading in places. Undertake appropriate repairs.

7. Undertake clearance of overgrown vegetation to ensure access to the discharge point is maintained.

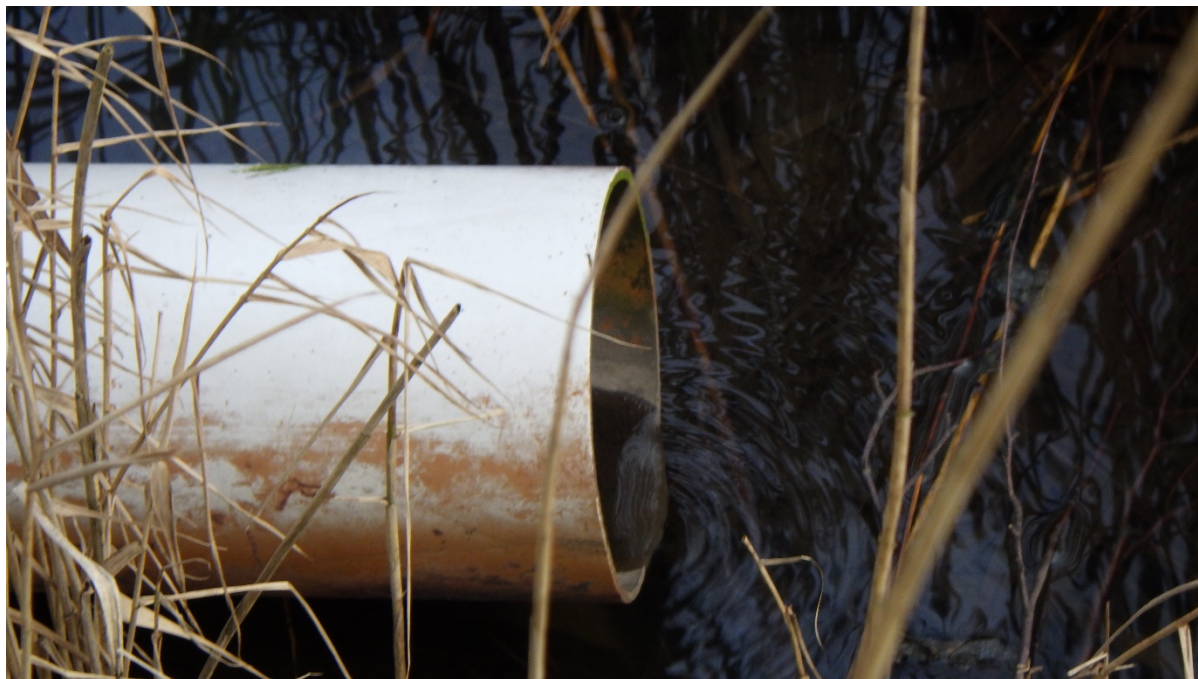
Figure 8 – Site visit photo: The discharge point and the effluent being discharged at the time of the visit.
