Compliance Assessment Report

Report ID:
CAR_NRW0035244

Site	Bryn Posteg Landfill	Permit Ref	BU77661C		
Operator/Permit holder	Sundorne Products (Ilanidloes) Ltd				
Regime	Installations				
Date of assessment	16/05/2019	Time in	11:00	Out	14:15
Assessment type	Report/Data Review				
Parts of the permit assessed	All mentioned below				
Lead officer's name	Ellis, Rhys				
Accompanied by	McClymont, James				
Recipient's name/position	David Williams / Tony Webber/ Technical manager/Site manager	Date issued	14/08/2019

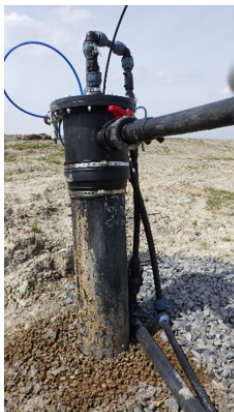
LCP 2 – Installed and connected to gas collection system. It was also confirmed that a leachate pump has also been installed, and records are being kept of the amount of leachate that is being pumped out

Photograph 1 - Newly installed LCP2

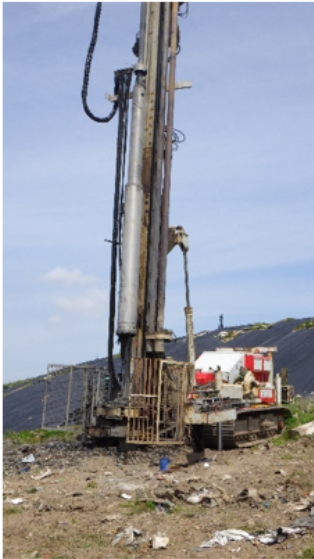
Whilst on site today it was explained that the drilling for leachate chamber **9B West** was undertaken at the incorrect location, and a Gas well will be installed in its place at this location. The leachate chamber will be installed on the correct location as marked with a peg on site in due course.

9D was going to be drilled next, this will give opportunity for a platform to be created for the drilling rig for chamber **9B west** mentioned above.

Photograph 2 - Drilling operation at Bryn posteg.

Please note : The CQA engineer explained that there will be changes to locations for some of the drilled chambers (for example sump 9B). Any deviation from the location highlighted in the CQA plan should be documented with information detailing why they have changed and information to support the new locations. Associated tables and plans etc should also be updated and forwarded to NRW as soon as possible . This is information that will also be required in the final CQA report.

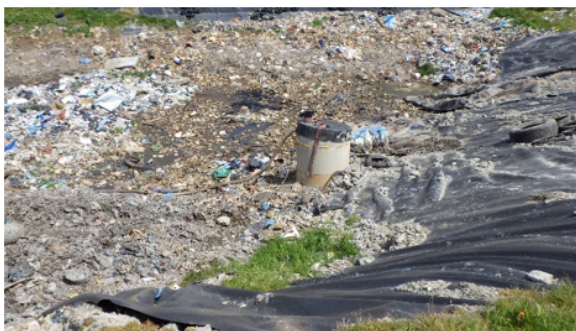
F1 - Odour/emission sources (RMLP9C North).

Photograph 3 - A potential point source emission was noted from chamber RMLP9C North

A potential point source emission was noted on this chamber (heat haze observed), particularly around a pipe on the headworks.

Condition 3.2.1 of the permit stipulates that emission of substances not controlled by emission limits shall not cause pollution. The operator shall not be taken to have breached this condition if appropriate measures have been taken to prevent or where that is not practicable, to minimise, those emissions.

Appropriate measures were not in place to contain gas emissions. Therefore, this condition has been breached. In the absence of GAZOMAT survey results, a CCS score of 3 is applied on this occasion. However please note, due to the polluting nature of landfill gas there is a risk of a CCS 2 breach (potential significant environmental effect) from this chamber.

ACTION 2 : Please can the site investigate this and take the necessary action to prevent any emission/odour from this chamber. This chamber might be a contributing factor to the odour detected off site. Operator to update NRW with actions taken no later than 28th June 2019.

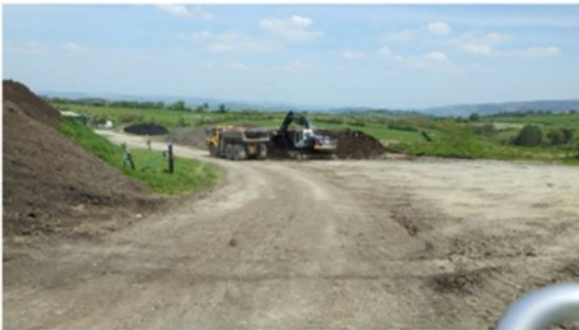
Work has commenced on removing the deposit of oversized un screened green waste located on the capping of the landfill, NRW were advised on site that a third has been removed off site. Please keep us updated on this matter.

Photograph 5 - Removal of oversized un screened green waste

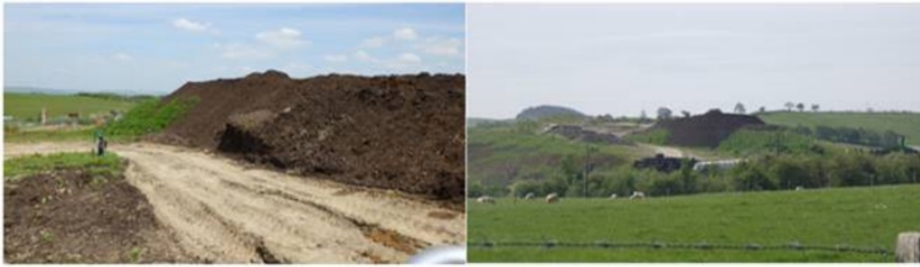
There seems to be a significant amount of additional compost that has been stockpiled on the cap. You have confirmed that the majority of this compost does not meet PAS100 and is therefore waste. The deposit of this waste is a breach of the suspension notice.

In addition to this, due to the quantity of waste compost stored, there is a risk of runoff entering controlled waters. Run off from this stockpile has previously been witnessed. The other concern is the potential fire risk exacerbated by the fact that it is stored in one single pile with no fire breaks.

Permit condition 2.1.1 stipulates the operator is only authorised to carry out the activities specified in schedule 1 table S1.1 (the activities). Storing waste on the cap of the landfill is not a permitted activity.

Please also note that storing material on the cap in this manner has the potential to damage the capping infrastructure on this location.

As a result, a CCS breach of 2 is applied on this occasion due to the breach having a potentially significant environmental effect

(Runoff to controlled waters, fire risk and damage to landfill cap exacerbated by the quantities and duration the compost has been stored here)

Photograph 6 and 7 - Significant amount of waste compost stored on landfill cap.

ACTION 7. Operator to detail what actions will be taken in regard to the composted material urgently. Please respond no later than 28th June 2019.

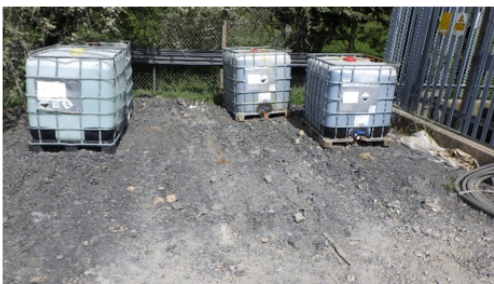
Photograph 8. IBC containing Ferric Chloride and Sodium Hydroxide stored on permeable base

IBC's containing Ferric Chloride and Sodium Hydroxide were being stored on permeable base with no secondary containment. It was noted that there were fewer IBC that last inspection, but there remains to be still breach of permit condition. Condition 3.2.3 stipulates that all liquids in containers, whose emissions to water or land could cause pollution, shall be provided with secondary containment, unless the operator has used other appropriate measures to prevent or where that is not practicable, to minimise leakage and spillage from the primary containment.

A CCS score of 3 is applied on this occasion.

The operator is proposing to construct a bulk storage facility with sealed drainage to resolve this issue.

ACTION 8 : Operator to confirm what temporary arrangements will be put in place for the safe storage of IBC on site until long term solutions are undertaken by 28th June 2019.

ACTION 9 : Operator to provide information on the long term proposals for the safe storage of these chemicals to comply with relevant permit conditions and best practice with timescales. A storage bulk tank was proposed by the operator. Please note that the operator should also consider containment in the delivery area of any bulk storage by 31st July 2019.

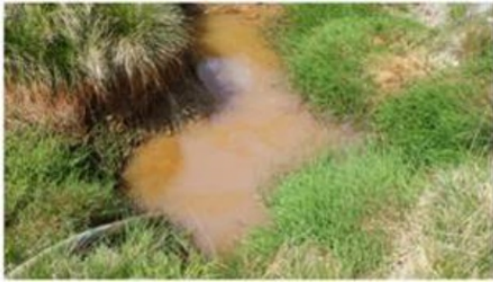
There was no discharge flowing from an excavated area within phase 1 today. It appeared that the liquid level within the excavated hole was low (as seen in photograph below). As discussed please continue to monitor this closely, there was other evidence of localised dampness in the ground in this area, please ensure that there are no other point source emissions from this area which

could impact surface water.

Photograph 9. Contaminated water within phase 1

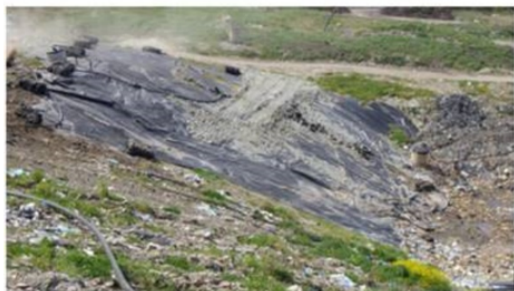
Photograph 10.

It was noted that repair works had now been undertaken on the emergency works on phase 9D

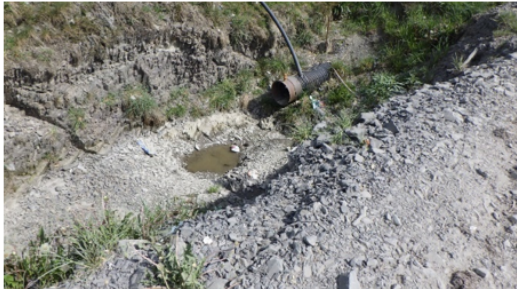
Photograph 11. Surface water drain by weighbridge

There was minimal flow deriving from site today.

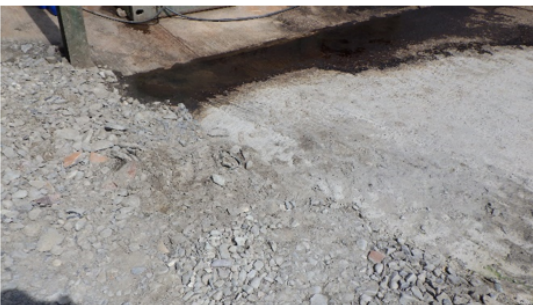
Photograph 12. Runoff of leachate to ground around the leachate treatment plant.

There was still evidence of runoff of leachate to ground around the leachate treatment plant. Although some additional hardcore material has been used to construct a bund this unfortunately is impermeable and is still seeping to ground and still breaching relevant permit conditions. Permit condition 3.1.1 stipulates that there shall be no point source emission to land except from the

sources and emissions points listed in Schedule 3.

As a result, a CCS breach of 3 is noted.

Operator to ensure that leachate is contained around the leachate treatment plant, and operator to provide an action plan for a long-term solution for this issue no later than 28th June 2019.

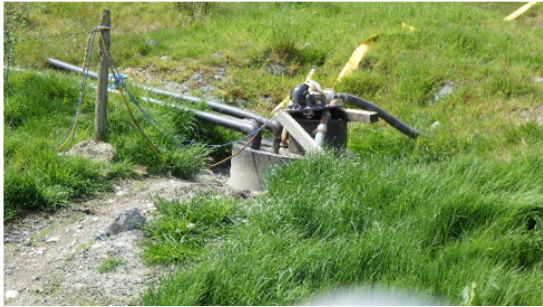
Photograph 13 Leachate chamber 9x

During a visit in February there was evidence that leachate had been overflowing from 'Sump 9x'. There was significant scorching and localised erosion around the chamber indicating evidence of previous significant discharges. The area was dry today and you have subsequently advised in a response dated 10th May that 'The chamber contains an electric pump. The electricity is provided by a generator. This generator is reducing in reliability. We have therefore issued an instruction to our site electrician to install a mains electric connection down to this facility to reduce this risk.'

Leachate from each sump in phase 9 is pumped into leachate chamber 9x before being pumped onwards to the leachate lagoon (as explained in your Leachate management plan).

It is our understanding that if there is a pump failure within chamber 9X, there would be build up of high strength leachate within the sump which would eventually overflow to an area that has a direct pathway to surface water causing a significant risk of pollution to ground and surface water.

In addition to the risks mentioned above, this chamber is also not sealed and is therefore potentially venting to atmosphere. What measures will be taken by the operator to reduce the risk of emissions to air? Please respond no later than 28th June 2019.

Please provide an update in regards to the above works no later than 28th June 2019.

Operator to confirm what measures are in place to inform the operator if there is a failure with the pump at chamber 9x before there is a discharge to ground/surface water. Please respond no later than 28th June 2019.
