## Compliance Assessment Report CAR\_NRW0049280

**Permit being assessed:** AN0267201

For: LAND ADJACENT TO TWYN ROAD YSTRAD, held by DWR CYMRU CYFYNGEDIG  
At: LAND ADJACENT TO TWYN ROAD YST, YSTRAD MYNACH ., YSTRAD MYNACH .,  
YSTRAD MYNACH ., ..

**Type of assessment carried out:** Site Inspection, Reason: Routine.

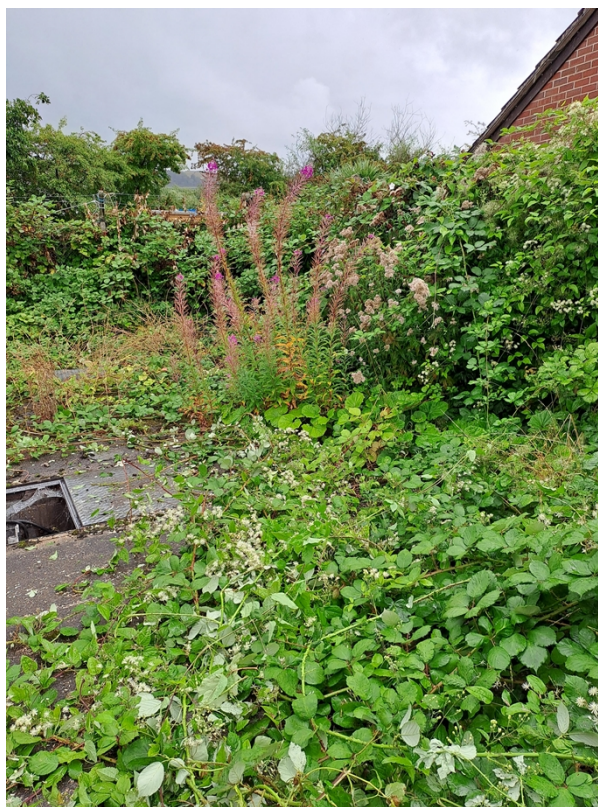
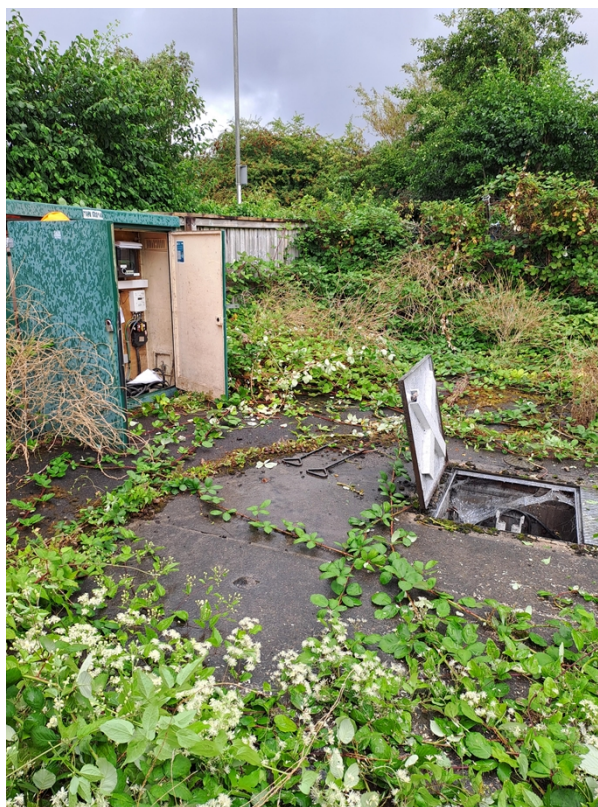
Site conditions were mixed at the time of the visit. Access to the secure compound was hindered by heavy vegetation growth, with DCWW operators experiencing a degree of difficulty in opening the access gate. Within the compound the vegetation was growing across the floor and over some of the chambers, although this did not overly hinder access. MM noted that they are waiting on grounds maintenance to undertake the clearance work of this vegetation, however I have added it as an action to this report and request that evidence be provided of its completion. The observations on site conditions can be seen in Figures 1 and 2.

Figure 1 – Heavy vegetation growth within the SPS compound as observed during the visit.

Figure 2 – Heavy vegetation growth within the SPS compound as observed during the visit.

| Criteria | Action needed | Complete by |
|---|---|---|
| WQ-A1 | Clear the vegetation from all areas of the SPS compound to ensure access and ease of maintenance. Evidence of works undertaken should be provided to NRW. | 03/11/2025 |

4. Clear the vegetation from all areas of the SPS compound to ensure access and ease of maintenance. Evidence of works undertaken should be provided to NRW.

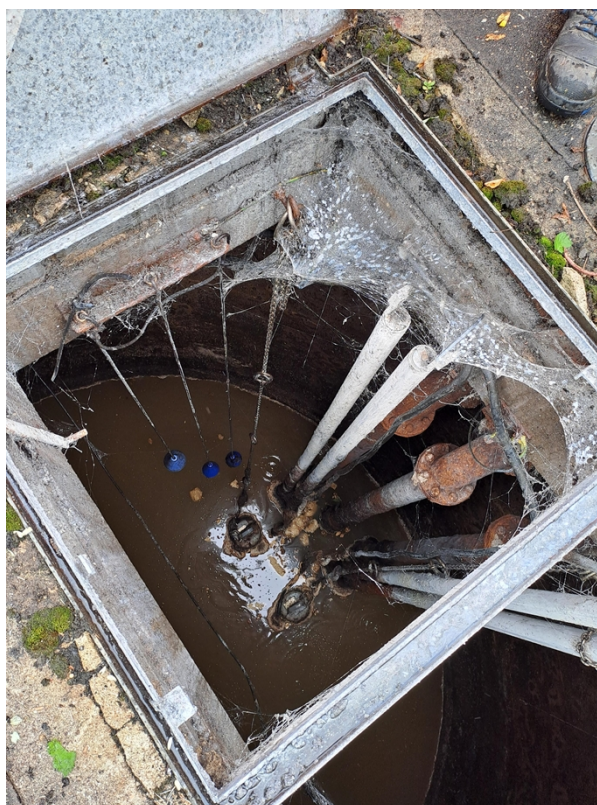
This SPS was stated to have a large wet well (confirmation of volume forthcoming). The integrity of the wet well walls appeared sufficient with no major cracks or damage present, but the chamber itself included a notable amount of fatty deposits, potentially a result of continued scheduled cleaning works being postponed. The wet well was last cleaned on the 03/05/2025. I request that the wet well undergo further cleaning to remove the fatty deposits as soon as possible to ensure no residual wastes are discharged in the event of a future spill. This is reflected in the actions list below. Additionally, there was some corrosion present on the metal infrastructure within the wet well. I have actioned an assessment of these components to ensure continued operational effectiveness. See the actions list for further details. Telemetry is in place with level sensors and EDM recording present. These systems were upgraded as part of the “Diffodd” project and are currently on a 4-year maintenance program. Please provide details on when these alarms were last serviced and calibrated. The observations above are evidenced in Figure 3.

Figure 3 – The condition of the wet well as observed during the visit.

| Criteria | Action needed | Complete by |
|---|---|---|
| WQ-A1 | Undertake a cleanse of the wet well to remove the excess fatty deposits observed. Evidence of works undertaken should be provided to NRW. | 03/11/2025 |
| WQ-A1 | Investigate and assess the corrosion present on some of the wet well infrastructure. Any maintenance required should be notified to NRW and evidence of works undertaken provided. | 03/11/2025 |

5. Undertake a cleanse of the wet well to remove the excess fatty deposits observed. Evidence of works undertaken should be provided to NRW.

6. Investigate and assess the corrosion present on some of the wet well infrastructure. Any maintenance required should be notified to NRW and evidence of works undertaken provided.

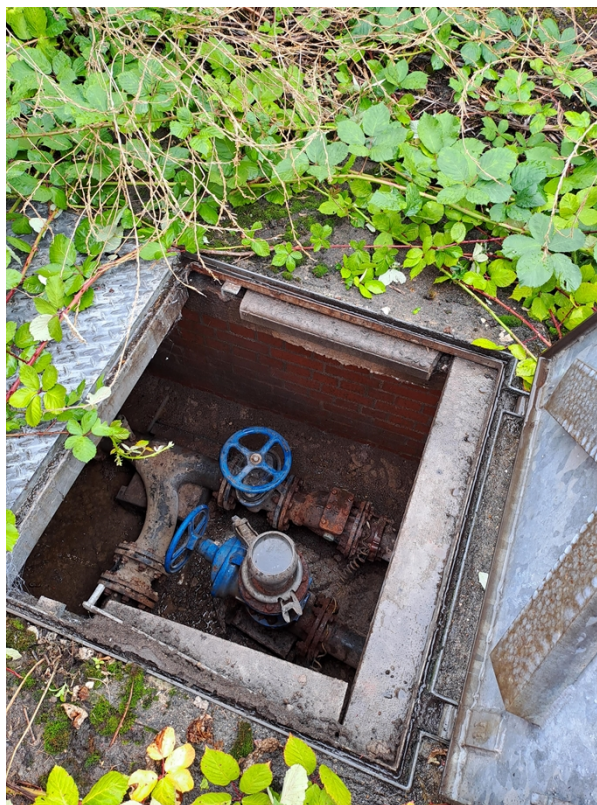
Access to the valve chamber was slightly hindered by the heavy vegetation growth, but once accessed it appeared to be in good working order with only minor corrosion present. The tanker point is also located within this chamber. This is evidenced in Figure 4.

Figure 4 – The valve chamber as observed during the visit.

It is noted that neither the wet well nor valve chambers had a safety grate installed. While not a permit requirement I have listed the H&S procedures to be reviewed for the benefit of any site operators.

2. Assess the H&S policies and procedures regarding the need for a safety grate over the wet well and valve chambers.

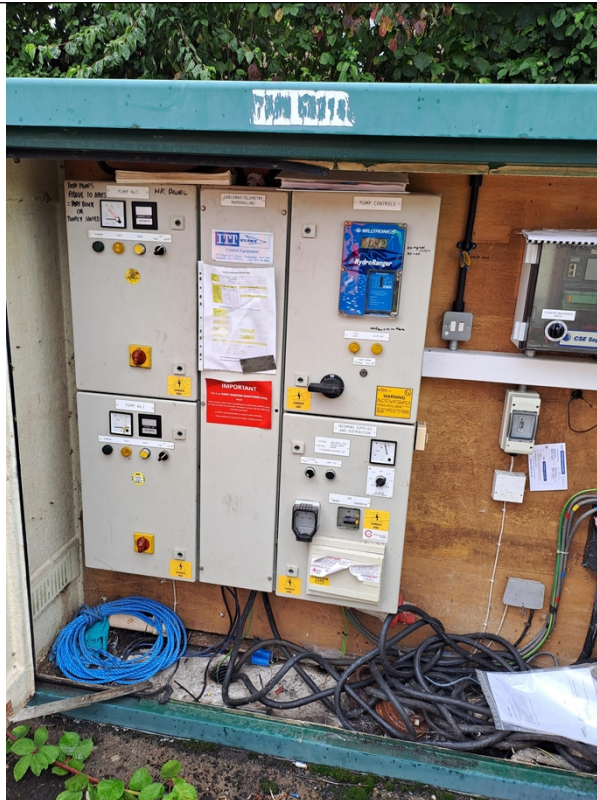
The control box, panels and systems were observed to be in a good condition with no damage or condensation present with all readouts being clear and working as designed (Figure 5). A point to connect a mobile backup generator was also in place, as seen in Figure 6. This is no emergency stop function at this asset, so an advisory comment has been included to reflect to possibility of including one.

Figure 5 – The control box and panels as observed during the visit.

1. There is no emergency stop function at this SPS. While not a permit requirement it is advised that the inclusion of one is explored as a contingency measure in the event

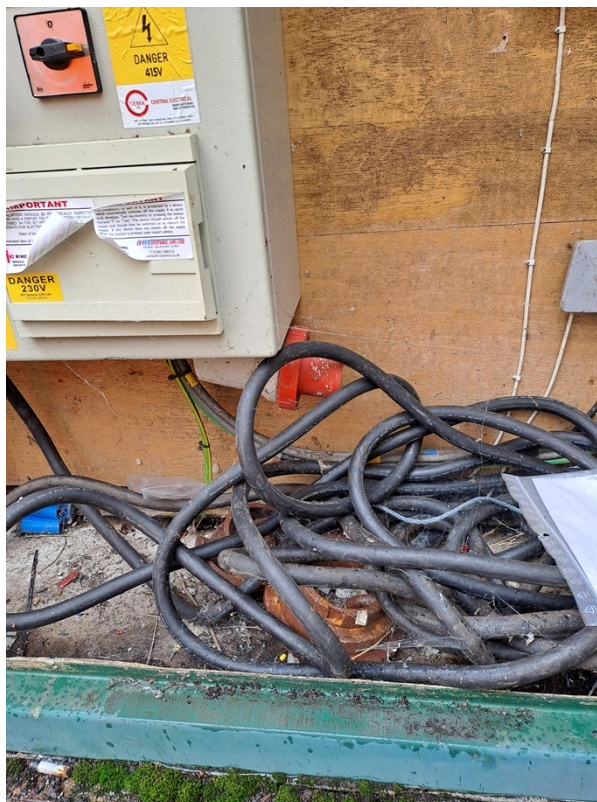
Figure 6 – The mobile backup generator point in place.

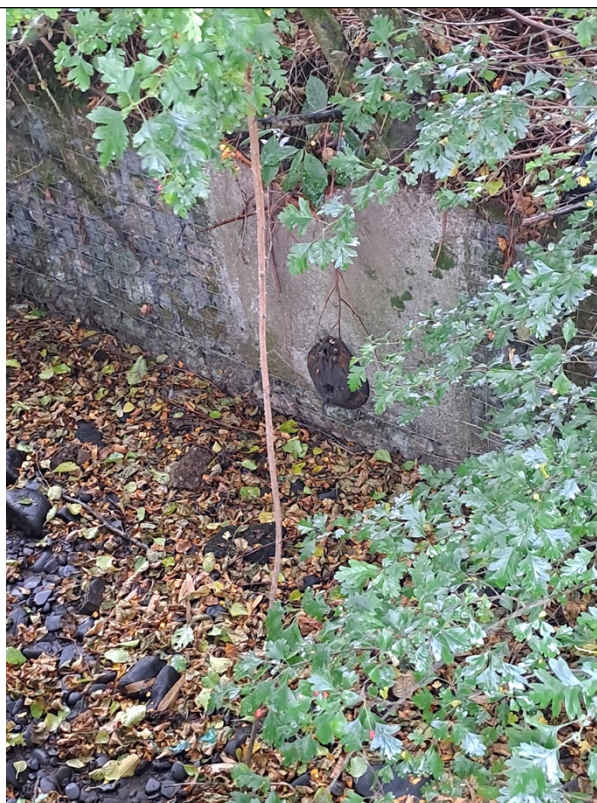
As a result, I stated that the permit will require a variation to reflect that the emergency overflow discharges to Nant Twyn yr Harris at ~ST1458393248. I also advise that this discharge point be listed as a new sample point as no other sewer or surface water lines connect into the EO line prior to the discharge point. While on site, I confirmed the location of the discharge point (at the above coordinates) and took photographic evidence as seen in Figure 8. This flap valve is accessible via a small public footbridge and should be appropriate as a combined discharge-sample point. The action to vary the permit is reflected below.

Figure 8 – The EO discharge point located at ~ ST1458393248 as observed during the visit.
