## Compliance Assessment Report CAR\_NRW0049273

**Permit being assessed:** AN0393401

For: GLYNGAER ROAD GELLIGAER CAERPHILLY, held by PERSIMMON HOMES LTD  
At: DEVELOPMENT AT GLYNGAER ROAD, GELLIGAER, CAERPHILLY, WALES, CF82 8FJ.

**Type of assessment carried out:** Site Inspection, Reason: Routine.

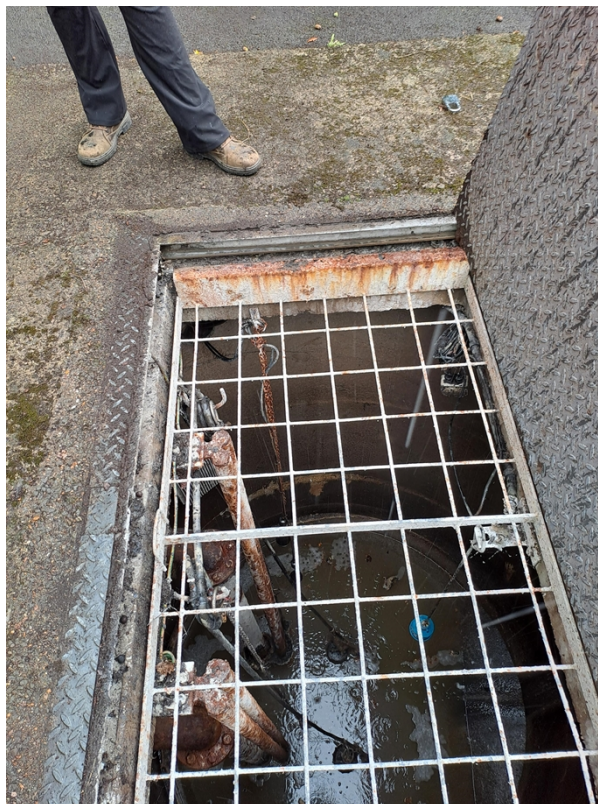
The wet well was inspected and found to be of concrete construction with no clear cracks or defects present, however some minor root ingress was observed. I requested that this be investigated and risk assessed by DCWW and is reflected in the actions list below. Additionally, there was some corrosion present on the metal infrastructure components within the wet well. As with the root ingress, please assess and address this as an action (reflected below). The wet well cleaning regime was queried and MM noted that this was

undertaken on a visual inspection basis. Evidence of when this was last undertaken was requested and actioned. A 10mm screen was observed to be in place and free of debris. These observations are evidenced in Figure 2.

Figure 2 – A view of the wet well as observed during the visit. The discharge outlet can be see with the 10mm screen in place.

2. Investigate the root ingress into the wet well and assess if any maintenance is required. Results of the assessment and associated works (if required) should be communicated with NRW.

3. Investigate and assess the corrosion present on some of the wet well infrastructure. Any maintenance required should be notified to NRW and evidence of works undertaken provided.

6. Confirm, with evidence, when the wet well was last cleansed.

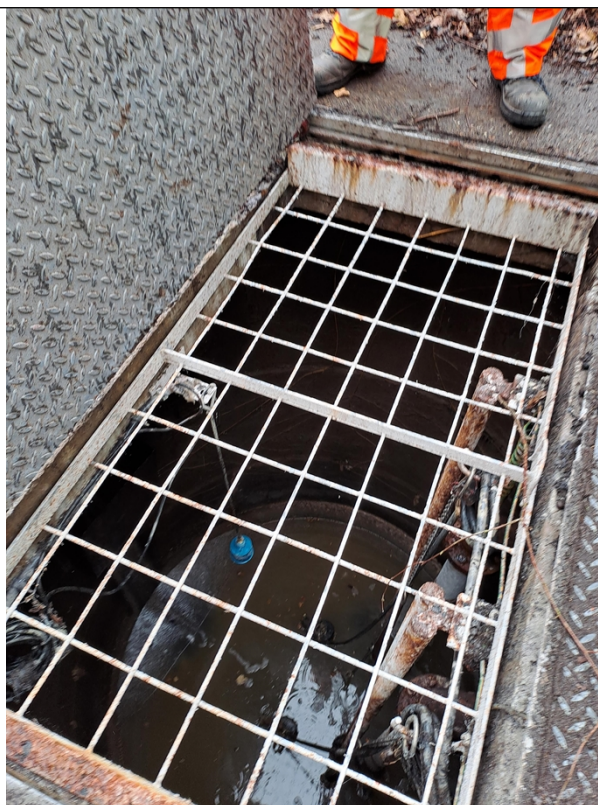
Telemetry systems (level sensor, flow and EDM monitors) are in place and were stated to have been upgraded in 2024 (as noted above). These systems were noted to be on a 4 year maintenance programme, to which I requested details on the last service and calibration. These observations are evidenced in Figure 3.

Figure 3 – The wet well where telemetry systems can be seen.

4. Provide evidence of the most recent telemetry systems maintenance and calibration.

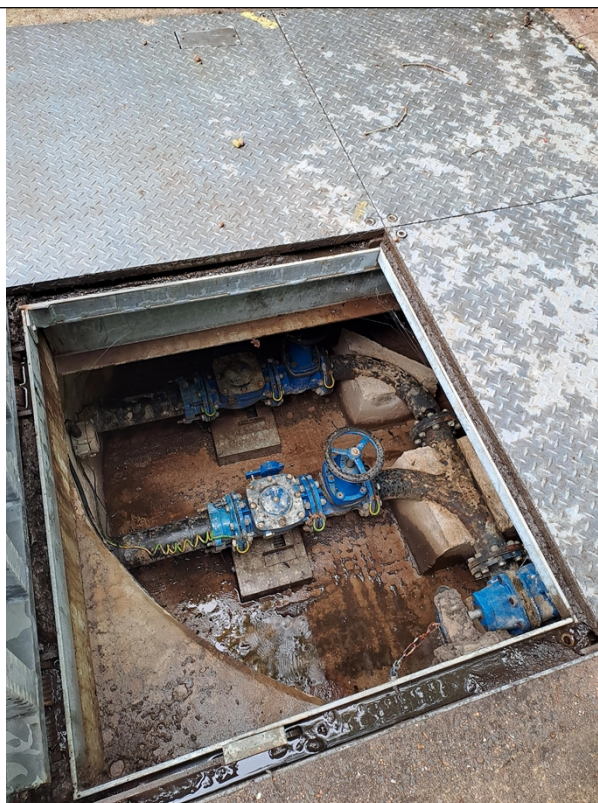
The valve chamber was opened and observed. The infrastructure was in good operational condition with no excessive corrosion present. A tankering point for the asset is located within this chamber. It is noted that this chamber did not pose a safety grate. While not a permit requirement, an advisory comment to review the H&S aspect of its omission has been added. These observations are evidenced in Figure 4.

Figure 4 - The valve chamber as observed during the visit.

1. Assess the H&S policies and procedures regarding the need for a safety grate over the valve chamber. Note this is not an action and no updates will be requested.

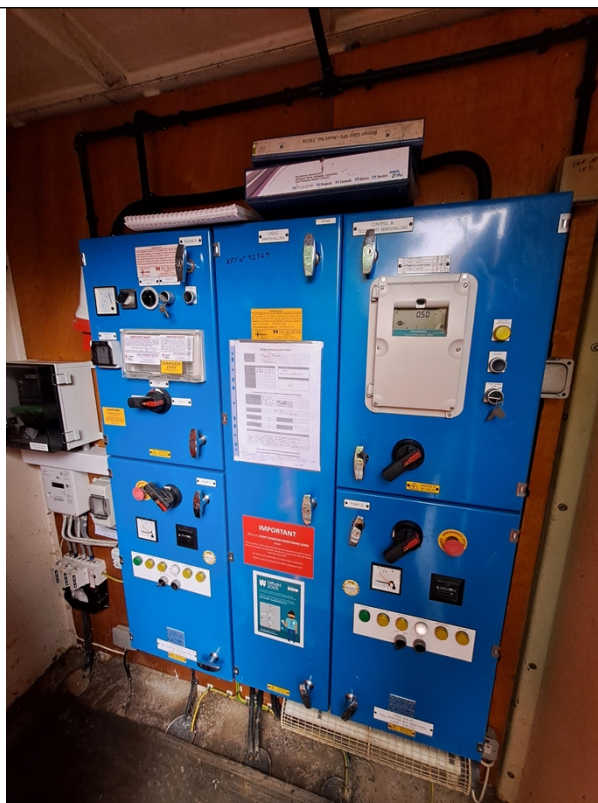
The control box and panels were inspected and found to be in good condition with no damage or condensation present (Figure 6). An emergency stop function and backup generator point were both present (Figure 7). All readouts were clear and in good working order at the time of the visit.

Figure 6 – The control panels and systems as observed during the visit.

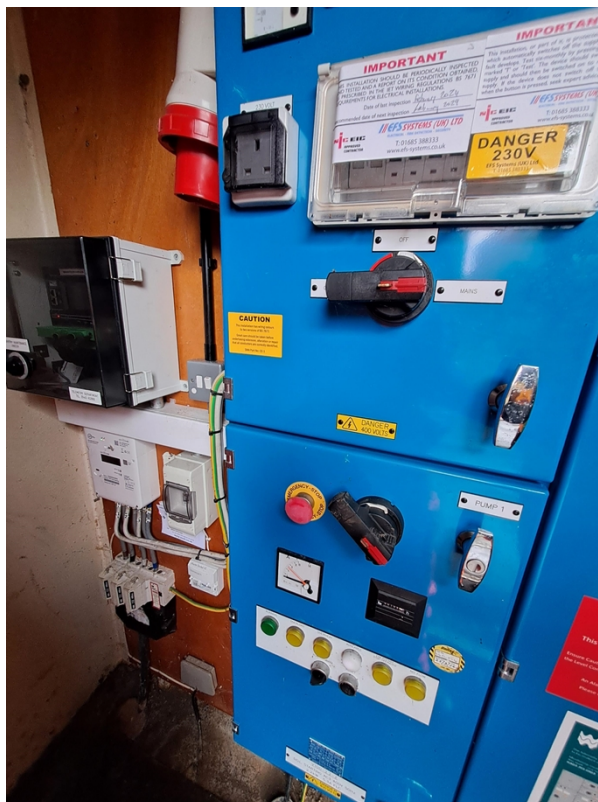
Figure 7 – The emergency stop function and backup generator point in place as observed during the inspection.

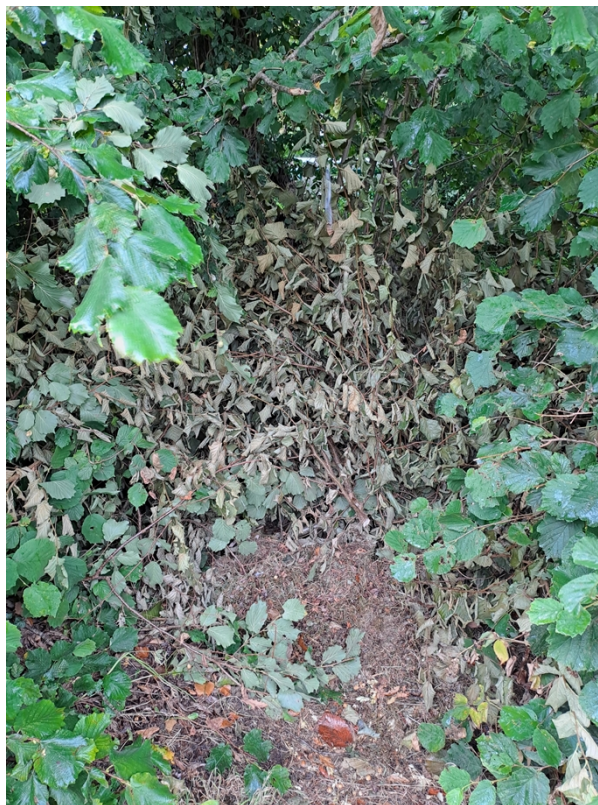
The sample point was inaccessible during the visit. The sample point, stipulated to be located at ST1393997211, was restricted by vegetation growth and what appeared to be deposited grass and foliage cuttings (Figure 8). It is unclear who undertook this work but it is the responsibility of the consent holder to ensure that the sample point is accessible at all times. As a result a minor breach has been given and an action added to undertake grounds maintenance to uncover and identify the sample point. Evidence of this work, once completed, shall be provided to NRW. See the actions list for further details.

Figure 8 – The vegetation and waste restricting access to the sample point as observed during the visit.

Access to the sample point was restricted by vegetation growth and deposited vegetation waste. This constitutes a minor breach to permit condition 4 and as such has been scored accordingly.

1. Clear the vegetation and remove the waste present so that the sample point can be identified and accessed. Evidence of this work shall be provided to NRW.

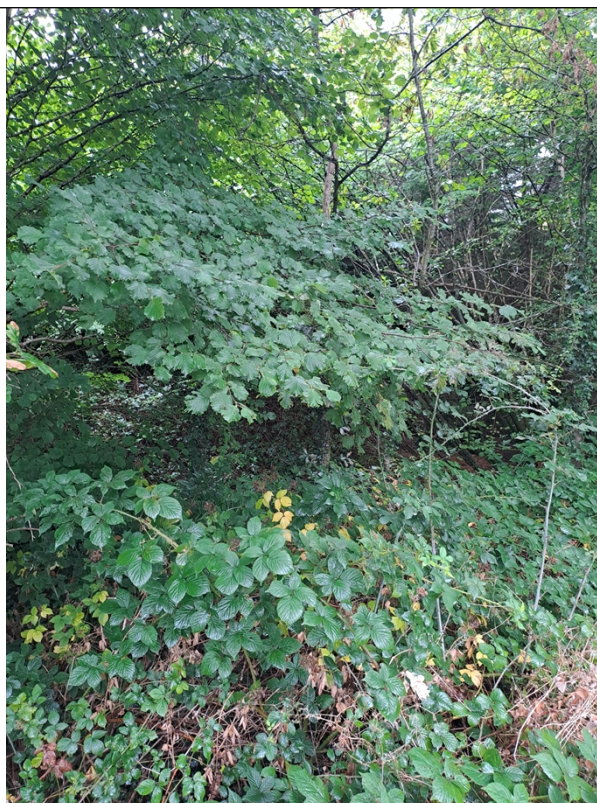
The discharge point (listed to be located at ST1396497236) was also inaccessible/unobservable at the time of the visit due to heavy vegetation growth as seen in Figure 9. However, access to the discharge point is not a permit requirement so not a breach of any conditions. As such, a future visit will be conducted when vegetation growth is reduced in an attempt to confirm the location of the discharge point.

Figure 9 – Heavy vegetation growth restricting the location of the discharge point at the time of the visit.
