ZTN201121C - As-left Report Gwynt Y Mor Met Mast

RWE

2 Project scope

3 Document scope

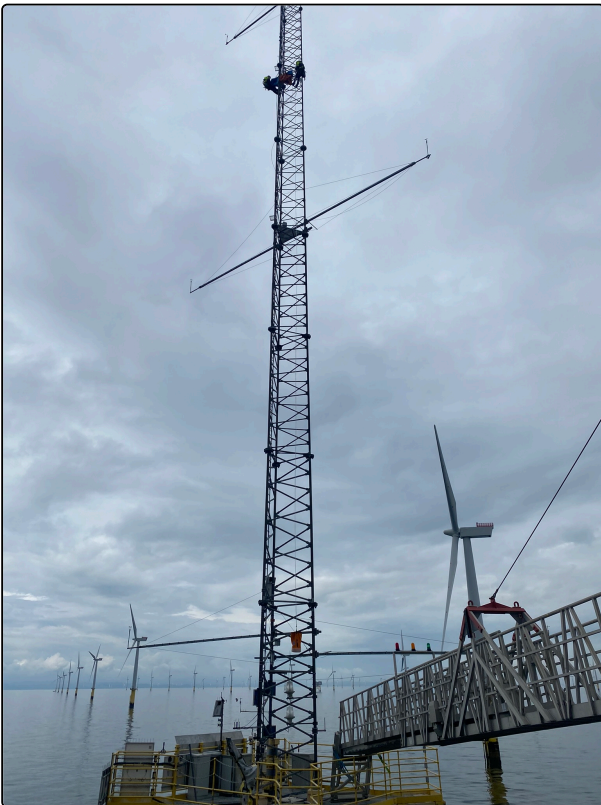
1 Lattice mast prior to removal.

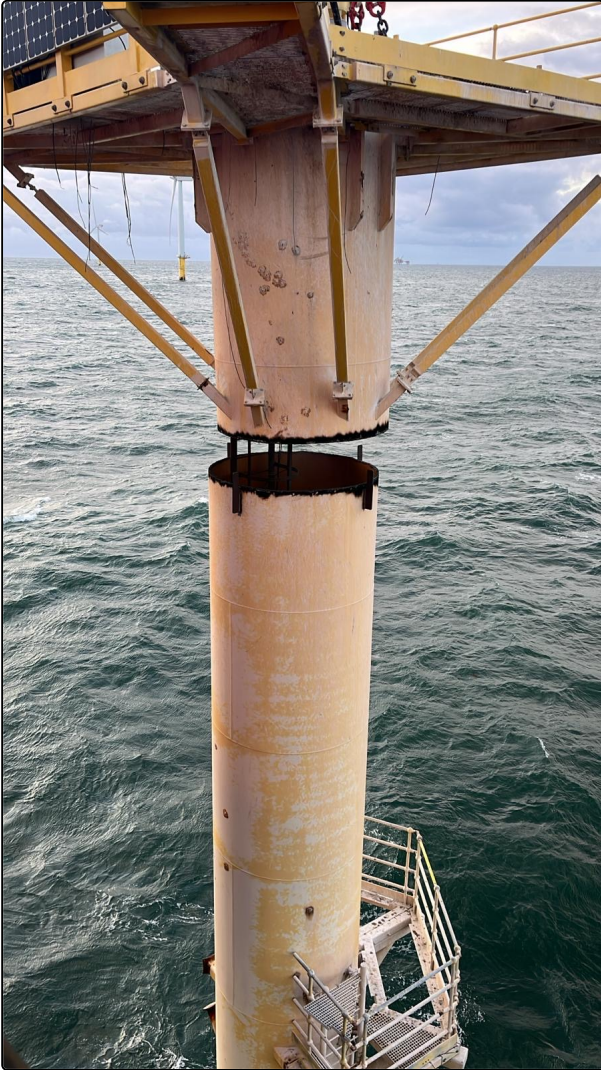
5 Upper platform cut and being lifted.

Immediately upon completion of jacking operations, work commenced on the removal of the upper platform of the meteorological mast. At 19:20 on 13 September 2025, the platform was lifted off at a weight of 18t and landed on the deck of WIND SERVER. Subsequent work focused on separating the platform struts and the cut monopile section. By approximately 23:40, both the platform and monopile section were fully disconnected and properly seafastened on deck.

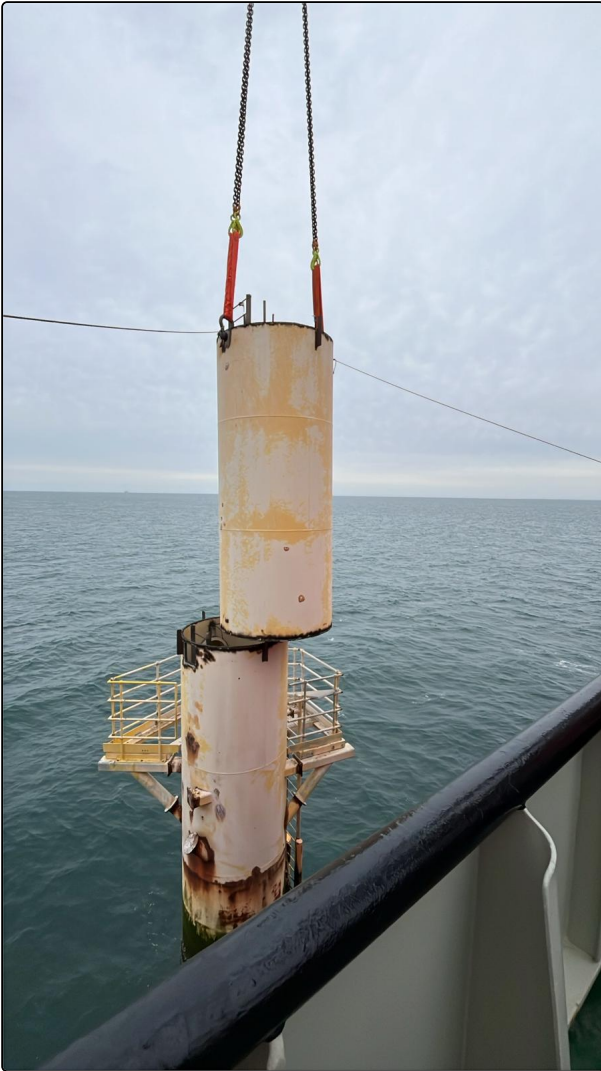
7 Upper monopile section cut from lower monopile section.

At 10:48 on the 14 September 2025 the upper monopile section had been cut from the remaining monopile and it was lifted to the deck of the WIND SERVER at a weight of 9.5t. At 12:30 the same day the section had been properly seafastened onto deck.

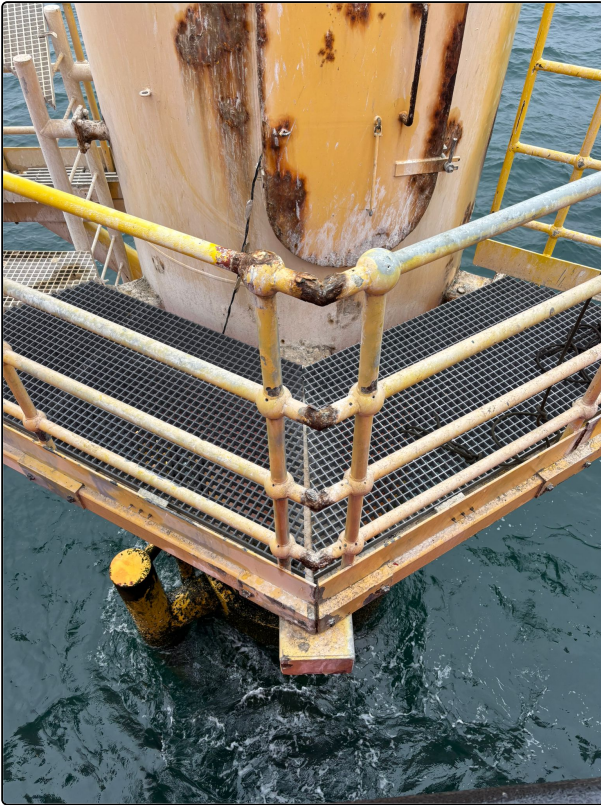
8 Access platform with new grating installed. Serving as working area.

Over the following days, adverse weather conditions limited progress, and work was carried out whenever conditions permitted. During this period, the external platform was refurbished to serve as a working area and the WIND SERVER had been repositioned to enable these tasks and to prepare for the final scope of operations. By 01:00 on 22 September, the upper internal platform had been removed, along with the internal ladder and lower internal platform. Finally, lifting brackets were installed on the monopile.

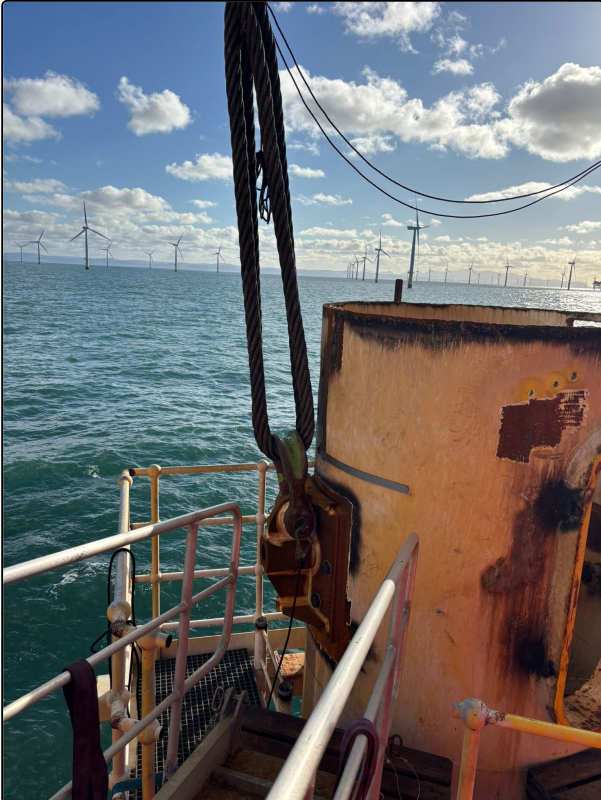
9 Lifting brackets installed.

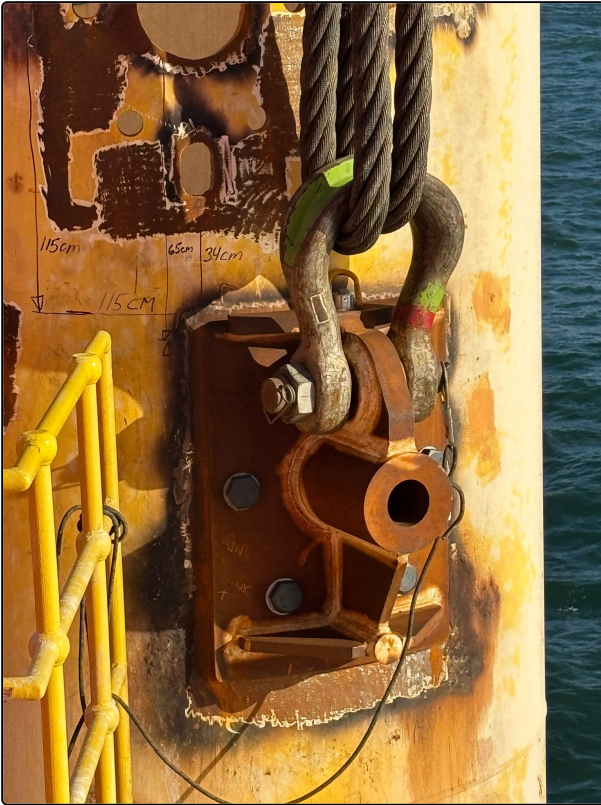
10 Lifting brackets installed.

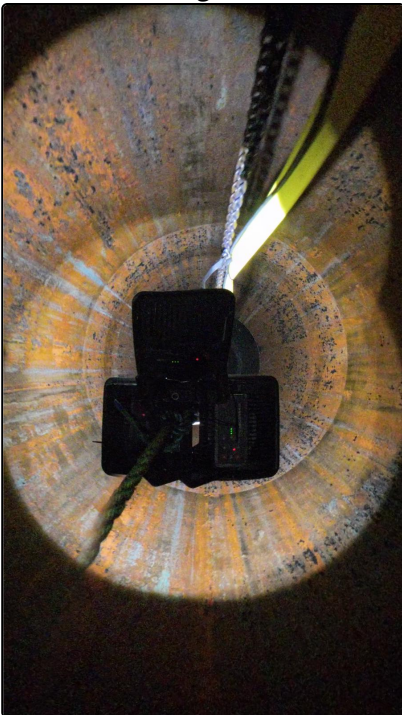
12 Camera and Lights being lowered into the monopile.

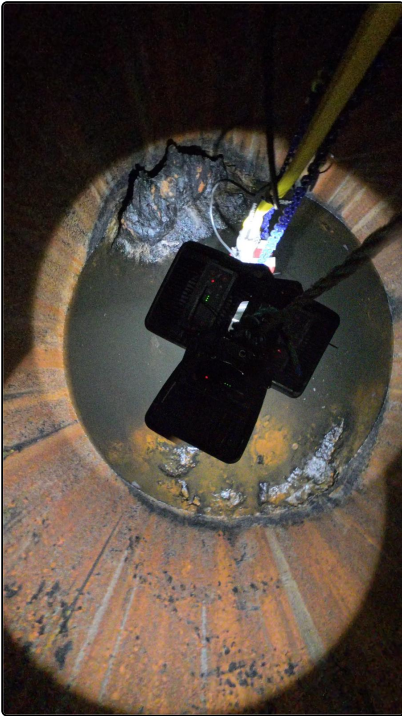
Subsequent inspections confirmed that no cleaning was required, as the entire almost 10 meters was completely clean and free from objects, marine growth, pebbles, or stones—contrary to what had been observed at some previous MP removal cases.

13 Camera and Lights at the bottom of the monopile.

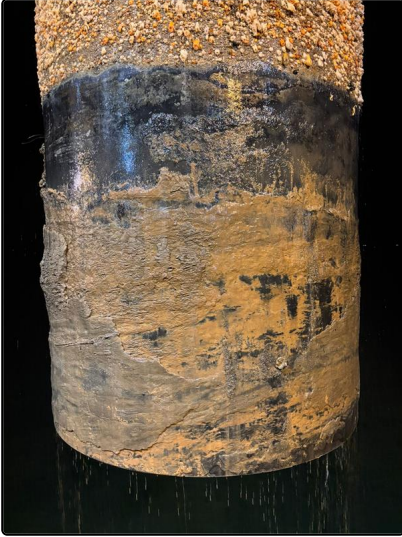
At approximately 05:30 on 23 September 2025, movement of the monopile was observed, indicating successful completion of the circumferential cut.

Subsequently, the monopile was lifted from the seabed, weighing 153.0 tonne.

15 MP being lifted out of the water

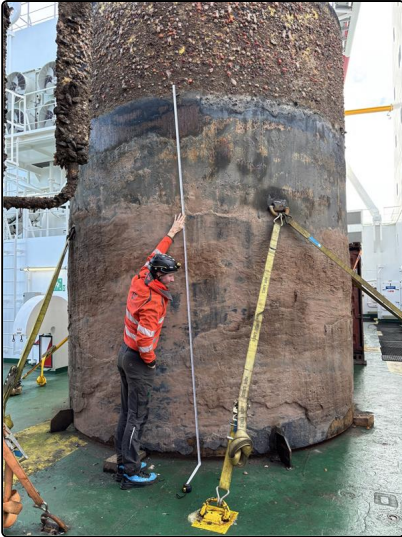
16 Level of barnacles indicated the external seabed level

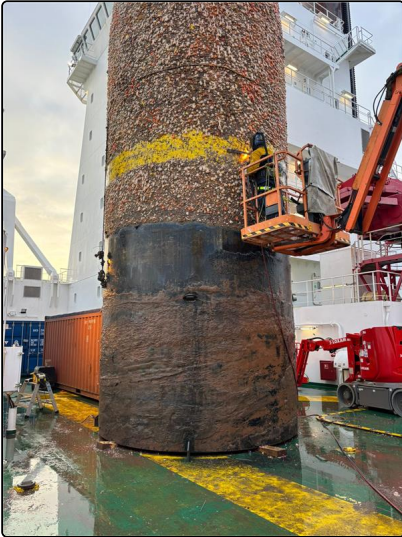
The monopile was landed and cut into 10 pieces and made ready for sea transport by properly seafastening them all.

18 Cutting into 5m sections
