## Compliance Assessment Report CAR\_NRW0049596

**Permit being assessed:** AN0395201

For: ABP BULK CARGO NORTH SIDE SOUTH, held by ASSOCIATED BRITISH PORTS  
At: ABP BULK CARGO, NORTH SIDE SOUTH DOCK, ALEXANDRA DOCK, NEWPORT, NP20 2UW.

**Type of assessment carried out:** Site Inspection, Reason: Routine.

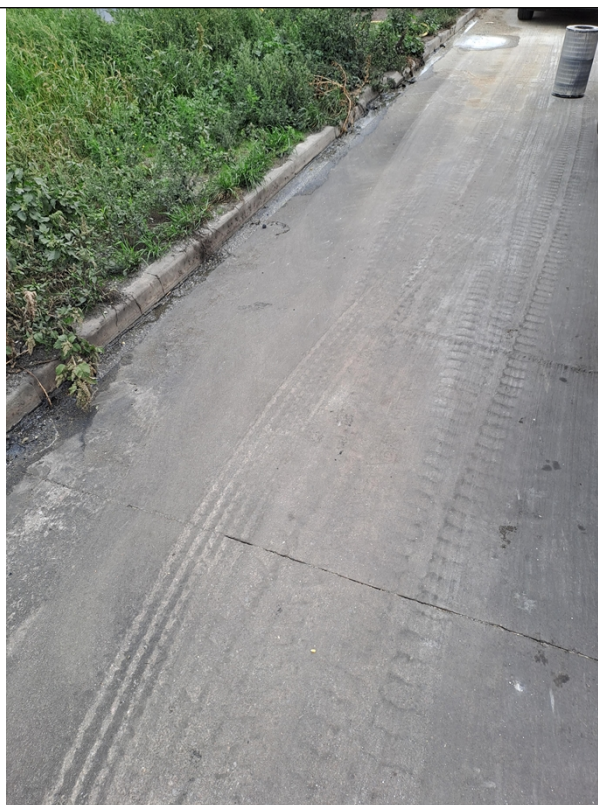
The wash-down area is located in the vicinity of ST3148284756. General site conditions were good at the time of the visit with the concrete pad in place and no sign of overspilling or residual oil/grease present. This is seen in Figure 1.

Figure 1 – General site conditions at the time of the visit.

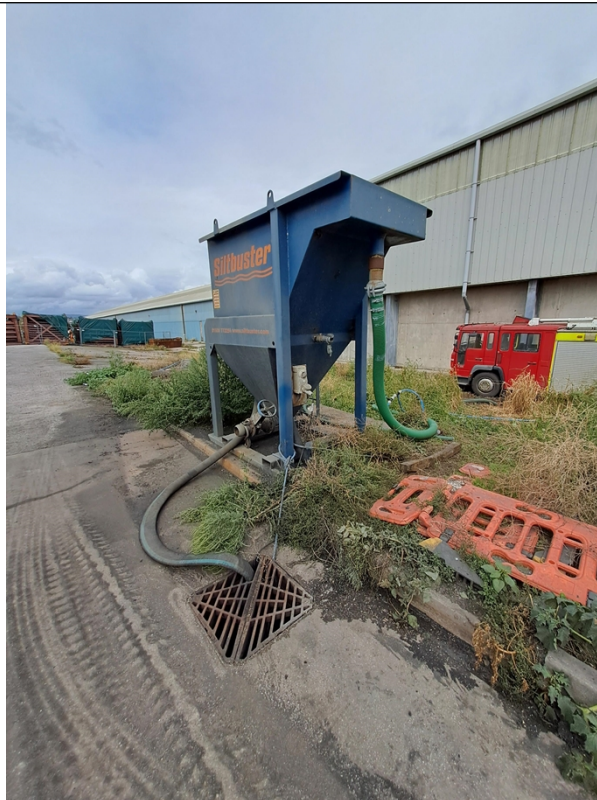
CN explained that all effluent from the sump/separator are pumped into an onsite silt buster (Figure 2) for treatment prior to discharge via the sample point. The sump/separator was observed and was seen to be capturing untreated effluent, with sufficient capacity remaining. It was noted that automatic pumping is in place through the use of a float switch. See Figure 3 as evidence of these observations.

Figure 2 – The silt buster as observed during the visit.

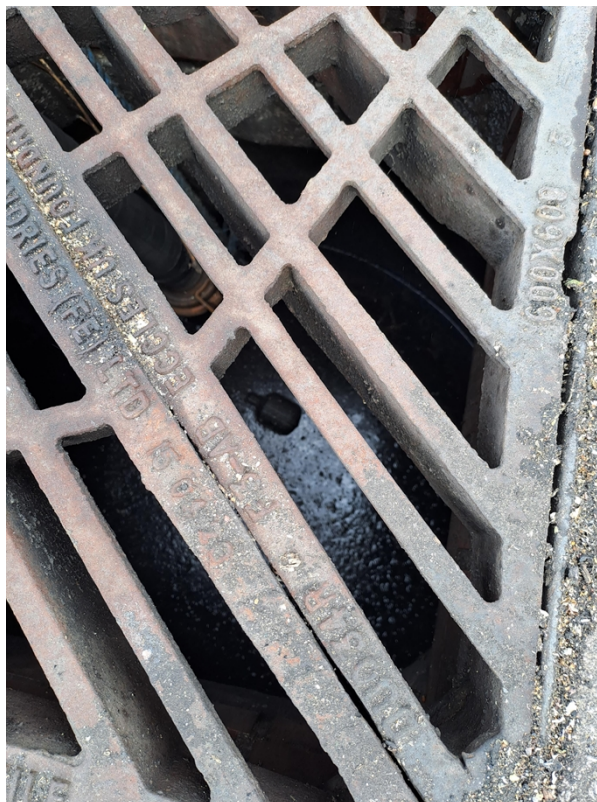
Figure 3 - The sump/separator conditions as observed during the visit.

The pump was not in operation at the time of the visit so an assessment of its operational effectiveness could not be made. The maintenance records show a new pump was installed in 2022, with a record that it experienced a failure in 2024 causing puddling of water in the wash-down area. It is not evident when this issue was resolved. Please provide the maintenance details for the remedial works undertaken and any subsequent maintenance records as evidence that the pump is working effectively. This is actioned below.

5. Provide NRW with the maintenance details of the pump failure that occurred in 2024 and a record of actions taken as evidence of effective operation and management.

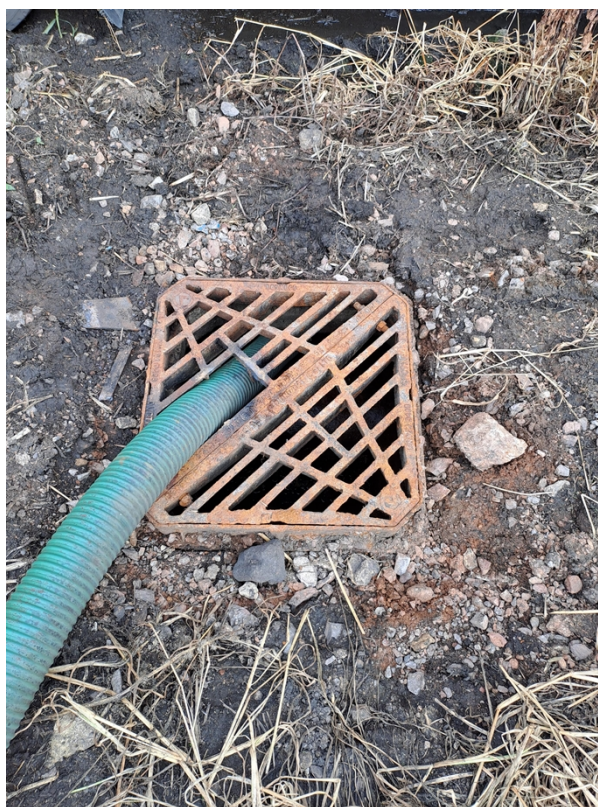
The treated discharge enters the surface water drain via a pipe at ST3148884778 (corrected to ST3148784772 while assessing aerial photos/mapping). It was noted that this was also the site's consented sample point. This chamber was completely accessible at the time of the visit. Whilst not in the exact permitted NGR location, it is within 5 meters of the listed point and given the presence of the pipe inserted into the drain (as seen in Figure 4) I am happy to accept that no confusion would be caused by this minor discrepancy and that the sample point location is compliant with the permit.

Figure 4 – The sample point as observed during the visit.

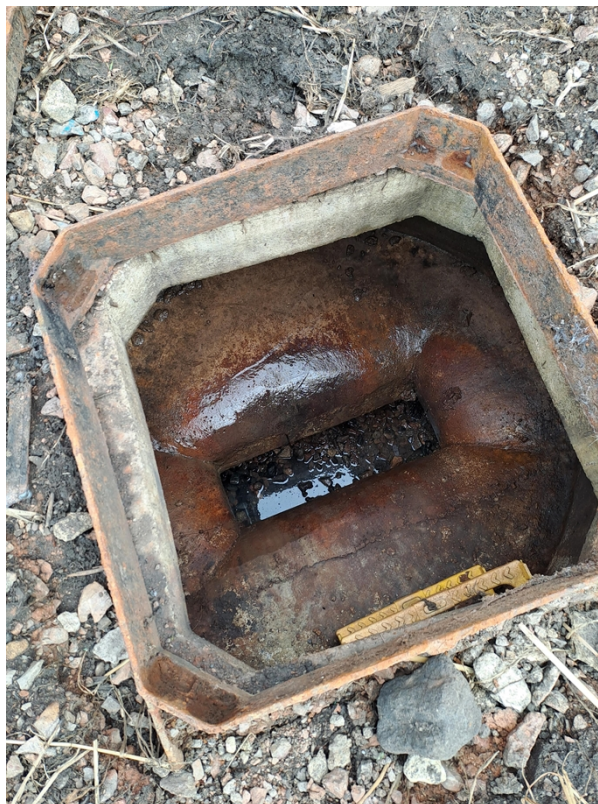
Whilst there was no discharge occurring at the time of the visit, I requested that the sample point grate and pipe be removed so that a visual inspection of the chamber could be conducted. As is evidenced in Figure 5, the chamber was clear of any oil or grease residue, with a very minimal amount of clear water pooling in the pipework. I noted the presence of some stone and aggregate within the pipe, which CN stated they have never

addressed as no issues associated with capacity or overflowing from the chamber has occurred. While it cannot be proved that this stone originated from ABP's operational areas (given the interconnected nature of the wider port surface water system encompassing numerous different operators and sites) I advise that the stone build up is assessed and addressed to ensure it does not cause any issues in future. This is outlined in the advisory comments below.

Figure 5 – The sample point chamber as observed during the visit.

1. Assess the build up of stone and aggregate within the sample point chamber and take any actions deemed necessary to ensure no issues arise from its presence.
