**MORFA NON-HAZARDOUS  
LANDFILL  
PORT TALBOT**

**ENVIRONMENTAL  
PERMIT BV7311IE**

**Review of  
Hydrogeological Risk  
Assessment**

*Report Number 2238r1v1d0622*

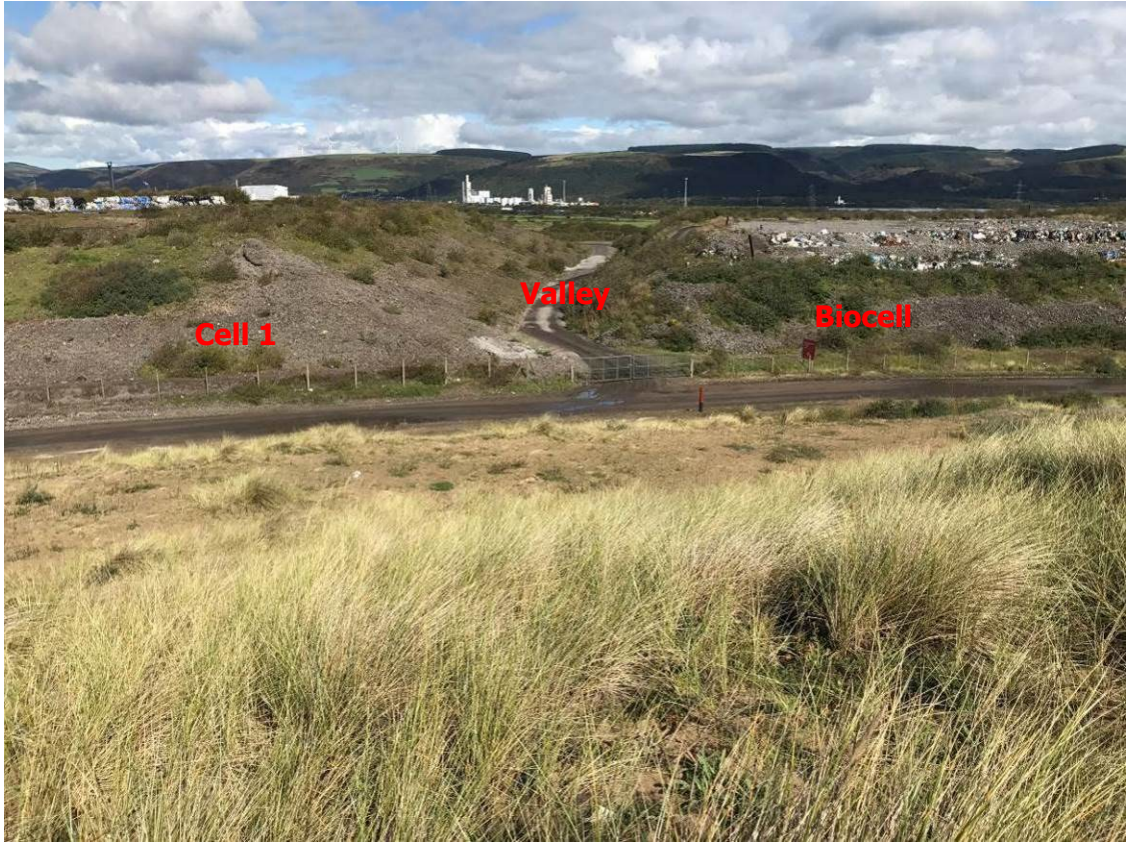
**Plate 3-1 View north towards Non-Hazardous Cell 1 prior to re-profiling, valley feature and uncapped Biocell**

Up until 2021, and at the time of the previous HRA review, the existing Biocell was separated from non-hazardous Cell 1 by a deep narrow valley where the opposing south flank of Cell 1 met the north flank of the Biocells, as shown in Plate 3-1. The approved restoration contours for the landfill require that this valley is infilled to produce a single elevated landform. To secure additional biodegradable void space, NRW approved a cut into the upper part of the southern flank of Cell 1 (to enable waste recovery) and extension of the biodegradable waste cell lining system over the remaining Cell 1 waste to provide sufficient biodegradable waste capacity to 2028. The scheme is shown schematically in Figure 7 and Plate 3-3 shows construction progress as of June 2022. At the same time as the bio-cell extension, Tata Steel also capped Biocells A and B. This work was also largely complete at the end of May 2022, as shown in Plate 3-3.

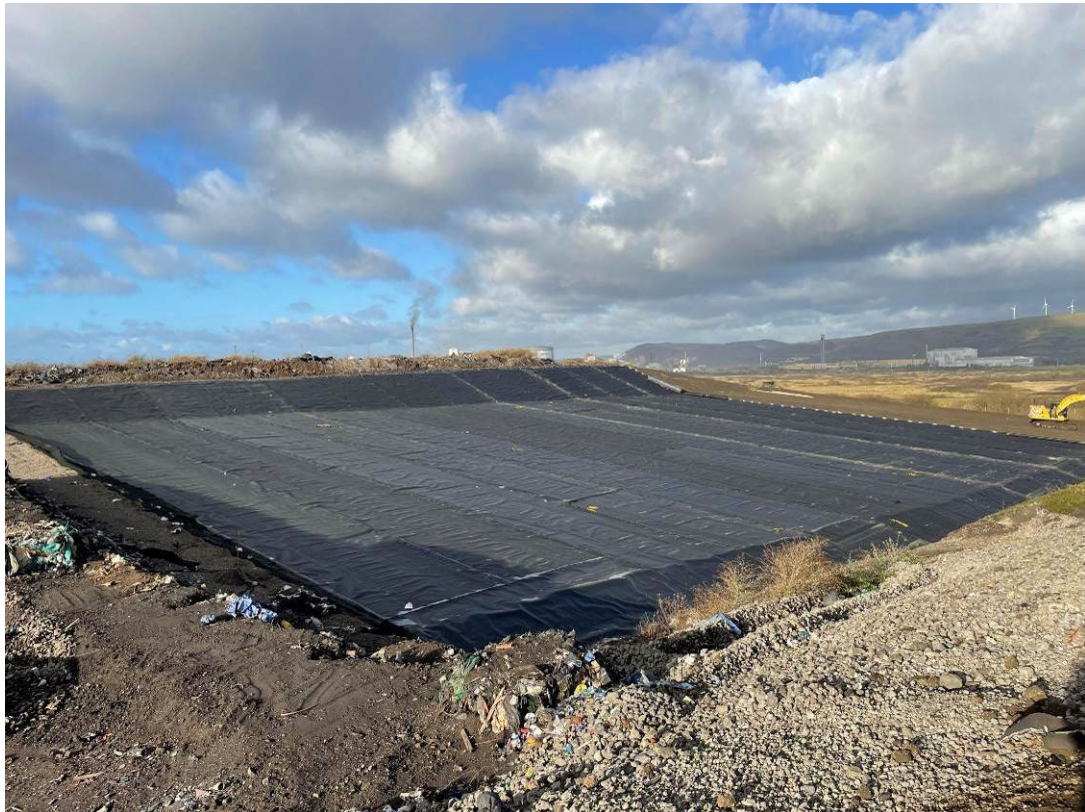
**Plate 3-2 View north over new Biocell extension geomembrane lining**

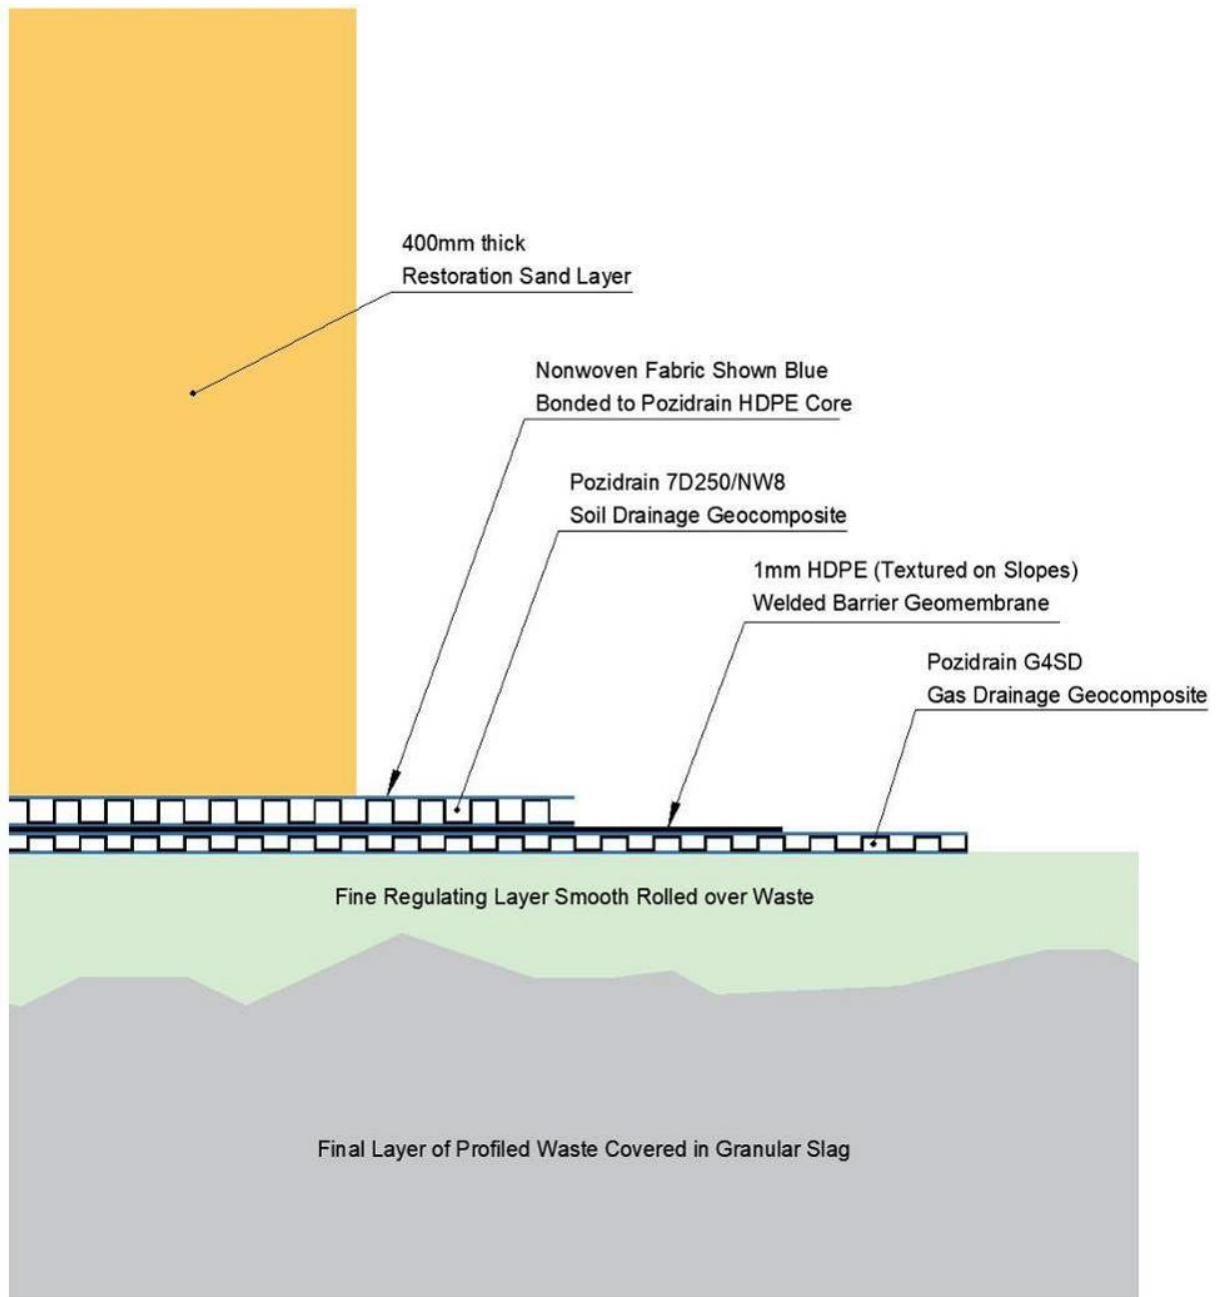
**Plate 3-4 Capping System Layers**

During early 2022, Biocells A and B were capped and restored with much of the work complete by the end of May 2022, as shown by the landform in Plate 3-3. The capping system and landform was constructed in the same way as that used to cap MCL and the design is shown in Plate 3-4. The works involved the placement of a regulating layer; a protection/gas drainage geo-composite, a 1mm HDPE geomembrane comprising both smooth and double rough sided (DRS) types (for plateau and slope areas); placement of a geo-composite surface water collection layer and finally the restoration soils comprising site won sand. The construction of the recharge trench to accept run-off from the newly capped areas is currently ongoing in accordance with the approved designs.

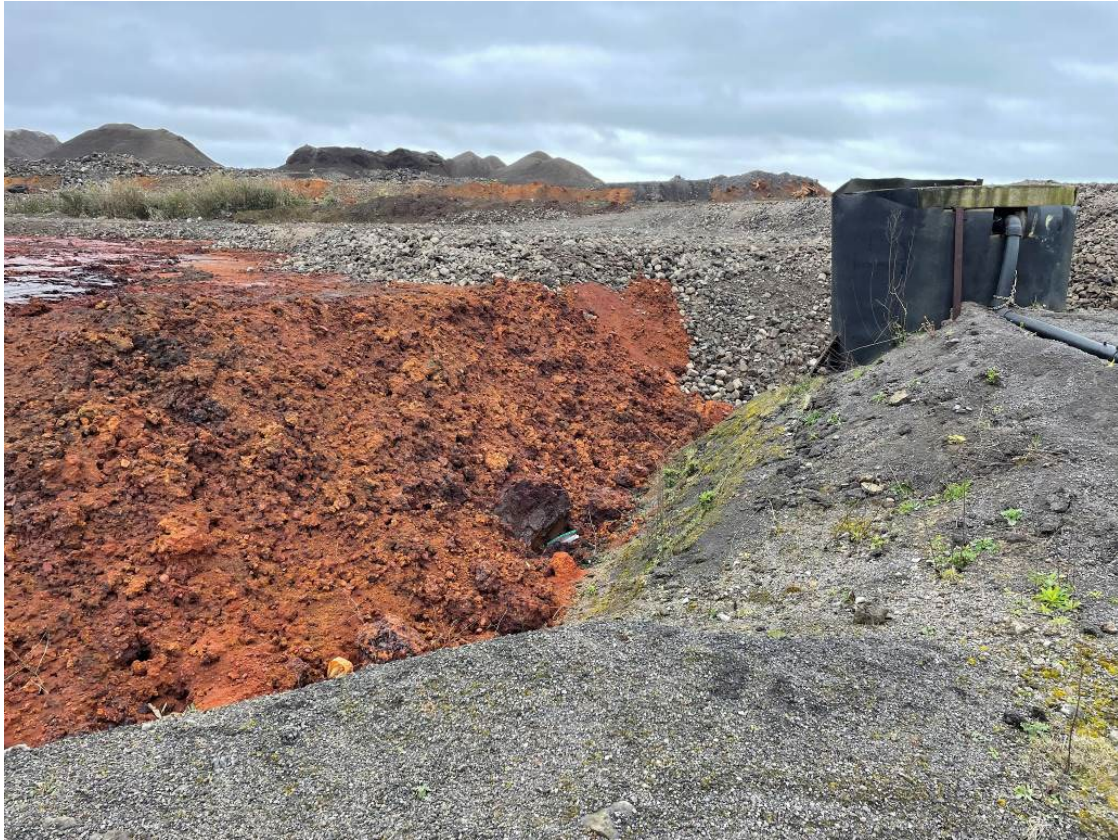
**Plate 3-5 Filtercake deposition adjacent to sump L8**

A summary of the waste types and tonnages deposited at the landfill as recorded by the landfill operator is regularly submitted to NRW in accordance with the Permit requirements. A full graphical record of waste deposition is presented in Appendix 1 and a summary in Chart 3-1. This shows the data records up to the end of 2021. It is evident that the mass of waste being landfilled is declining significantly. Some of the waste being landfilled is shown in Plates 3-5 and 3-6.

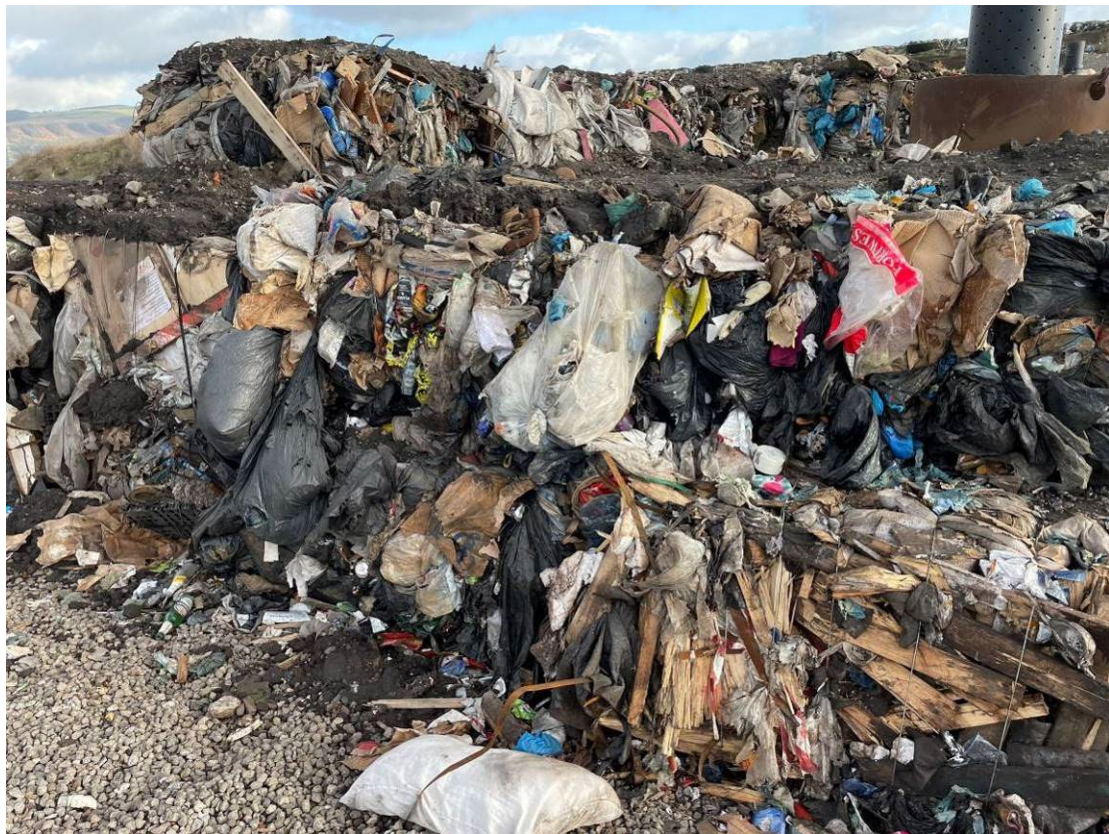
**Plate 3-6 Typical waste placed in bio-cell beneath daily cover**

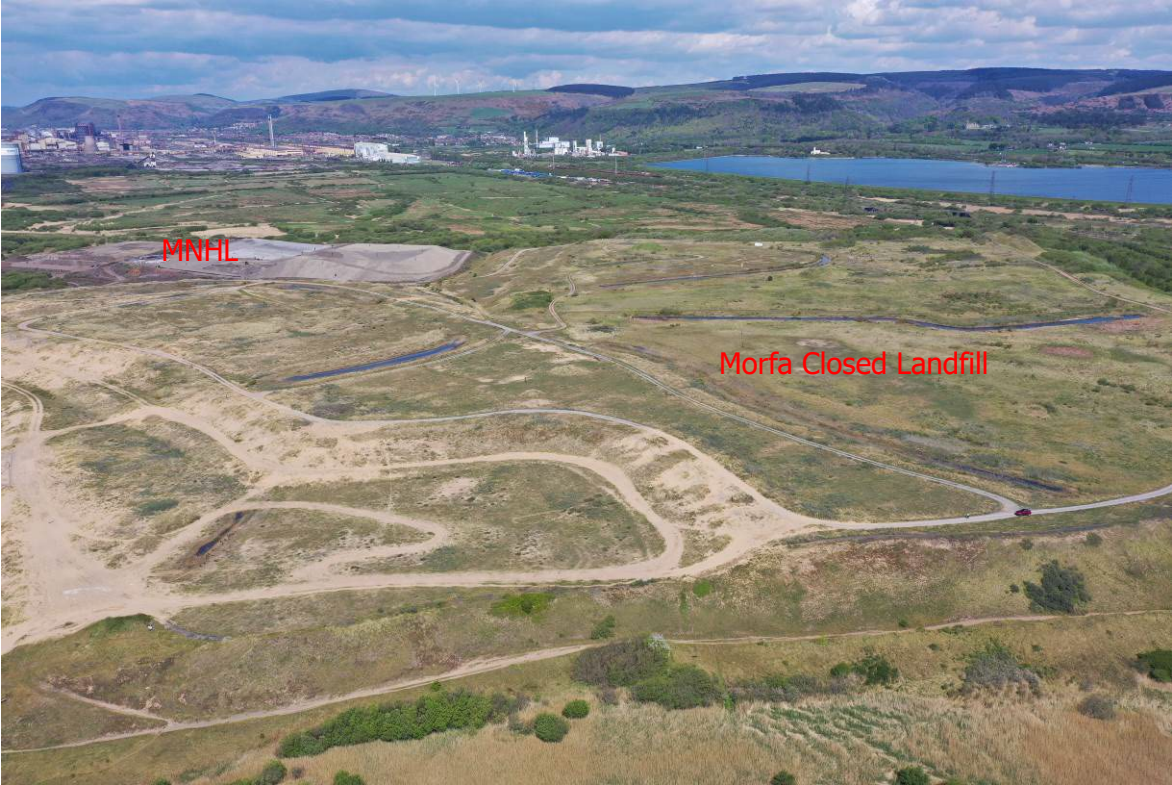
**Plate 3-7 Typical restoration profile on surface of MCL**

Phased restoration of unlined MCL was undertaken between 2004 and 2013. The restoration involved the placement of site won dune sand over the plateau and parts of the re-profiled slopes. Below the sand, the restoration scheme involved placement of geomembranes shown in Plate 3-4 which, in combination, provide gas and surface water management as well as providing barriers to precipitation ingress and gas egress. The sympathetic restoration also involved the placement of sand on top of the geomembranes, creating dune morphology like the surrounding land. The restoration landscape, managed in accordance with an Ecological Management Plan, is shown in Plate 3-7.

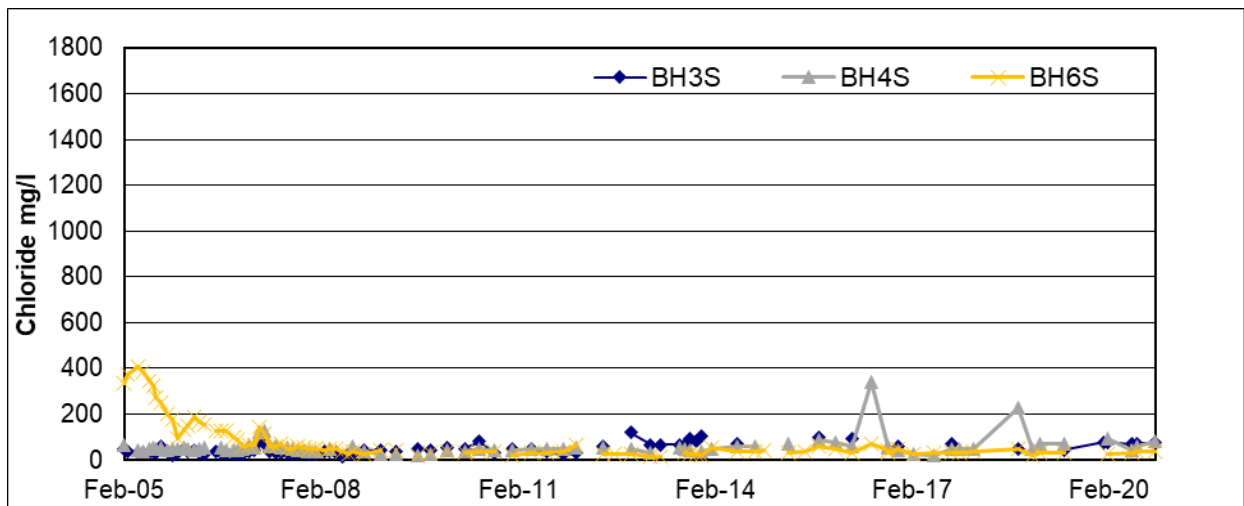
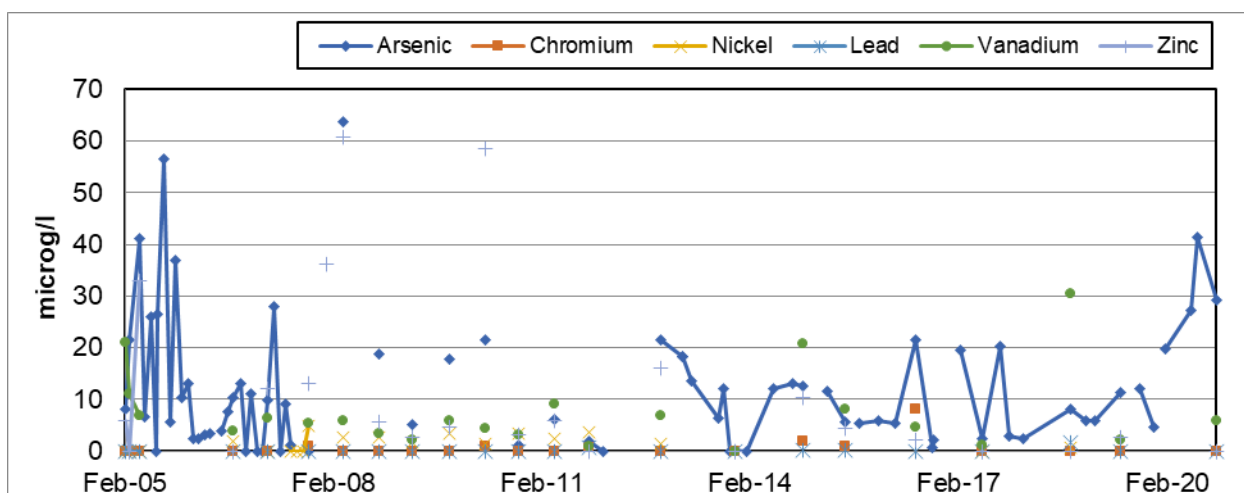
**Chart 6-6 Temporal variation of water chemistry around edge of site**

In the shallow aquifer downgradient of the active cells, samples of groundwater have for some time revealed relatively short-term increases in alkalinity. These are considered to be related to the leaching of alkaline components from MCL, other areas of unlined waste and variations in shallow groundwater levels. Short-term variations (spikes) in the concentration of ammonia, calcium and several trace metals may also be due to the same processes and such occurrences are not currently persistent. There is currently no evidence to suggest seepage from MNHL is the cause of these variations as chloride, a key indicator of MNHL leachate, is not sustainably increased, as shown below.

Groundwater quality downgradient of MNHL, along the boundary with Margam Moors SSSI (BH3, BH30, BH4 and BH6) is similar to the upgradient chemistry observed at GWT3A and BH17S – BH20S. At BH30 and BH4, the groundwater is less mineralised than groundwater to the west at BH3 and to the east at BH6. This may be indicative of variations in shallow groundwater quality caused by the occurrence of the springline to the west and historical seepage from MCL to the east.
