Compliance Assessment Report CAR_NRW0049600

Permit being assessed: ZB3090HA

For: BRYNMAWR SEWAGE PUMPING STATION, held by DWR CYMRU CYFYNGEDIG
At: BRYNMAWR, EBBW VALE, BLAENAU GWENT, SOUTH EAST WALES, NP23 4SH.

Type of assessment carried out: Site Inspection, Reason: Routine.

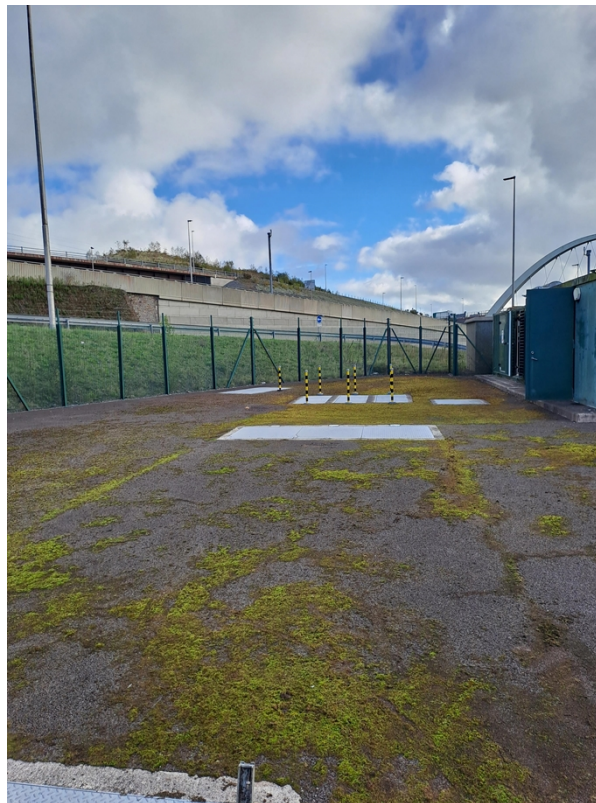
General site conditions were good at the time of the visit. The appropriate security fencing, gates and signage were all in place and the compound was clear of any obstructions or hazards. This is evidenced in Figure 1.

Figure 1: General site conditions as observed during the visit.

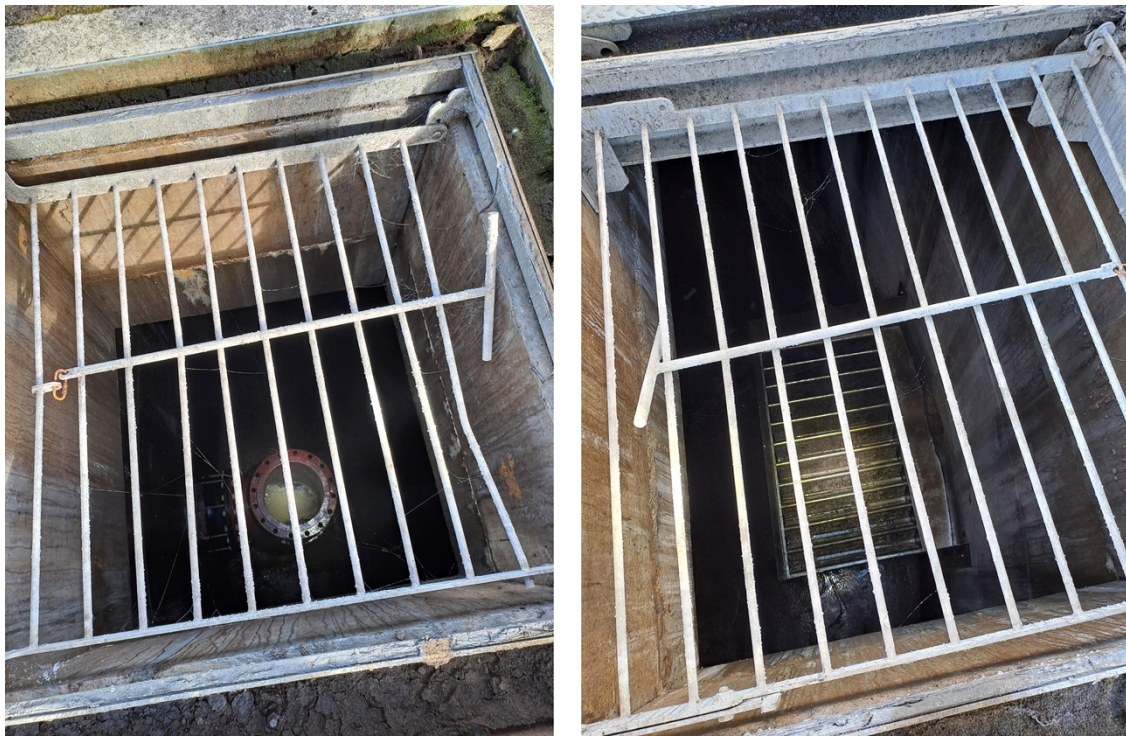
The inlet and screens were observed and were found to be clear of debris, as seen in Figure 2. It was noted that they are both cleaned at the same time as the wet well, as described below. It was also stated that the asset operates a grit trap, which is on a timer, and is also a part of the same routine cleaning schedule. I had no concerns or advisory comments to make on these components.

Figure 2: The inlet and screen as observed during the visit.

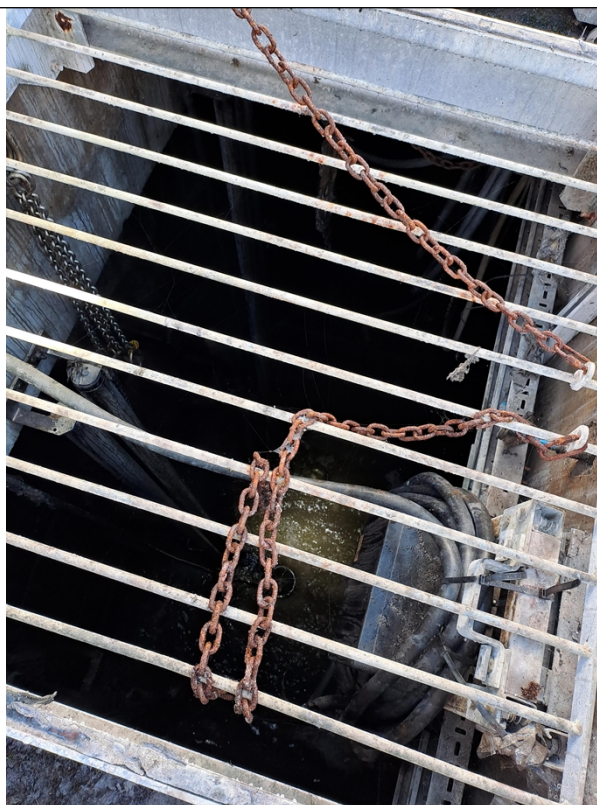
The wet well was inspected, with TB noting that this asset has a large well, the condition of which can be seen in Figure 3. As seen, chamber covers and safety grates were in place over all exposed voids. There were no apparent cracks or defects present and there was sufficient capacity at the time of the visit. I requested that TB confirm the storage capacity at the site which is actioned below. The well is on a quarterly cleaning and maintenance programme, the most recent clean conducted on the 19/09/2025. This record was observed in the site log book which is discussed below. No noxious odours were present.

When queried, it was explained that the 3 pumps on site are situated within the “lower well” and are operated on a 1 duty, 1 assist and 1 standby arrangement. These pumps all have a capacity to pump at 90l/s. The pumps were in operation at the time of visit and appeared to be in good working order and not producing any concerning noise indicating effective operation. I requested information on the last instance of pump maintenance which is actioned below due to the details not being available at the time of the visit.

Figure 3: The wet well as observed during the visit.

1. Confirm the storage capacity of the system.

2. Provide, with evidence, the records showing all recent maintenance on the pumps.

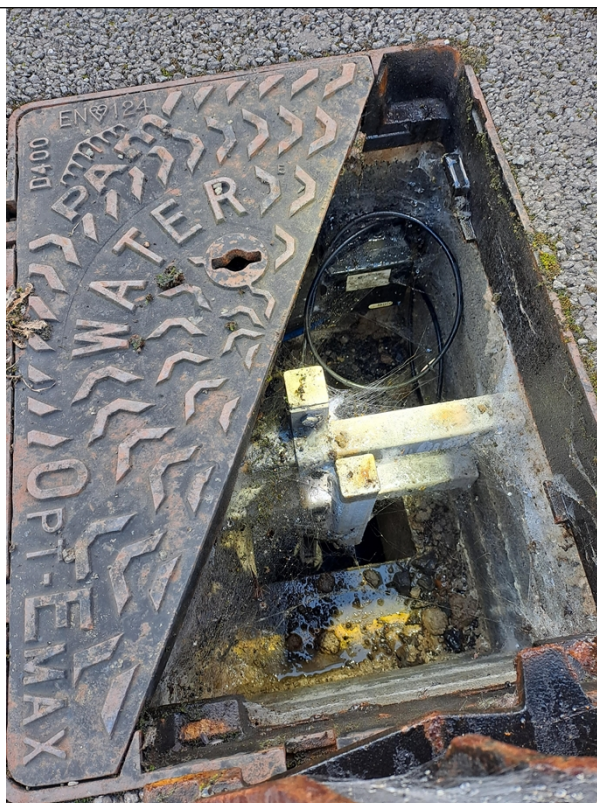
Telemetry and level sensors are located within the wet well (albeit accessed by a separate chamber) (Figure 4). They were clean and operational, with flow meters stated to be in place on each pipe within the valve chamber. It was noted that the telemetry systems were on a yearly maintenance schedule, of which I requested the most recent service and maintenance report(s) as actioned below. I also requested a copy of EDM (including spill/discharge events) and flow monitoring data, which is also reflected in the actions list below. TB noted that they were not aware of any recent discharges via the emergency overflow. At the time of the visit, the system was running at 87l/s.

Figure 4: The telemetry and EDM sensors as observed during the visit.

3. Provide, with evidence, the records showing all recent maintenance and calibration

of the telemetry systems.

4. Provide EDM data records for the 12 months prior to the inspection (Sept 2024 – Sept 2025).

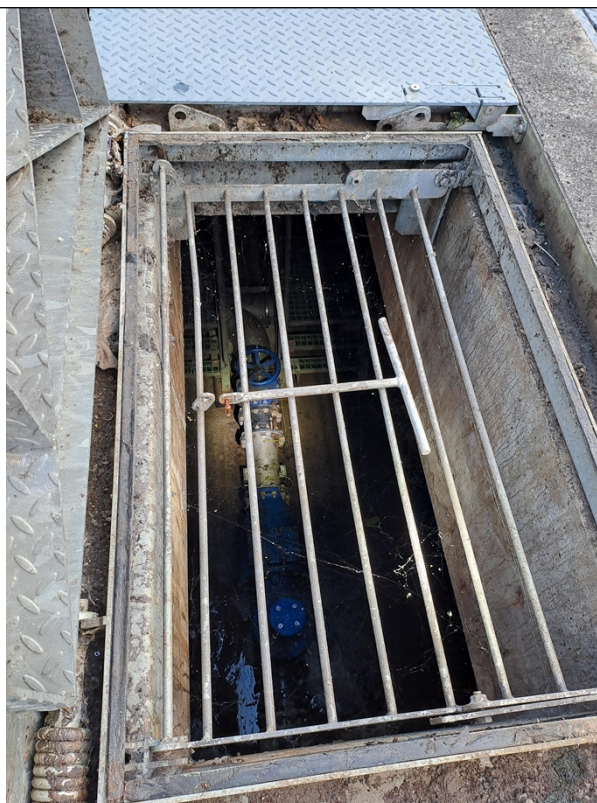
The valve chamber was inspected and was found to be secure and accessible. All infrastructure within appeared to be in a good condition with TB noting the isolation and non-return valves were working and that the system also possesses air valves. These observations are seen in Figure 5.

Figure 5: The valve chamber as observed during the visit.

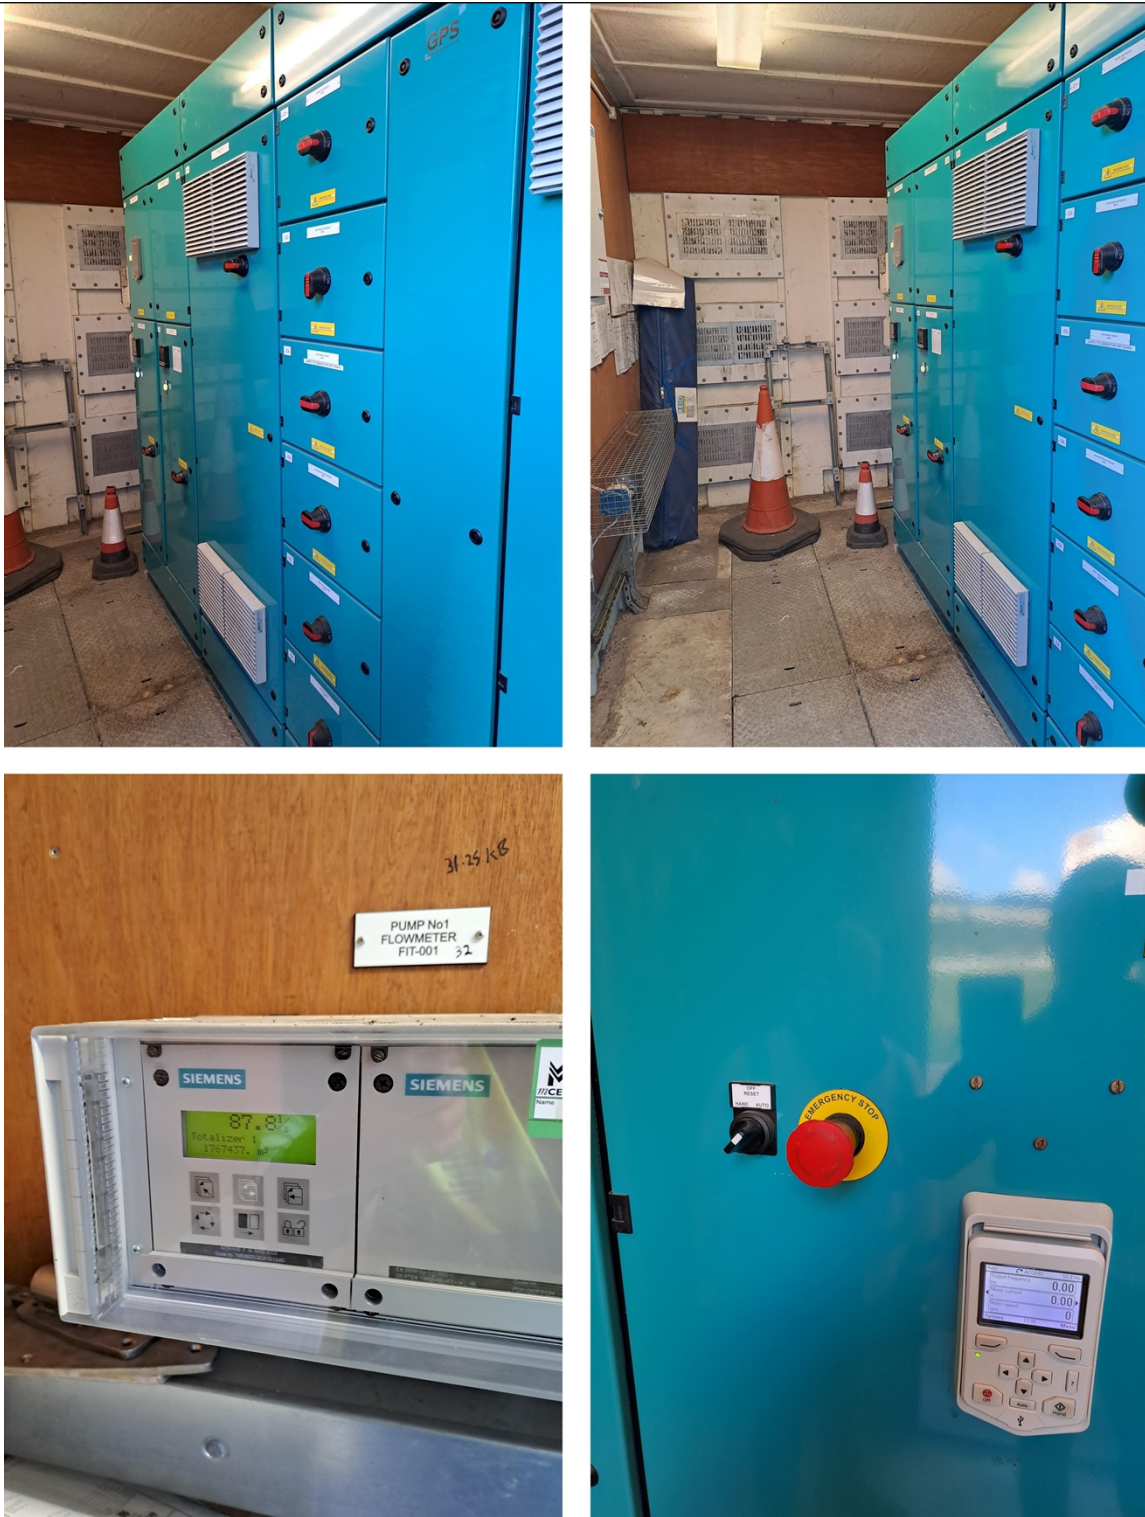
On inspection, it was clear that the control panel and unit were in a good condition. All panels were clean, clear and dry with no cracks or condensation present. An emergency stop function was in place as well as a backup generator on site. TB displayed the generator was in good working order through a brief activation, as well as providing evidence that the fuel level sat at 5613l with a capacity to hold 7500l, although it was stated no more than 7000l was ever stored on site at once. These observations are evidenced in Figure 6.

Figure 6: The control room infrastructure as observed during the visit.

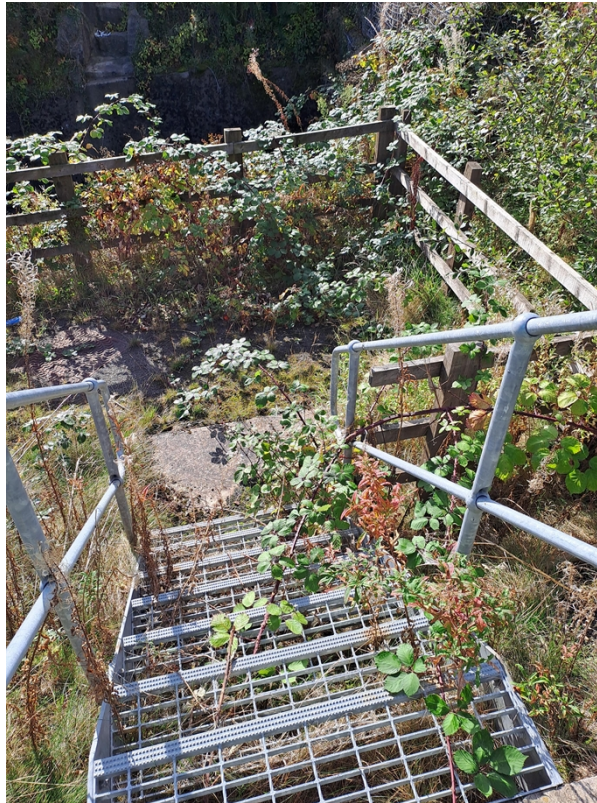
The sample/discharge point was accessible, however some overgrown vegetation was present on the access steps, as seen in Figure 7. It was noted that a clearance of this

vegetation would be actioned.

Figure 7: The access route to the sample/discharge point as observed during the visit.

6. Clear the access route to the sample/discharge point of vegetation and provide evidence of its completion.

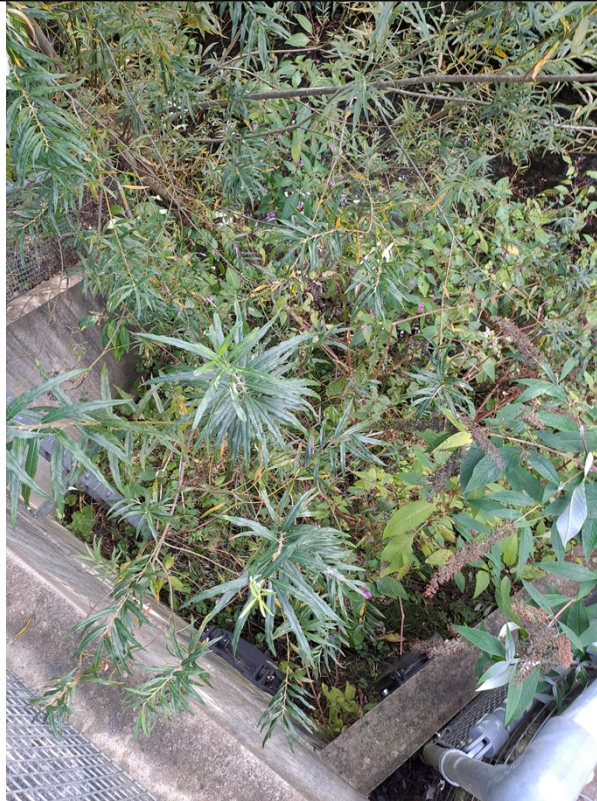
The sample/discharge point was located and recorded to be situated at SO1973612159, ~20m upstream of the listed coordinates in the permit, but is within the acceptable discrepancy and as such is compliant. The outfall (as observed in Figure 8) was not discharging at the time of the visit, with no evidence of recent discharges present. There was no debris in, around or downstream of the outfall. As with the access, the outfall was slightly restricted by vegetation growth. This could hinder the ability of operators undertaking required sampling work so an action to clear the outfall of vegetation has been set. Please see the actions list below for further details.

Figure 8: The outfall as observed during the visit.

7. Clear the outfall of vegetation to ensure access for all maintenance and sampling required and provide evidence of its completion.
