Pumping Test Report & Hydrogeological Impact Appraisal

Vale Resort

Hensol Rd, Hensol, Pontyclun, CF72 8JY

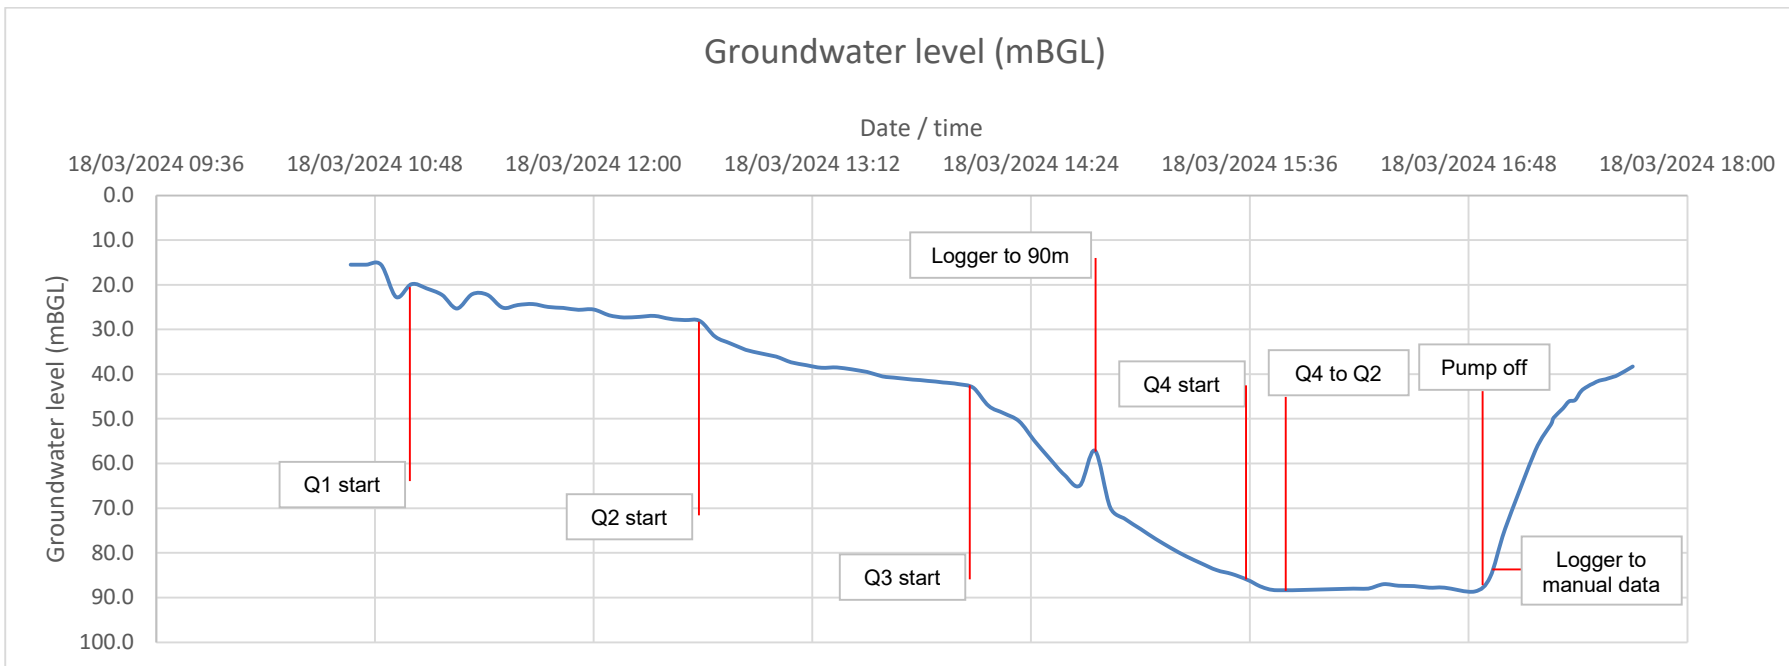
Figure 2-2 Shooting Range Borehole step test – groundwater level (mBGL)

A number of aspects of the step test have been labelled in Figure 2-2 including changes between steps, changes to the logger depth where this was necessary due to rapidly falling groundwater level, changes to a previous step to collect steady-state data, and the end of the test when the pump was turned off. Some disturbance is indicated at the start of step 1 which indicates adjustments to the flow control being made in order to attain the desired pump rate.

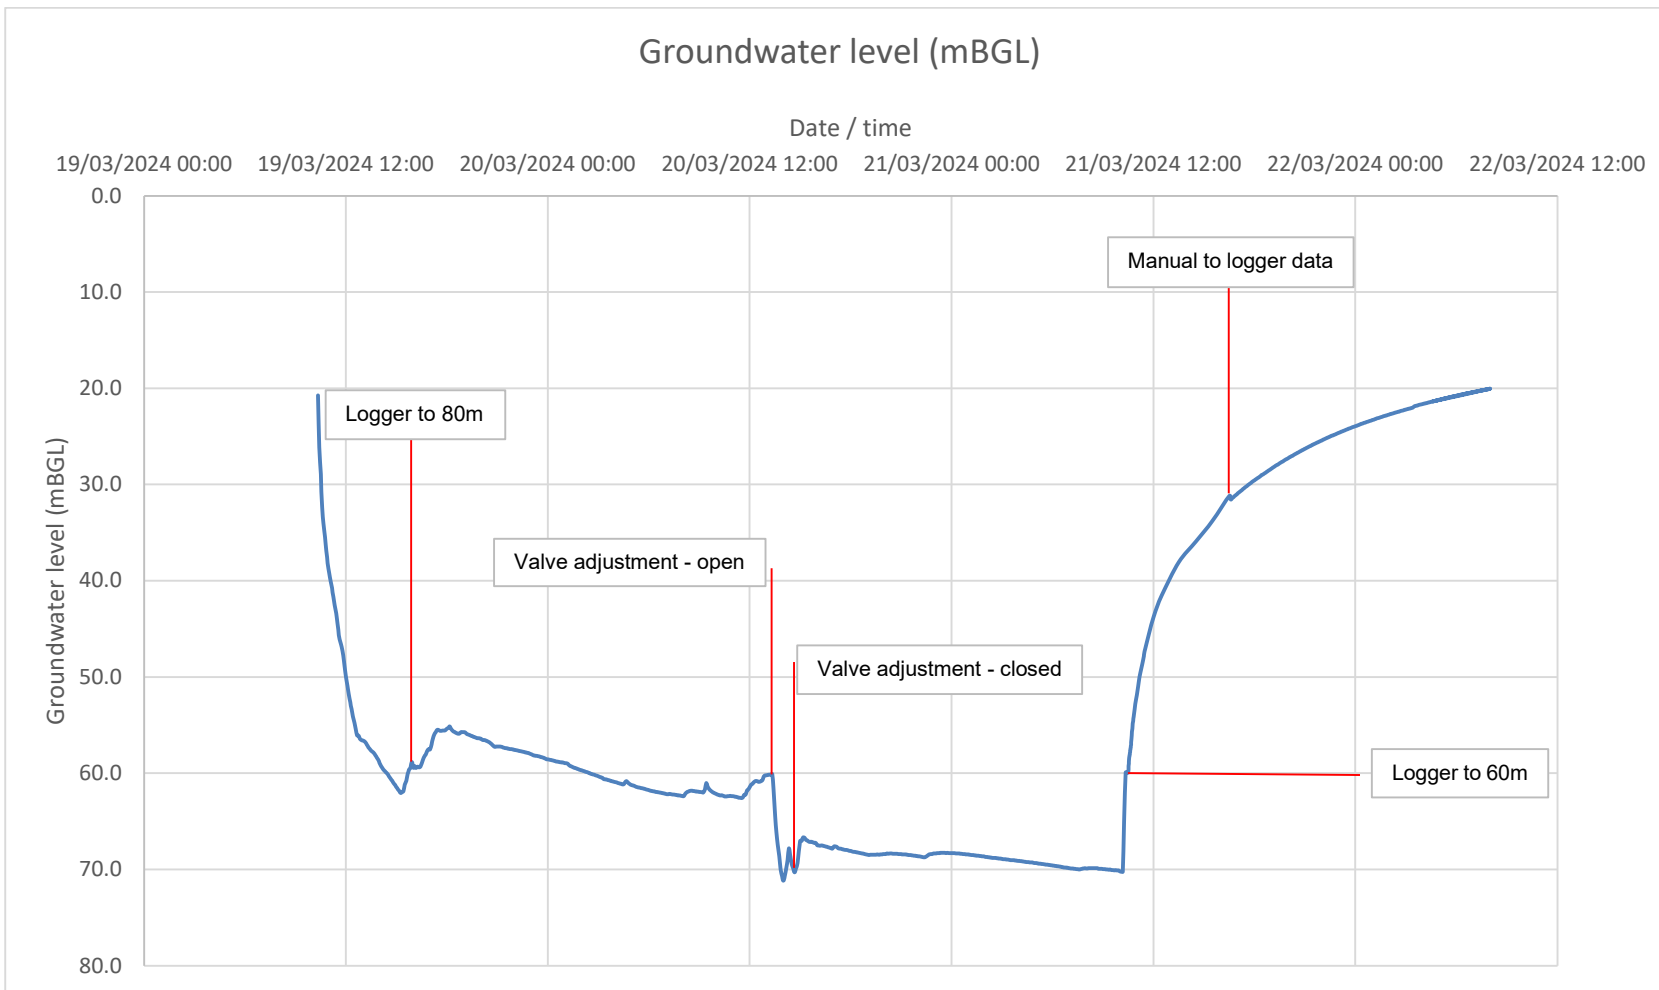
Figure 2-3 Shooting Range Borehole constant rate test - groundwater level (mBGL)

Through the course of the constant rate test it was observed that the pump rate initially set was decreasing gradually, and then more significantly on the 20th March 2024, therefore an attempt was made to reset back to and maintain the original rate. However, any slight adjustment proved difficult with the flow control valve installed and it was decided to leave the pump rate as it was without further adjustment. This event has been marked on Figure 2-3 along with other events such as changes to the logger depth.

The initial groundwater level drawdown was rapid, from a pre-test resting level of 15.81mBGL to over 60mBGL after approximately 4 hours. The groundwater level was drawn down to a maximum level of 70.22mBGL (or 54.41m drawdown) at the end of the constant rate test on the 21st March 2024.

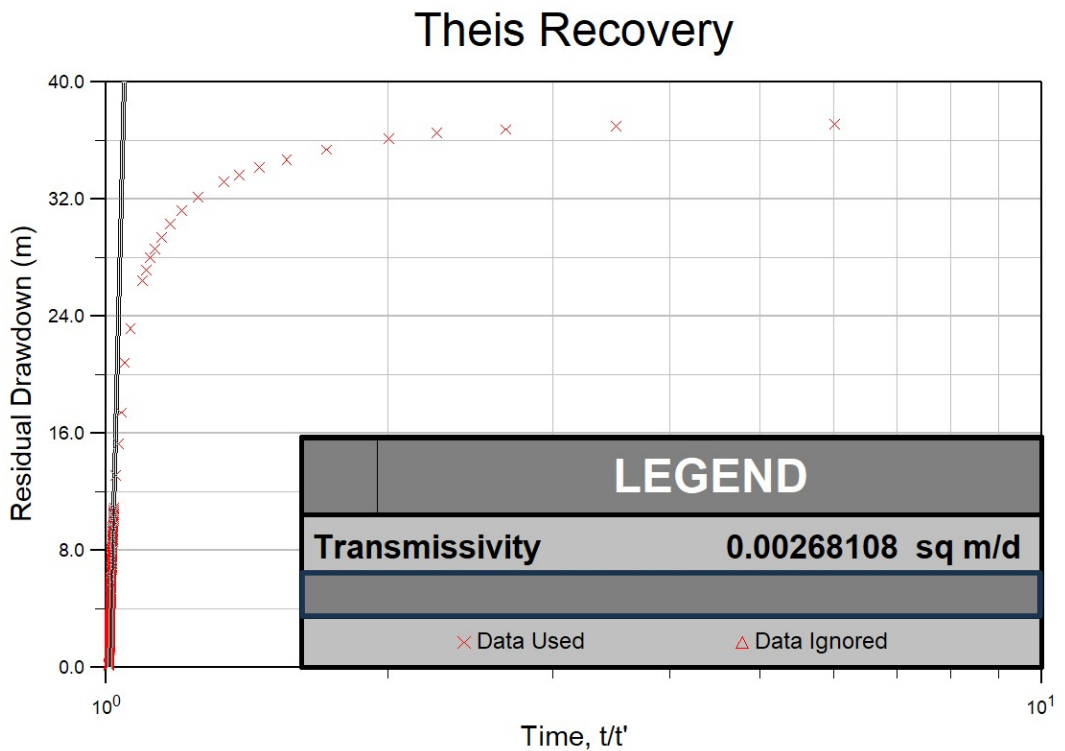
The recovery phase of the test at the Shooting Range Borehole was analysed in AquiferWin32 using the Theis recovery method, shown in Figure 4-3 to Figure 4-5.

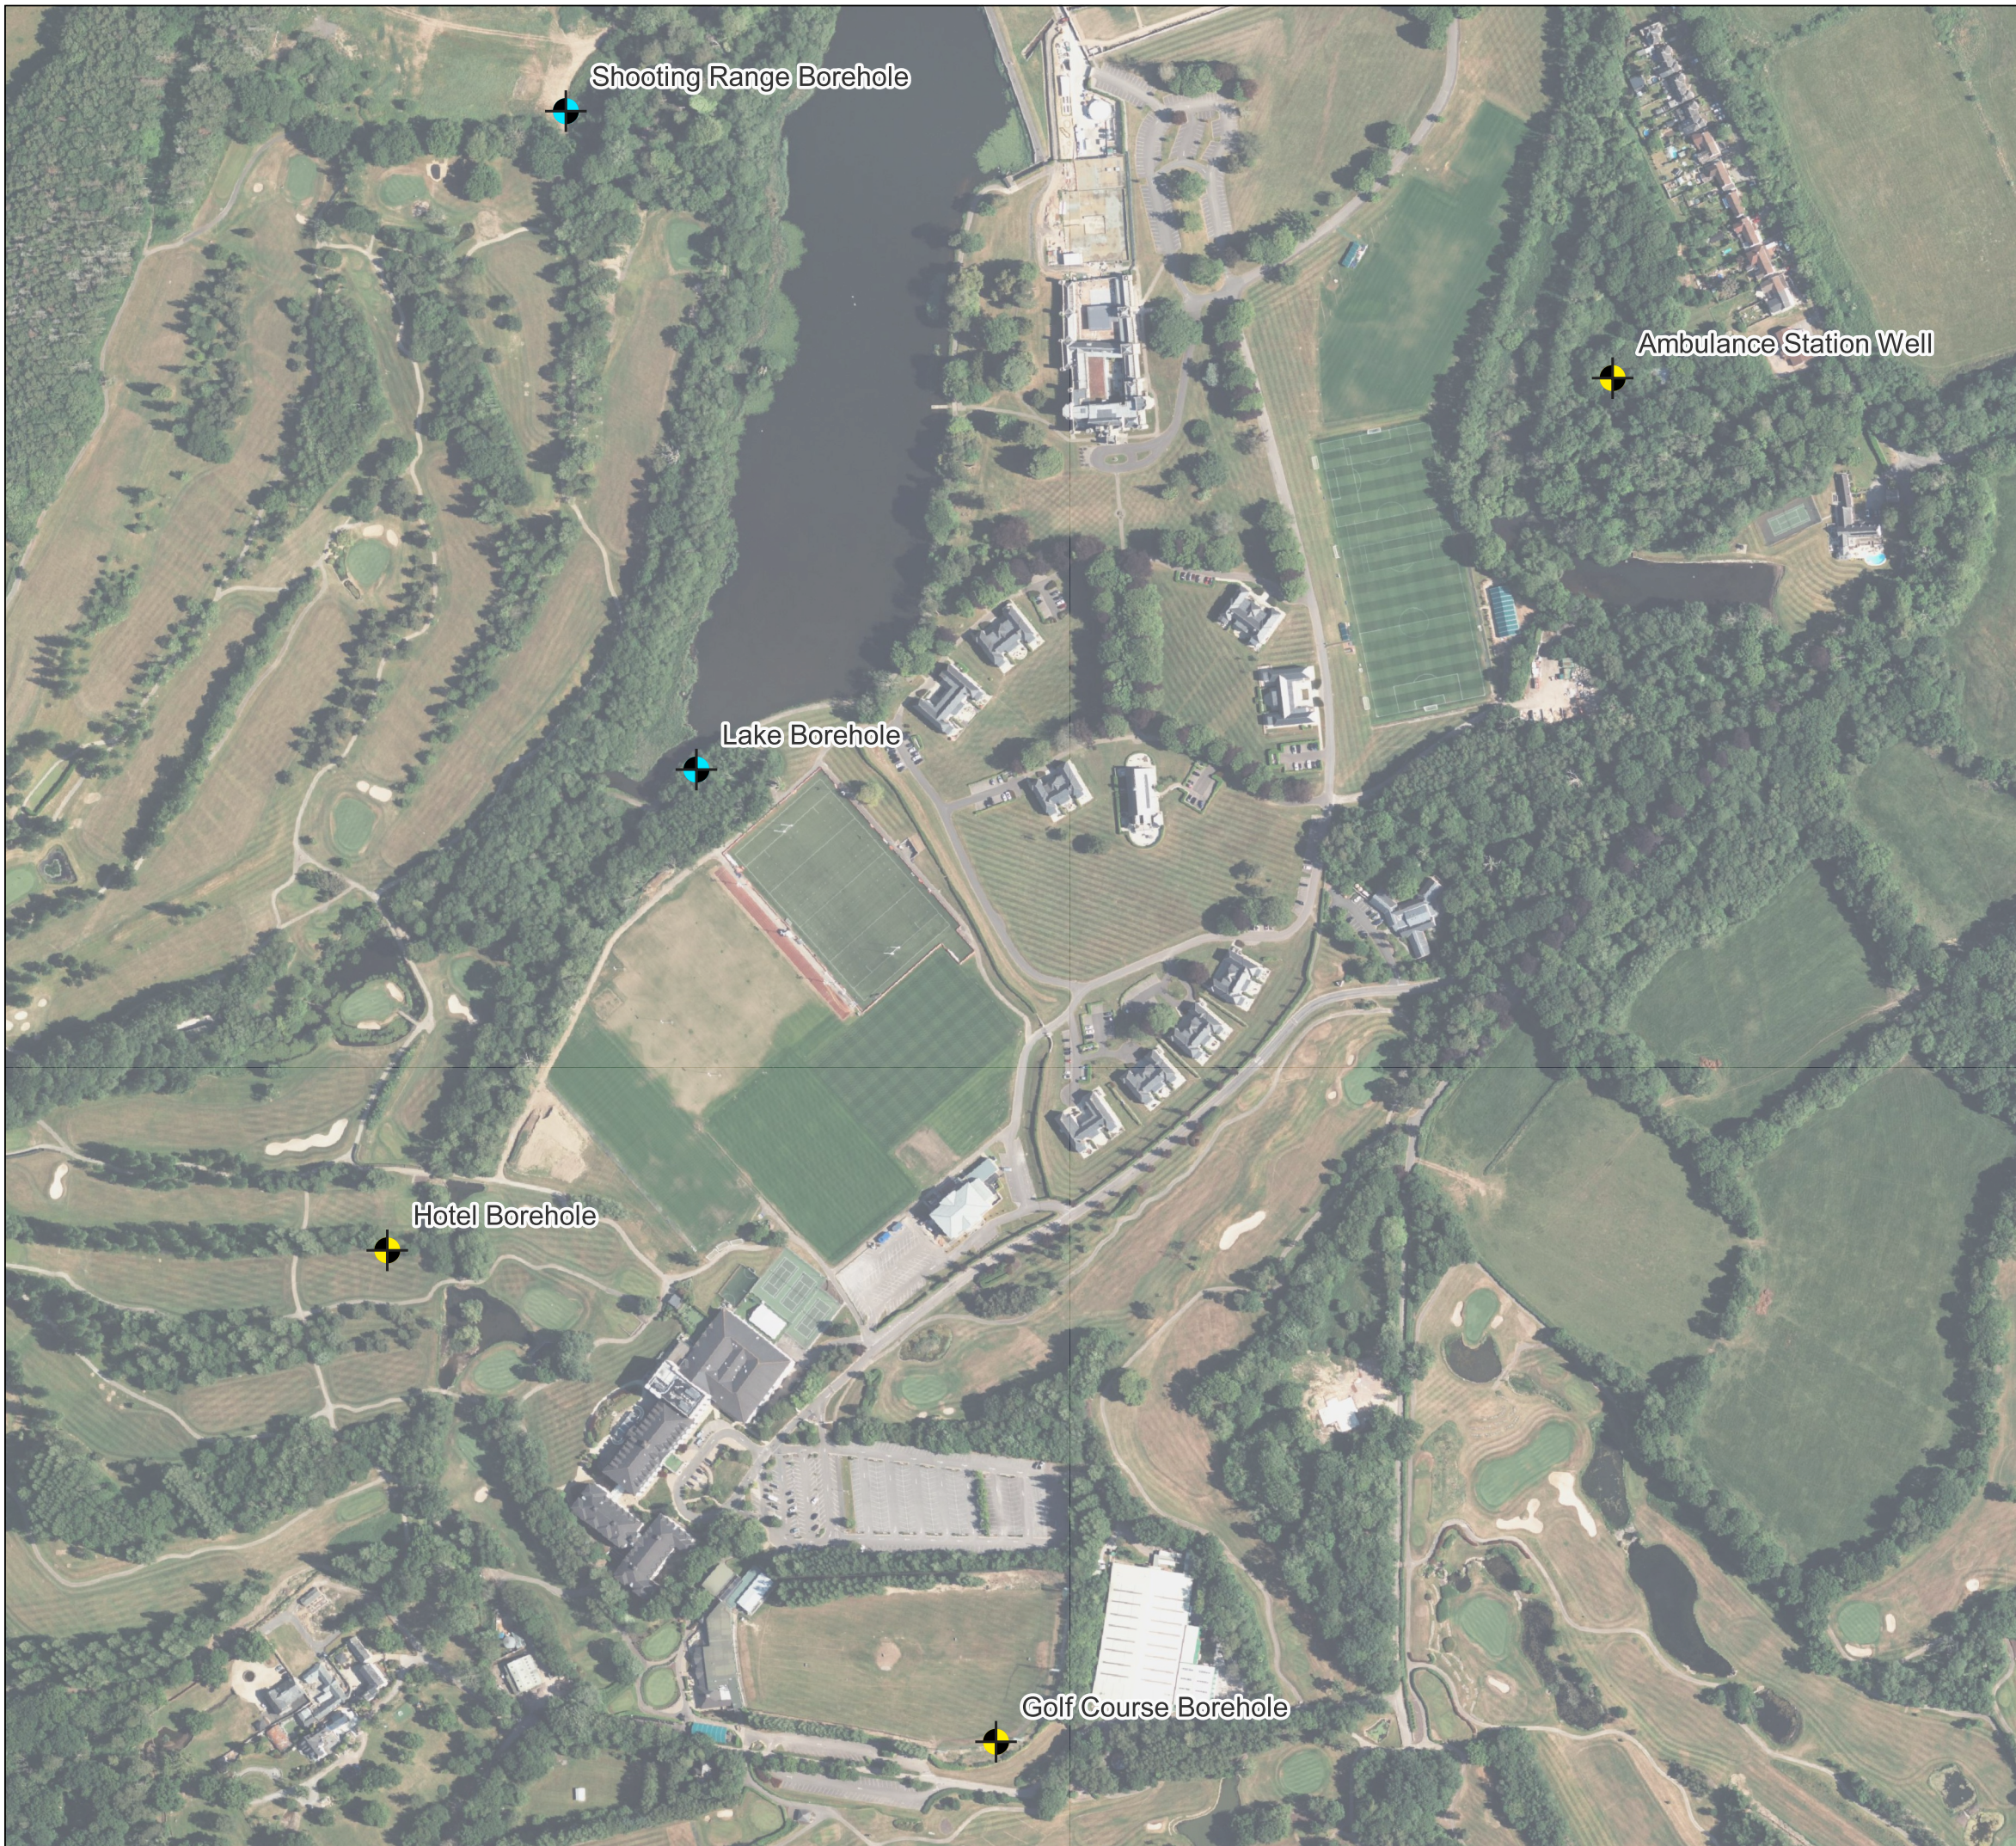
Drawing 3

Borehole location plan

Locations of existing boreholes informed by BGS data and Technical Memorandum by Rigare Limited, January 2020
